# Emergency Watershed Protection Measures in Highly Unstable Terrain on the Blake Fire, Six Rivers National Forest, 1987<sup>1</sup>

Mark E. Smith and Kenneth A. Wright<sup>2</sup>

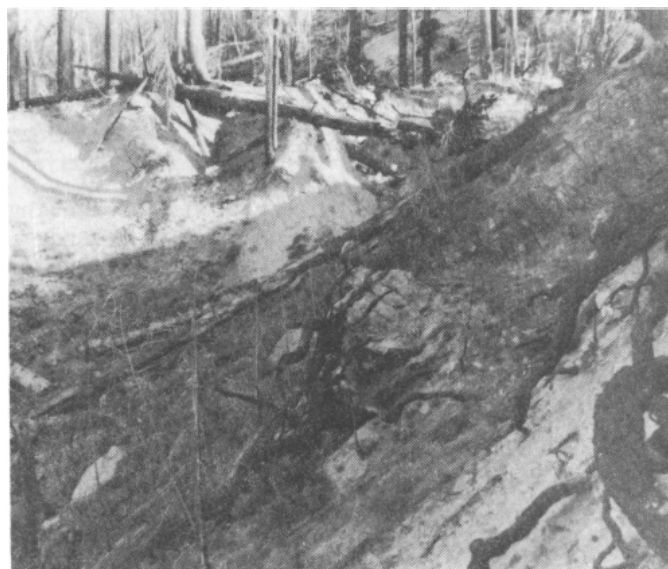
Figure 2--Typical condition of burned out innergorge/gully area. Note 100 percent tree mortality and bare, unstable sideslopes.

mortality of trees within and adjacent to innergorge/gully areas where the channel acted as a chimney and concentrated the heat of the fire (fig. 2). Much of the large organic debris also was consumed in these channels because of the extremely dry fuel conditions (fig. 3). Material that was not consumed tended to be large and often was suspended above the channel bottom. Many hardwoods were burned, but most of their root systems have survived and are sprouting.

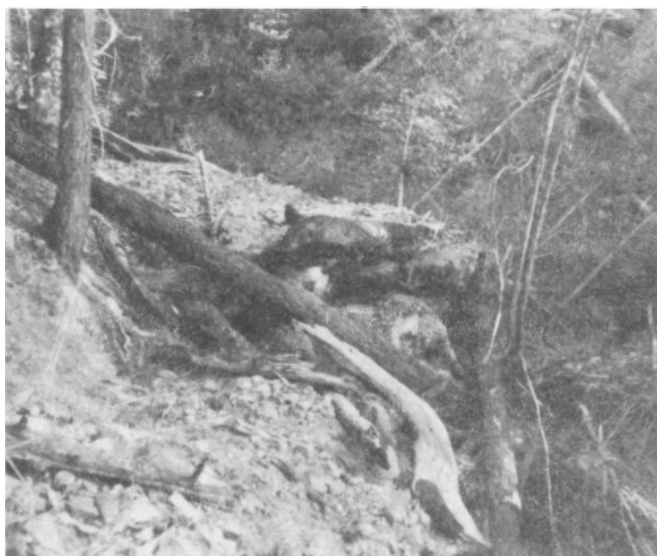
Figure 3--Detail of postfire channel condition showing burned out organic debris and unstable sediment deposits.

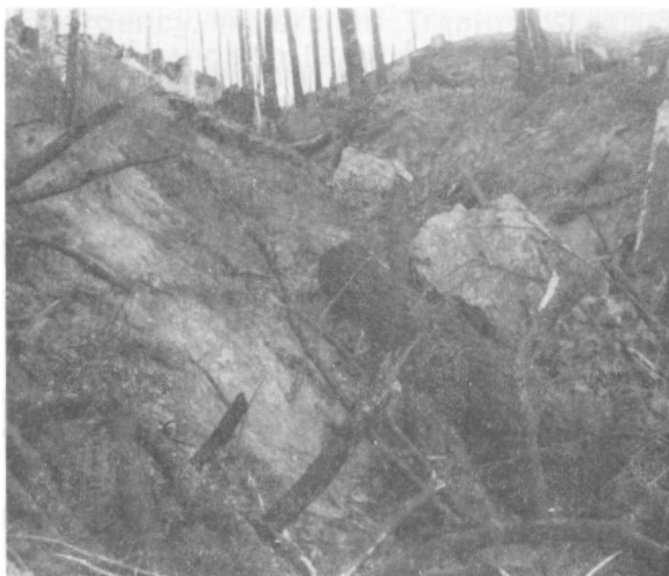
The emergency rehabilitation produced a mixed success. In larger drainages (8 to 12 m deep) where bigger logs were needed, satisfactory placement was difficult to achieve. Some logs were poorly emplaced because the green wood did not break into shorter sections as easily as expected. Bucking existing material usually produced a better result, but hazardous conditions prevented bucking some suspended logs or felled trees that would have created a more effective structure. A workable compromise was to criss-cross logs sub-parallel to the draw axis. Sometimes, a second tree effectively crushed and embedded another log or tree that could not be bucked safely. Wedging logs behind large boulders was another effective technique used in these drainages (fig. 4).

Figure 4--Logs crisscrossed behind 12-foot boulder in large innergorge/gully. Note person in upper center of photo for scale.

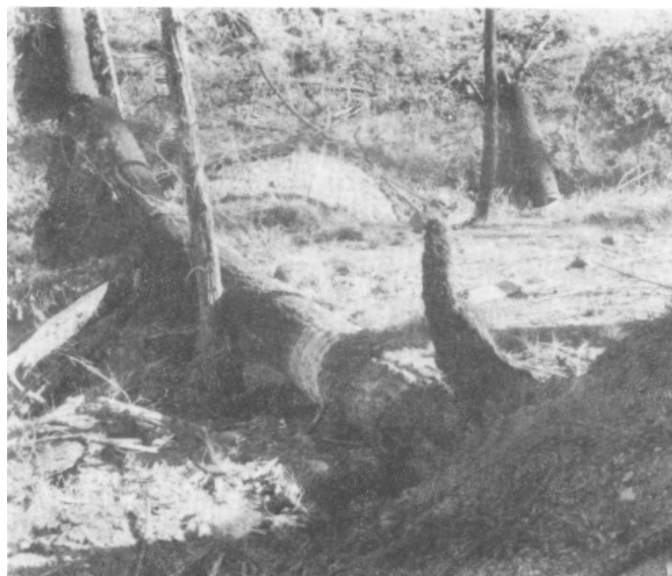
In the smaller drainages, downed material was cut more easily into 6 to 10-foot lengths, forming an arc perpendicular to the draw axis. This generally produced satisfactory structures, but they have less capacity and may not be as permanent as the other more chaotic structures.

The 1987-88 winter produced no major storms. Only moderate amounts of sediment were mobilized in the burned area as a result of landsliding. Despite the mild winter, most of the structures in the smaller drainages filled to capacity, mainly with the sediment that was formerly retained behind burned out organic debris (fig. 5). The combination of wedged straw bales and logs appeared to work most effectively in the smaller drainages, judging by the amount of sediment that they retained. In some places, partial breaches developed beneath or around a log, suggesting that straw bales alone would have been considerably less durable in these steep gradient channels.

Figure 5--Typical log and straw bale retention structure in one of the smaller drainages. Note accumulation of sediment behind structure.
