# Emergency Watershed Treatments on Burned Lands in Southwestern Oregon<sup>1</sup>

Ed Gross, Ivars Steinblums, Curt Ralston, and Howard Jubas<sup>2</sup>

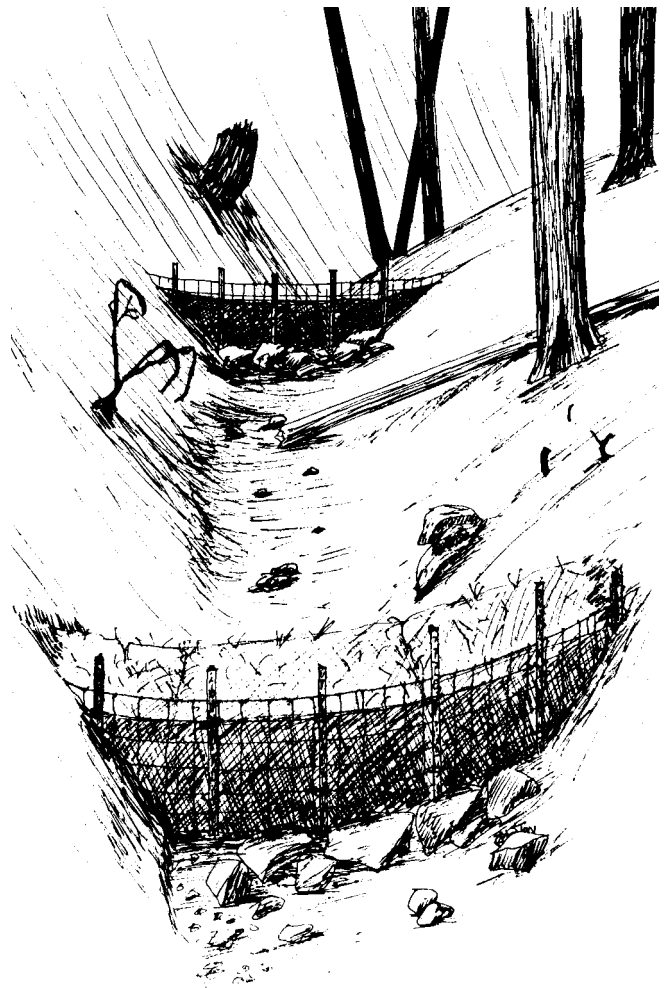
Figure 1--Straw bale check dam. Bales are wrapped in plastic netting, placed against woven wire fence, sealed at ground line, and staked.

- Straw bales placed against woven wire fence and wrapped in netting were effective dams in streams with few cobbles and boulders (fig. 1). water sometimes undercut check dams that were not sealed on the stream channel.

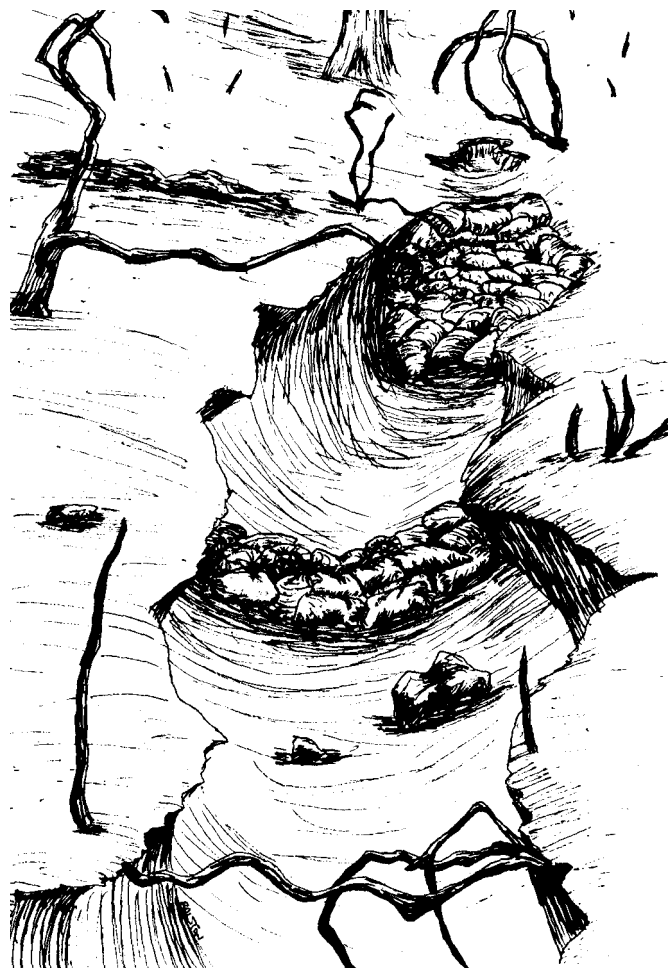
Figure 2--Sand bag check dam. Rot-proof sand bags are filled on-site and keyed to gully bottom and walls.

- Sand bags were highly effective and worked best to prevent headward cutting of the stream channels in fine textured soils (fig. 2). Bags made of slow-to-degrade erosion cloth should be used to insure that the structures will last for several seasons.

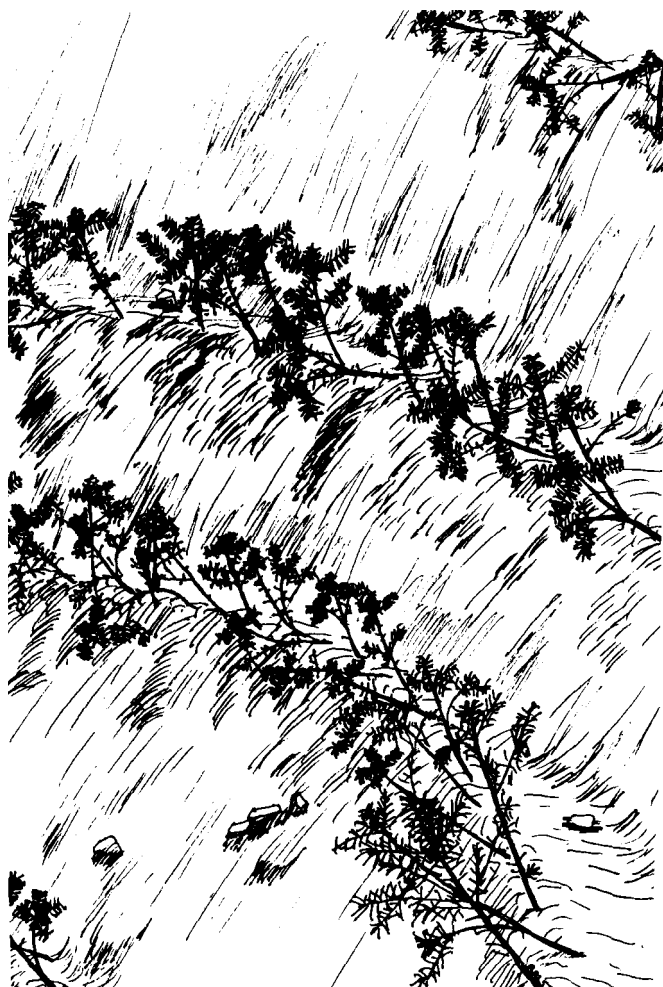
Figure 4--Douglas-fir 2/0 seedling cordones planted on a steeply sloping landslide.

-Douglas-fir 2/0 seedlings were planted in "cordone" style on a 90 percent slope of a pre-fire landslide (fig. 4). This slide posed renewed erosion activity following the Longwood Fire. We expect the cordones will provide an excellent, long-term ground cover on these highly erodible soils.
