# CHANNEL-DYNAMIC CONTROL ON THE ESTABLISHMENT OF RIPARIAN TREES AFTER LARGE FLOODS IN NORTHWESTERN CALIFORNIA<sup>1</sup>

Thomas E. Lisle<sup>2</sup>

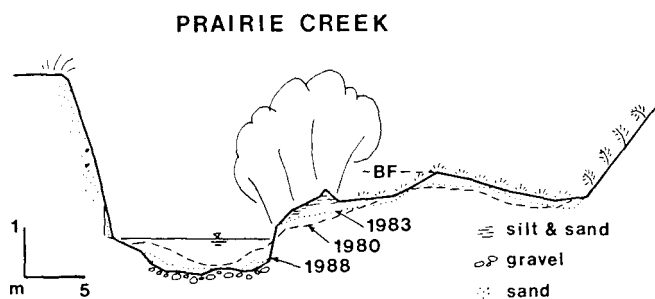
**Figure 1** – Cross section of Prairie Creek, showing bed elevation changes from 1980 to 1988 and the distribution of riparian vegetation and substrate. Approximate bankfull elevation is indicated by BF.

A natural levee approximately 0.7 m high had accreted progressively on the inner right bank immediately adjacent to the mobile bed from 1980 to 1988 (fig. 1). The levee, which was composed of fine sand, silt, and organic debris, supported a narrow dense stand of red alder (*Alnus oregona*). The levee was highly irregular, due to locally thick deposits of newly laid fine sediment and local scour around large woody debris caught among the alders. The alders were rooted at about one-half of bankfull stage, and thus were probably flooded several times on average each year. Bankfull elevation in this cross section was poorly defined but, by extrapolation from adjacent reaches, corresponds approximately with the top of the bar.

In contrast to the levee, the adjacent bar surface was smooth and covered with low herbaceous vegetation. The bar accreted less than 0.3 m from 1980 to 1988. The bar surface in 1980 was composed of sand and pebbles and scant herbaceous vegetation; by June 1988, a denser mat of vegetation and organic matter had accumulated. This mat was probably more efficient at trapping fine sediment than the sparsely vegetated surface of 1980.

Repeated surveys of this cross section since 1980 suggest the following sequence of processes in forming the levee on the inner right bank. A major flood occurred in the Redwood Creek basin in 1975 (Harden and others 1978). Tree-ring dating of the largest trees on the levee indicate that trees within the channel were stripped by the flood but reestablished within a few years. The entire streambed was extensively reworked by the flood, or in other words, the bed apparently became mobile over its entire width (39 m).

Afterward, the mobile zone of the bed contracted to approximately its width at the time of study (10m), and alder were able to colonize the low-water's edge along the left margin of the bar. At this time the bar surface merged smoothly with the mobile bed, as indicated by the 1980 survey. During even modest stormflows, high

friction generated by alders rooted low in the water created steep velocity gradients away from the main flow and promoted rapid deposition of fine sand, which is only intermittently suspended. Sand comprises as much as 55 percent of suspended sediment in Prairie Creek (Lisle in press). Sedimentation rates over the remainder of the bar were slower because of its smoothness and the depletion of coarse suspended fractions at the levee. As a result, the levee originated at a lower elevation but built faster than the bar, so that a level floodplain may be formed eventually. Channel incision since 1980 apparently helped to define a higher bank as the levee built (fig. 1). Root strength probably helped to stabilize these higher banks.

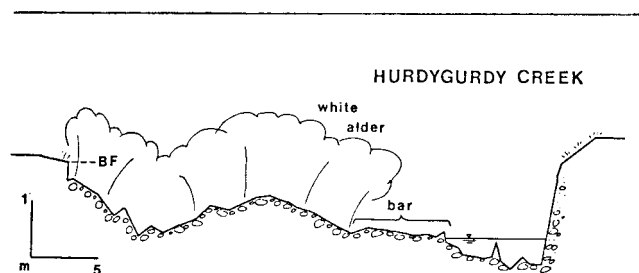
**Figure 2** — Cross section of Hurdygurdy Creek surveyed in July 1986, showing growth pattern of riparian trees and substrate. BF indicates bankfull elevation.

White alders (*Alnus rhombifolia*) grew within the channel of Hurdygurdy Creek, but in contrast with trees in Prairie Creek, were not associated with bank formation (fig. 2). The alders were rooted near the low-flow water surface elevation, which was at less than one-half of bankfull stage. At this cross section, alders on the left portion of the channel ended abruptly at a certain point that was not related to elevation, but instead probably defined the left margin of the mobile bed. The bed to the right of the alders had an equal elevation and thus equal availability of moisture. This area was an active bar deposited against the larger, stabilized flood bar upon which the alders had established. The bed among the alders was clearly not mobile enough to cause removal of the trees. The alders grew among mossy boulders that had not moved apparently since the flood of 1964. Cores extracted from the largest trees indicated colonization of the bar was no later than 1966. The alders had trapped abundant large woody debris but little fine sediment.

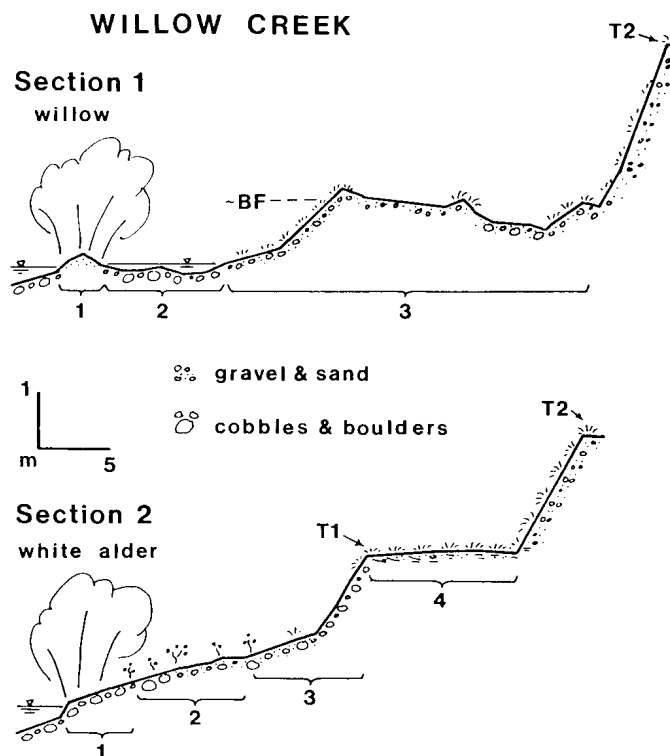
**Figure 3** — Partial cross sections of Willow Creek surveyed in June, 1988, showing distribution of riparian vegetation and substrate. Numbered brackets show vegetation zones of table 1. BF indicates approximate bankfull elevation; T1 and T2 are alluvial terraces.

Wet-site trees and herbs, including white alder, willow (*Salix hindsianai*; *S. lasiolepis*), black cottonwood (*Populus trichocarpa*), and sweet clover (*Melilotus albus*), grew in a narrow band (2-5 m wide) along the low-flow water's edge (Zones 1 and 2 in Section 1, Zone 1 in Section 2, fig. 3; table 1). Riparian alders and willows were established no higher than about 0.4 m above a stage typical of late summer, which is approximately 0.3 m below that during the survey. Bankfull was poorly defined, but corresponded roughly with the top of the bar in Section 1. Riparian trees were rooted at less than one-half of bankfull stage as defined. Cores extracted from the largest trees indicated colonization in 1973-1975. Herbaceous species growing on higher, drier sites (Zones 3 and 4) were typical of those that invade disturbed ground and have a wide range of moisture tolerances. The base of the drier zones was 0.2 m (Section 1) and 0.9 m (Section 2) above late summer stage.

As in Prairie Creek, riparian trees were rooted densely at the low-flow water's edge and appeared to stabilize alluvium sloping toward the channel thalweg. The trees thereby helped to define streambanks that were well below bankfull stage. As in Hurdygurdy Creek, however, little fine sediment deposited among the trees, which would lead to bank formation.

**Table 1** – Species, relative abundance, and indicated habitat conditions of vegetation along zones of Sections 1 and 2 (fig. 3), Willow Creek.
