# RESTORING AND MAINTAINING RIPARIAN HABITAT ON PRIVATE PASTURELAND<sup>1</sup>

Nancy Reichard<sup>2</sup>

*Abstract: Protecting riparian habitat from livestock grazing on private land is a complex task that requires paying attention to sociological and economic as well as physical and biological factors. Six livestock exclusion fencing projects on private property in northwestern California are described. The importance of long term maintenance and the need for landowner incentives are discussed. Significant gains may be made via a statewide, coordinated effort to encourage the protection of riparian habitat on private property.*

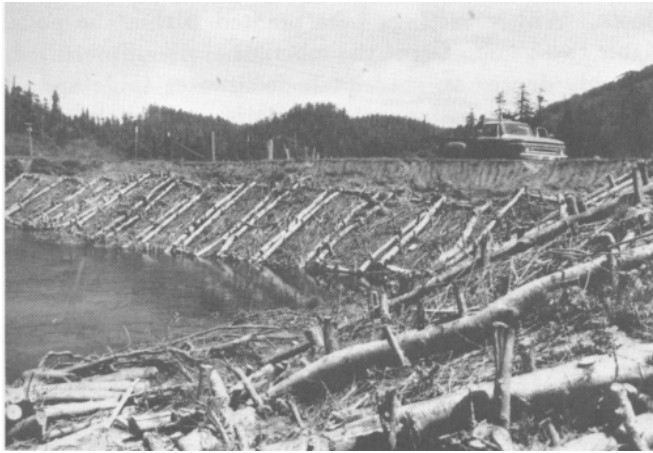
**Figure 2**— Bank stabilization along Prairie Creek. Willow logs and hog wire were staked to what was a bare, eroding streambank. January 1984.

He was willing to convert several acres of pasture into a protected riparian corridor in return for our publicly-funded services used to apply various bio-technical stabilization measures to his banks (figs. 2 & 3). Unlike many landowners RCAA has talked with, he recognized the role that vegetation can play in maintaining streambank stability. As a secondary benefit, he knew that streamside fencing would trap flood-borne woody debris, which he previously had to clear from his pastures after each flood.

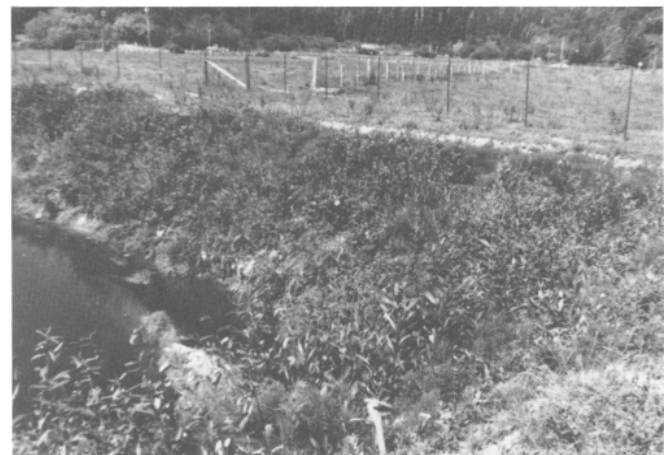
**Figure 3**— Same site as in figure 2, June 1984. Note livestock exclusion fencing installed along top of streambank. As of 1988, willows and alders at this site were six to eight feet tall.

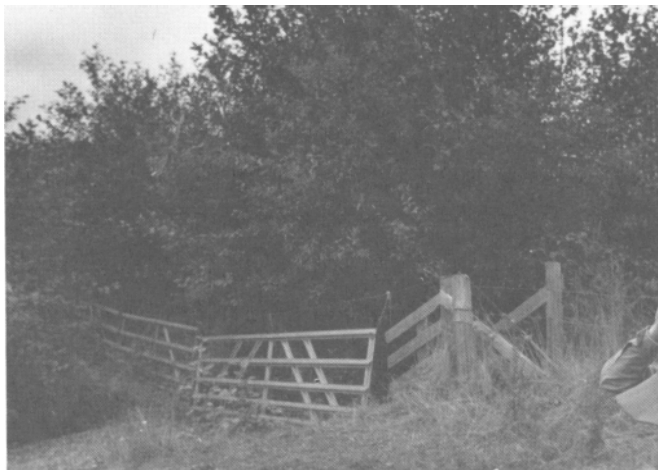
**Figure 5—** McDonald Creek, same site as in figure 4, September, 1987. Planted and volunteer red alder is the predominant vegetation.

The McDonald Creek property was being managed for both agricultural and recreational uses. Establishing trees along the stream and improving fish habitat makes the area more attractive to visitors, which was an acceptable trade for the loss of pasture (figs. 4 & 5).
