# PACIFIC SOUTHWEST Forest and Range Experiment Station

## REDUCING FIRE HAZARD IN PONDEROSA PINE THINNING SLASH BY MECHANICAL CRUSHING

1969. **Reducing fire hazard in ponderosa pine thinning slash by mechanical crushing.** Berkeley, Calif., Pacific SW. Forest & Range Exp. Sta. 9 p., illus. (U.S.D.A. Forest Serv. Res. Paper PSW-57)

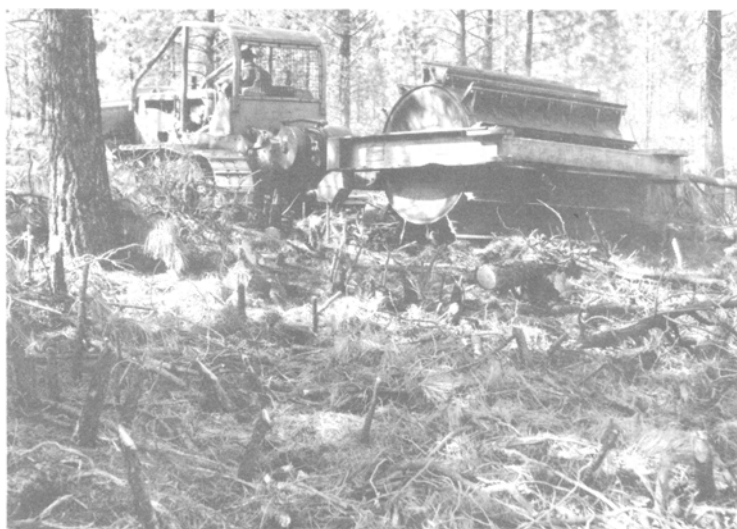
Figure 2.—The Marden brushcutter has been used extensively for land clearing in southeastern United States and, more recently, in lodge-pole pine logging slash in the West.

The Marden brushcutter<sup>7</sup> is a hollow steel cylinder, with cutting blades on the rolling surface (*fig. 2*). Brushcutters and similar equipment are designed for a variety of land clearing and cultivating uses. Larger

The Model SB-8 used in this study was towed behind the D-7 tractor. It is 8 feet wide, has a drum diameter of 5 feet, and a water (or diesel) holding capacity of 1,100 gallons. It weighs more than 16,000 pounds when empty, about 25,000 pounds filled.

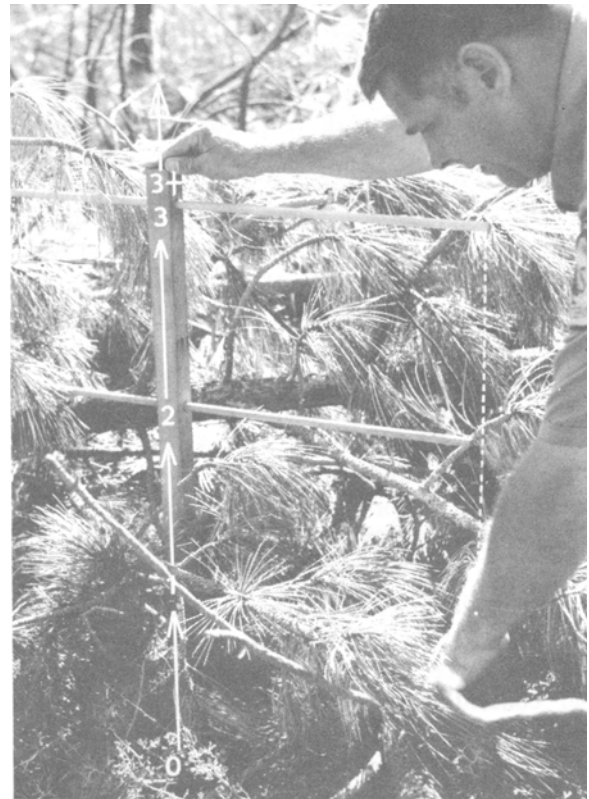
Figure 3.—A plot measuring device was used, before and after treatment, to measure fuel amount and distribution at 1-foot intervals on a vertical plane. A die was cast at each plot measuring point to determine orientation of the plane in relation to the transect line.

Sampling to determine number and vertical distribution of woody stems was done before and after treatment on 22 square-yard, vertical-plane sub-plots located along a line transect in each 5-acre plot. A measuring device (fig. 3) was designed for this purpose. We recorded the number of stem intercepts by the vertical plane in which they occurred. Fuels were classified by these diameters: (a) up to .50 inch,

The small stumps from thinned trees (*fig. 3*) did not prove to be obstacles to any of the equipment we tested. However, some caution was required to avoid larger stumps where recent commercial logging had preceded thinning—and where thinning slash obscured the stumps.

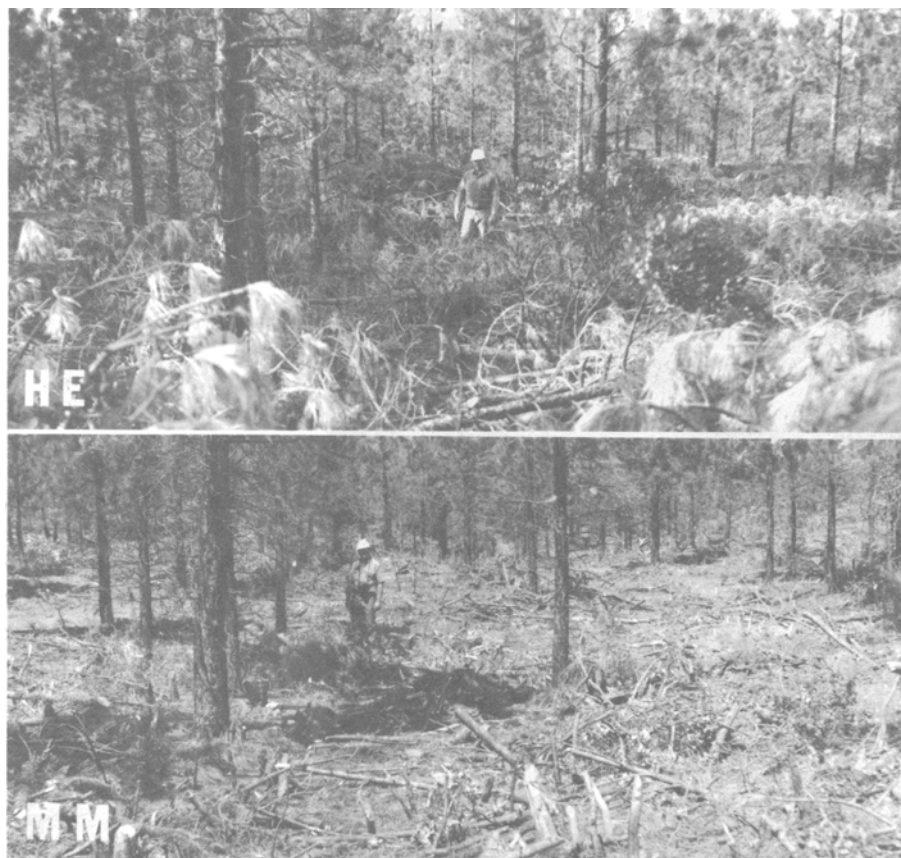
Figure 4.—Treatment of slash by the "Tomahawk" crusher reduced the fire hazard rating from HE (high, extreme), top, to MM (moderate), bottom.

Fuel treatment with the "Tomahawk" crusher most nearly met the six objectives of the study. The attachment proved effective in treating green thinning slash. It lowered the hazard rating in this fuel from HH to MM (*table 2*). In heavier loadings of red slash, it changed the rating from HE to MM (*fig. 4*). The "Tomahawk" treatment was the most effective for mulching finer fuels with soil and for redistributing fuels over a larger ground area. It could cut and chop fuels up to 4 inches in diameter. The larger fuels, 6 to 8 inches in diameter, were scarred, de-limbed, and compacted close to the ground.

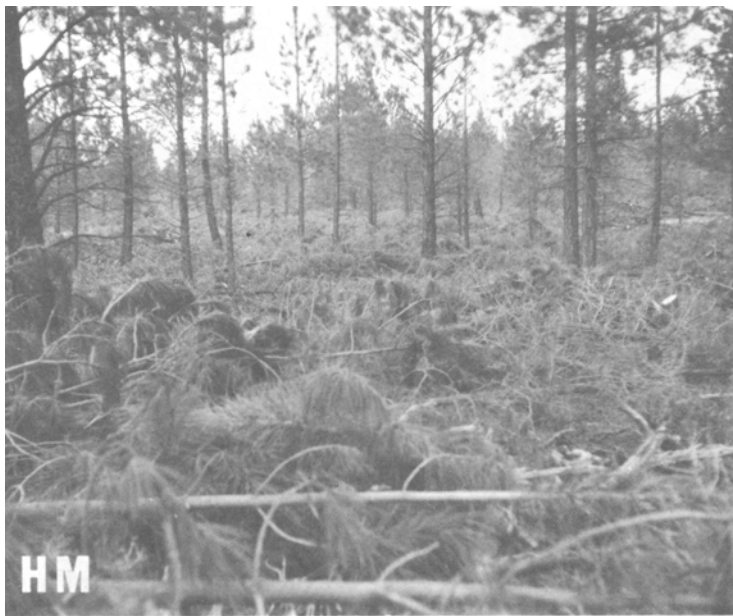
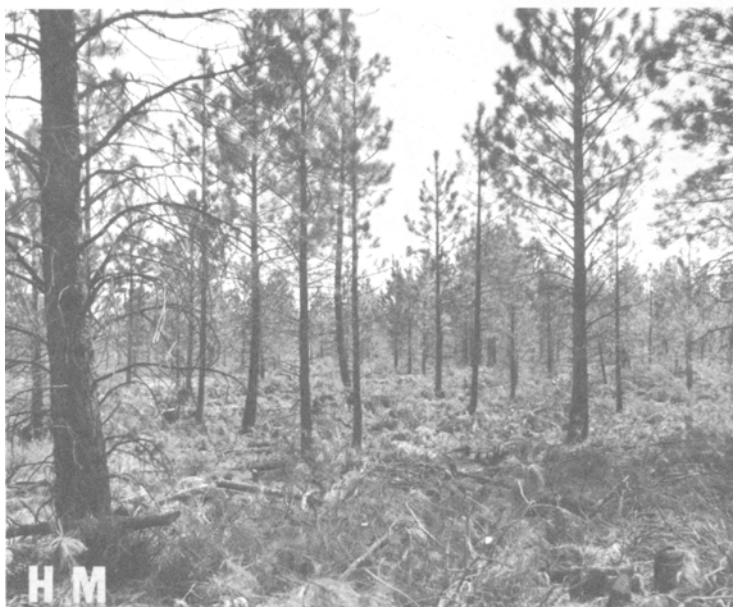
Figure 5.—Tractor crushing in fresh, green slash modified the vertical distribution of the fuels somewhat, but not enough to change the original hazard rating. Top, before treatment; bottom, after two passes by the tractor.

The D-7 tractor did not prove satisfactory in crushing green slash because it could not break up and mulch small fuels. This treatment made some changes in the fuel (*fig. 5*), but not enough to reduce the original rating (HM). In red slash, however, two passes with the smaller D-6 tractor reduced a heavy fuel concentration from EE to HM. The more complete breakdown of the red slash was attributed to its dry, brittle condition. The tractors by themselves did not prove as effective for chopping the fuels into smaller components as they did when the "Tomahawk" and Marden units were attached.

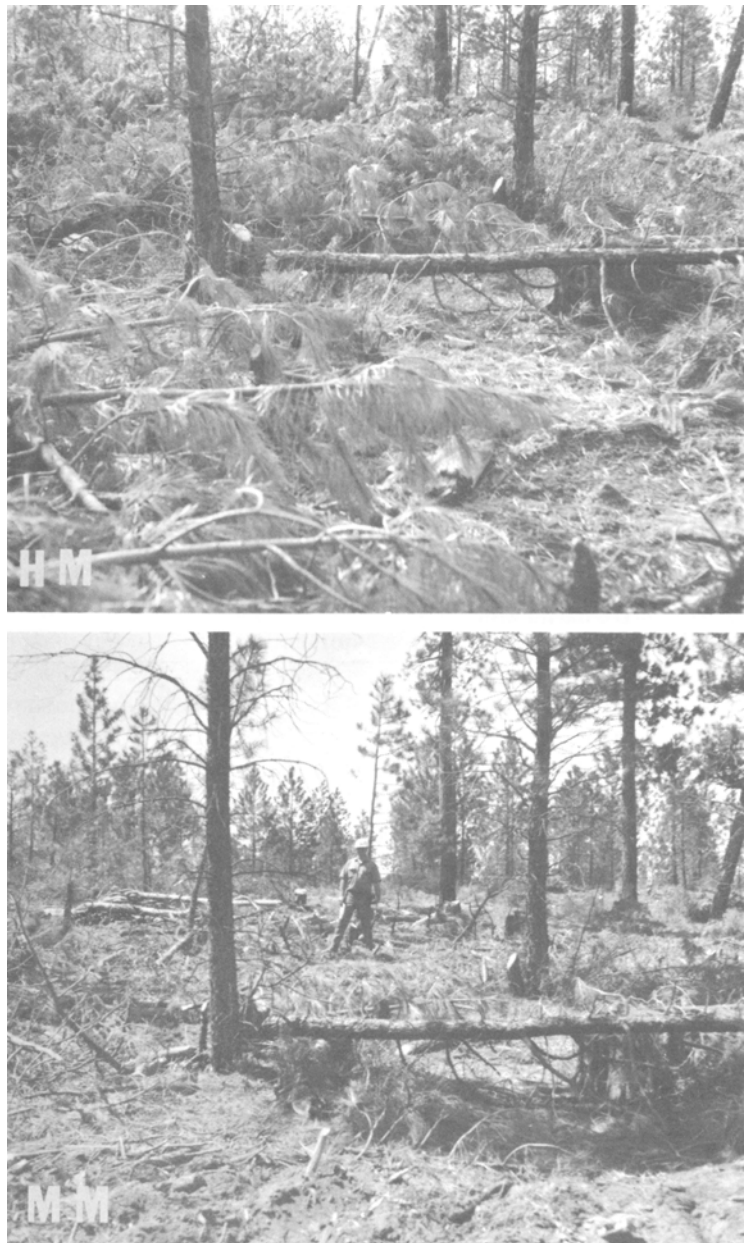
Figure 6.—The Marden brushcutter was effective where it could reach, but had difficulty treating slash close to leave trees, as shown in the bottom photo.

operate, but its size caused handling difficulties in close quarters. It could chop through fuels in the 6- to 8-inch category—cutting them into 1- and 2-foot lengths. Fuel type classification in green slash after this treatment dropped from EE to HM. In red slash, the rating was changed from HM to MM (*fig. 6*).
