General  
Technical  
Report  
FPL-GTR-186

# Occurrence of Mold in a Two-Story Wood- Frame House Operated at Design Indoor Humidity Levels

# Occurrence of Mold in a Two-Story Wood-Frame House Operated at Design Indoor Humidity Levels

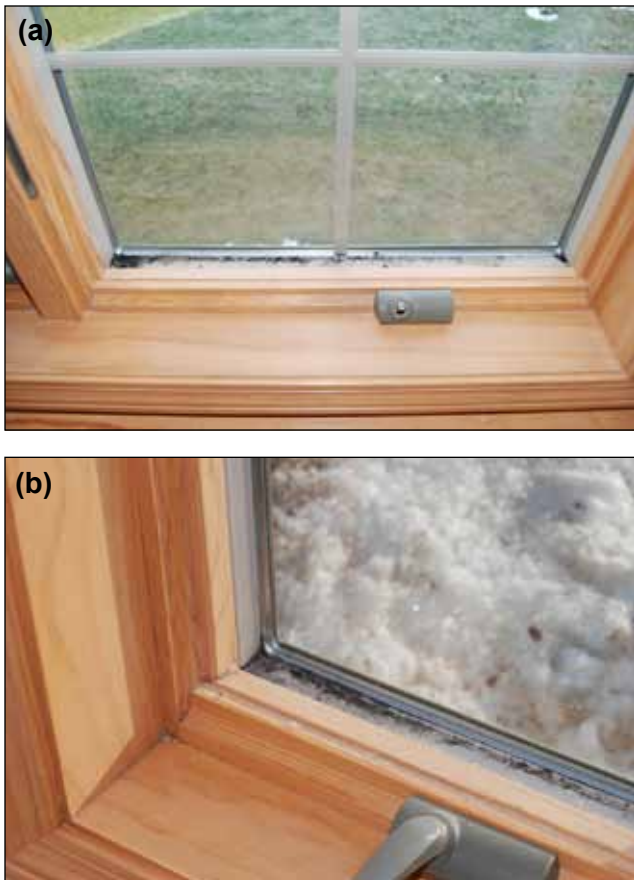
Mold growth on a window and the panels of the entry door are shown in Figures 3 and 4, respectively. The mold was restricted to edge areas of door panels or to areas on windows near the lower edge of a glass pane. Most of the windows in the house were casement windows. The window sash had

wood cores, with all surfaces of the sash encased in polyvinyl chloride (PVC). These windows had interior wood stops at the sides (jamb) and top (head) that contacted the sash when it was closed and latched. At the bottom (sill) of the window was a piece of wood stop trim. This was machined with the same outer profile as the jamb and head stops but was hollow-backed to conceal the window operating hardware. The two windows in the basement were of “hopper” style—hinged at the bottom, opening inward at the top. All surfaces on these windows were PVC. The entry door was flanked on each side with a multi-lite side-lite panel. Each panel consisted of a 0.36- by 2.0-m wood sash containing five vertically stacked panes, with wood muntins between panes. All three window types showed mold growth in January 2008. In all cases, mold was visible on the window sash but was restricted to the bottom rail of the sash or to muntins between panes in the sash. In all cases, the bulk of the mold was very close (within 8 mm) to the lower edge of a glass pane.<sup>2</sup> Mold was also present on the sill window stop trim of

the casement windows, especially at the corners where the stop trim interfaced with the jamb stops. Corridors of mold growth, which sometimes coincided with presence of condensed water, were regularly observed between the sash and the stop trim. A limited amount of mold was also present on interior wood trim below one of the basement windows, but this did not appear to be associated with run-down of condensed water from the window sash.<sup>3</sup>

**Figure 3 (a, b)—Mold growth on interior surfaces of lower rails of two representative vinyl clad window sash. Mold growth is most prevalent near pane edges and at corners, where condensate has collected. (Photo by Robert Munson, Forest Products Laboratory, January 10, 2008.)**

All areas of visible mold growth are described in Table 2 and defined according to the structure level, room description, geographic direction, product description, and substrate material. Figures 3 and 4 are representative of the extent of the mold growth. Mold was cultured from visible locations on all three levels of the house from window and door surfaces facing all geographic directions. Substrates supporting mold growth included PVC, cellulose insulation, and wood. Mold is capable of growth on virtually any substrate under favorable moisture conditions by using nutrients from detritus that has collected on surfaces, or in the case of cellulose-based building materials, by digesting simple sugars found in the wood component. Mold fungi can also adhere to, colonize, and change the physiochemical properties of plastic polyvinyl chloride (Bochkareva and Orchinnikov 1977; Webb and others 1999, 2000).

Mold was present on the lower portions of the sash of every window in the house by January 2008. Because the overwhelming majority of windows had sash with PVC surfaces, much of the observed mold occurred on PVC surfaces. Even without the presence of detritus as a food source, mold growth can occur on inert surfaces (Bochkareva and Orchinnikov 1977; Webb and others 1999, 2000). In cases of prolonged high humidity or condensation, some species of *Penicillium*, *Aspergillus*, and *Alternaria* can grow on glass and plastic (Zabel and Morrell 1992). The house was unoccupied, although it was entered periodically for tours and research work. A large amount of particulate matter was found in the basement air samples. The duct system for the house is equipped with an electrostatic filter. The ducts in the basement are sealed with a combination of metal foil tape and mastic; the basement has neither supply nor return registers. The first and second stories of the building appear to be realizing a beneficial effect from the electrostatic filter. In contrast, the basement, by reason of its isolation from the duct system, apparently realizes no or minimal removal of airborne particulates by the filter.

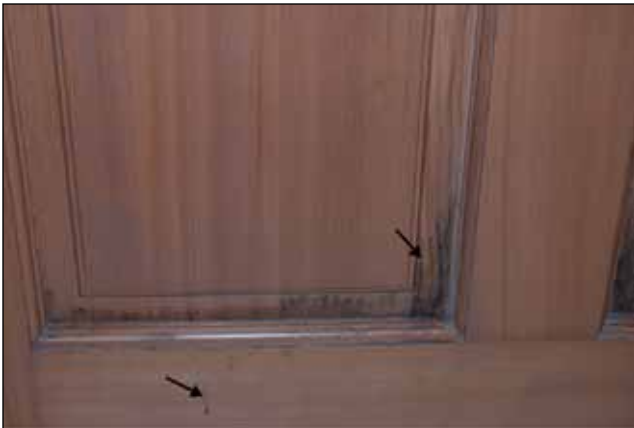
**Figure 4—Mold growth on the edges of panels of the front entry door. Evidence of run-down of condensate (seen as staining and mold growth) is also apparent on the rail below the panel, particularly on the profiled edge of the rail. (Photo by Robert Munson, Forest Products Laboratory, January 10, 2008.)**
