## Chapter 8

### Durability of Building Joint Sealants

**Christopher C. White,<sup>1</sup> Kar Tean Tan,<sup>1</sup> Donald L. Hunston,<sup>1</sup>  
and R. Sam Williams<sup>2</sup>**

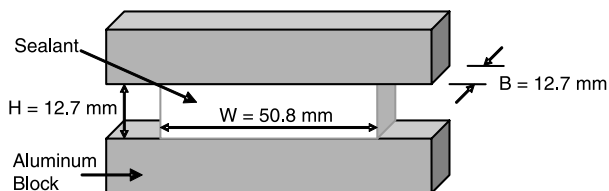
Figure 1—Schematic illustration of the test geometry used (not to scale).

A commercial sealant was provided by a member of a NIST/industry consortium, and formed into sealant joints conforming to the ASTM C719<sup>9</sup> specimen geometry shown in Figure 1. Specimens were prepared by extruding the sealant from a cartridge into a specimen cavity (50.8 mm x 12.7 mm x 12.7 mm) composed of aluminum supports (76.2 mm x 12.7 mm x 12.7 mm) on opposite sides with a polytetrafluoroethylene (PTFE) film on the back and PTFE spacers (12.7 mm x 12.7 mm) on each end. The specimens were cured in this fixture for 5 h at room temperature, and then removed from the fixture, keeping the PTFE spacers and the aluminum blocks intact. The samples were then allowed to cure for an additional three weeks as specified in the ASTM C719 test method.

where  $W$  and  $B$  are the width and breadth of the sealant (see Figure 1),  $L$  is the load,  $t$  is the time, and  $\lambda$  is the extension ratio, which is given by:

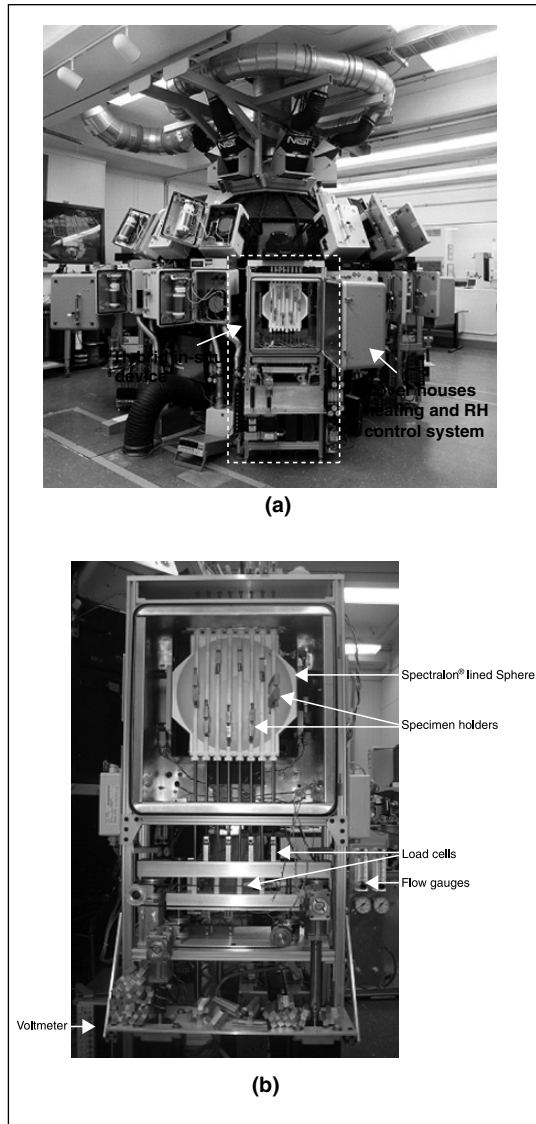
Figure 2—(a) An integrating sphere-based weathering chamber, referred to as the Simulated Photodegradation via High Energy Radiant Exposure (SPHERE), and (b) an in-situ device.

Specimens were exposed to both field and laboratory accelerated conditions. The accelerated tests were conducted using a custom-made in-situ device with independent and precise control of temperature, humidity, radiation, and cyclic strain movement, and

built-in characterization functionality (see *Figure 2*). A full description of the hybrid device is documented elsewhere.<sup>10</sup> Temperature control was achieved via a precision temperature regulator; humidity control was accomplished via the proportional mixing of dry and saturated air. Highly uniform UV radiation was attained through the use of an integrating sphere-based weathering chamber, referred to as the Simulated Photodegradation via High Energy Radiant Exposure (SPHERE).<sup>11</sup> Six high intensity light sources were used in the SPHERE to produce a collimated and highly uniform ultraviolet flux of approximately  $480 \text{ W/m}^2$ . A computer-controlled stepper motor and a precision transmission system were used to provide precise movement control that imposed mechanical deformations on the sealant specimens. There was a total of eight specimen holders, each of which was attached to a hermetically sealed load cell (Model SSM-AJ-250, Interface, Scottsdale, AZ) with a capacity of  $\pm 113.4 \text{ kg}$ . To precisely measure device movement, two linear variable differential transformers (LVDT) (Model HSD-750, Macro Sensors, Pennsauken, NJ) with a deflection range of  $\pm 6.35 \text{ mm}$  were used.

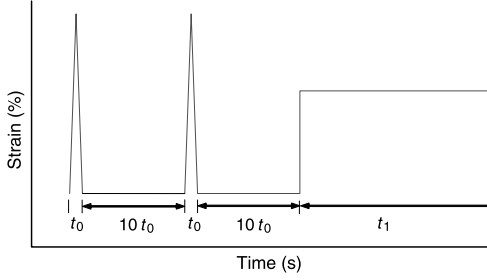
Figure 3—Strain history used for Mullins cycles and stress relaxation tests.

recovery from one loading was complete before the next loading was initiated, the specimen was allowed to rest for  $10t_0$  or  $10t_1$  between loadings (Figure 3). For these tests, the values for  $t_0$  and  $t_1$  were 20 s and 3 h, respectively. The motivation for the two loading-unloading cycles was to see if any Mullins Effect was present and to mitigate any Mullins Effect in the subsequent stress relaxation test. This Mullins Effect is a phenomenon observed in filled elastomers: the stress at a given strain is higher the first time the specimen is deformed than it is for subsequent deformations. As long as the maximum strain achieved during the first deformation is not exceeded, all subsequent loadings follow the same stress-strain curve. As a result, it is common to pre-strain a sample to high values so that the results are reproducible in subsequent testing.

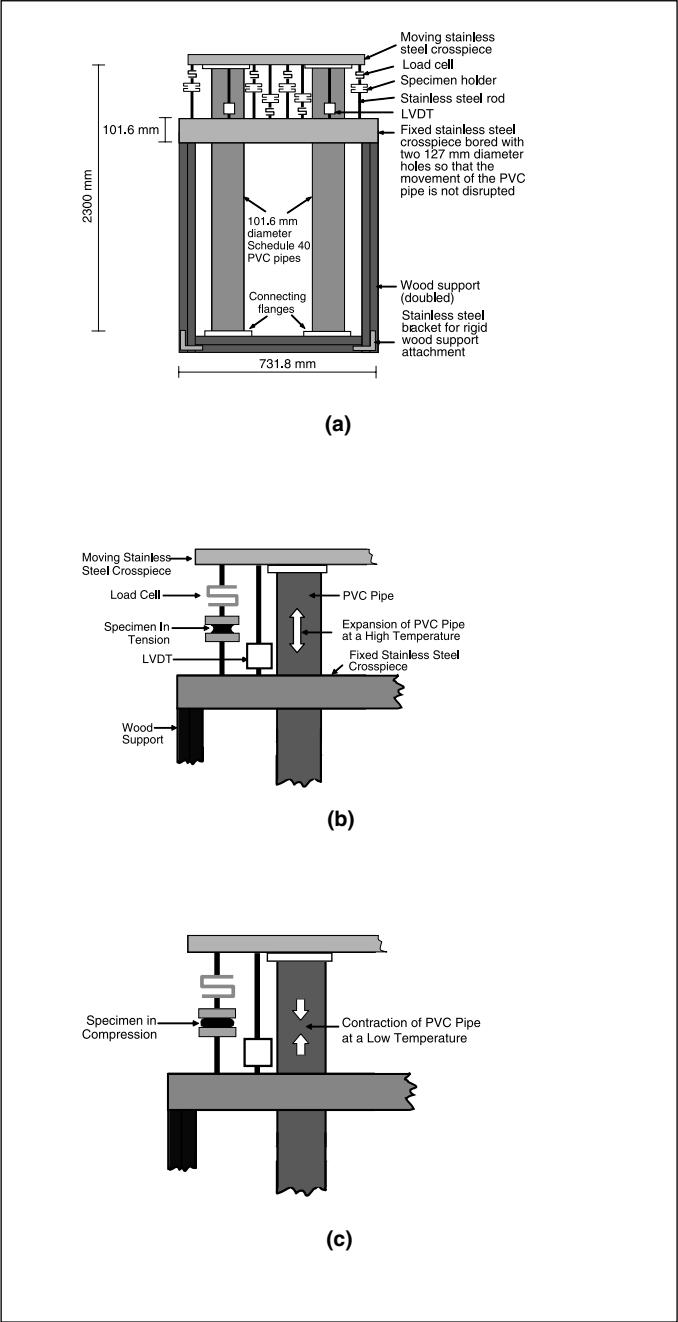
Figure 4—Schematic illustrations of (a) the thermally driven PVC engine, and the mechanism of the engine: (b) at a high temperature, the PVC pipe expands causing the specimen to be loaded in tension; and (c) at a low temperature, the pipe contracts causing the specimen to be loaded in compression.<sup>15</sup>

Field exposure was performed in Gaithersburg, using custom-made *thermally* driven outdoor exposure engines, as shown in *Figure 4*. Each engine was composed of a moving frame and a fixed support frame. The moving frame consisted of two 101.6 mm diameter polyvinyl chloride (PVC) pipes (Schedule 40), a stainless steel crosspiece, six stainless steel rods, and six specimen holders; while the fixed support frame was comprised of a wood support frame, and a fixed stainless steel crosspiece. The strain on the sealant samples was generated by thermal changes in the exposure environment combined with the relative difference in the coefficient of thermal expansion between the PVC pipe and the end grain wood frames. A full description of the devices is reported elsewhere.<sup>15</sup> Specimens were placed into the device at a time when the temperature was approximately 13°C (55°F), so they were under no load at that temperature. At high temperatures PVC pipes expand, causing the specimens to be loaded in tension; conversely, the specimens are loaded in compression when the pipes contract at low temperatures, as shown schematically in *Figure 4b* and *c*. Consequently, the engines are also known as “winter/compression” or “summer/tension” engines. The engines were mounted facing south towards the equator at an angle of 90° from the horizontal plane.

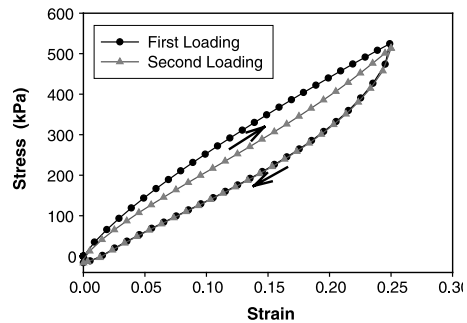
Figure 5—Loading-unloading curve for Mullins cycle.

Figure 5 shows typical results for the two loading-unloading curves in the first characterization test on a specimen. The Mullins Effect is clearly present with higher stress levels during the first loading curve versus the second. Note that the unloading curves are the same in both cases. All subsequent loading-unloading curves will fall on top of the data in the second cycle.

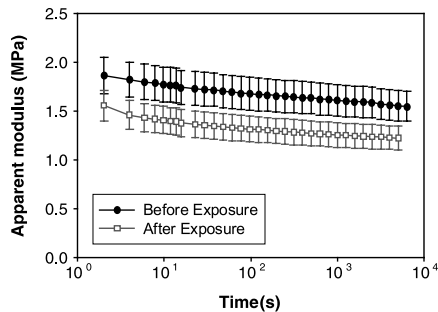
Figure 6—Variation of apparent modulus as a function of relaxation time for specimens under “static/hot/wet” conditions before and after exposures.

Figure 6 shows a representative plot of changes in apparent moduli as a function of relaxation time for specimens under “static/hot/wet” conditions prior to exposure and after completion of fatigue deformation cycle. There were up to four replicates in each test, and the vertical bars indicate experimental uncertainty. Consequently, the difference seen between the two curves is significant. Note that there is no change in the curve shape, implying that time dependency of the apparent modulus is very similar before and after exposure. The magnitude of the apparent modulus, however, decreased significantly after exposure. Similar curves can be generated for all eight exposure conditions, but a plot with all 16 curves and their uncertainty is much cluttered. To facilitate comparison between different exposure conditions, stress relaxation data are presented as a fractional change in apparent modulus,  $F$ , as a function of relaxation time (see equation (3)). In such a graph, no change would be represented as a horizontal straight line at  $F=1.0$ . A horizontal line above or below  $F=1.0$  indicates that exposure caused a vertical shift in the stress relaxation curve but no change in shape, i.e., the time dependence did not change. Something other than a horizontal straight line indicates a change in the

time dependence. The experimental uncertainty can be shown as a hashed region on each side of  $F=1.0$  so if the point for a given curve falls within this region, there is no changes outside the experimental uncertainty. Stress relaxation data at different combinations of temperature and RH for static tests are shown in Figure 7. The lines at very low values of  $F$  indicate the samples have failed. The near straight lines parallel to the abscissa show that there is no change in the curve shape for all conditions.

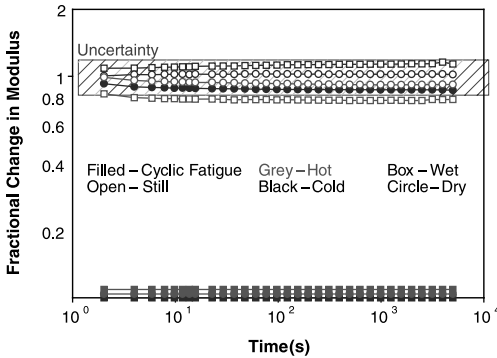
Figure 7—Stress relaxation curve for both static and cycle fatigue tests.

fatigue tests are included in Figure 7. In a “cold” and “dry” environment, the effect of fluctuating loads on the cyclic performance of sealant joints is insignificant. Furthermore, changes in the stiffness index of specimens, which were measured by the slopes of loading curves in the load-displacement plot for fatigue deformation cycle, were examined. The corresponding squared correlation coefficients,  $r^2$ , for the fitted slopes were also obtained to assess the goodness-of-fit of the slopes. The results for “fatigue/cold/dry” are shown in Figure 8. The results for “static/cold/dry” are also included for comparison, but the slopes are always zero because there was no fatigue deformation cycle. In Figure 8a, the stiffness index of specimens under “fatigue/cold/dry” remained unchanged over a month of exposure, which agreed with the comparable stress relaxation data. The relative high values of corresponding squared correlation coefficients confirmed the reliability of the data obtained (see Figure 8b).

However, as shown in Figure 7, the combination of cyclic fatigue with a high temperature, or with a high RH, or the combination of three aging factors, resulted in substantial changes in moduli. All joints tested under these conditions failed; thereby, the curves were plotted with ordinate magnitudes equal to zero. Changes in stiffness index and linear regression coefficients as a function of exposure time for “fatigue/hot/dry” are shown in Figure 9. It can be seen that there was no change in stiffness index in early stages of exposure. With increasing exposure, the stiffness index decreased and was eventually followed by specimen failures. The stiffness index plots for “fatigue/cold/wet” and “fatigue/hot/wet” are shown in Figures 10 and 11, respectively. The stiffness for these specimens decreased drastically upon exposure, and then failures followed.

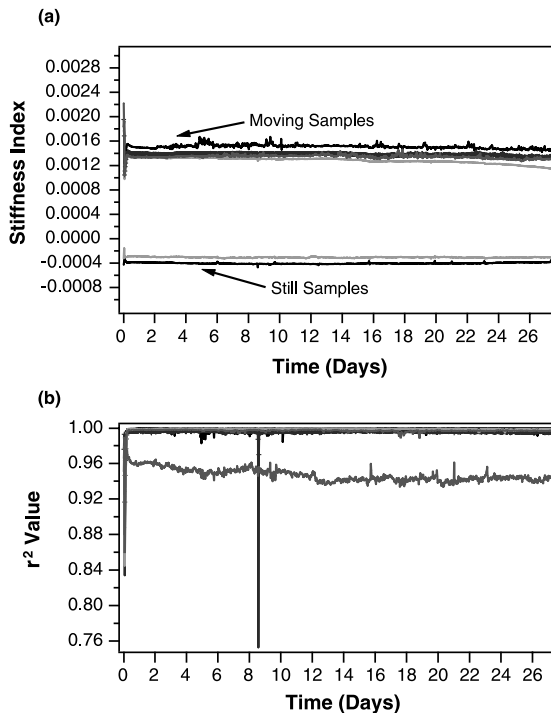
Figure 8—(a) Changes in stiffness index for samples with movement and no movement. (b) Corresponding squared correlation coefficients,  $r^2$ , as a function of exposure times in days for specimens under “fatigue/cold/dry” conditions. No visible failure is evident in the samples during the entire exposure.

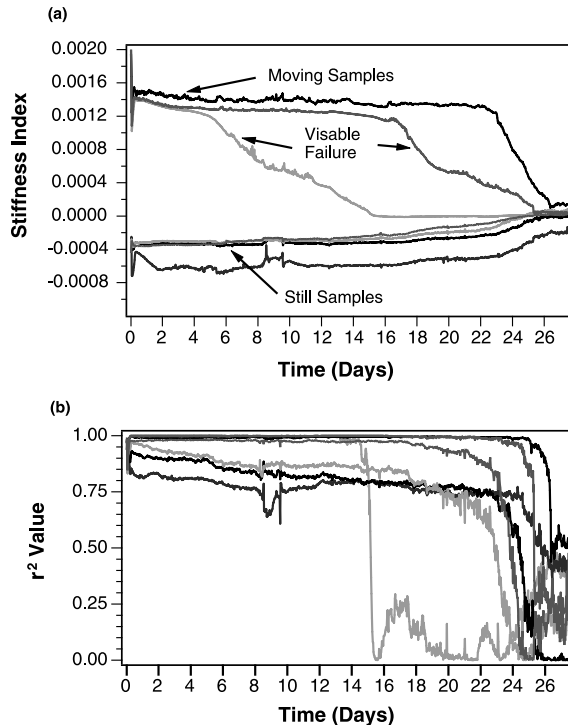
Figure 9—(a) Changes in stiffness index for both samples with movement and no movement. (b) Corresponding squared correlation coefficients,  $r^2$ , as a function of exposure times in days for specimens under “fatigue/hot/dry” conditions. Visible failure is evident in the three samples experiencing movement starting at eight days to 25 days.

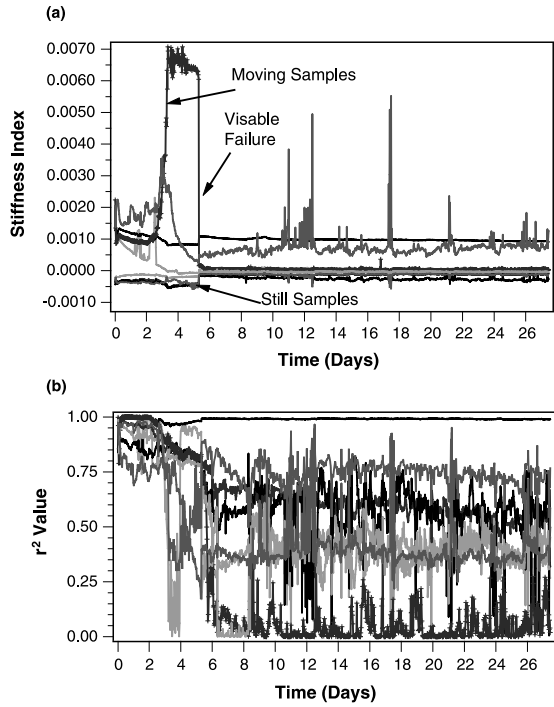
Figure 11—(a) Changes in stiffness index for both samples with movement and no movement. (b) Corresponding squared correlation coefficients,  $r^2$ , as a function of exposure times in days for specimens under “fatigue/hot/wet” conditions. Visible failure is evident in the samples at times less than two days.

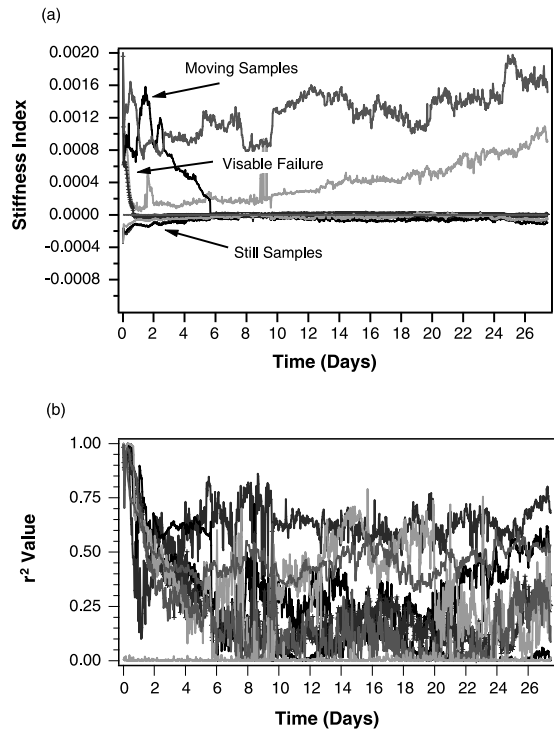
Figure 10—(a) Changes in stiffness index for both samples with movement and no movement. (b) Corresponding squared correlation coefficients,  $r^2$ , as a function of exposure time in days for specimens under “fatigue/cold/wet” conditions. Visible failure is evident in the samples at times less than six days.

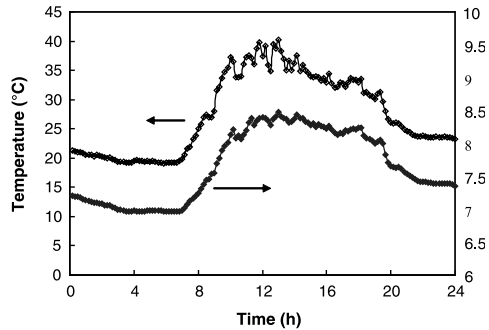
*Figure 12—Variation of temperature of PVC pipe and the resulting displacement as a function of time. Measurements were made on July 1, 2004.*

In the case of field exposure, specimens were exposed to cyclic deformation induced by dimensional changes of PVC engines in which specimens were loaded in tension when outdoor air temperature was relatively high and in compression when the outdoor air temperature was relatively low. The evidence showing that changes in outdoor air temperature directly affect the magnitude of cyclic deformation imposed on specimens is shown in *Figure 12*. Because of temporal variations in outdoor air temperature, cyclic loading varies with the time of day. Such cyclic loading time series was what would be

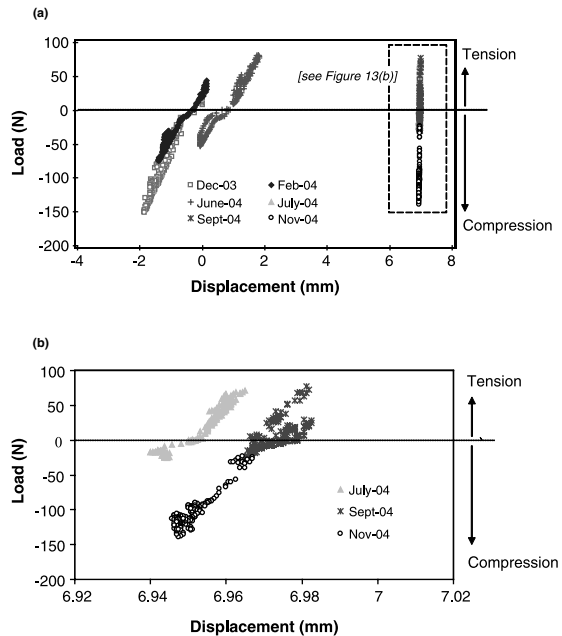
*Figure 13—Load versus displacement recorded over one year of field exposure for displacement ranges of (a)  $-4$  mm to  $8$  mm, and (b)  $6.92$  mm to  $7.02$  mm.*

expected with sealants used in building structures. Load and displacement experienced by specimens were continuously monitored over one year, and the results are shown in *Figure 13*. In this plot, the data points on the right and left hand sides of the zero displacement line indicate which specimens were in tension and compression, respectively. For clarity, only data points collected over a day in each month were plotted. It should be noted, however, that data points for other days in the same month were very similar. From *Figure 13*, hysteresis in the load-displacement plot is clearly seen, demonstrating the viscoelastic nature of the sealant, which is common for all sealants although their observed degrees vary. It can

Continuous monitoring of load and displacement allowed changes in stiffness to be examined, which was measured by the slopes of load-displacement plots (*Figure 13*). The values of stiffness are tabulated in *Table 1*, and squared correlation coefficients,  $r^2$ , for fitted curves are also included. It can be seen that  $r^2$  value is relatively high for each month, signifying that each curve in the load-displacement plot can be fitted by a straight line with a highly reliable slope. From *Table 1*, it can be seen that the stiffness for freshly exposed specimens was 10 N/mm in December 2003. In the next seven months, the stiffness remained statistically unchanged, but in July 2004 the stiffness increased substantially to 400 N/mm. This significant increase in the stiffness shows that the sealants have undergone profound structural changes, and that summer exposure was more severe than winter exposure. Physical examination of the specimens revealed that the specimens had hardened considerably compared to unexposed specimens, indicating that extensive embrittlement had occurred. This observation indeed correlates well with the relatively high stiffness recorded. In later stages of exposure, the stiffness continued to increase to approximately 500 N/mm, and, eventually, the sealants failed cohesively.

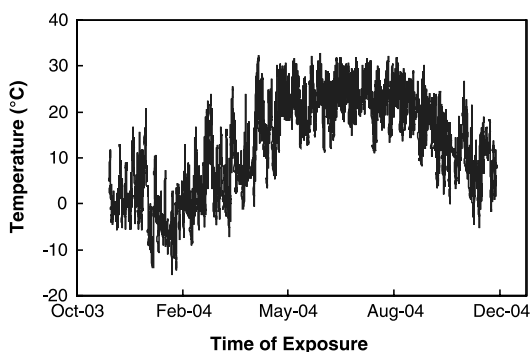
*Figure 14—Changes in air temperature from December 2003 to November 2004.*

It is evident from the above discussion that the indoor laboratory accelerated test allows not only the individual effects of cyclic fatigue, temperature, and RH to be investigated independently, but also the synergistic effect of combining two or more factors. By using this test method, it has been shown that specimens were able to resist the individual influence of cyclic fatigue, high temperature, and RH, but degraded substantially when exposed to the combination of cyclic fatigue with a high temperature or RH, or the combination of these three factors. Fatigue, high temperature, and RH collectively provide strong synergism, thus accelerating the degradation mechanism and rapidly deteriorating sealant properties. Such observations correlated well with observations made under field exposure in that summer exposure was found to more aggressive in terms of environmental attack than winter exposure. This is because air temperature was generally higher in summer, as shown in *Figure 14*.
