# Using GIS Technology to Analyze and Understand Wet Meadow Ecosystems

**Abstract**—A Cibola National Forest wet meadow restoration was implemented as part of the Forest Road 49 enhancement near Grants, New Mexico. An Arc/View 3.0 Geographic Information System (GIS) was used to track the recovery of this ecosystem. Layers on topography, hydrology, vegetation, soils and human alterations were compiled using a GPS and commonly available data. Cartographic information allows visual interaction of natural features that could not be interpreted from tabular data sets. First results indicate that stream confinements by the railroad trestle, old channel fill, old two-track roads, Forest Road 49, and mis-graded construction affected the flow and location of spring floodwaters in 1998.

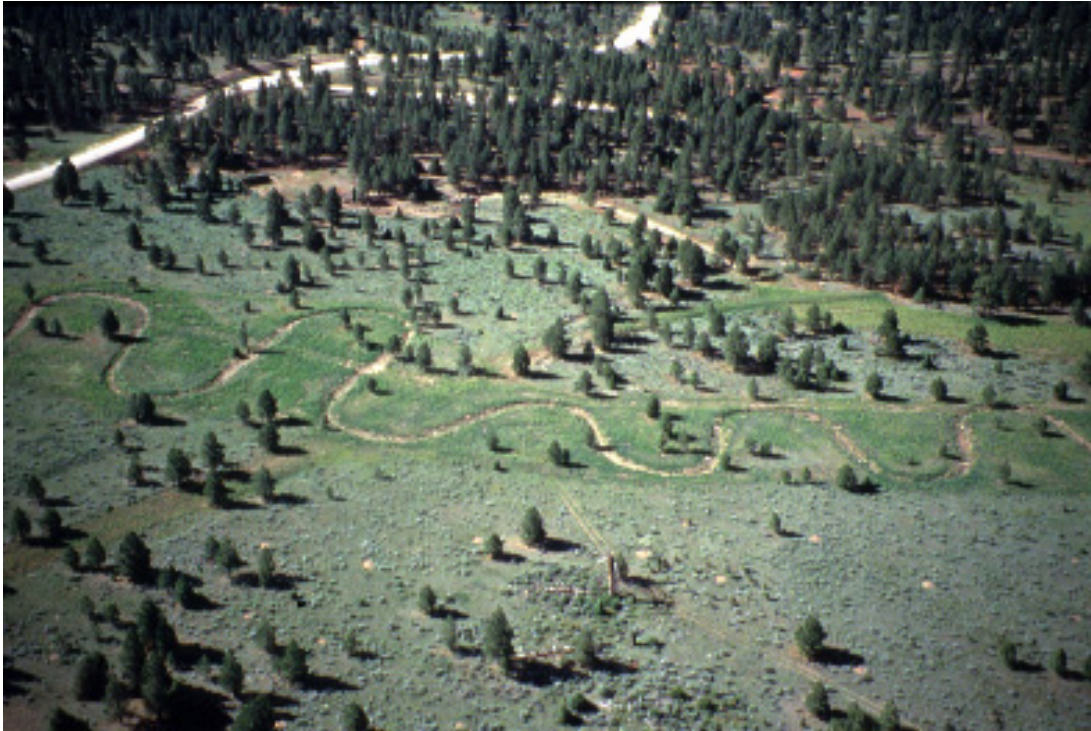
**Figure 1**—This photo shows the “green belt” surrounding the meanders of the newly installed channel. This channel is shallow and wide with 37 meanders in the study area. The old channel show in figure 1 is relatively straight and more deeply incised.

Funds to reroute Agua Fria Creek were provided in 1995 via a Forest Road improvement project with the Federal Highway Department. The goal of the restoration design was to increase the period of flow through the meadow (Jackson, 1994b). Slower water velocity and more water absorption over a larger area of the meadow were planned through construction of a highly sinuous channel (fig. 1).

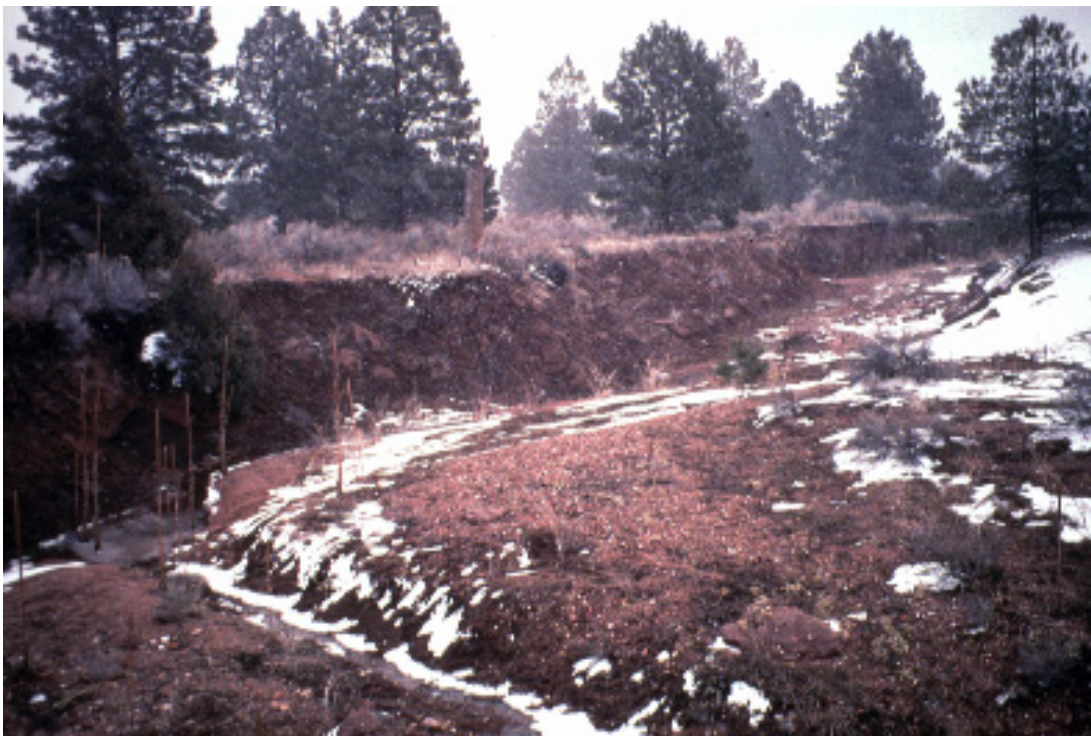
**Figure 2**—Previous restoration projects amplified erosion in the old channel on the south side of the meadow. This photo shows the ensuing escarpment, looking upstream.

The new channel runs down the center of the meadow, 2-3 m in elevation above the old channel. It is only .60-.75 m deep in contrast to the old channel which was incised as much as 3 m in places (fig. 2). Thus the new channel has a much smaller cross sectional area which encourages flooding and water retention in the meadow.

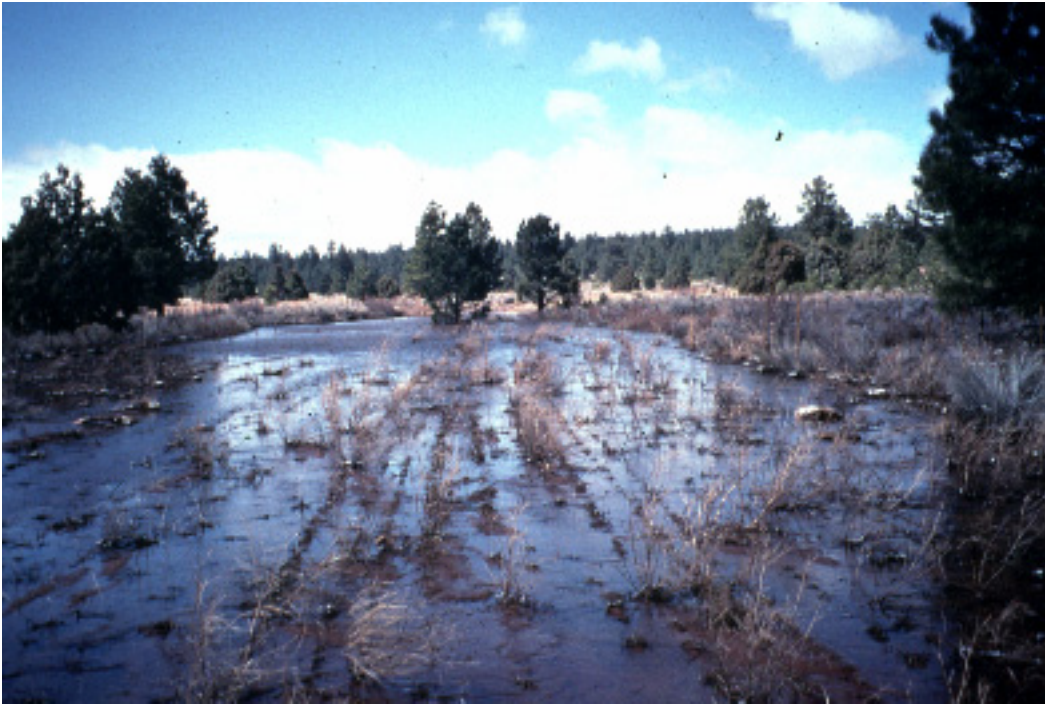
**Figure 4**—Downstream of the new channel breach, below Forest Road 49, standing water and sheet flow cover the reseeded and filled old channel, during the spring of 1998.

across the surface and followed the course of the old stream channel, most of which had been previously filled in with soil from the borrow pit. Increased surface slope at the lower end of the study area caused overland flows to initiate erosion and headcutting in the area where the diverted water rejoined the new channel (fig. 4). By the time runoff stopped, headcuts had formed up to 1.50 m deep and 30 m to 50 m long (fig. 5).

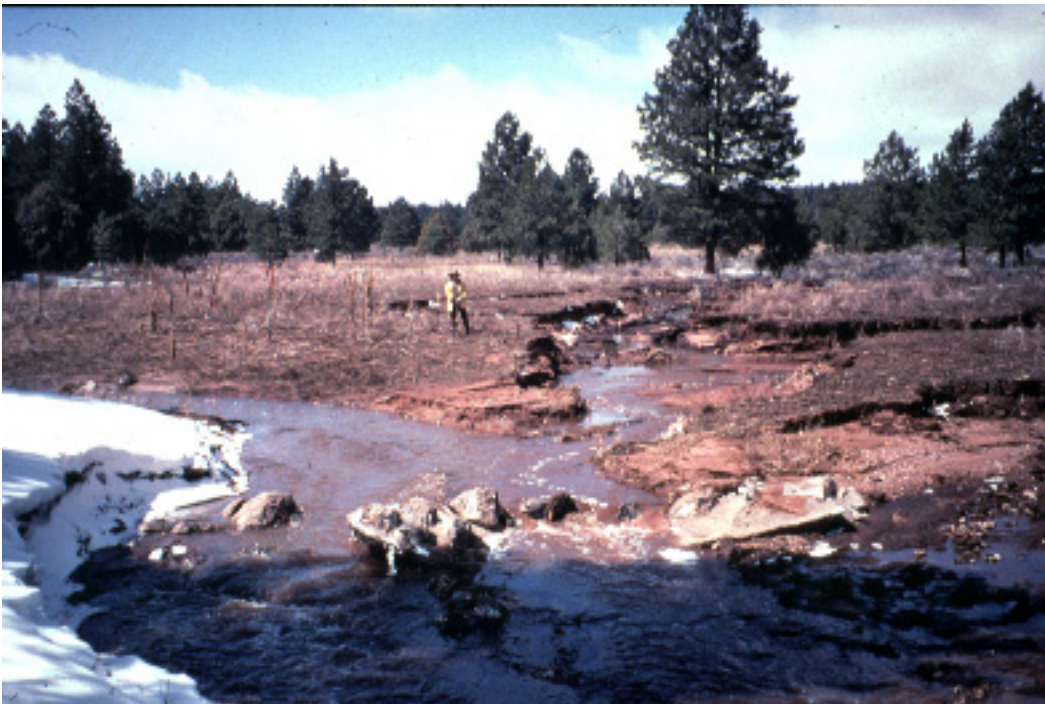
**Figure 5**—Major erosion due to spring 1998 flooding. This photo is taken looking upstream from the fenceline project boundary. The second to last constructed concrete weir is in the center of the photograph.
