# Nondestructive Evaluation of Timber Highway Guardrail Posts

James P. Wacker<sup>1</sup>, Xiping Wang<sup>2</sup>, David E. Kretschmann<sup>3</sup>, Douglas R. Rammer<sup>4</sup>

Wacker, James; Wang, Xiping; Kretschmann, David; Rammer, Douglas 2010. Nondestructive evaluation of timber highway guardrail posts. In: Proceedings of the 11th world conference on timber engineering, 2010 June 20-24. Riva Del Garda, Italy. Ariio Ceccotti and Jan Willem van de Kuilen, eds. (CD only, without page numbers).

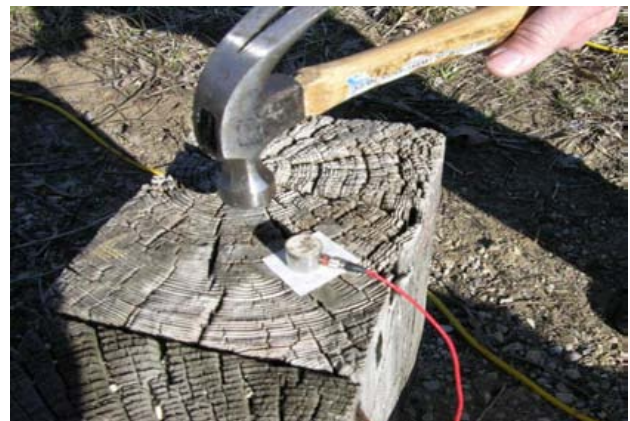
**Figure 2:** Pulse-echo acoustic testing of an old guardrail post in the field

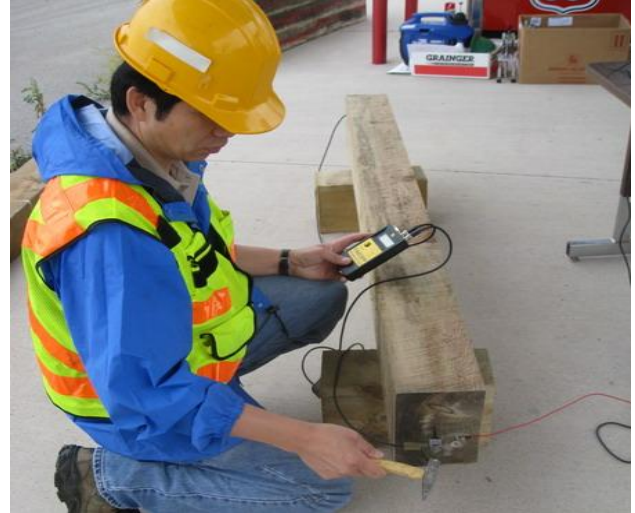
**Figure 5:** Parallel-to-grain stress wave timing of new posts prior to installation at the Royalton test site

Stress wave measurements were collected along the longitudinal axis of all new guardrail posts as shown in Figure 5. These tests were performed in order to determine the inherent sound velocity for each post. A stress wave timing device (Fakopp Enterprise, Hungary) was used to measure the time it takes for sound waves to travel through the 2m post length. In addition, similar stress wave measurements were collected along the exposed sides of the guardrail posts after installation.

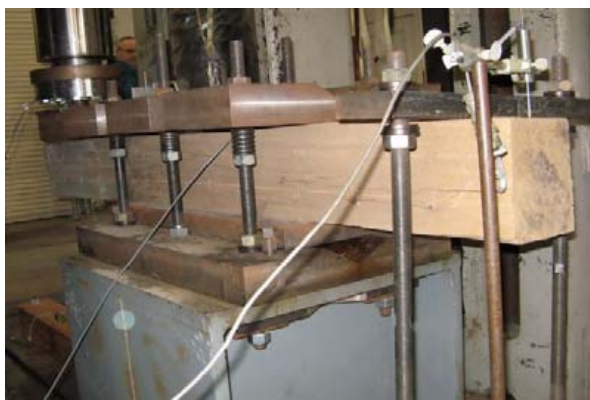
**Figure 8:** Destructive testing for cantilevered post strength

All 40 old posts salvaged from both test sites were transported to FPL for further evaluation. Prior to mechanical testing, measurements of the posts included dimensions, weight, diagrams of major defects, and stress wave MOE. This information will be used to help understand the limitations of the pulse-echo acoustic evaluation technique used in the field assessments. All posts were then loaded to failure in cantilevered bending as shown in Figure 7. The testing configuration was designed to estimate the in-service guardrail system geometric conditions with the load point located 527mm from the support. LVDT deflections were measured at the loading point and near the base support. In addition, deflections were recorded at opposite, unloaded end to detect uplift. Loading was applied at a uniform rate of 8.4mm per minute until load resistance dropped below 50 percent of the maximum load. Loads were recorded using a 222kN load cell. Figure 8 shows a guardrail test being conducted at the FPL million pound test machine. At the conclusion of testing, samples were cut near the fractured zone for determination of moisture content and specific gravity.

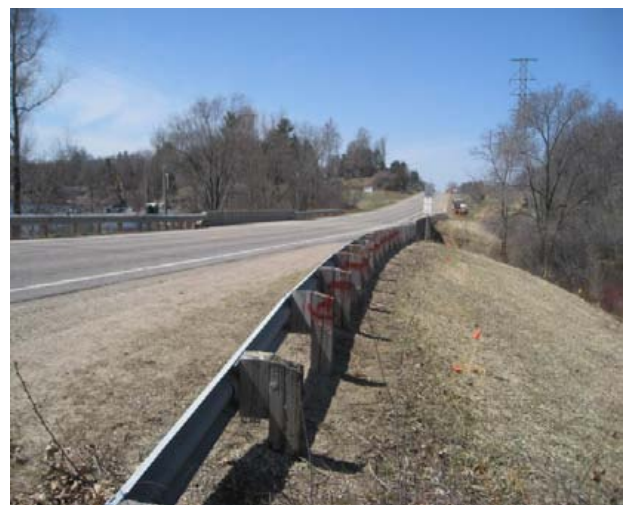
**Figure 9:** Merrimac field site showing old posts in-service

Guardrail posts were evaluated at two different field sites in the state of Wisconsin as described in Table 1. The southernmost site, shown in Figure 9, is located along state highway 113 near the city of Merrimac in Sauk County. The northernmost site, shown in Figure 10, is located along state highway 54 just east of the city Royalton at the railroad overpass in Waupaca County.

Both field sites contained strong-post w-beam guardrail systems that had been in-service for several years. All guardrail posts evaluated in this study were strong-posts measuring approximately 15x20cm in cross-section. The length of the guardrail posts varied from 1.8 to 2.0m depending on embedment length. Salvaged posts were southern pine while new posts were either red or white pine, both being local softwood species in the state of Wisconsin.

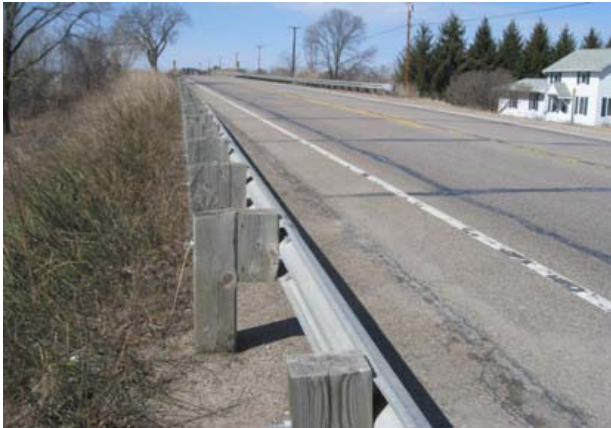
**Figure 10:** Royalton field site showing old posts in-service

At the Royalton test site, all 20 guardrail posts were evaluated at the southeast corner approach guardrail at the railroad overpass bridge. The Royalton guardrail posts were in-service since 1996, or approximately 13 years, at the time of removal.

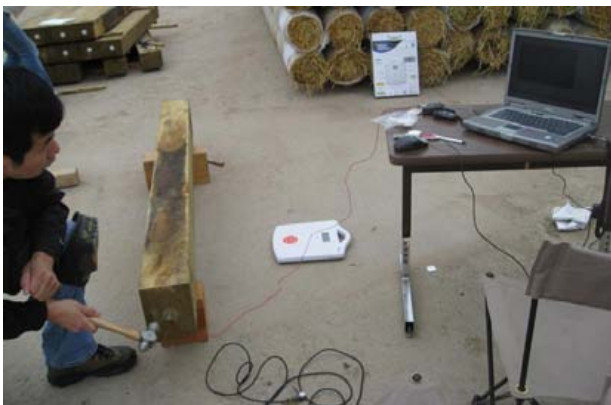
**Figure 11:** Testing of new posts prior to installation at the Merrimac test site

Prior to installation of the new posts at the field test site, all new guardrail posts were evaluated out-of-ground using similar pulse-echo acoustic techniques as shown in Figure 11. These tests were conducted in the field adjacent to the construction site. A stainless steel label was applied to each post to identify it for future inspections and/or condition monitoring.
