Forest  
Products  
Laboratory

General  
Technical  
Report  
FPL-GTR-203

# Physical Deterioration of Preservative Treated Poles and Pilings Exposed to Salt Water

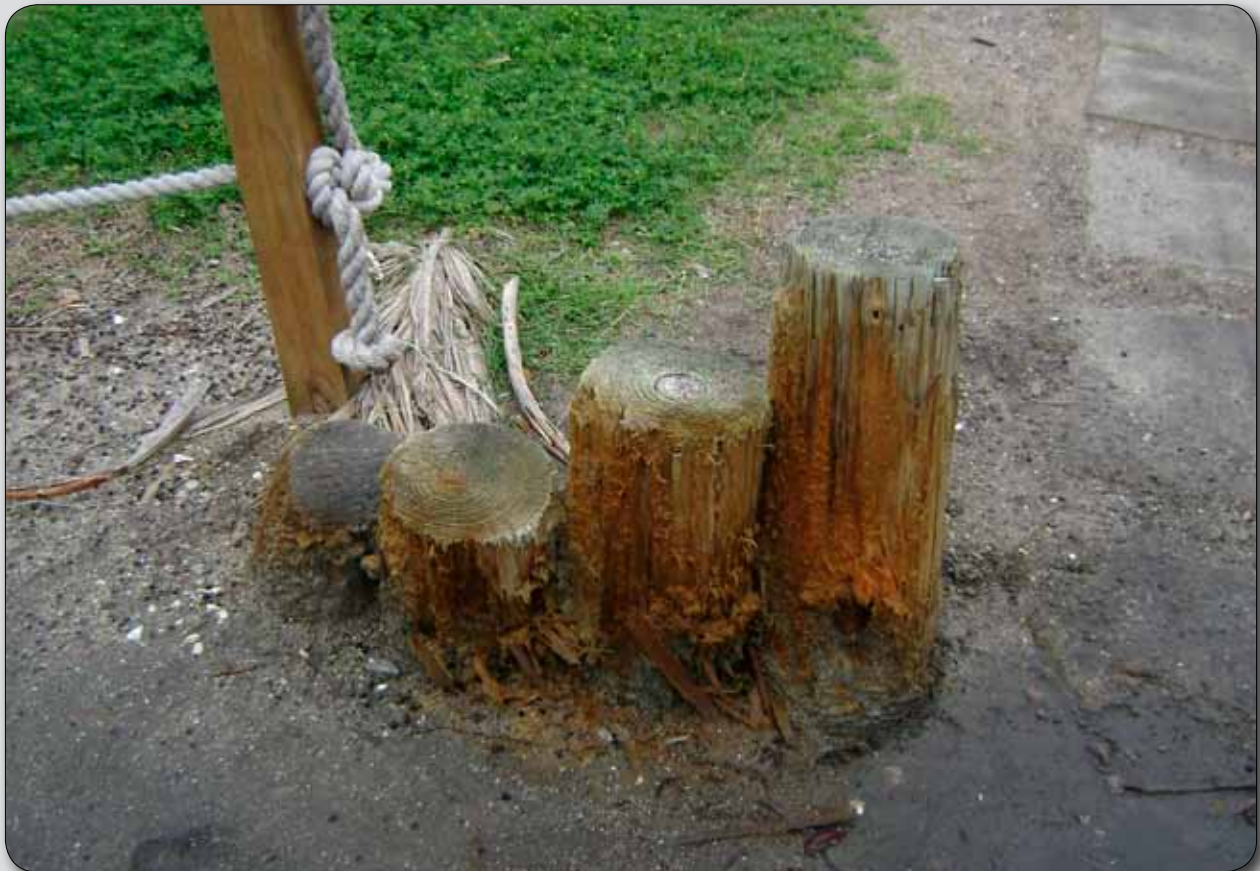
**Significance of Cover Photo:** Salt damage or “fuzzy wood” can be mistaken for biological deterioration, although it actually represents physical deterioration. This image of a deck piling has extensive salt damage from seawater exposure. The seawater is wicked through the piling by capillary forces, splashed up by wave action, and as the water evaporates, the residual salt is deposited in the fibers near

the top of the pole. This is commonly seen in wood exposed to saline conditions and is largely considered cosmetic damage. As illustrated in this picture, the pilings do not have to be submerged in saltwater for damage to occur; these pilings were located directly adjacent to a wharf in Charleston, South Carolina, and were frequently inundated with seawater. (Photo provided by Jim Healey, Cox Industries, Orangeburg, South Carolina).

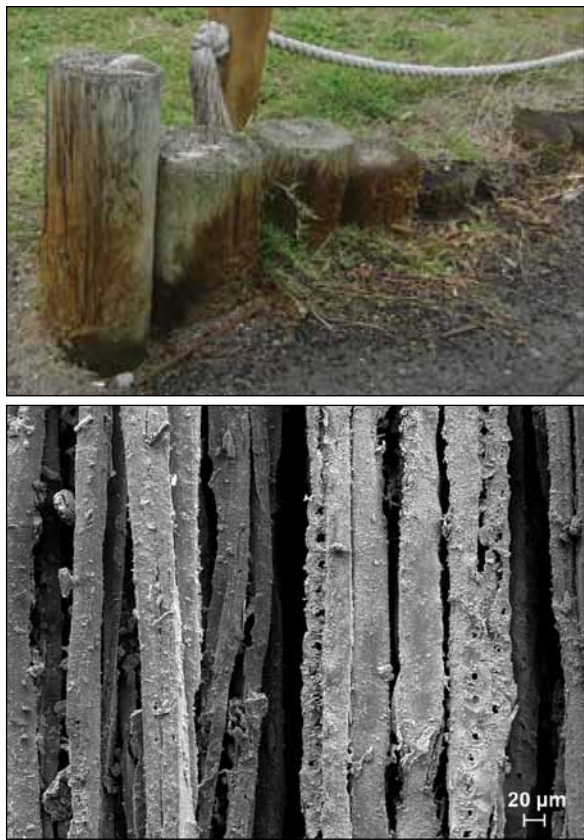
**Figure 2.** Image of salt-damaged pilings and corresponding sample showing tracheid separations and no fungal presence using SEM (175× magnification).

SEM micrographs were generated for a subset of the samples. The advantages of SEM are that high-resolution images can be obtained at micrometer scale and this method allows us to observe changes to the wood structure as well as the presence of fungal hyphae. No indication of brown-, white-, or soft-rot fungi were found in any of the samples. Tracheid separation was apparent in marina samples (Fig. 2), and SEM micrographs did show cubical salt crystals throughout the marina sample (Fig. 3). Oxalic acid crystals are typically needle-like or tetrahedral (Green and others 1996).

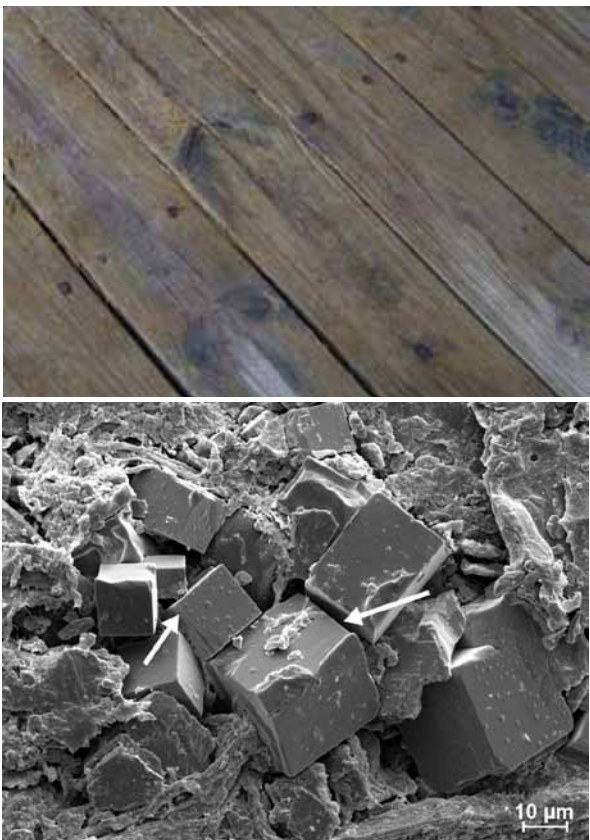
**Figure 3.** Image of salt damaged deckboards at Isle of Palms Marina (a) and salt crystals (white arrows) located in corresponding sample using Scanning Electron Microscopy (b, 450× magnification).
