# Rill and Gully Formation Following the 2010 Schultz Fire

**Abstract:** The Schultz Fire burned 6,100 ha on the eastern slopes of the San Francisco Peaks across moderate to very steep ponderosa pine and mixed conifer watersheds. There was widespread occurrence of high severity fire, with several watersheds classified as over 50% high severity. This resulted in moderate to severe water repellency in most soils, especially those on steep slopes. Prior to the fire there were no rills or gullies as the soil was protected by a thick O horizon. This protective organic layer was consumed leaving the soil exposed to raindrop impact and erosion. A series of flood events beginning in mid-July 2010 initiated erosion from the upper slopes of the watersheds. Substantial amounts of soil was eroded from hillslopes via a newly formed rill and gully system, removing the A horizon and much of the B horizon. The development of an extensive rill and gully network fundamentally changed the hydrologic response of the upper portions of every catchment. The intense, short duration rainfall of the 2010 monsoon interacted with slope, water repellency and extensive areas of bare soil to produce flood flows

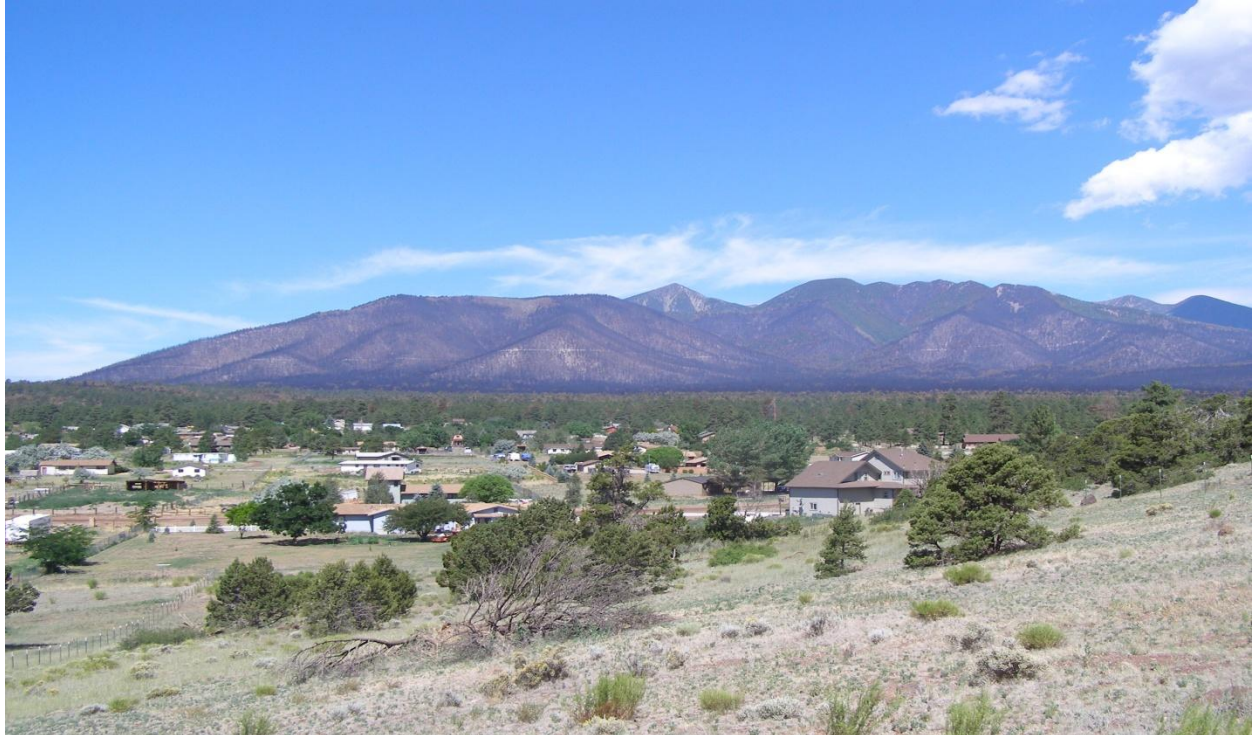
**Figure 1.** Schultz Fire burned area on the east flank of the San Francisco Peaks, July 2010.

The Schultz Fire burned 6,100 ha on the eastern slopes of the San Francisco Peaks, a dormant Middle Pliocene to Holocene aged stratovolcano in northern Arizona (Figure 1). The fire burned in the Coconino National Forest between June 20<sup>th</sup> and 30<sup>th</sup>, 2010, across moderate to very steep ponderosa pine and mixed conifer watersheds (Neary et al. 2011, Youberg et al. 2011). About 40% of the fire area was classified as high-severity, mostly on -mountain slopes greater than 30% and in places exceeding 100%. The upper slopes rise to over 3,300 m and are the source for high energy water, coarse sediments, and woody material. A steep gradient of nearly 1,000 m exists from the upper slopes to the base of the lower fans. Summer thunderstorms tend to develop over the mountain due to orographic lifting. Over the course of an active 2010 Monsoon, ranking the fourth highest in rainfall on record, the burned area received numerous precipitation events. The largest event occurred on July 20<sup>th</sup>, 2010, and was characterized by a peak rainfall (Peak  $I_{10}$ ) of 24 mm in ten minutes, with a normalized Peak  $I_{10}$  of 144 mm hr<sup>-1</sup>. This rainfall resulted in numerous debris flows, historic floods and substantial hillslope erosion. Flood flows were one to two orders of magnitude larger than those produced by similar pre-fire rainfall events. Another precipitation event on August 16<sup>th</sup> re-initiated debris flows from the July 20<sup>th</sup> storm. The Peak  $I_{10}$  was less at 15 mm. and the normalized Peak  $I_{10}$  was 90 mm hr<sup>-1</sup>.

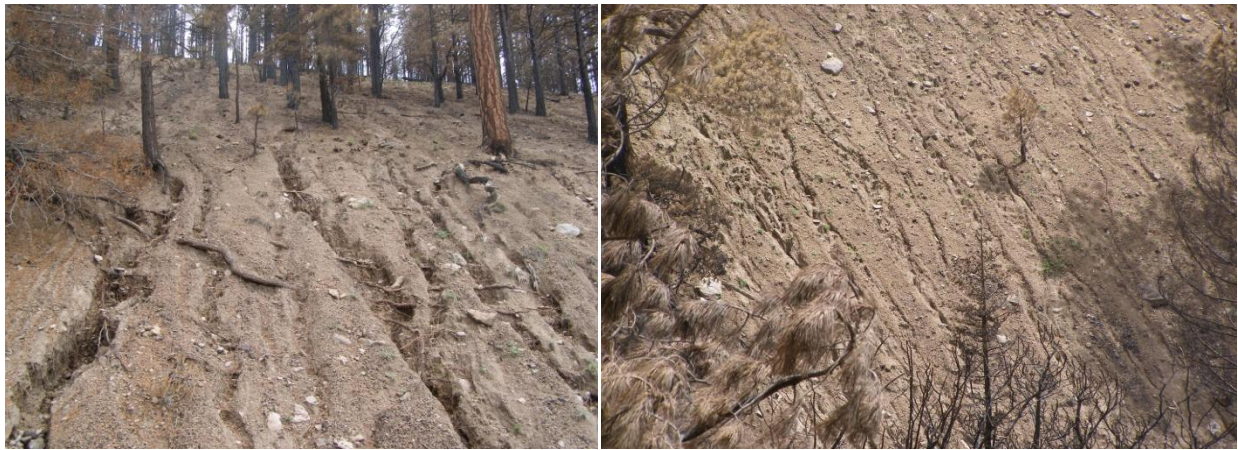
The development of an extensive rill and gully network fundamentally changed the hydrologic response of the upper portions of every catchment (Figure 2). Rills are self-organizing erosion systems characterized by numerous and randomly occurring small channels of only several centimeters in depth and centimeters to tens of meters long. Sediment yields increase with increasing slope, rill spacing decreases as slope angle increases, rill patterns show an increased

**Figure 2.** Large rill systems developing on a steep slope (right) and small gully development beginning (left). Schultz Fire, 2010, above the Waterline Road, Coconino National Forest, USA.

elongation and parallelism on steeper slopes, and hillslope rills tend to be evenly spaced on bare, straight slopes (Favis-Mortlock et al. 2000). Rills on the upper slopes of the San Francisco Peaks within the Schultz Fire perimeter are now 10-20 cm deep into the B and C horizons running the entire length of slopes. Parallel rills in the right photo of Figure 2 demonstrate the transition from sheet erosion to rill erosion. The rills are 30 to 40 cm apart crossing entire slopes. They are up to 5 cm deep and beginning to coalesce. The rills shown on the left are transitioning to small gullies 20 to 30 cm deep. They are cutting below the ponderosa pine surface root systems and into fragmented and weathered C horizon andesite and dacite.

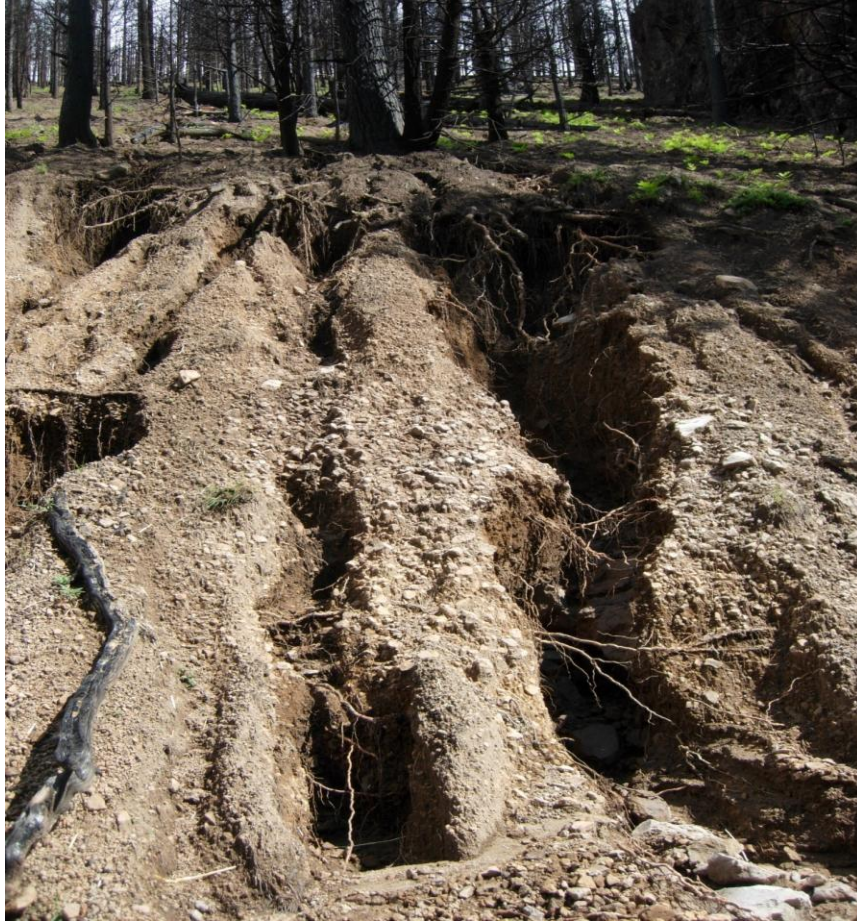
Small lateral gullies that are 50 to 100 cm deep (Figure 3) merge into now deeply incised main drainage gullies (3 to 5 m deep) that occupy previous swales in the upper mountain slopes (Figure 4). Despite the elevation and precipitation regime there are no perennial stream channels. Flood flows in July and August of 2010 incised deeply into the slopes consisting of volcanic colluvial material and ash and tephra deposits. In many places the gullies have cut down to bedrock, thus

**Figure 3.** Rapidly deepening gullies on the upper mountain slopes of the San Francisco Peaks within the high-severity portion of the Schultz Fire of 2010.

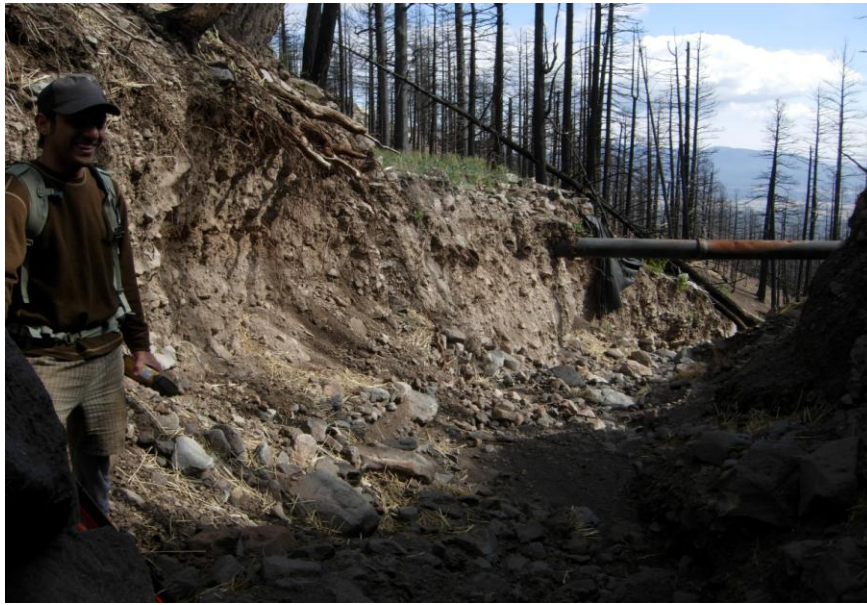
allowing subsequent flood flows to scour out fresh, un-weathered material. The pre-fire slope surface was about 1 m above the individual on the left in Figure 4. The deep incisions of these main drainage gullies has lowered the base level of the smaller lateral gullies, leading to additional headward cutting of the gully system.

**Figure 4.** Deeply incised (3 m) main drainage gully within the Schultz Fire along the Waterline Road, Coconino National Forest, Arizona.
