# Field Trip Guide to the 2010 Schultz Fire Burn Area

Arizona Hydrological Society  
Annual Symposium  
Flagstaff, Arizona  
September 18, 2011

### **Wildfire, Rain and Floods: A case study of the June 2010 Schultz Wildfire, Flagstaff, Arizona**

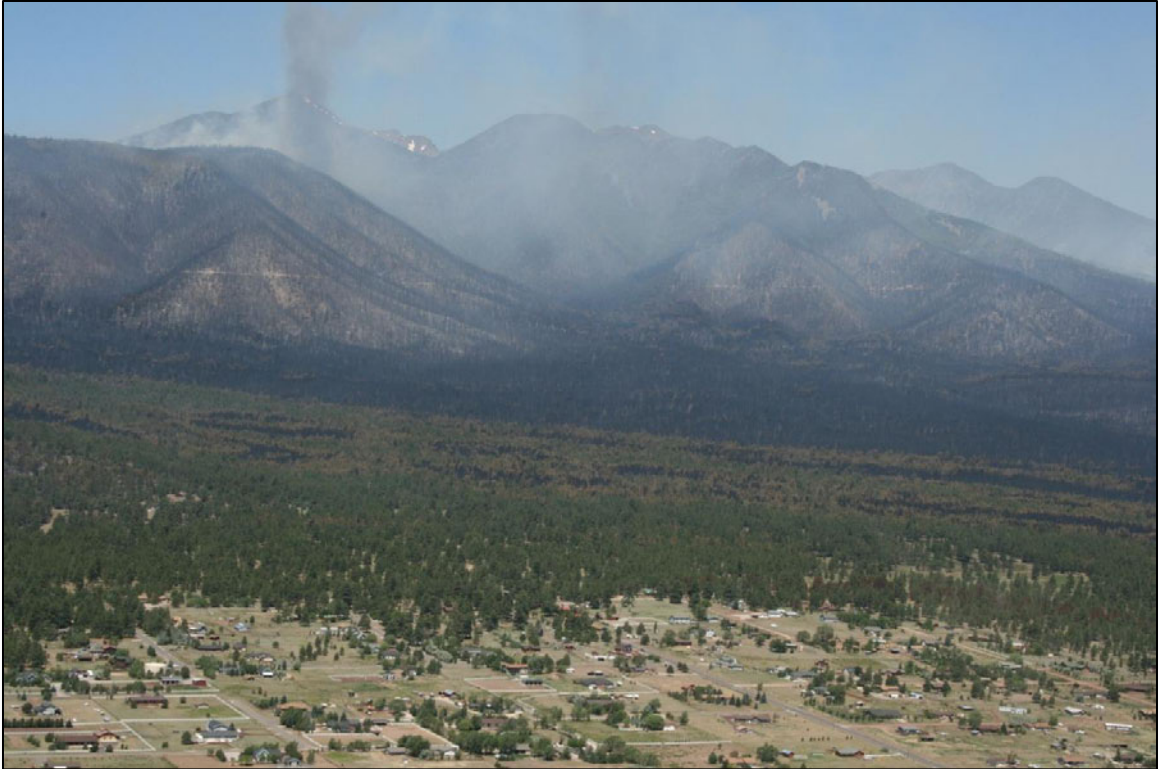
Figure 3. View of the Schultz Fire on June 24. The white almost horizontal line on the steep slopes is FR146 (waterline). Timberline Estates in the foreground. Photo: D. Fleishman, USFS.

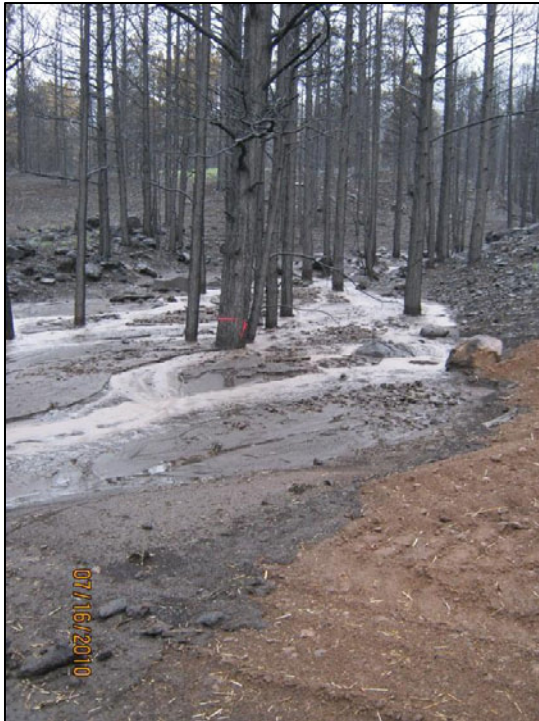
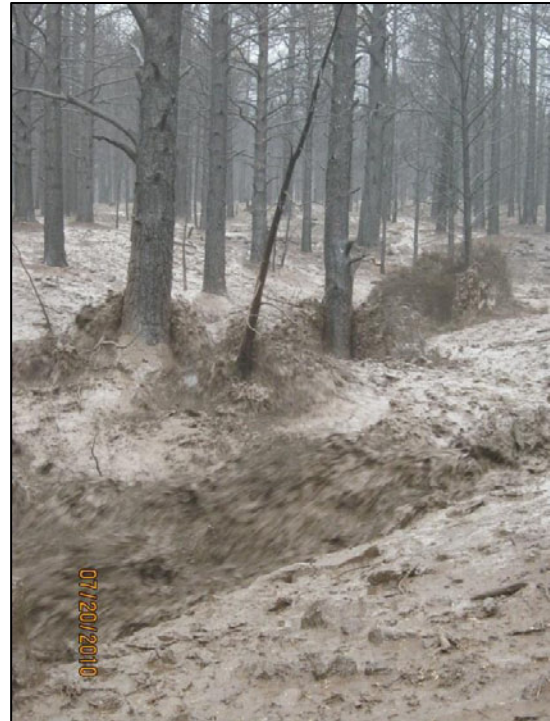
Figures 5 and 6. Figure 5, left, Flood flow in drainage crossing FR420 on July 16. Flow from upper right to lower left. Recorded precipitation amounts at the ALERT rain gauges varied from 0.01-0.55 in. Photo: A. Stevenson, USFS. Figure 6, right, Flood flow in drainage crossing FR420 early in the storm on July 20th. Flow from upper right to lower left. Recorded precipitation amounts at the ALERT rain gauges varied from 1.46-1.78 in. Photo: A. Stevenson, USFS. Video: B. Prusse, USFS.

The first rain fell on July 16<sup>th</sup> with minimal impacts. Flood waters resembled typical black, post-fire, ash-laden flows (Figure 5). The next storm, on July 20<sup>th</sup>, produced 1.78 in of rain in 45 minutes, with a very high peak 10-minute intensity of 0.98 in (Figure 6). This short duration, high-intensity precipitation event produced debris flows and flooding that eroded channels and broke the waterline in two places. Downstream flooding was surprisingly widespread, extending into the community of Timberline west of US89, through the Fernwood development east of the highway, and ultimately inundating low-lying areas in the Doney Park development 4 miles from the burn. Another high intensity storm on the 16<sup>th</sup> of August delivered 1.06 in of rain in 46 minutes with a peak 10-minute intensity of 0.59 in and produced a second round of debris flows. Several other storm events caused repeated flooding between and after these events, but the storms of July 20<sup>th</sup> and August 16<sup>th</sup> were the only ones known to generate multiple debris flows in seven basins.

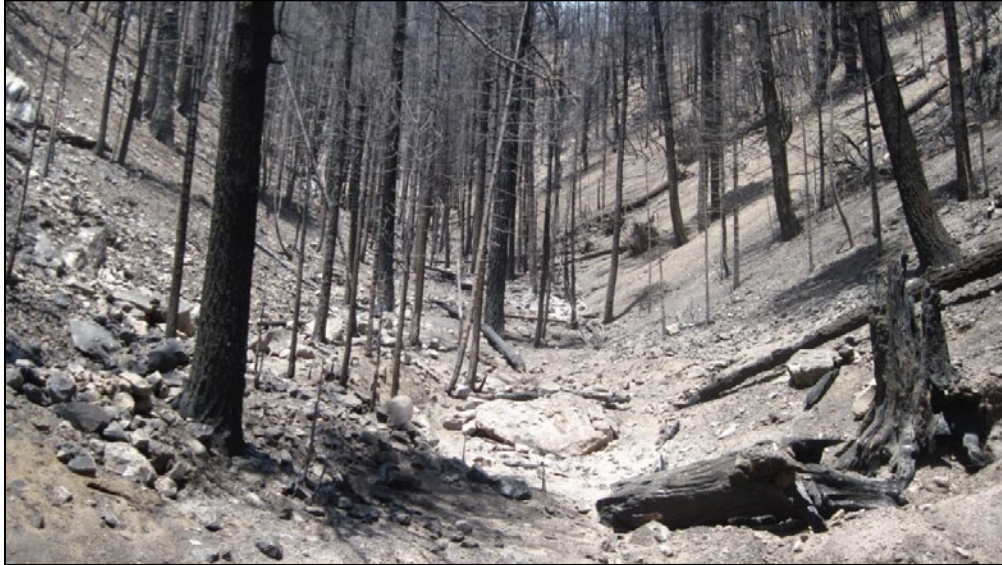
Figure 7. Drainage swale along FR146 (waterline) taken on June 29 after the fire but before rain. Note the swale and smooth hillslopes. Photo: City of Flagstaff Water Department.

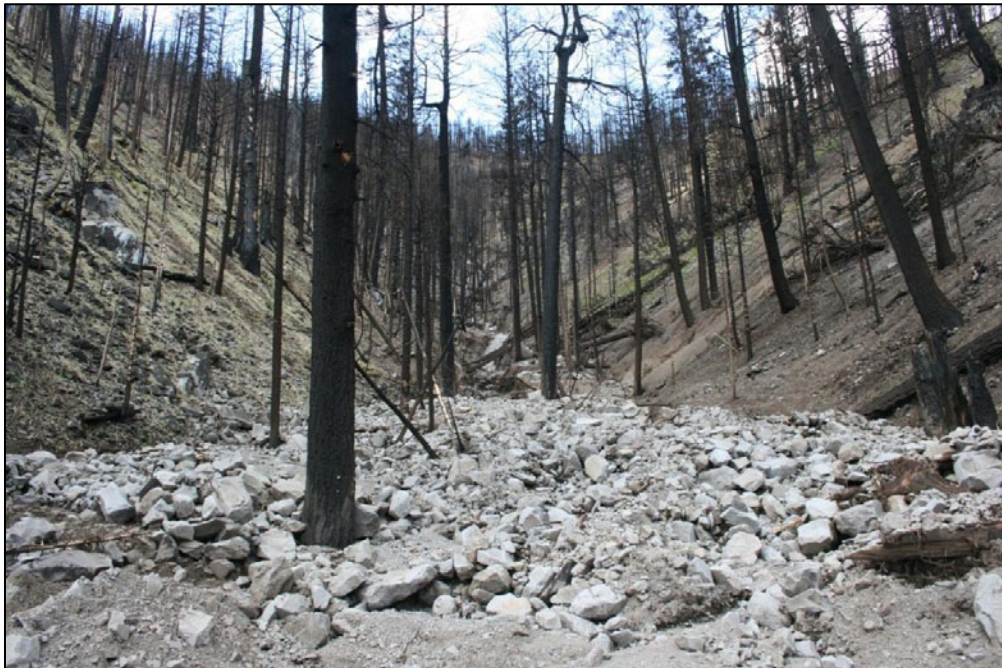
Figure 8. Same drainage as Figure 7. This photo was taken on August 9th after the July 20th debris flows and several other rain storms. Photo: D. Fleishman, USFS.

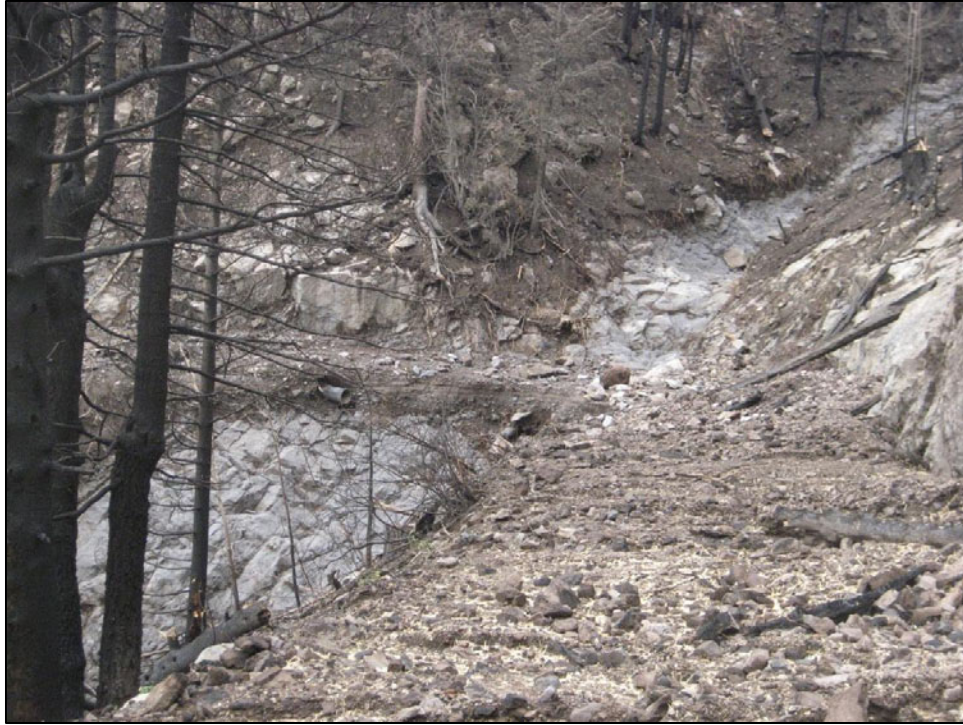
Figure 9. Photo taken on July 25th of FR146 at the drainage where the waterline was severed and removed by debris flows on July 20th. Half of the roadbed was removed by the debris flows; the remaining roadbed was removed during the August 16th debris flows. Photo: D. Fleishman, USFS.

Post-fire flooding and debris flows performed a significant amount of geologic work in a very short period of time. The first major flood event of July 20<sup>th</sup> exposed bedrock in channels that had previously contained substantial amounts of sediment. The rip-rap barriers installed to protect FR146 and the waterline beneath at drainage crossings were completely destroyed and the waterline was broken at two drainage crossings. The following photos from two drainages (Figures 7, 8 and 9) and along FR 146 (waterline, Figure 10) illustrate the impact of this fire and subsequent rains on Coconino National Forest lands. There are several key points to note in these photographs. Photos taken after the fire but before monsoon rains show drainage swales with no defined channel bottom or banks (Figure 7), while post-storm channels are either filled with fresh debris (Figure 8) or scoured to bedrock with steep banks up to 3 m high (Figure 9).

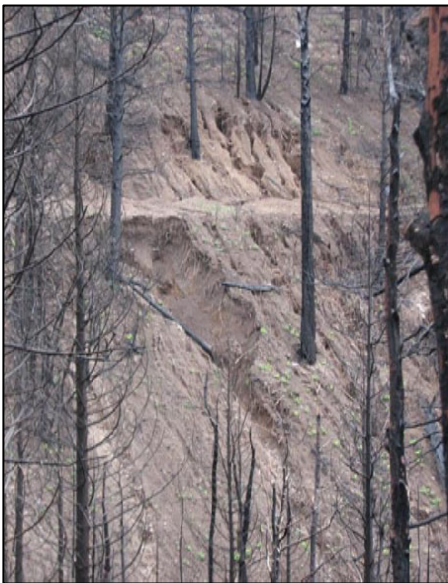
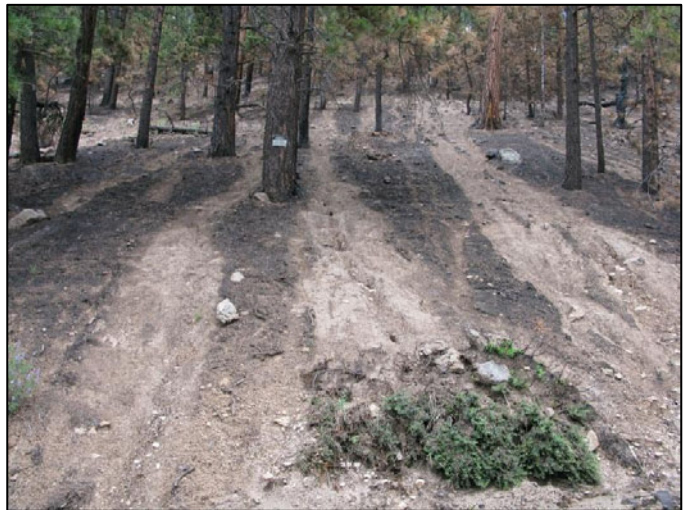
Figures 10a and 10b. Figure 10a, left, hillslope and gully erosion along FR146 on August 17th. Figure 10b, right, hillslope rilling along FR146 on August 6<sup>th</sup>. Photos: A. Youberg, AZGS.

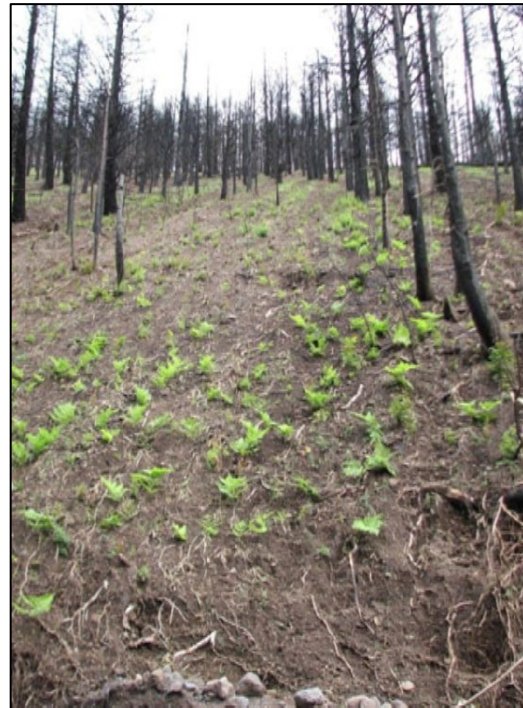
Figure 11. Native vegetation regrowth on steep hillslopes above FR146 (waterline) Photo: A. Youberg, AZGS, August 17th, 2010.

While vegetation has begun to recover even on very steep, high-severity burn slopes (Figure 11), it will take a few years to significantly reduce runoff. Sediment-laden floods repeatedly inundated residential areas this past summer. Coconino County Emergency Management and Coconino County Flood Control have worked around the clock to help residents prepare and deal with the flooding. The County continues to work on solutions for routing flood waters to minimize widespread flooding and to protect communities. Several individuals have suggested constructing retention basins to accommodate debris and flood flows from the burn area. Construction of retention basins is expensive, requires constant sediment-removal, will not retain flood waters, and probably could not be built before vegetation recovers sufficiently to reduce runoff and flood flows.

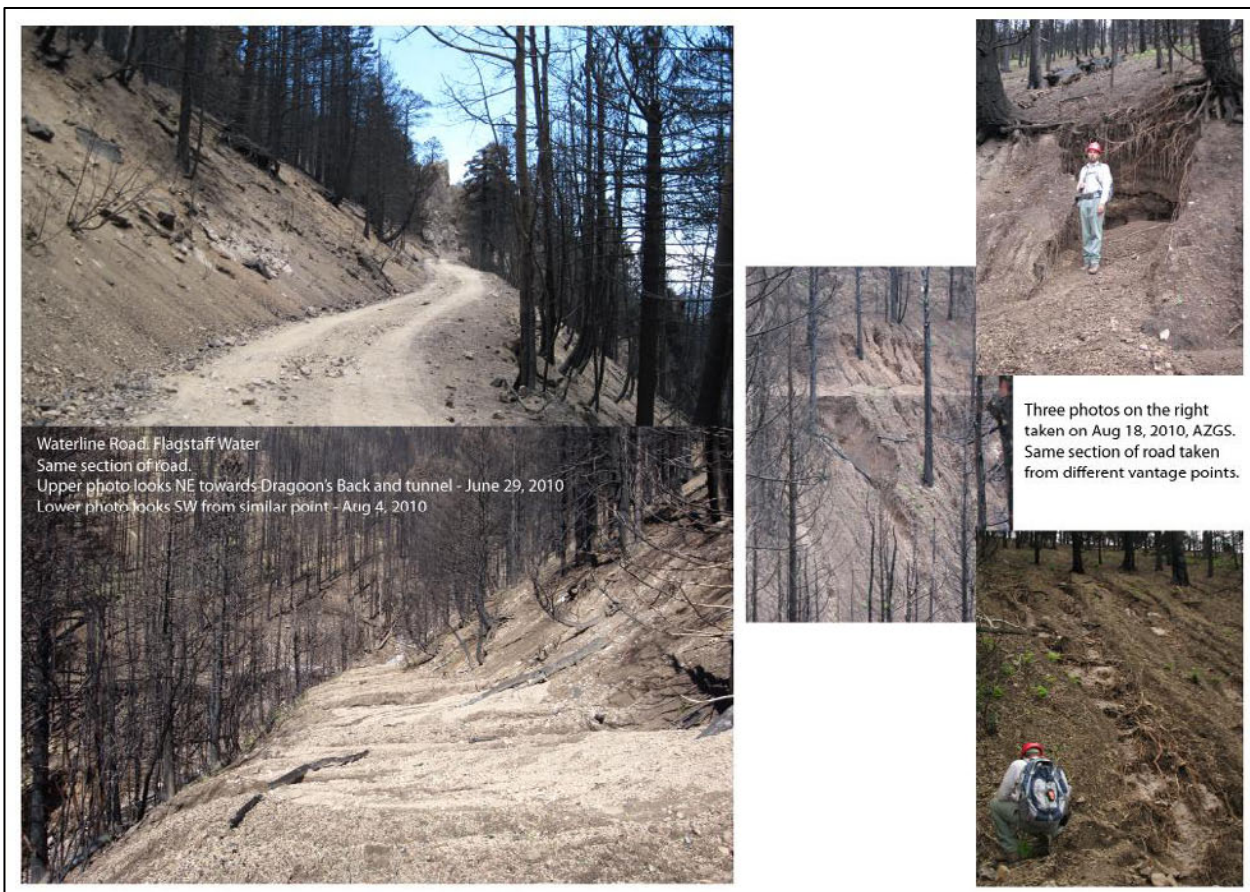
Figure 12. Examples of hillslope erosion along the Waterline Road immediately after the fire (upper left) and after rainfall.

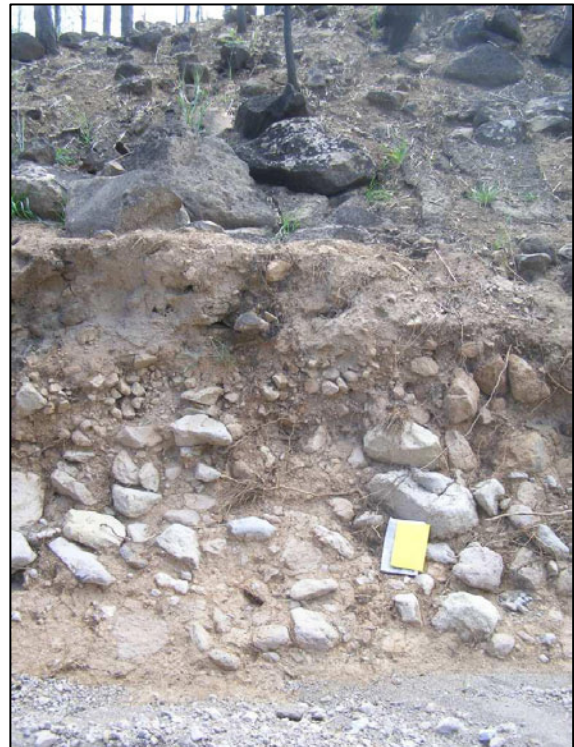
Figure 15. Channel incision in the piedmont zone exposing prehistoric debris flow and flood deposits near. Photo: K. Koestner USFS RMRS.

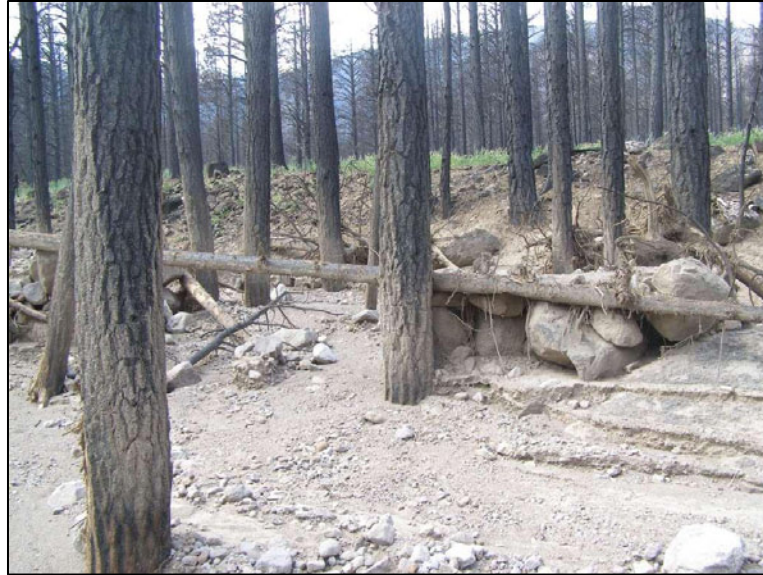
Figure 16. Log jams from down woody debris, which is in ample supply following severe fires, can cause temporary (as seen to the left) or semi-permanent areas of sediment storage within channels. Log-jam debris dams alter flow and erosional processes within channels and can be hazardous during high intensity flow events due to the potential for breach hydrology Photo: K. Koestner, US FS RMRS, 2010.

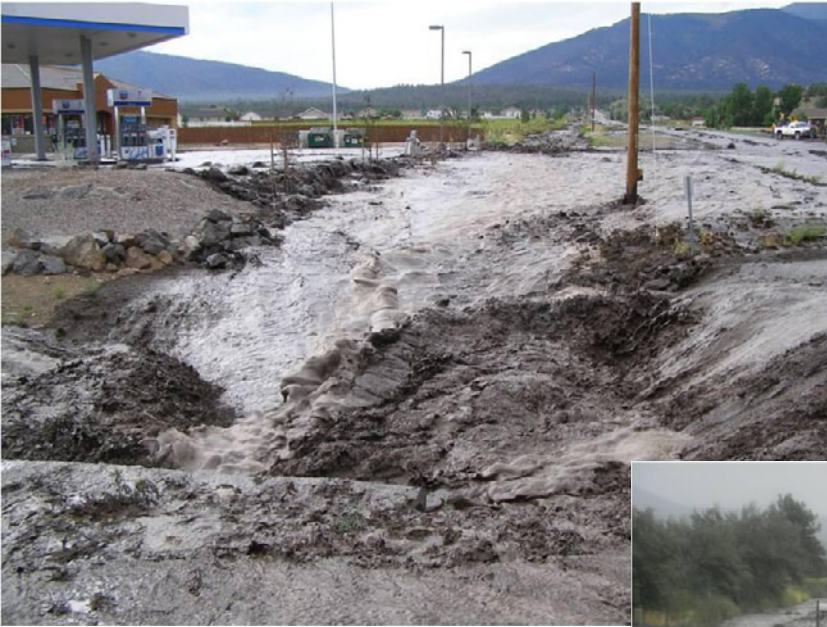
Figure 17 (upper left). Flow from Campbell Avenue and ditch at the Chevron Station, Timberline, during first major post-fire flow event, 20 July 2010 (prior to infrastructure upgrades). Photo: D. Neary US FS RMRS.

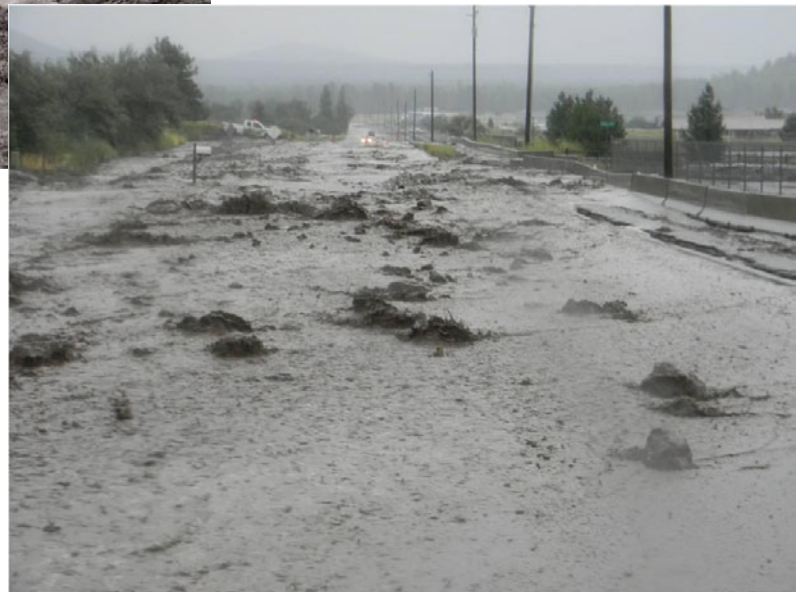
Figure 18 (lower right). Flow down Campbell Avenue towards HW 89 upstream of improved canal structure on the south side of the street, August 19, 2011. Photo: D. Neary US FS RMRS.

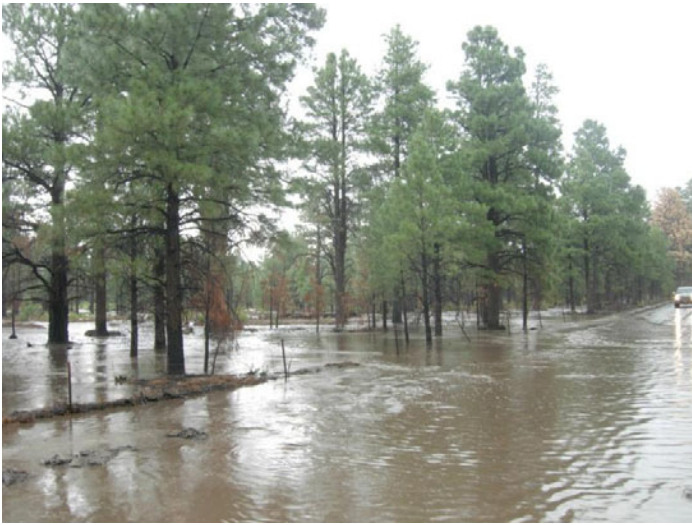
Figure 19. Sheet flooding across land fill road. Slow moving sheet flows carry fine particulates and ash in suspension. A minimum to two flood events impacted this area. Photo: K. Koestner USFS RMRS

- Sheet flooding left extensive fine sediment and ash deposits from the Timberline area into Doney Park (Figure 19).

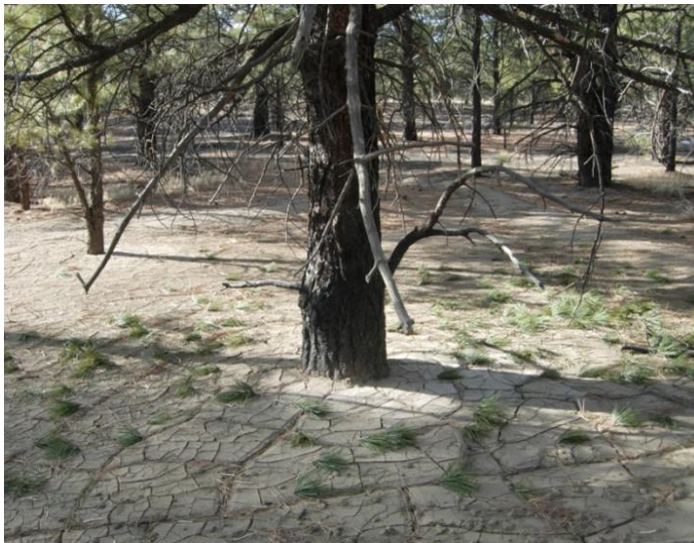
Figure 20. Silt flood deposits near landfill reduce surface roughness and allow subsequent flows to travel farther faster. Photo: K. Koestner USFS RMRS.

- Surface sealing from silt size particles prevents infiltration into cinders (Figures 20 & 21). Coconino County and the Forest Service responded by scarifying the flood deposits to expose underlying cinders and improve infiltration of flood waters and local rainfall.

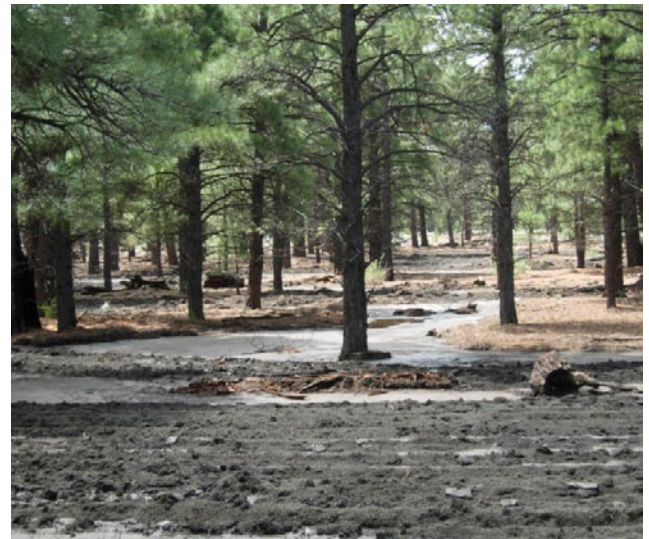
Figure 21. Scarification of sheet flow deposits near landfill to expose underlying cinders. Photo: K. Koestner USFS RMRS.
