# **EVALUATING THE EFFECTIVENESS OF BURNED AREA EMERGENCY RESPONSE (BAER) EFFORTS AFTER THE 2003 WILDFIRES, SOUTHERN CALIFORNIA**

Peter M. Wohlgenuth, Pacific Southwest Research Station, USDA Forest Service, Riverside, CA  
pwohlgenuth@fs.fed.us

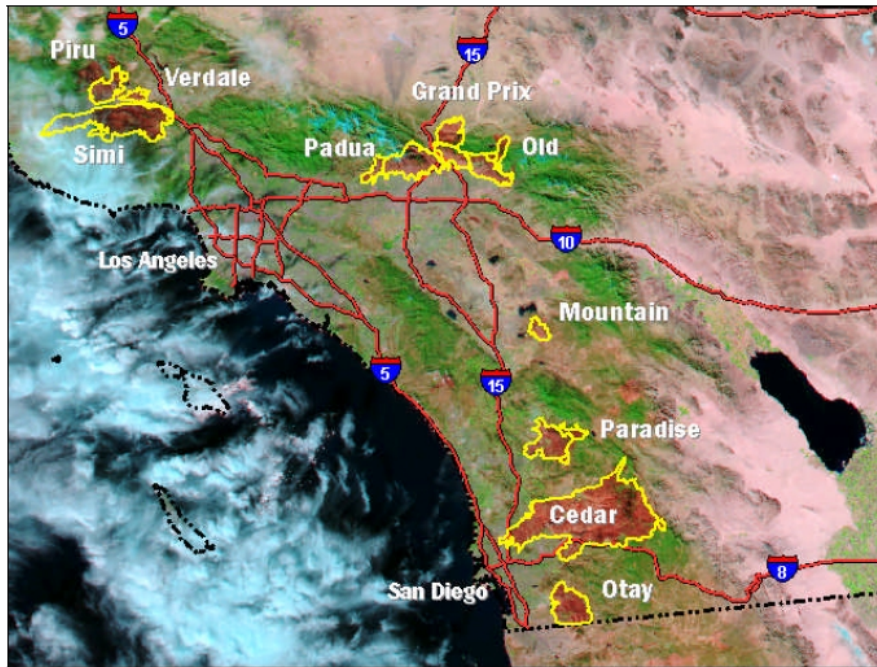
Figure 1. False-Color Infrared MODIS Scene Showing Fire Locations, Acquired November 5, 2003 (Clark et al. 2003)

The wildfires that began in late October 2003 consumed more than 300,000 hectares (750,000 acres) across southern California (Figure 1). Wildfire can dramatically alter the erosion response of upland landscapes by removing the protective vegetation canopy and surface organic material. In addition, the combustion of soil organic matter can create a subsurface water-repellent layer that restricts infiltration and promotes overland flow (DeBano 1981), enhancing sediment yield (Wells 1981). In southern California, first-year post-fire sediment yield is 35 times greater on average than comparable unburned annual levels (Rowe et al. 1954).

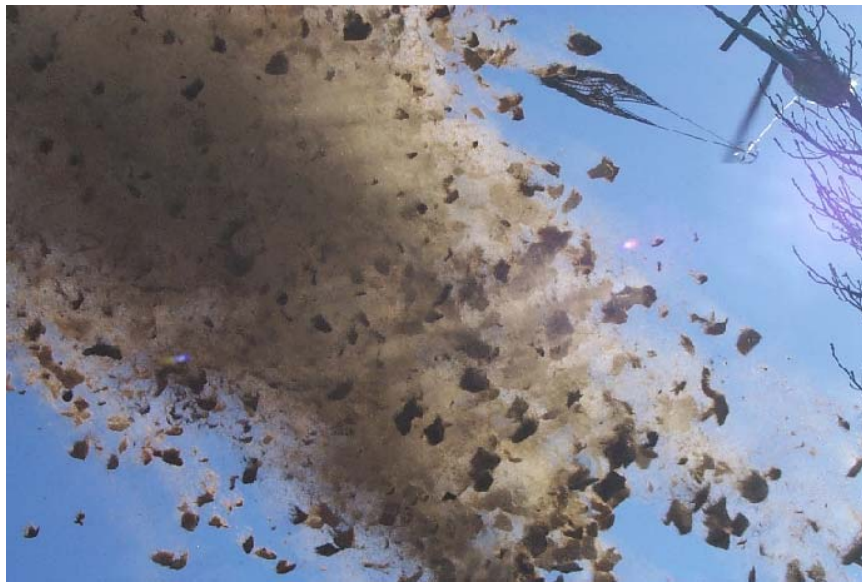
Figure 2. Delivery of Aerial Straw Mulch (Janiki and Grant 2002)

Over four million dollars were spent on hillslope treatments following the 2003 wildfires. The treatments consisted of ground covers to dissipate rain beat and retard overland flow, and barriers to trap water and sediment. Specific treatments included hand straw mulching, aerial straw mulching, installation of fiber rolls (straw wattles), and aerial hydromulching. Straw mulch, whether applied by hand or aerially, was spread on the ground at a rate of 2300 kg per ha (one ton per acre). Aerial straw mulching, delivered by cargo nets suspended from a helicopter (Figure 2), was most practical for large blocks of open terrain. Hand straw mulching was used in areas of complex terrain and thick, standing dead vegetation. Fiber rolls are permeable barriers prefabricated from rice straw wrapped in tubular plastic netting. Measuring 23 cm (9 in) in diameter and 7.5 m (25 ft) in length, the fiber rolls were placed along the hillside contour and secured with wooden stakes. The rolls were placed in an overlapping pattern (Figure 3) with a vertical spacing of 5-10 m (15-30 ft), inversely proportional to hillslope angle. The aerial hydromulch is a wood and paper mulch matrix with a non water-soluble binder. The mulch is mixed as a slurry and applied by helicopter (Figure 4). It was delivered at two application rates: 100 percent cover, and 50 percent cover in 30 m (100 ft) contour strips.

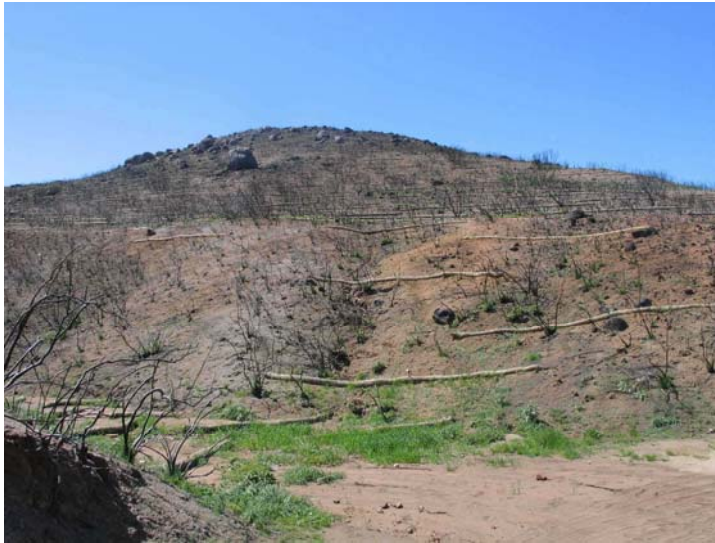
Figure 3. Fiber Rolls in an Overlapping Pattern with Spacing Inversely Proportional to Slope Angle on the Cedar Fire

Based on repeat photography, the fiber rolls were generally effective at preventing erosion on the hillside slopes. Fiber roll performance was strongly related to the quality of their initial installation. However, because of low precipitation during the first post-fire winter, there was very little movement of sediment on the hillslopes. It is unclear how effective these rolls would be under larger rainfall events. In any case, the fiber rolls did not perform well in swales and drainages. In these locations, the rolls failed by undercutting, necessitating expensive repairs.

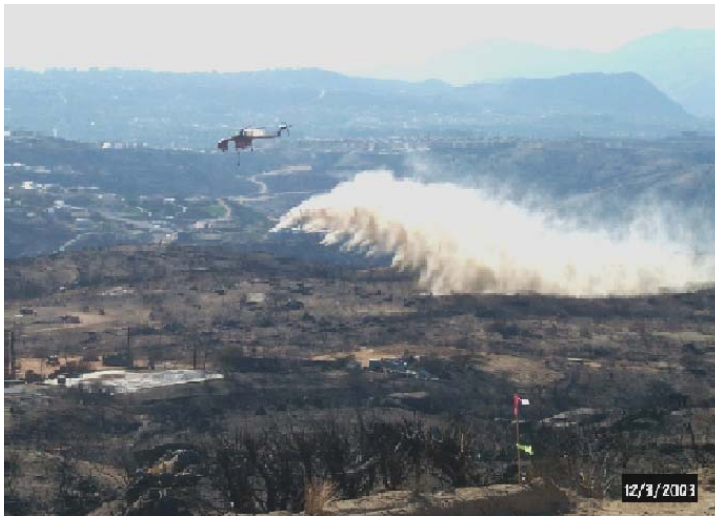
Figure 4. Delivery of Aerial Hydromulch on the Cedar Fire

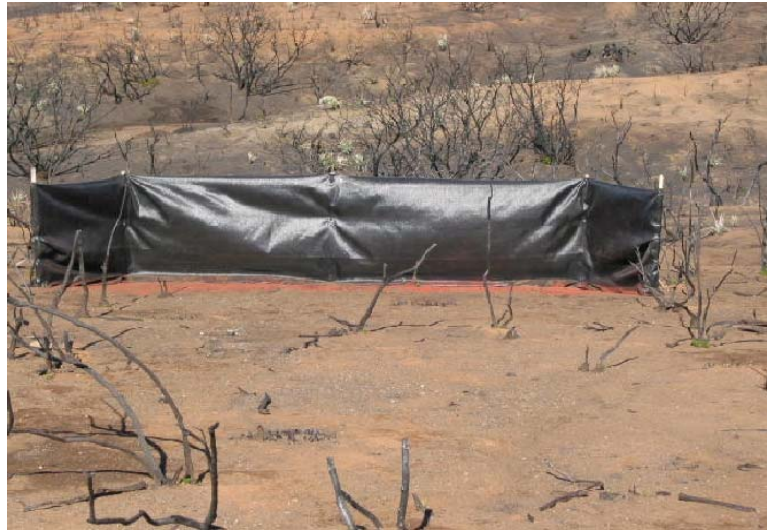
Figure 5. Silt fence for Measuring Hillslope Erosion

Hillslope treatments and their associated control areas were to be monitored with silt fences to evaluate their effectiveness. A silt fence is a barrier of geotextile fabric secured to upright posts constructed along the hillside contour (Figure 5) to trap hillslope erosion (Robichaud and Brown 2002). Sediment would be periodically shoveled out from behind the fences and field weighed. Comparisons of repeated cleanouts of trapped material from treated and untreated hillsides would be used to gauge treatment performance.

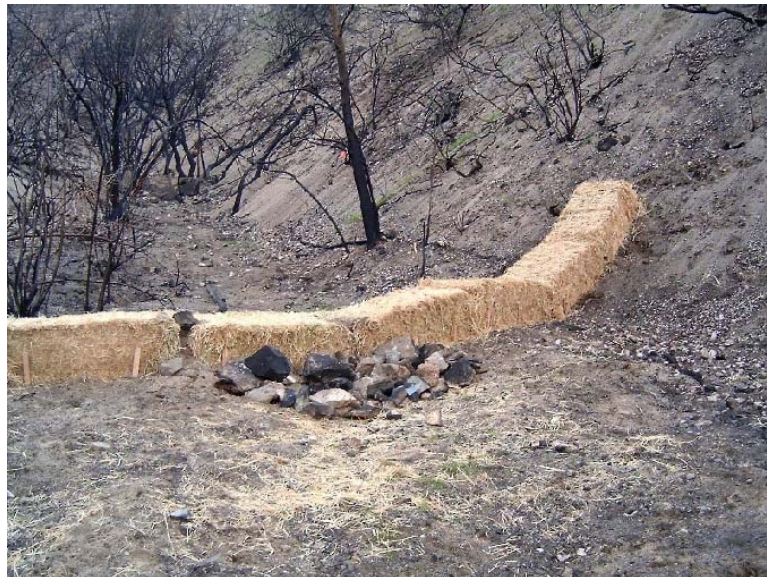
Figure 6. Straw Bale Check Dam in a Steep Channel on the Old/Grand Prix Fire (photo by Vicky Sjöberg)

Several hundred thousand dollars were spent on channel treatments following the 2003 wildfires. The treatments consisted of check dams to trap transported sediment and act as grade control structures to prevent streambed incision. Specific treatments included straw bale check dams and log check dams. Straw bale check dams are constructed of bales of straw secured with metal fence posts (Figure 6). Stored sediments by design are slowly released over time as the straw check dam materials deteriorate over a period of 1 to 3 years. Log check dams are constructed of fire-killed trees with a 15-45 cm (6-18 in) diameter pinned together with wooden pegs. The end logs are keyed into the adjacent stream banks (Figure 7). Dams of either material are designed to match the morphology of the original channel.

Both of the channel treatments were unreplicated case studies without controls, and their effectiveness was evaluated by subjective interpretation. The straw bale check dams did trap some sediment and initially stabilized the stream bed. As the winter season progressed, however, the dams could not prevent subsequent downstream channel incision. Moreover, there is concern in the future that as the straw deteriorates, the trapped deposits will be remobilized by second and third year storms, posing continued threats to the downstream values at risk. The log check dams also initially trapped some sediment, but subsequently failed by end cutting and undercutting. Once breached, the trapped deposits were quickly scoured and transported downstream. Furthermore, there is concern in the future that the loss of bank stability by decaying tree roots will produce more erosion and downstream sedimentation.

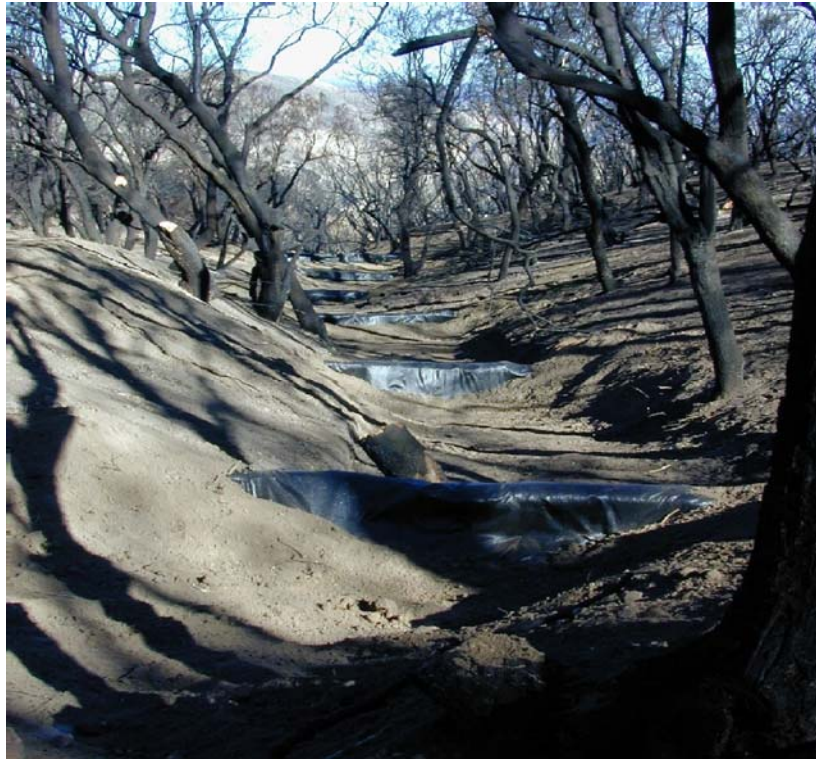
Figure 7. A series of log check dams on the Piru Fire (photo by Allen King)
