## Post-fire rill and gully formation, Schultz Fire 2010, Arizona, USA

Daniel G. Neary<sup>a\*</sup>, Karen A. Koestner<sup>a</sup>, Ann Youberg<sup>b</sup>, Peter E. Koestner<sup>c</sup>

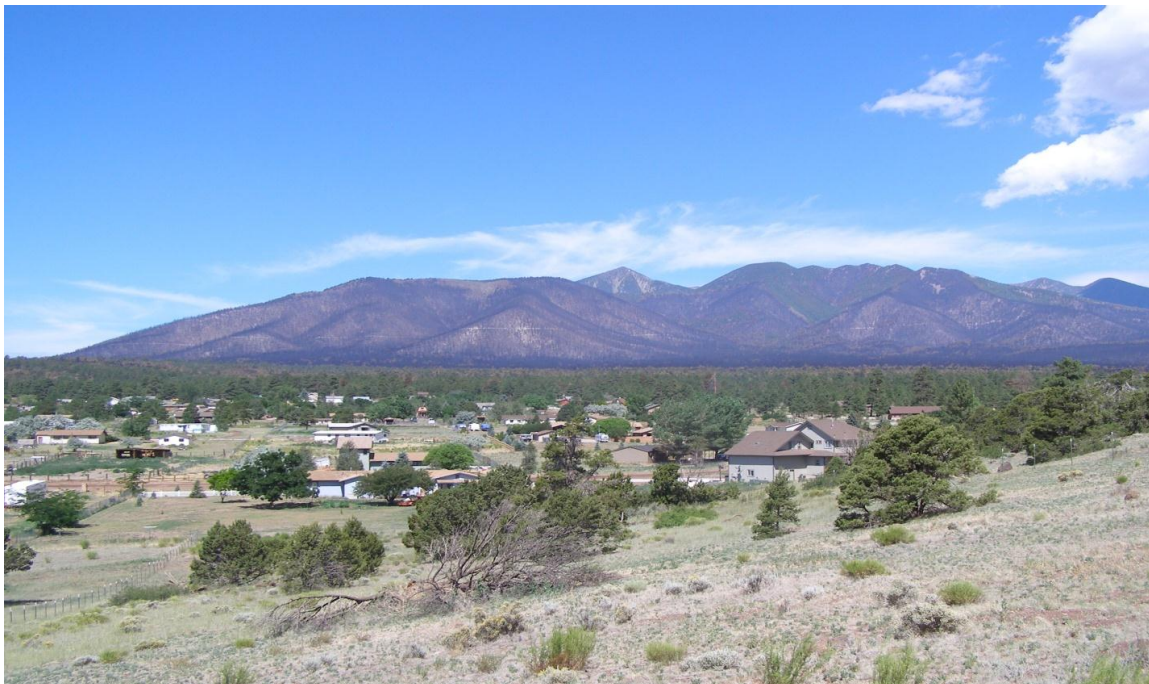
**Figure 1.** Schultz Fire burned area on the east flank of the San Francisco Peaks, July 2010.

The Schultz Fire burned 6,100 ha on the eastern slopes of the San Francisco Peaks, a dormant Middle Pliocene to Holocene aged stratovolcano in northern Arizona (Figure 1). The fire burned in the Coconino National Forest between June 20<sup>th</sup> and 30<sup>th</sup>, 2010, across moderate to very steep ponderosa pine and mixed conifer watersheds. About 40% of the fire area was classified as high-severity, mostly on mountain slopes greater than 30% and in places exceeding 100%. The upper slopes rise to over 3,300 m and are the source for high energy water, coarse sediments, and woody material. A steep gradient of nearly 1,000 m exists from the upper slopes to the base of the lower fans. Summer thunderstorms tend to develop over the mountain due to orographic lifting. Over the course of an active 2010 Monsoon, ranking the fourth highest in rainfall on record, the burned area received numerous precipitation events. The largest event occurred on July 20<sup>th</sup> and was characterized by a peak rainfall of 25 mm in fifteen minutes, resulting in numerous debris flows, historic floods and substantial hillslope erosion. Flood flows were one to two orders of magnitude larger than those produced by similar pre-fire rainfall events.

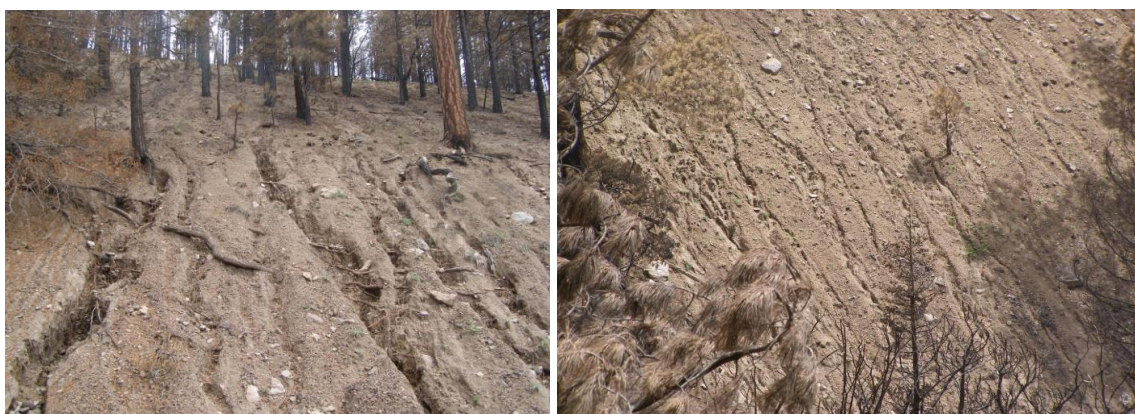
**Figure 2.** Large rill systems developing on a steep slope (right) and small gully development beginning (left). Schultz Fire, 2010, above the Waterline Road, Coconino National Forest, USA.

The development of an extensive rill and gully network fundamentally changed the hydrologic response of the upper portions of every catchment (Figure 2). Rills are self-organizing erosion systems characterized by numerous and randomly occurring small channels of only several centimetres in depth and centimetres to tens of metres long.

slopes. Parallel rills in the right photo of Figure 2 demonstrate the transition from sheet erosion to rill erosion. The rills are 30 to 40 cm apart crossing entire slopes. They are up to 5 cm deep and beginning to coalesce. The rills shown on the left are transitioning to small gullies 20 to 30 cm deep. They are cutting below the ponderosa pine surface root systems and into fragmented and weathered C horizon andesite and dacite. Small lateral gullies that are 50–100 cm deep (Figure 3) merge into now deeply incised main drainage gullies (3–5 m deep) that occupy previous swales in the upper mountain slopes (Figure 4). Despite the elevation and precipitation regime there are no perennial stream channels.

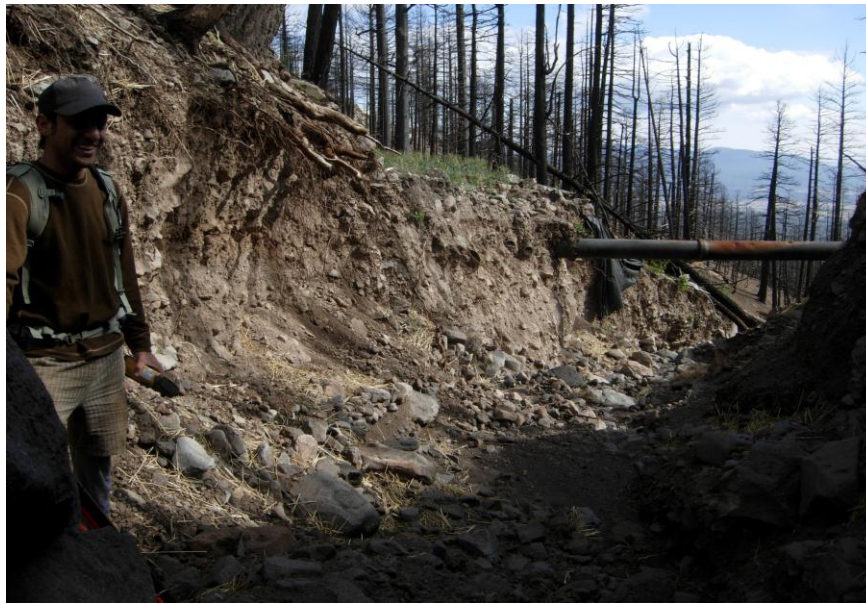
**Figure 4.** Deeply incised (3 m) main drainage gully within the Schultz Fire along the Waterline Road, Coconino National Forest, Arizona.

Flood flows in July and August of 2010 incised deeply into the slopes consisting of volcanic colluvial material and ash and tephra deposits. In many places the gullies have cut down to bedrock, thus allowing subsequent flood flows to scour out fresh, unweathered material. The pre-fire slope surface was about 1 m above the individual on the left in Figure 4. The deep incisions of these main drainage gullies has lowered the base level of the smaller lateral gullies, leading to additional headward cutting of the gully system.
