THESIS

GEOMORPHIC ANALYSIS OF THE MIDDLE RIO GRANDE –  
ELEPHANT BUTTE REACH, NEW MEXICO

Tracy Elizabeth Owen

Colorado State University

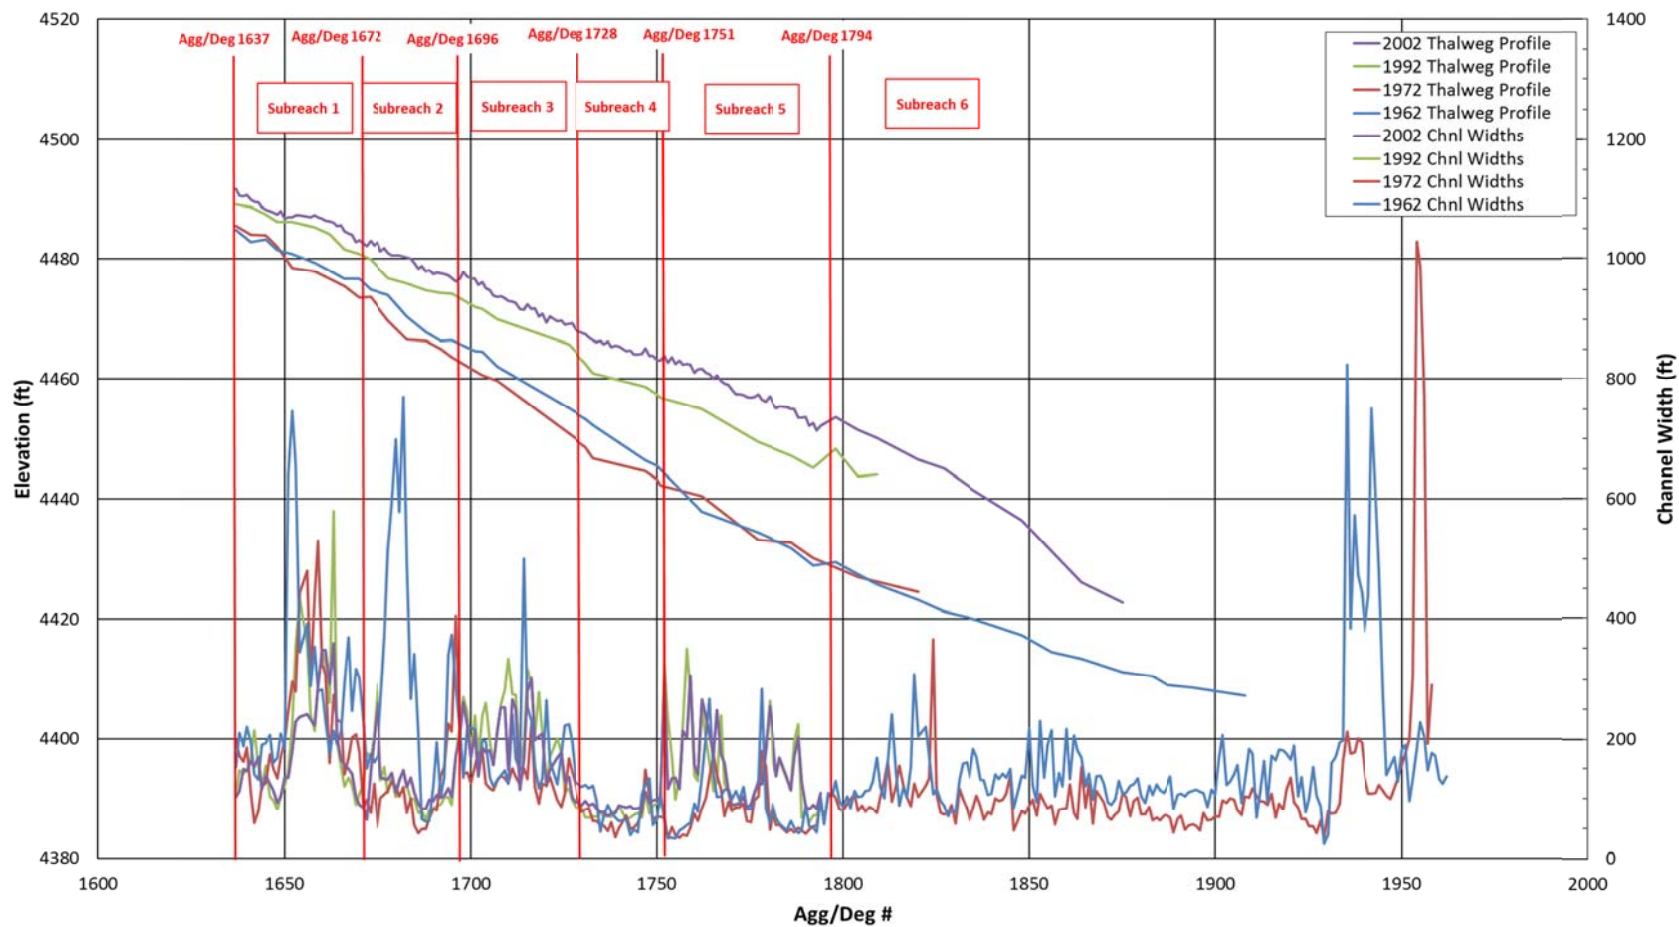
Figure 2.2 Profile of Elephant Butte Reach Widths and Thalweg at Agg/Deg Lines

To determine the subreach divisions, the active channel widths, as measured from edge of vegetation to edge of vegetation, were plotted for the entire Elephant Butte Reach for years 1962, 1972, 1992, and 2002. The thalweg at each Agg/Deg-line was also plotted for each set of years, as shown on Figure 2.2. The subreaches were chosen based on the 2002 dataset because of the abundance of both GIS and Agg/Deg Cross-section data during this year, but subreaches were confirmed using the 1962, 1972, and 1992 datasets.

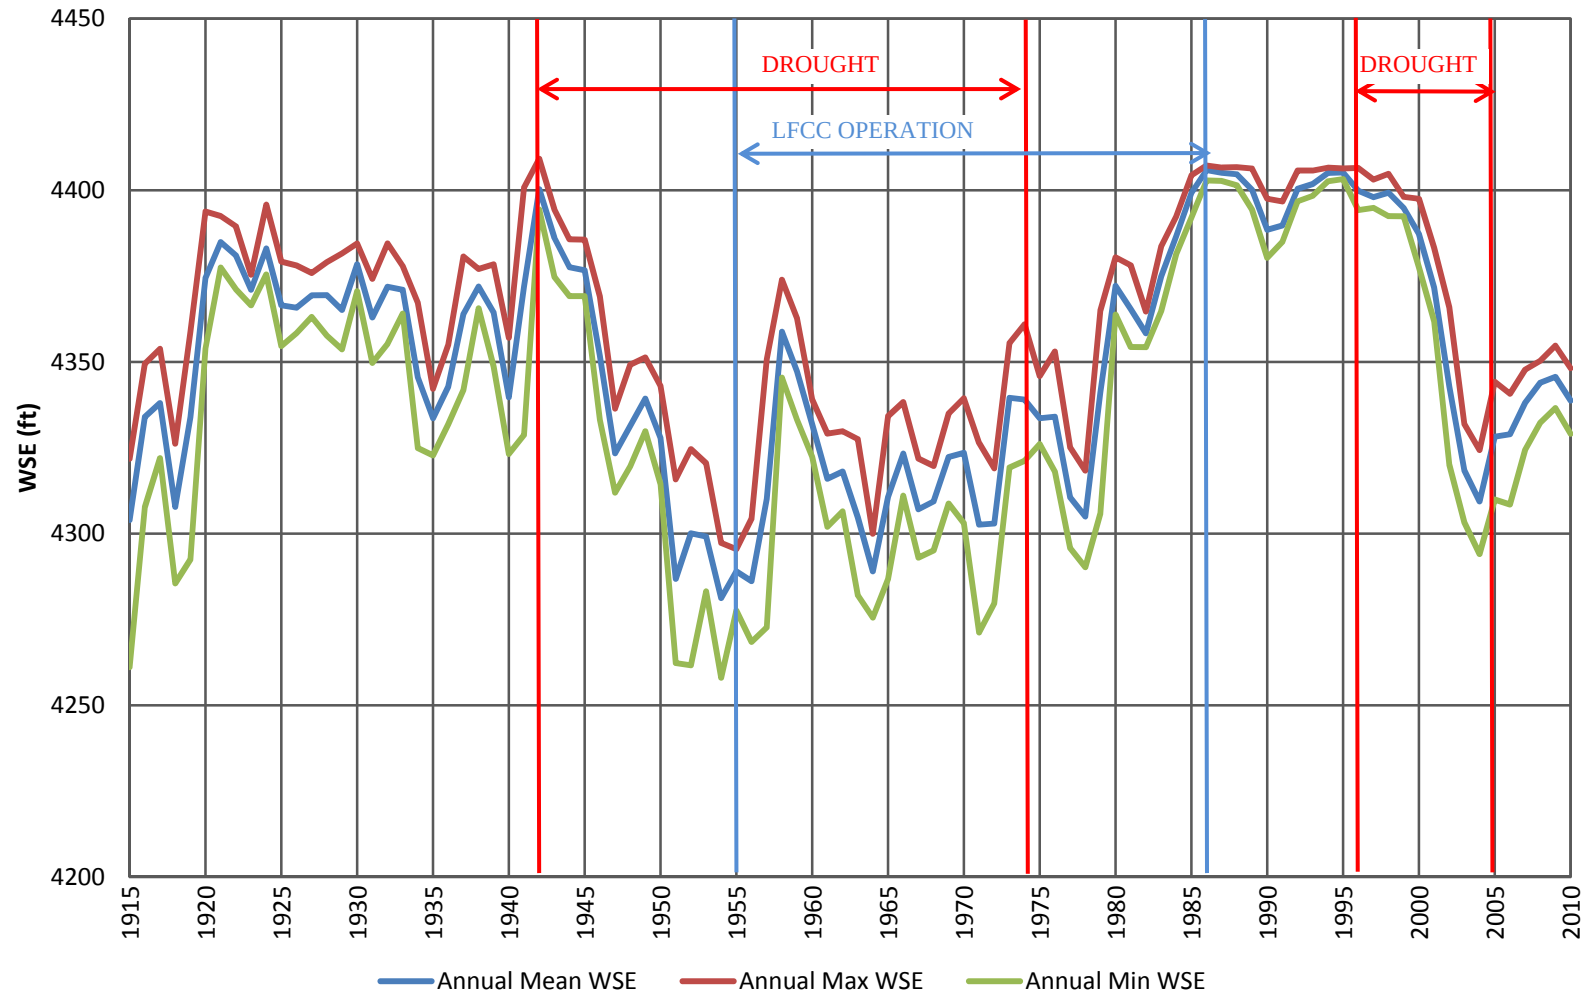
Figure 3.1 Elephant Butte Reservoir Level Time Series

A reservoir level analysis was performed for the Elephant Butte Reservoir, located at the downstream end of the Elephant Butte Reach. Figure 3.1 shows the Elephant Butte Reservoir level time series. Elephant Butte Dam construction began in 1908 and was completed in 1916, with water storage operations beginning in January of 1915 (Reclamation, 2008). The maximum water surface elevation (WSE) of Elephant Butte Reservoir is 4407.0 ft. Since its inception, the WSE behind Elephant Butte Dam has varied more than 150 ft in elevation. The reservoir was not completely filled until 1942, at which point the reservoir level dropped about 150 ft between 1942 and 1954, due to a drought which lasted from about 1942 to about 1974 (Figure 1.2). The low flow conveyance channel (LFCC), which was built to hydraulically efficiently transport water to Elephant Butte Reservoir and runs the entire length of Elephant Butte Reach, was in operation by 1955 and operated until 1986. With the operation of the LFCC during the drought, the reservoir WSE averaged between El 4331 and El 4404. By about 1977 the reservoir began to fill again until it was full, or essentially full, from 1985 to 1999, at which point another drought impacted the reservoir level, which decreased to an average WSE of about 4340 ft in 2010.

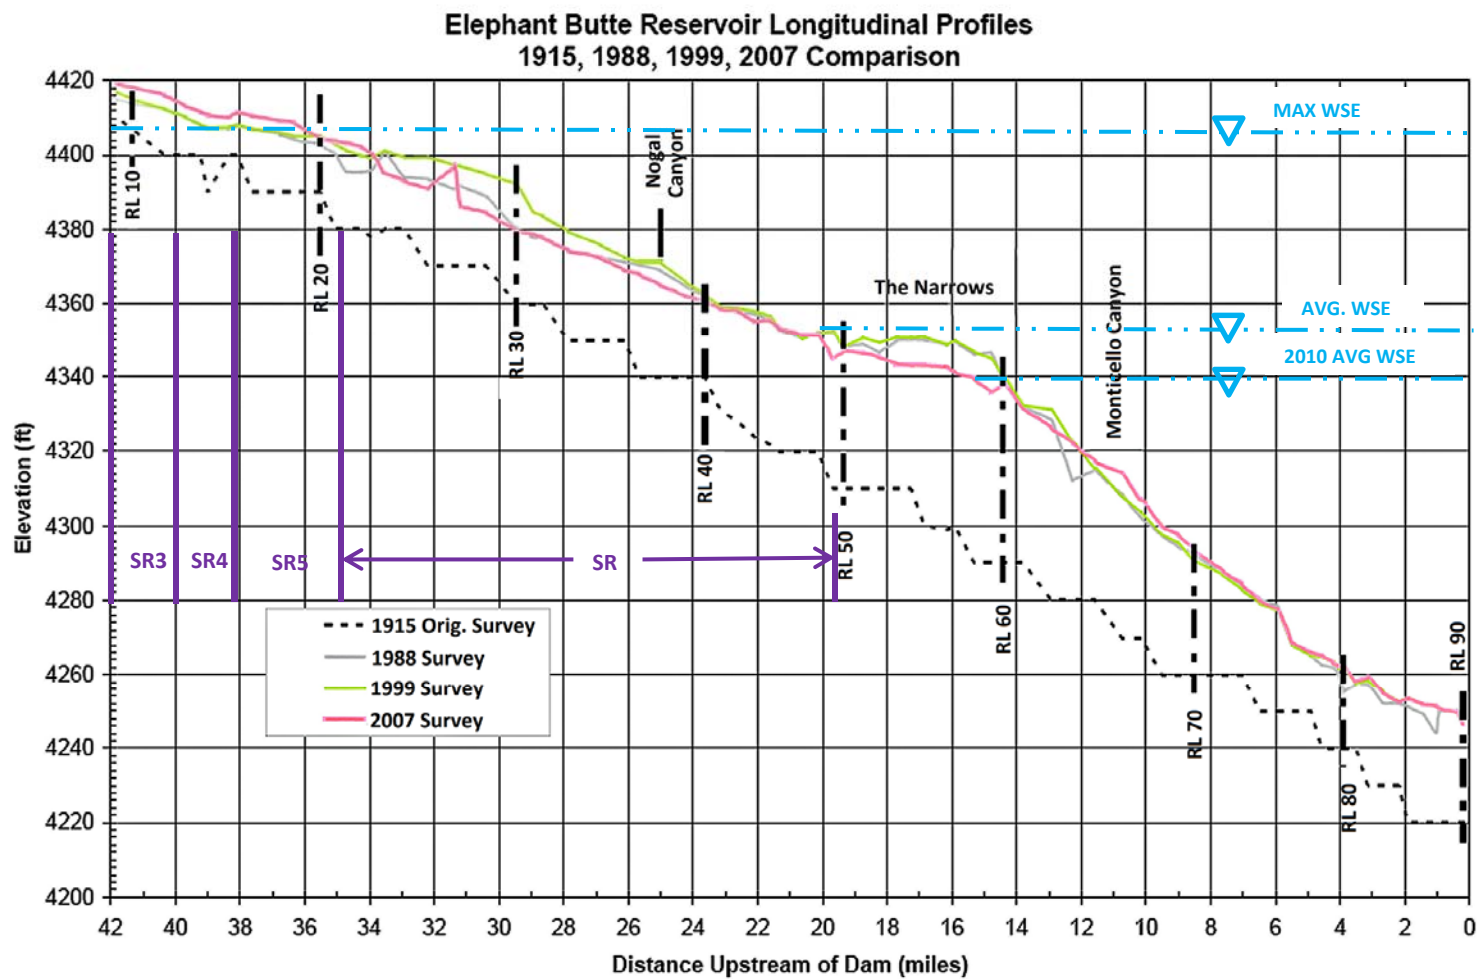
Figure 3.2 Elephant Butte Reservoir Historical Sediment Survey Longitudinal Profile (Reclamation, 2008)

In 1915, when the reservoir had just begun to fill, had the reservoir been at its maximum WSE, then the upstream extent of the reservoir would have reached RL 10 (or the upstream end of Subreach 3). By 2007, the upstream extent of the reservoir at its maximum WSE would have been about RL 20 (or the upstream end of Subreach 6). This means the maximum upstream extent of the reservoir would have shifted downstream approximately 6 miles. The level of the reservoir impacts Elephant Butte Reach, due to sediment deposition as a result of an increased base-level. The longitudinal profile of Elephant Butte Reach is base-level controlled; with an increase in base-level, the channel adjusts vertically by way of sediment deposition, resulting in channel aggradation.

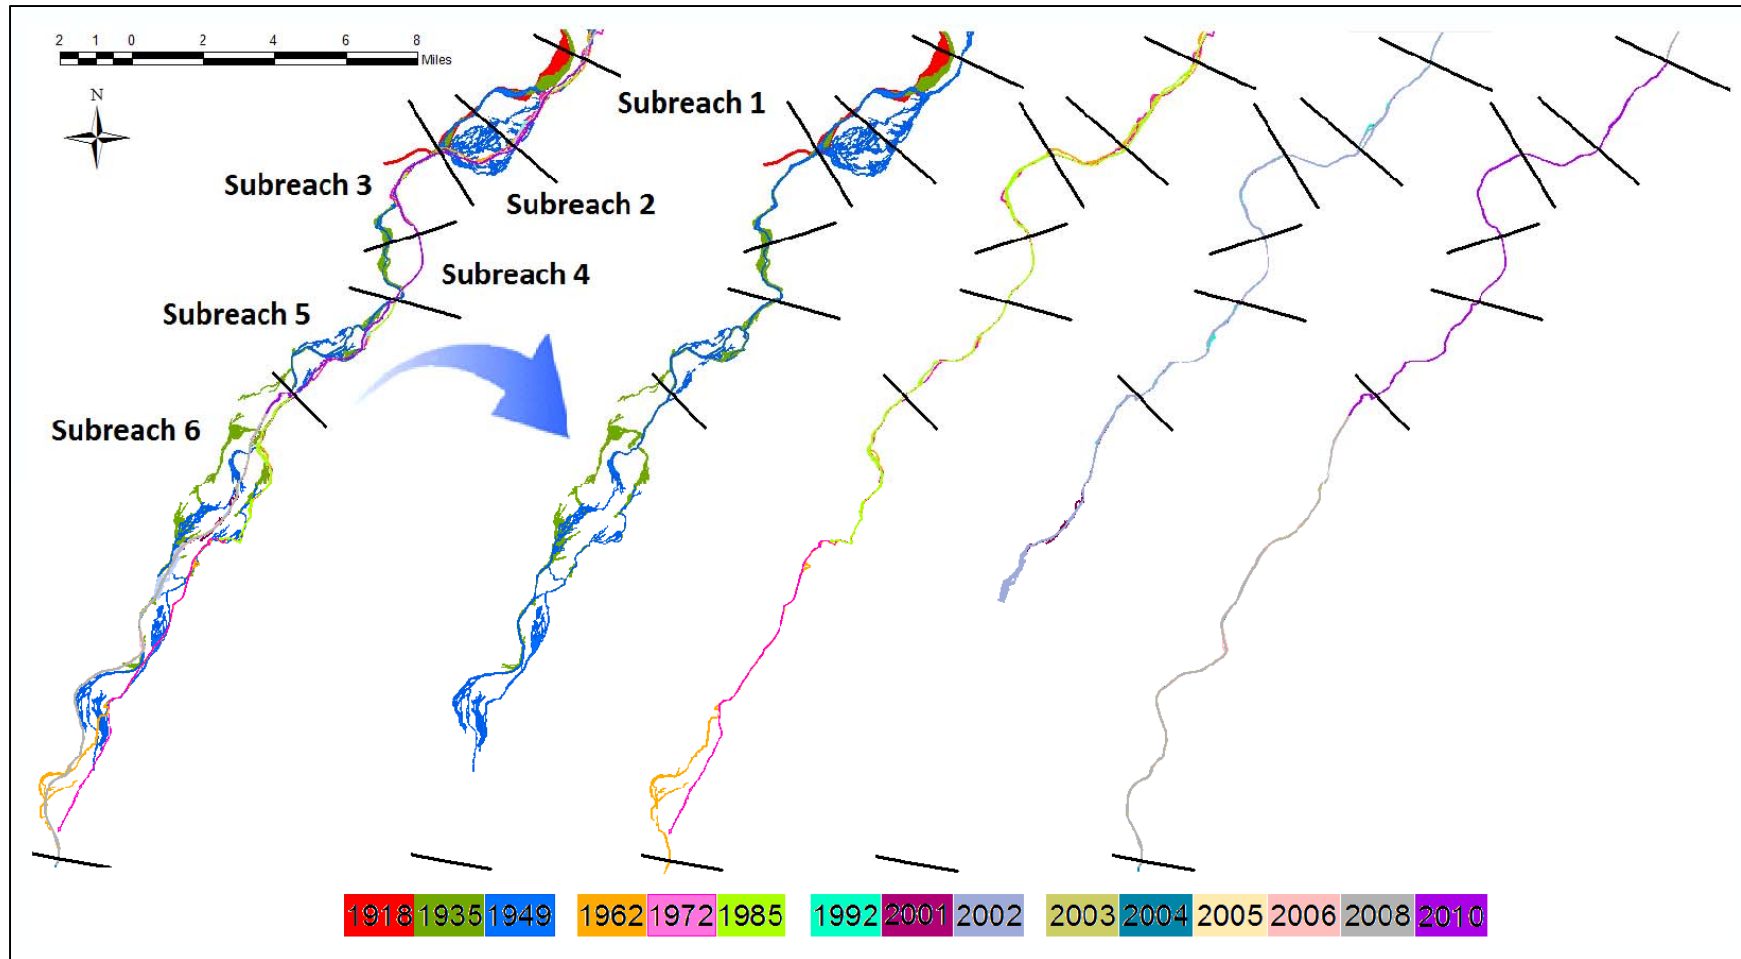
Figure 4.1 Channel Planforms from Aerial Photography

Figure 4.1 shows the channel planforms that were delineated in ArcGIS. Figure 4.2 through Figure 4.7 show magnified versions of Figure 4.1. Based on visual observations, the overall channel has narrowed and changed from a multithread channel to a primarily single-thread channel. Subreaches 1, 2, 5, and 6 have straightened and narrowed primarily between 1918 and 1962, and have remained relatively unchanged since then. The multithread characteristics of the river observed from 1928 to 1949 are not repeated after the recession of the reservoir from 2001 to 2003, because Reclamation regularly excavated pilot channels within Subreach 6 (Baird, D., Pers. Comm.).

Note that the difference between the first set of delineations, 1918-1949, is 31 years, the second set of delineations, 1962-1985, is 23 years, the third set of delineations, 1992-2002 is 10 years, and the fourth set of delineations, 2003-2010 is only 7 years. Based on a qualitative visual analysis, the first delineation comparison covers the longest time period and shows the most change and the last delineation comparison shows the shortest time period with the least change. Nevertheless, narrowing and straightening of the reach is observed over time.

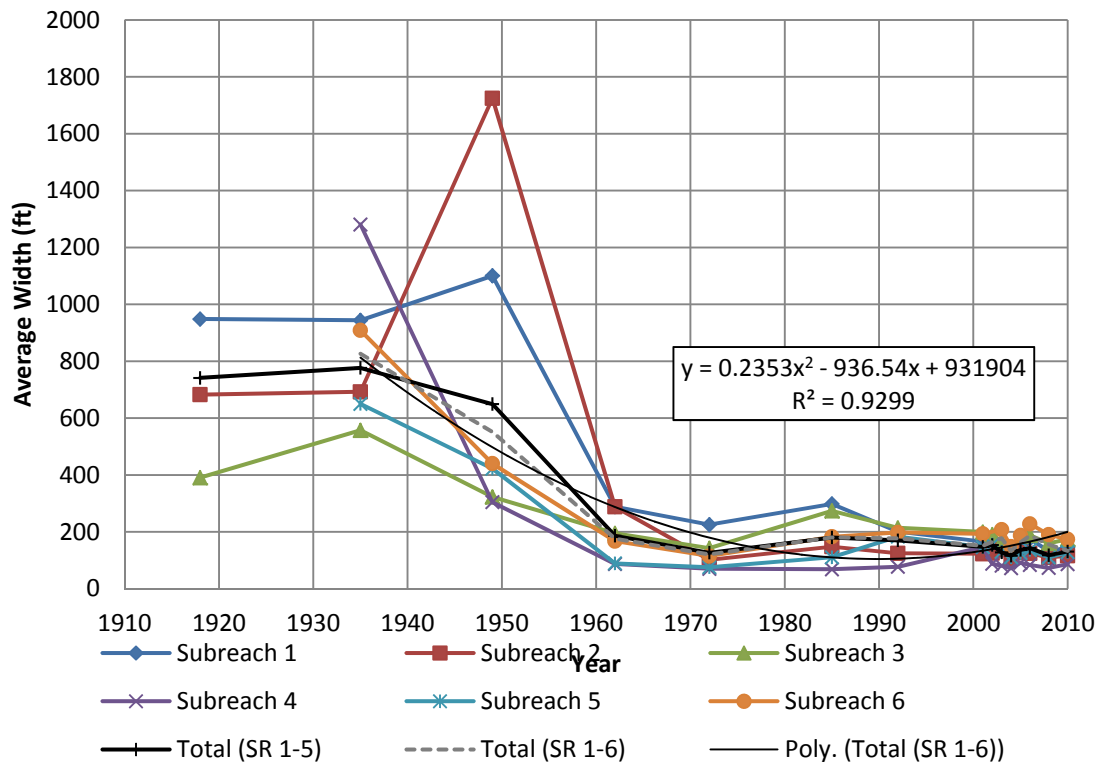
Figure 4.8 Channel Widths from GIS (1918 - 2010)

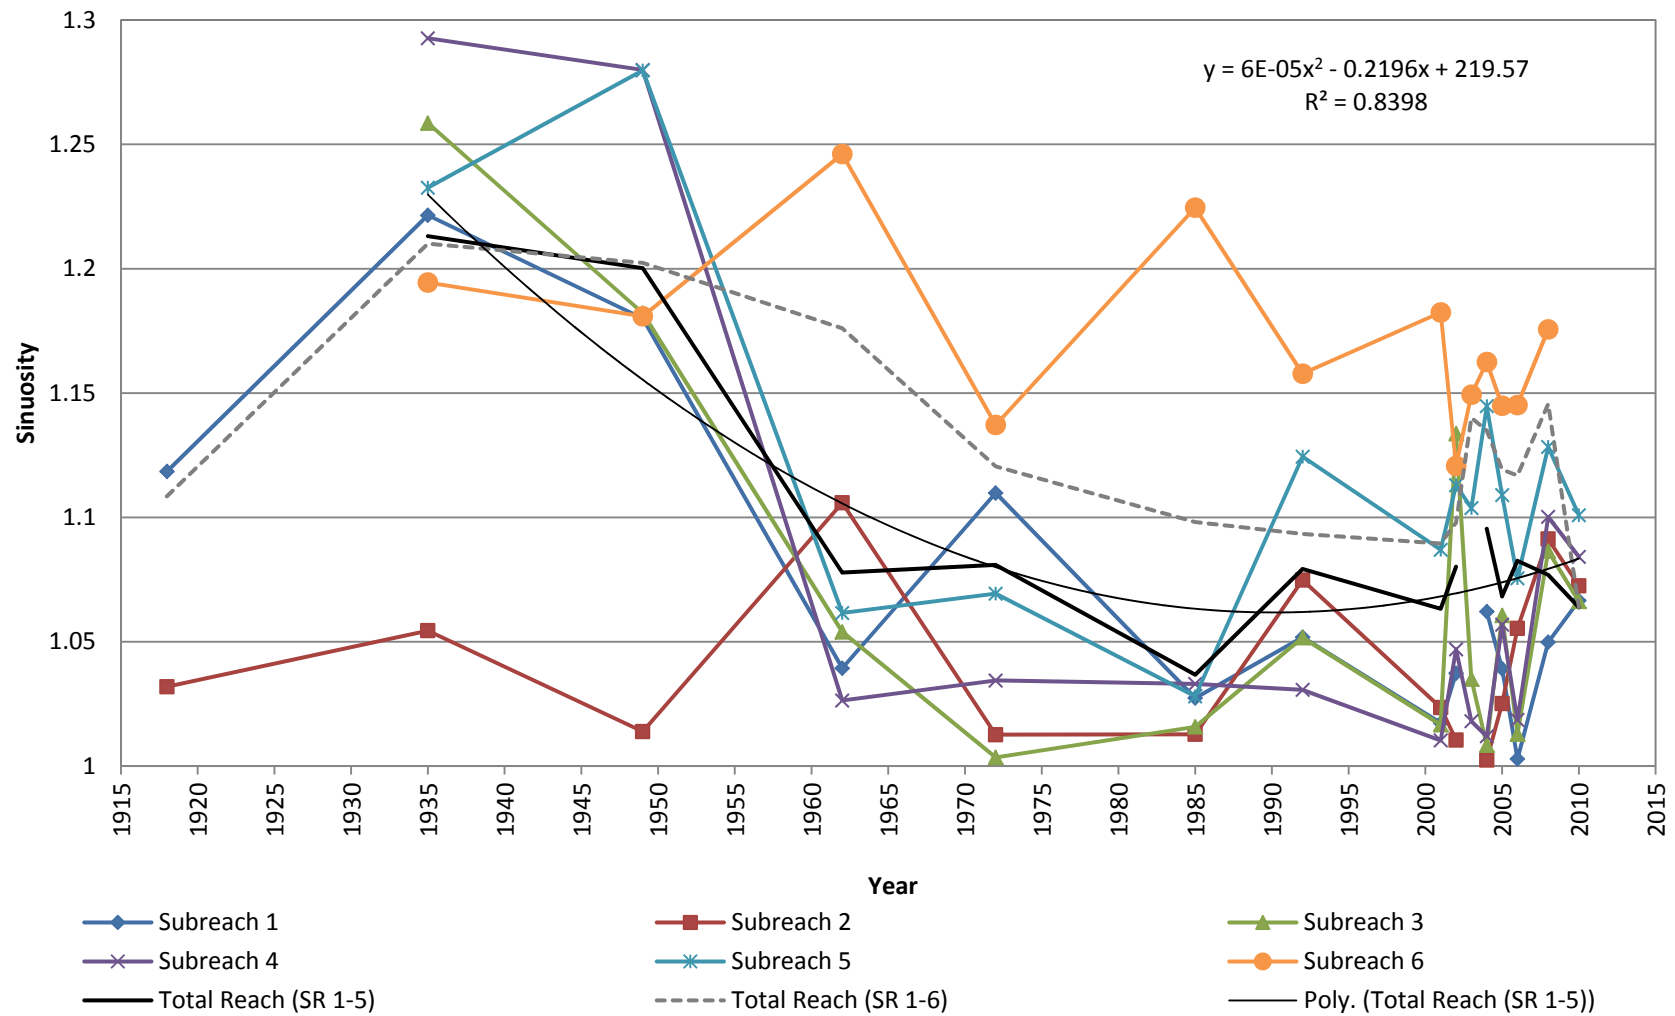
Figure 4.11 Temporal Sinuosity Trends

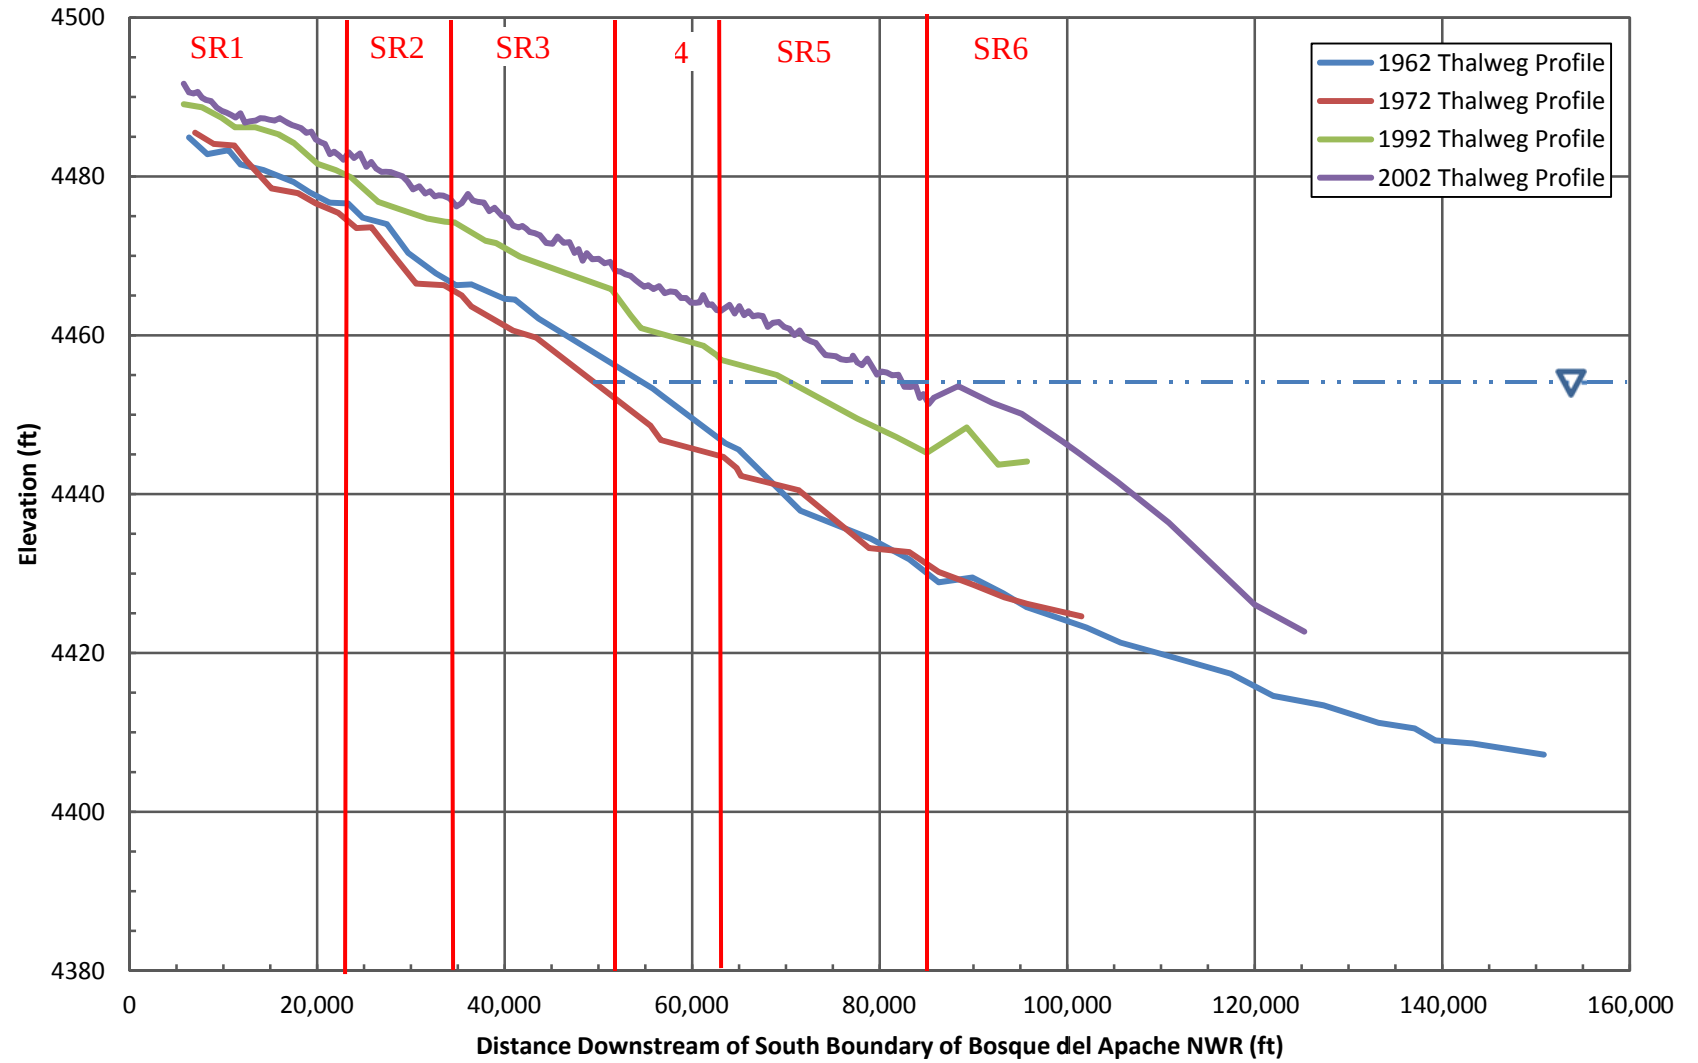
Figure 4.12 Thalweg Elevation Profile From Agg/Deg Surveys

The channel thalweg profile from the Agg/Deg survey data was utilized to demonstrate how the minimum elevation and slope of the reach has changed over time, as shown in Figure 4.12. The average bed slope for each subreach and for the entire reach was determined by first plotting the thalweg profile versus downstream distance, as measured along the estimated thalweg in GIS, and fitting a linear regression trendline to each subreach. The slope of the linear regression line was considered the average bed slope of the respective subreach. A linear regression trendline was also fit to the total reach thalweg profile, from which the slope of the regression trendline was considered the average bed slope of the total reach. This method was used for 1962, 1972, 1992, and 2002. The average bed slope for each subreach and for the entire reach is shown in Figure 4.13.

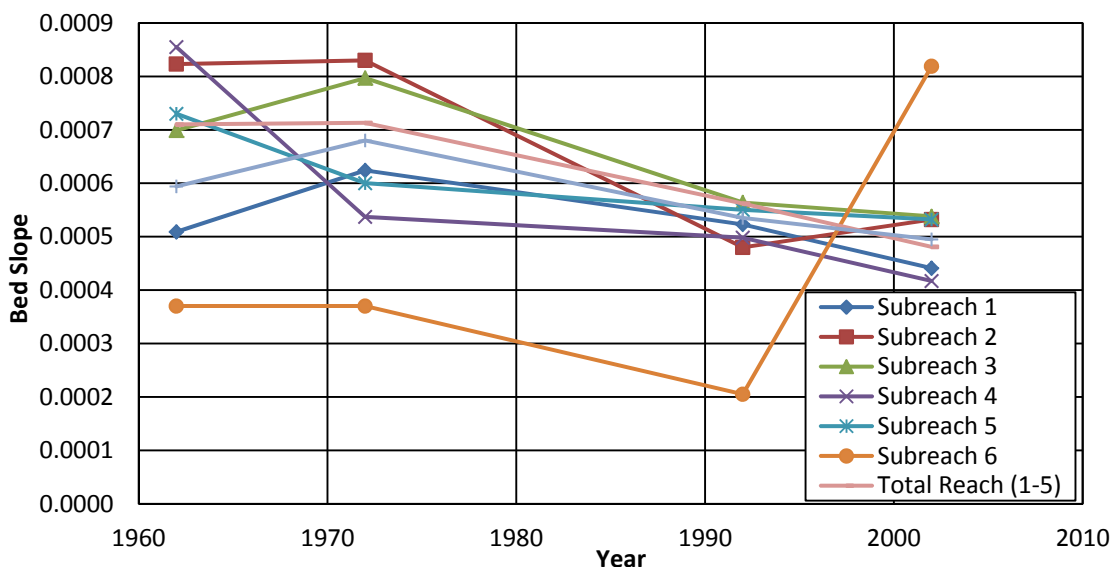
Figure 4.13 Bed Slope from Agg/Deg Surveys

Between the years 1962 and 1972, the bed slope increased between 15 and 30 percent for Subreaches 1, 2, and 3; bed slope decreased 40 and 20 percent for Subreaches 4 and 5, respectively. From 1972 to 1992, bed slope decreased between 10 and 45 percent for all subreaches. From 1992 to 2002, Subreach 2 increased 10 percent and Subreach 6 increased fourfold; all other subreaches decrease between 3 and 15 percent. The overall decrease in bed slope along the entire reach suggests aggradation has occurred between 1962 and 2002. The decrease in bed slope from 1972 to 1992 in Subreach 6 could be caused by the increased Elephant Butte Reservoir level (base-level), which increased by about 130 ft. The fourfold increase in bed slope from 1992 to 2002 in Subreach 6 could be due to the drop base-level, which dropped about 85 feet between 1992 and 2002. The longitudinal profile of Elephant Butte Reach is base-level controlled; with an increase in base-level, the channel adjusts vertically by way of sediment deposition, resulting in channel aggradation and a decrease in channel slope. It is important to note, however, that these trends could also be due to the lack of data in Subreach 6, especially in 1972 and 1992, which could skew the calculated bed slope

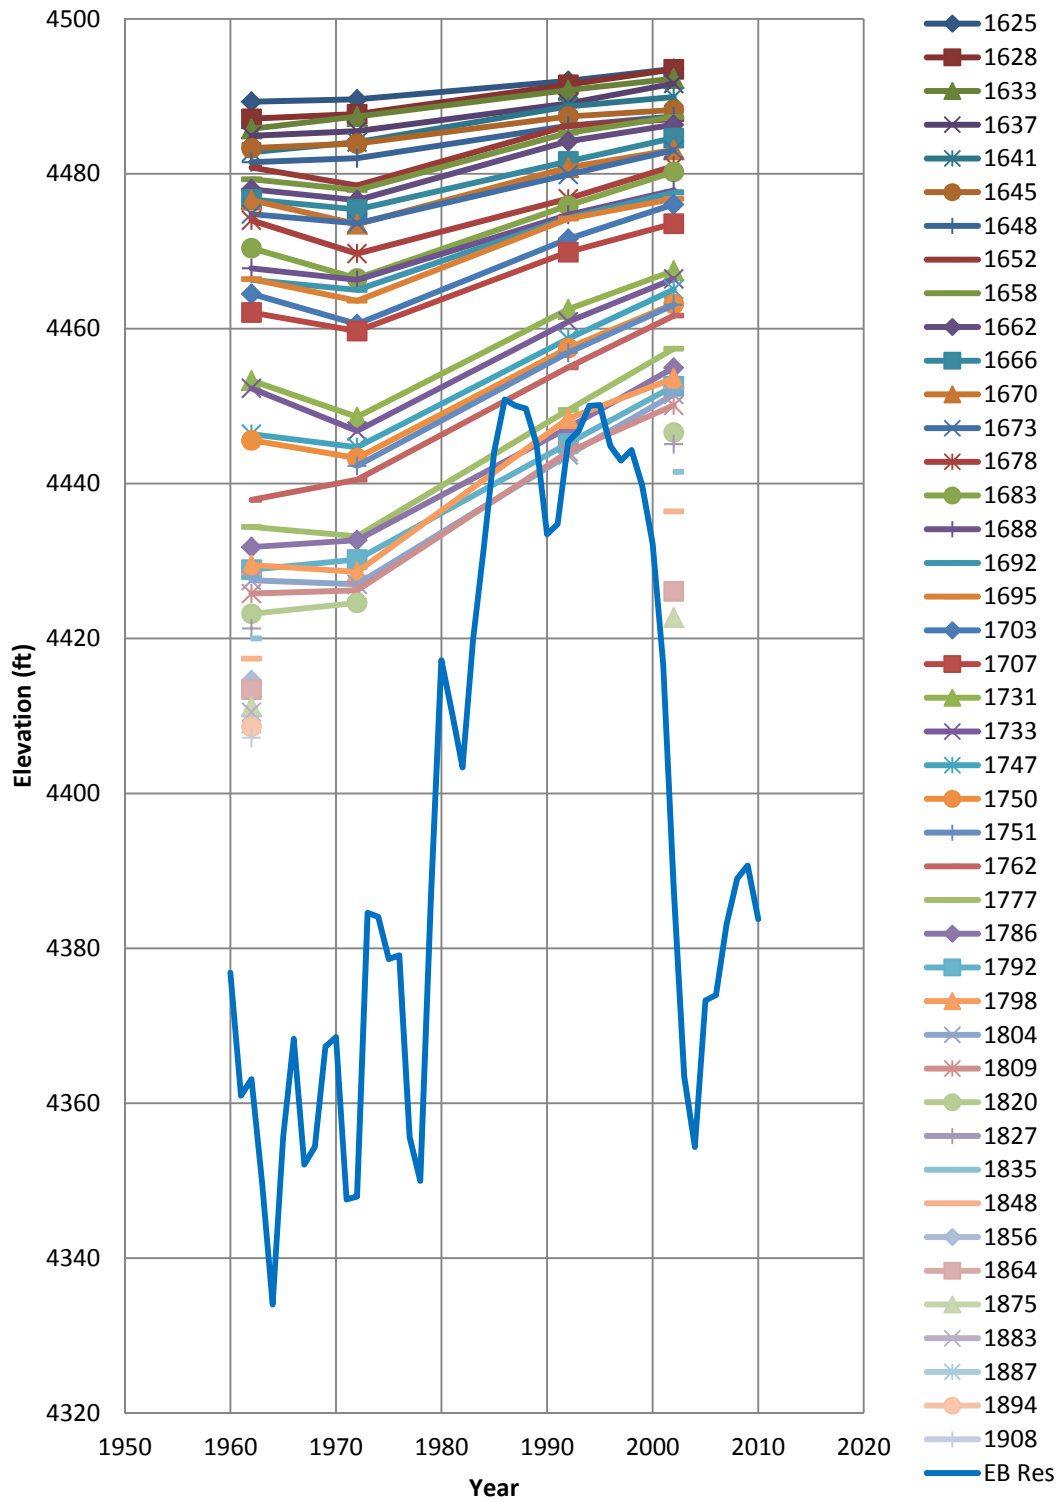
Figure 4.19 Temporal Trend in Thalweg Elevation at Agg/Deg Lines

Figure 4.19 shows the change in the thalweg elevation at selected Agg/Deg lines from 1962 – 1992. Only Agg/Deg lines with sufficient years of sample data were plotted. It can be inferred from this plot that as the reservoir level increases, the channel thalweg elevation increases at each Agg/Deg line, and that the increase in channel thalweg elevation is more pronounced in the downstream direction, closer to the reservoir.

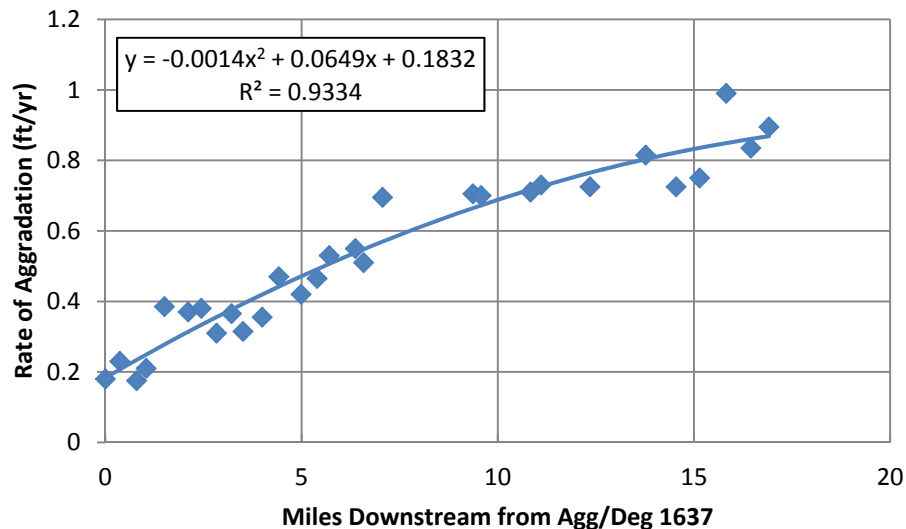
Figure 4.20 Rate of Channel Aggradation between 1972 and 1992

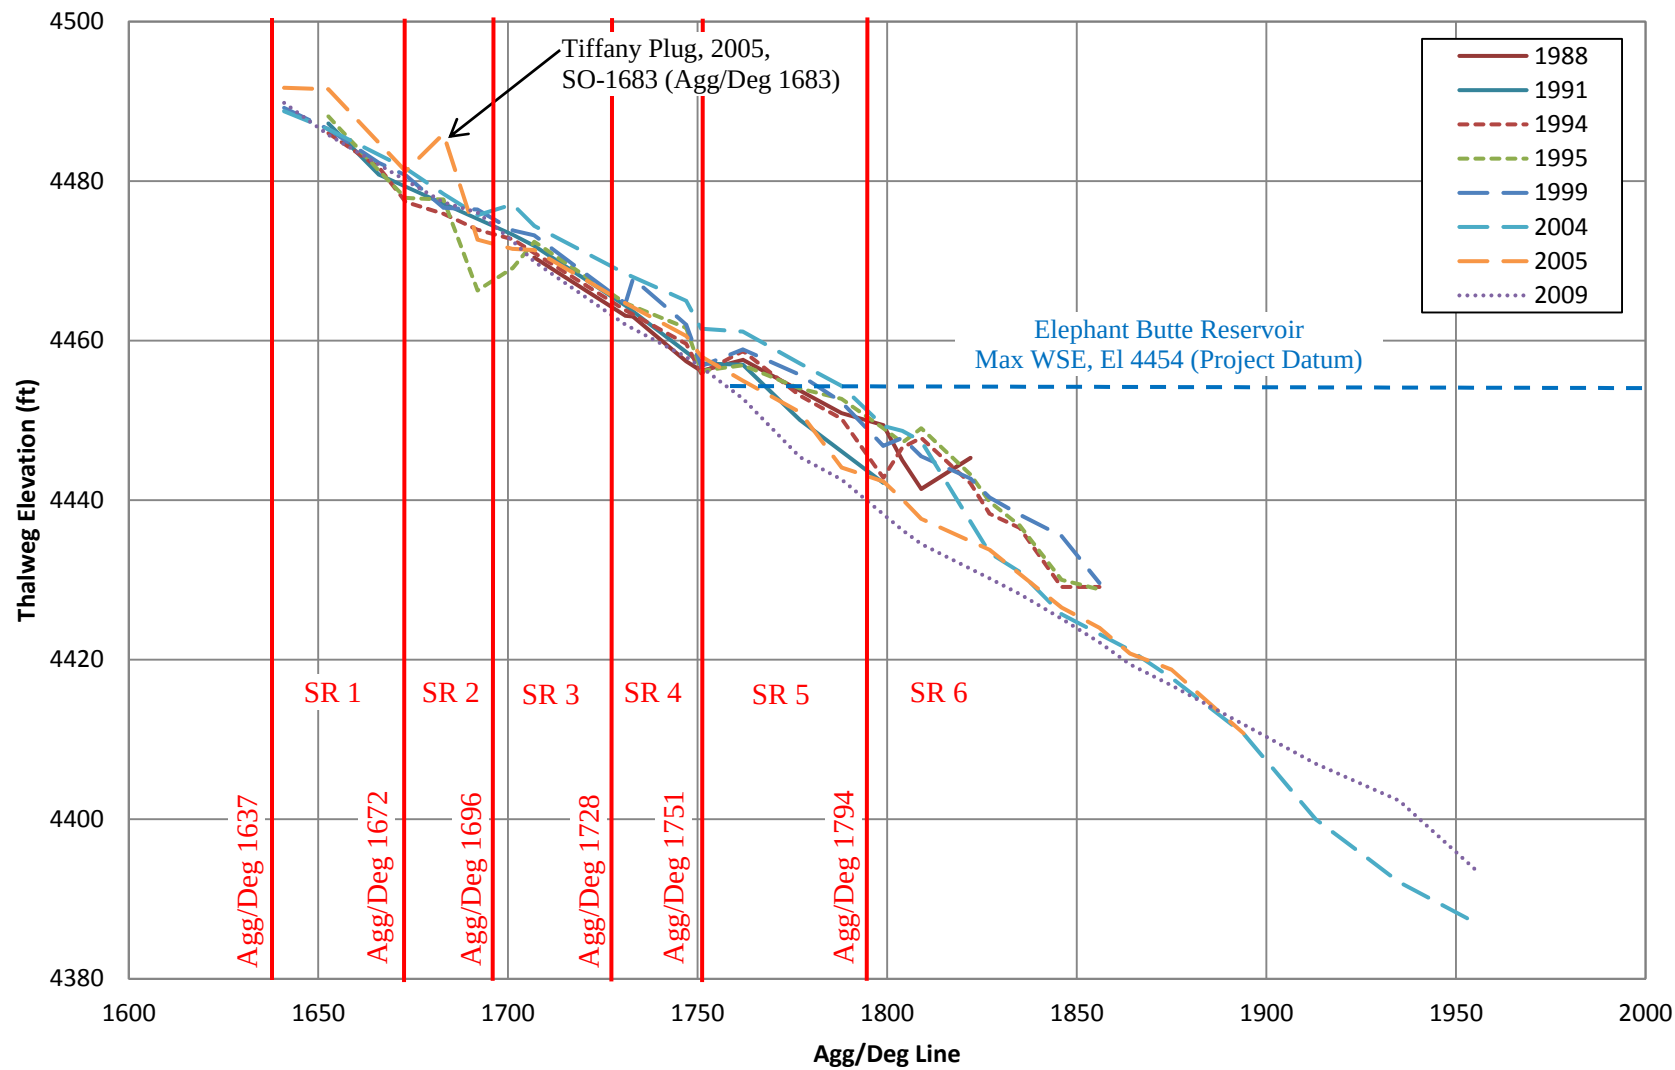
Figure 4.21 Thalweg Elevation Profile From Range Line Survey Data

trend of varying aggradation and degradation over time. One of the most notable trends from this plot is the flattening of the channel slope from 2004 to 2009 in the downstream half of the reach, which is due to the aggradation induced by a rise in base-level from 2004 to 2009. Also noteworthy is the significant aggradation in 2005 upstream of EB-10 (Agg/Deg 1707). The Tiffany Plug formed in 2005 at SO-1683 (Agg/Deg 1683), just upstream of EB-10, which can be seen in the profile. In 1995, severe degradation can be seen downstream of SO-1683 (Agg/Deg 1683), and virtually no change at SO-1683, even though a sediment plug had formed upstream of SO-1683 in 1995. This is likely explained by the timing of the survey, which seems to have occurred after the sediment plug was mechanically removed by Reclamation.

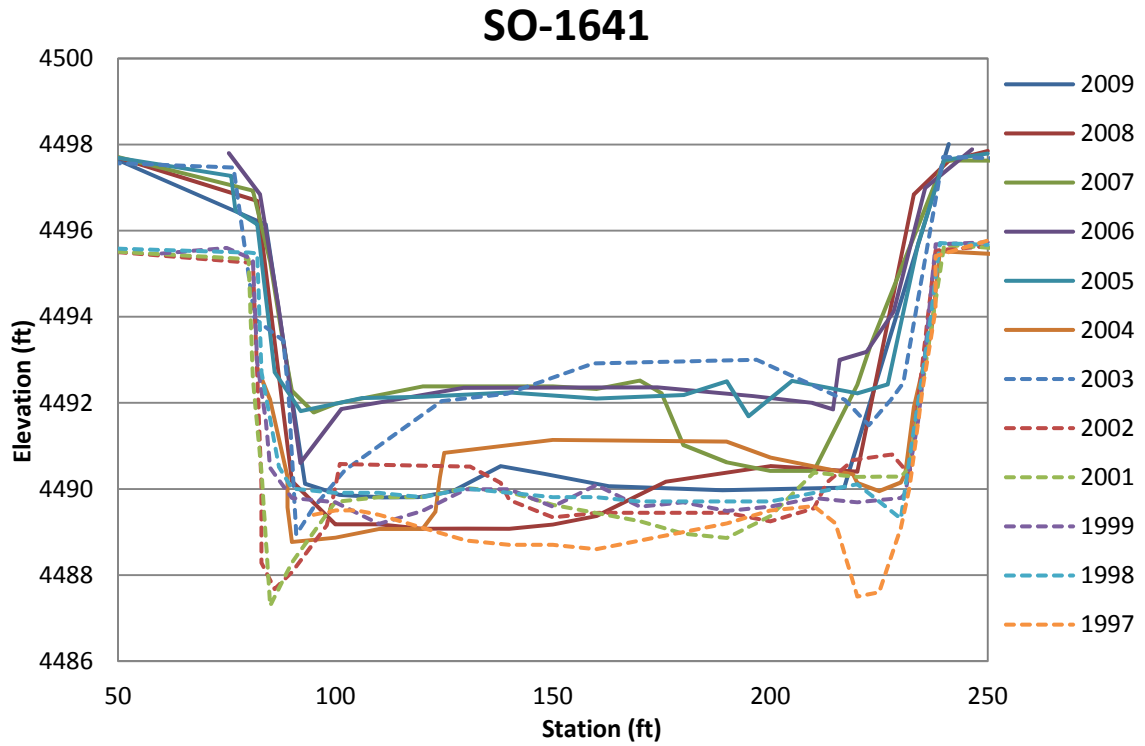
Figure 4.28 Subreach 1: SO-1641 Surveyed Cross-Sections

Cross-sections were plotted at select range lines for all years of available data and are presented in Appendix F. Figure 4.28 through Figure 4.36 show representative cross-sections of Elephant Butte Reach. SO-1683, Figure 4.29, is located in Subreach 2. From 2004 to 2005 the channel aggraded by about 8 ft and then degraded by about 8 ft from 2005 to 2006. This is the location of the Tiffany Sediment Plug in 2005. The sediment plug was removed by excavating a pilot channel, which accounts for the decrease in bed elevation from 2005 to 2006. EB-41, Figure 4.36, is located in Subreach 6. When the reservoir was full from 1985 to 2000, this range line was inundated by the reservoir, which is why there is only data available beginning in 2004.

As seen in Figure 4.28 through Figure 4.36 aggradation and degradation occur across the entire channel bed, not just the thalweg. Therefore, the following analyses focus on the change in thalweg elevation temporally and spatially. Figure 4.37 shows the change in the thalweg elevation at selected range lines from 1980-2010. Only range lines with sufficient years of sample data were plotted.

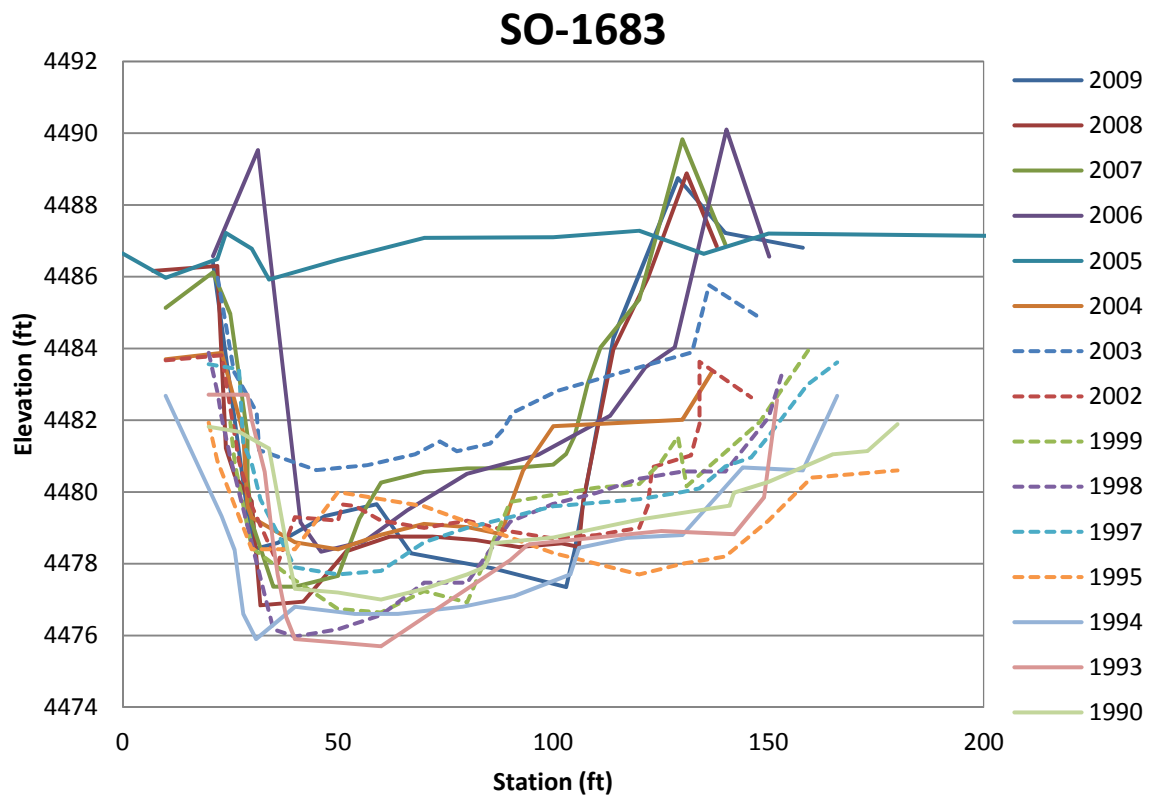
Figure 4.29 Subreach 2: SO-1683 Surveyed Cross-Sections

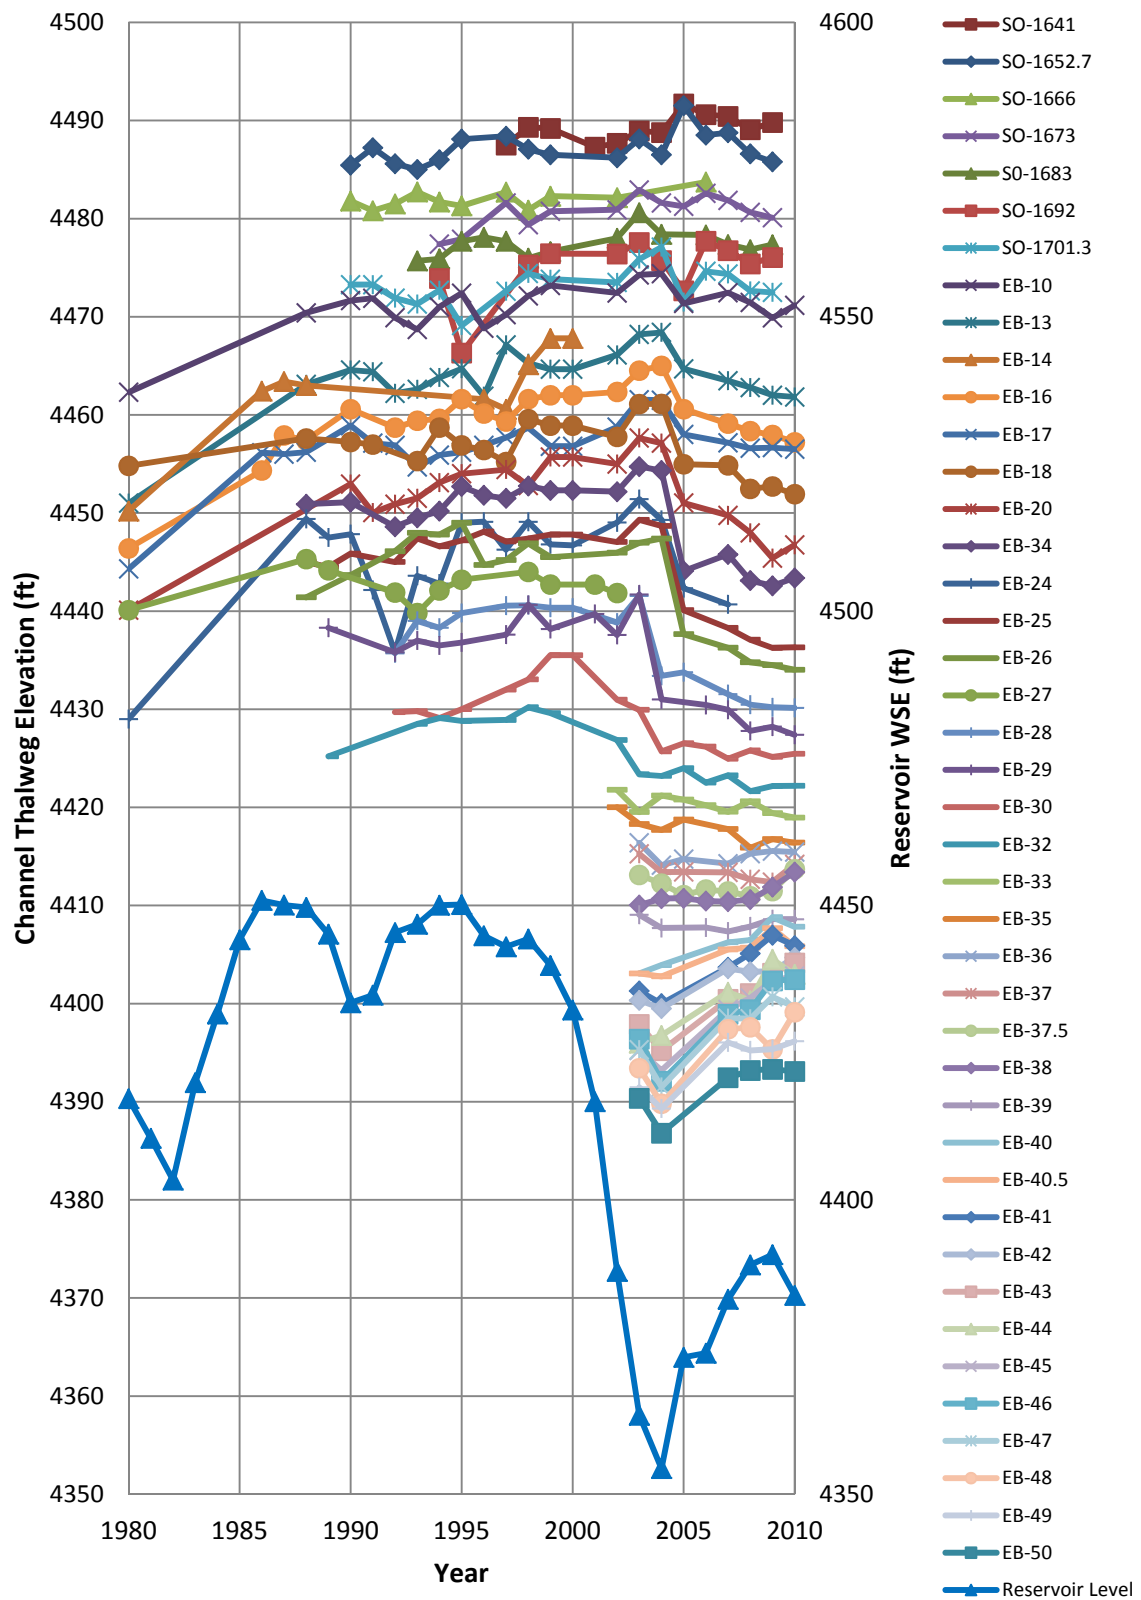
Figure 4.37 Change in Thalweg Elevation at Range Lines (1980 – 2010)

From 1980 to 1988, aggradation occurred at all range lines for which there is data. From 1988 to 1994, the thalweg elevation alternated between increasing and decreasing elevation, typically changing no more than 3 ft in either direction. From 1994 to 1995, mostly aggradation occurs, up to 6.2 ft, near the upstream reservoir extent; degradation occurs just downstream of the 1995 Tiffany Sediment Plug at SO-1692 and SO-1701.3, 7.6 ft and 3.6 ft, respectively. From 1995 to 2002, the change in channel thalweg elevation varies between aggradation and degradation. From 2002 to 2003, aggradation occurs from SO-1641 to EB-29, ranging between 1 ft and 4 ft; degradation occurs downstream of EB-29, up to 3.5 ft. From 2003 to 2004, the channel degraded from SO-1641 to SO-1692, and from EB-20 to EB-50 by up to 10.7 ft; the channel aggraded from SO-1701.3 to EB-18 by up to 1 ft. From 2004 to 2007, aggradation occurred from SO-1641 to SO-1692, up to 2.3 ft, and from EB-40 to EB-50, up to 7.6 ft; degradation occurred from SO-1701.3 to EB-39, up to 11 ft. From 2007 to 2008, degradation occurred from SO-1641 to EB-37.5, up to 2.7 ft; aggradation occurred from EB-38 to EB-50, up to 1.4 ft. From 2008 to 2009, the channel degraded from SO-1641 to EB-37, up to 2.6 ft; the channel aggraded from EB-37.5 to EB-50, up to 4.2 ft. From 2009 to 2010, the channel varied between aggradation and degradation, ranging between -1.8 ft and 2.2 ft in elevation change.
