THESIS

GEOMORPHIC ANALYSIS OF THE MIDDLE RIO GRANDE –  
ELEPHANT BUTTE REACH, NEW MEXICO

Tracy Elizabeth Owen

Colorado State University

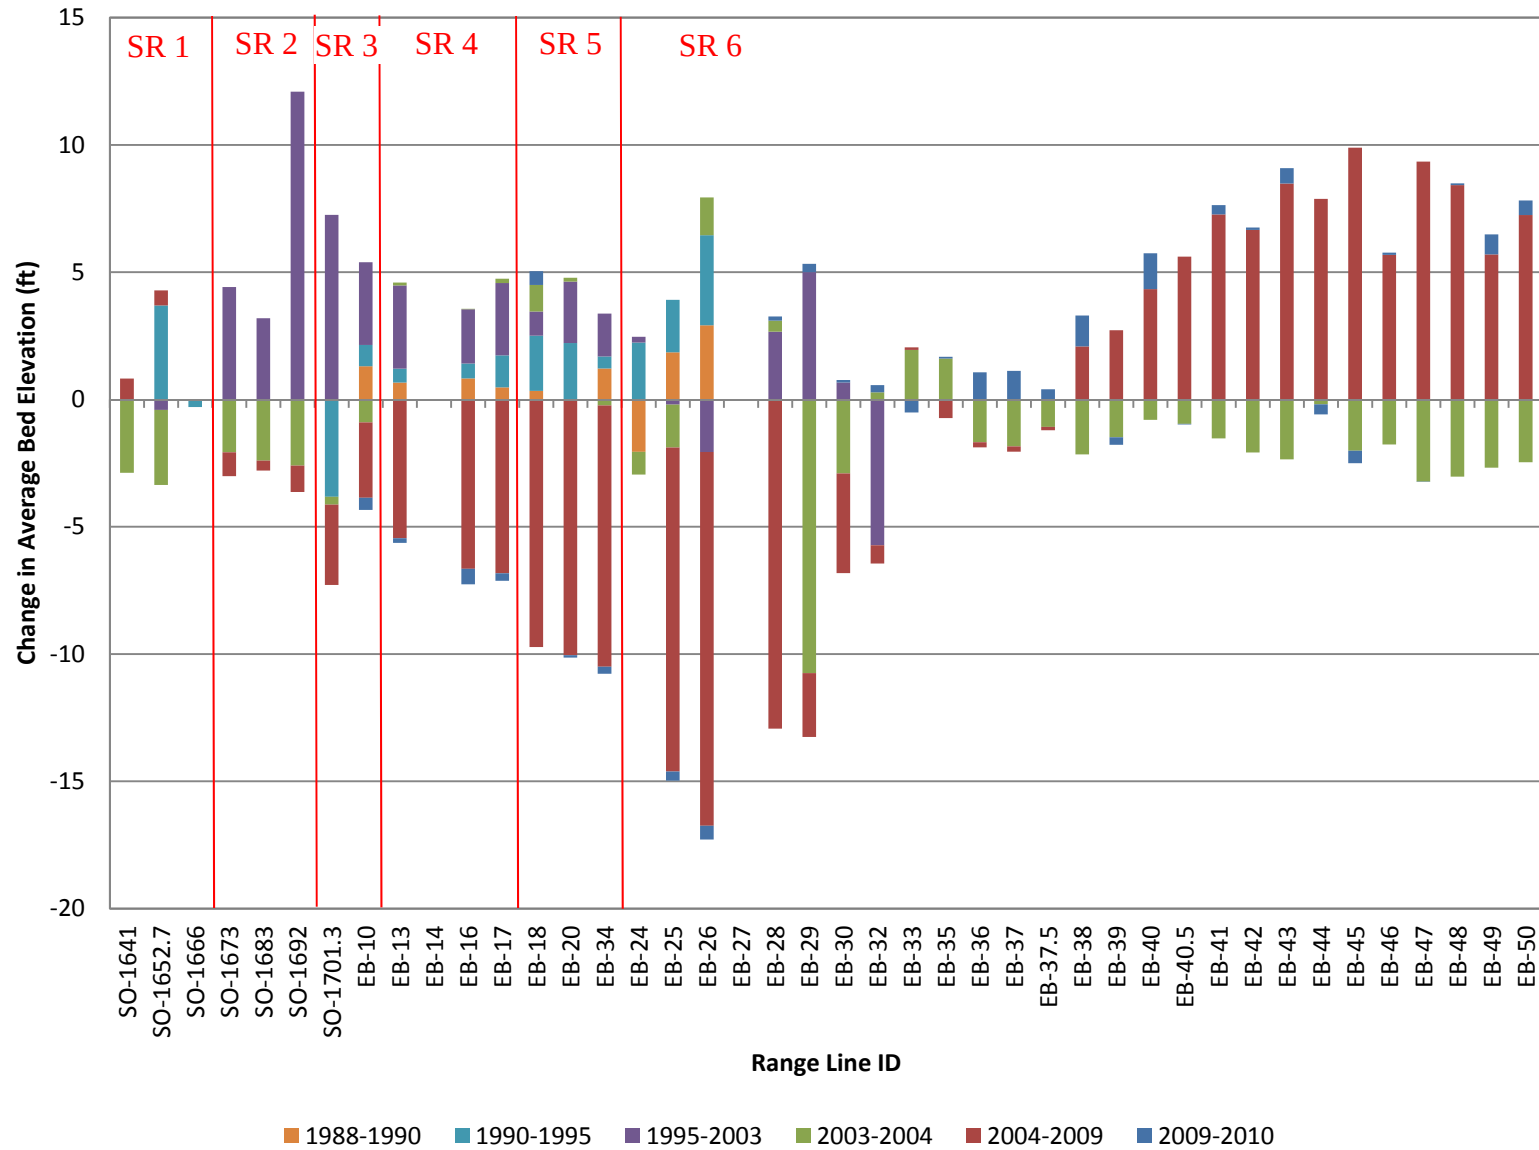
Figure 4.38 Change in Average Channel Bed Elevation at Range Lines (1988-2010)

Because data was not available each year for every range line, different ranges of years had to be used to calculate the change in elevation. This is indicated by the different colors of bars in Figure 4.38 for the change in average bed elevation analysis, and Figure 4.39 for the change in thalweg elevation analysis. The orange bars show a change in elevation for range lines between 1988 and 1990; the turquoise bars show a change in elevation between 1990 and 1995; the purple bars show a change in elevation from 1995 to 2003; the green bars show a change in elevation between 2003 and 2004; and the red bars show a change in elevation from 2004 to 2009; and blue bars show a change in elevation from 2009 to 2010. Note that each set of bars has a different time increment; this is because the selected years contain data for most of the range lines, and the year sets represent an overall aggrading or degrading trend.

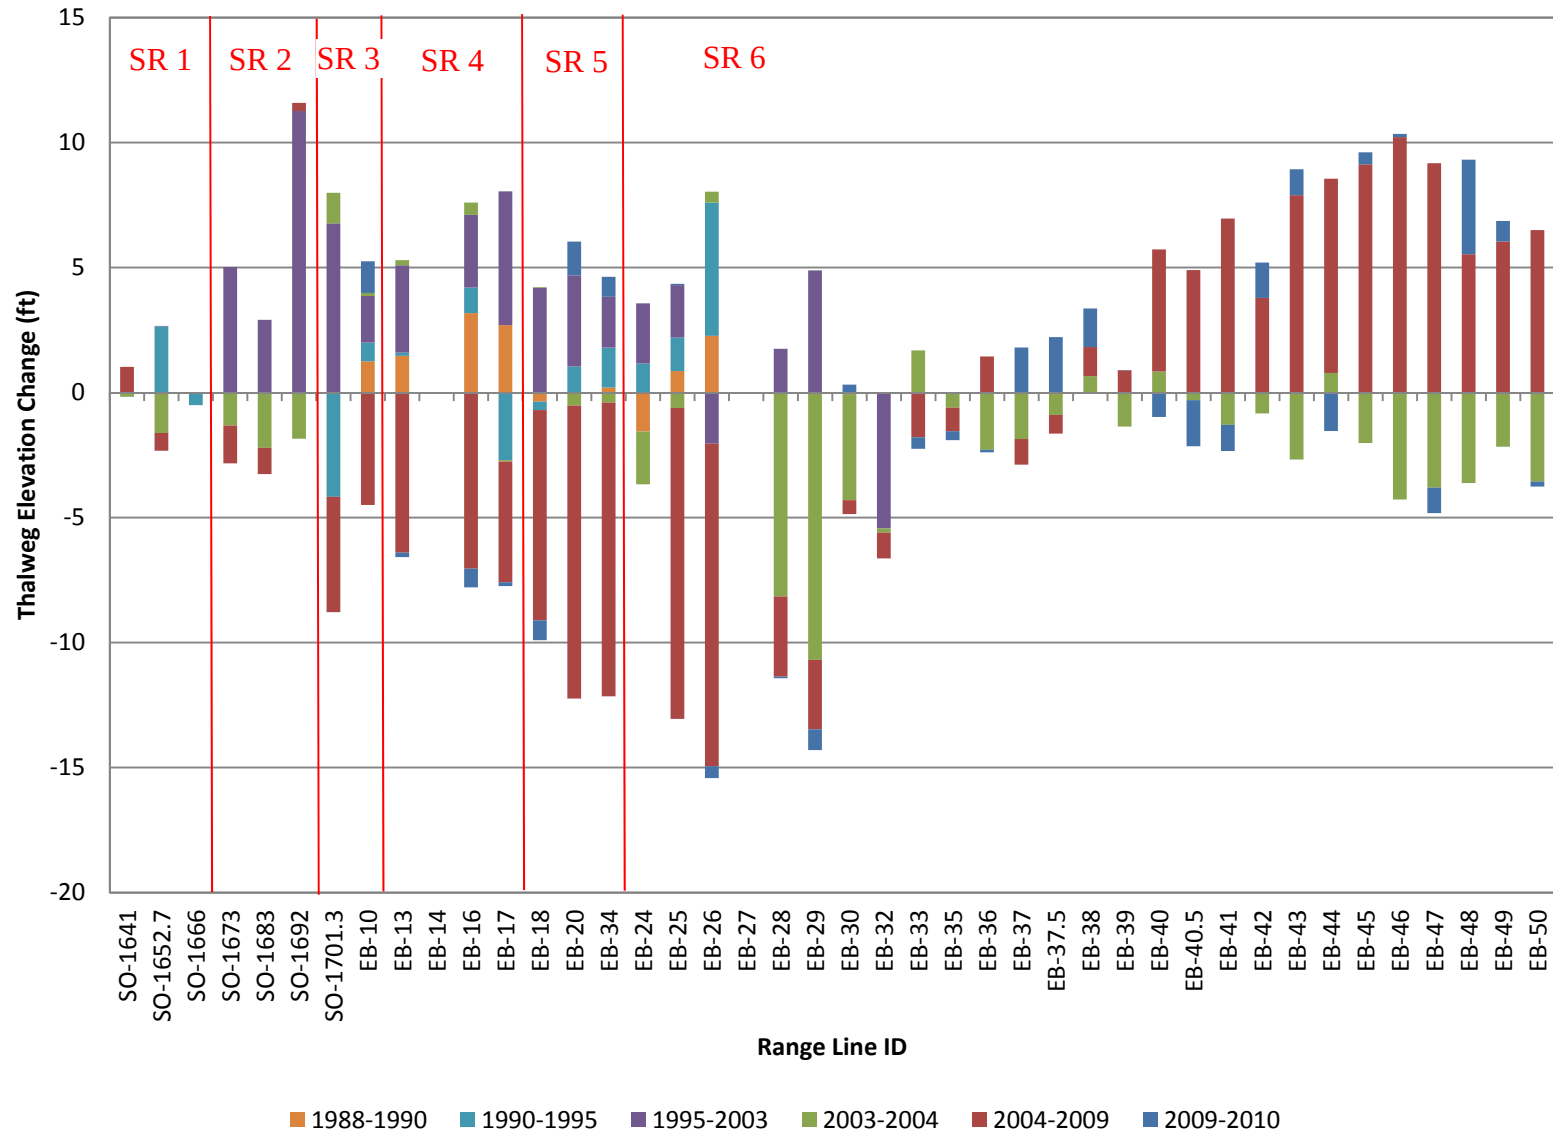
Figure 4.39 Change in Channel Thalweg Elevations at Range Lines (1988-2010)

The following observations are based specifically on the change in thalweg elevation; however, the general trends observed are similar for the change in average bed elevation. From 1988 to 1990, primarily aggradation occurred, up to 3.2 ft. From 1990 to 1995, which includes the first instances in which the Tiffany Plug formed, there is aggradation and degradation observed, depending on the range line; there does not appear to be a hinge point spatially separating aggradation and degradation. From 1995 to 2003, after the second Tiffany Plug, there is mostly aggradation between SO-1673 and EB-29, up to 11.3 ft. From 2003 to 2004, there is degradation the majority of the reach, up to 10.7 ft. From 2004 to 2009, degradation is observed from SO-1652.7 to EB-37.5, at which point aggradation is observed from EB-38 to EB-50. From 2009 to 2010, the channel alternates between aggradation and degradation along the reach profile, with the greatest magnitude of aggradation, 3.8 ft, occurring at EB-48.

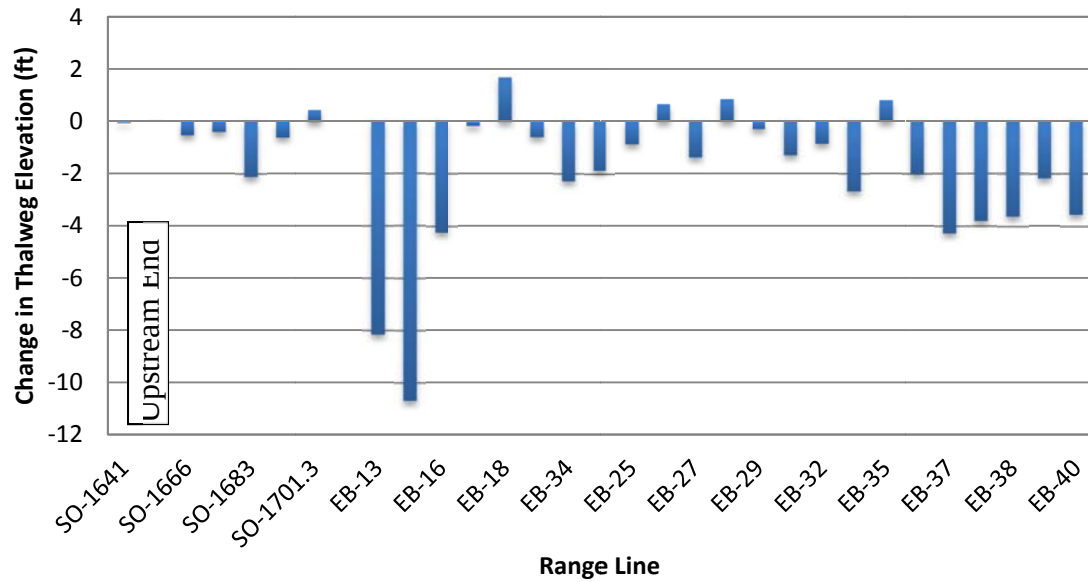
Figure 4.40 Magnitude of Aggradation and Degradation at Range Lines (2003-2004)

From 2003 to 2004, shown in Figure 4.40 and Figure 4.41, degradation is observed along the entire reach, except for at five range lines. The wave of degradation between EB-13 and EB-50 (Wave 3) is in response to the drop in base-level (Reservoir WSE) by about 100 ft between 1995 and 2004. Figure 4.41 shows the magnitude of degradation from 2003 to 2004 at River Miles, which is represented by the following second order polynomial equation:

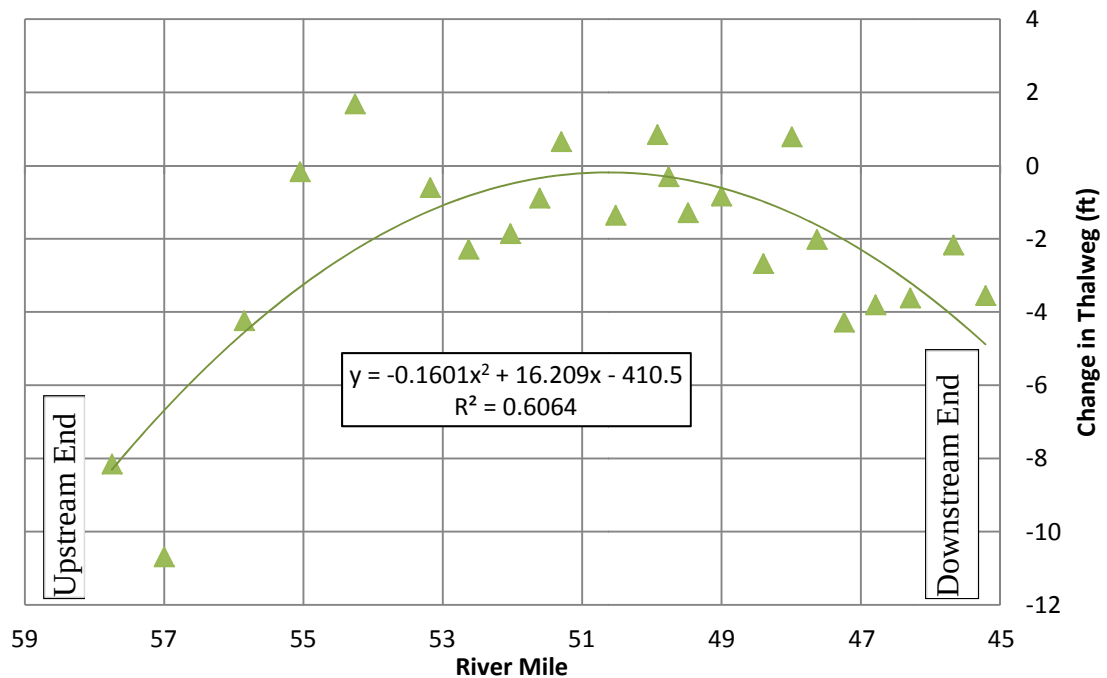
Figure 4.41 Magnitude of Aggradation and Degradation at River Miles (2003-2004)

Where, y is the magnitude of degradation and x is the longitudinal location along the reach in River Miles (RM, as defined by Reclamation, where measurements begin at the

downstream end of the Middle Rio Grande River); this equation is appropriate for RM 45.21 to RM 57.75.

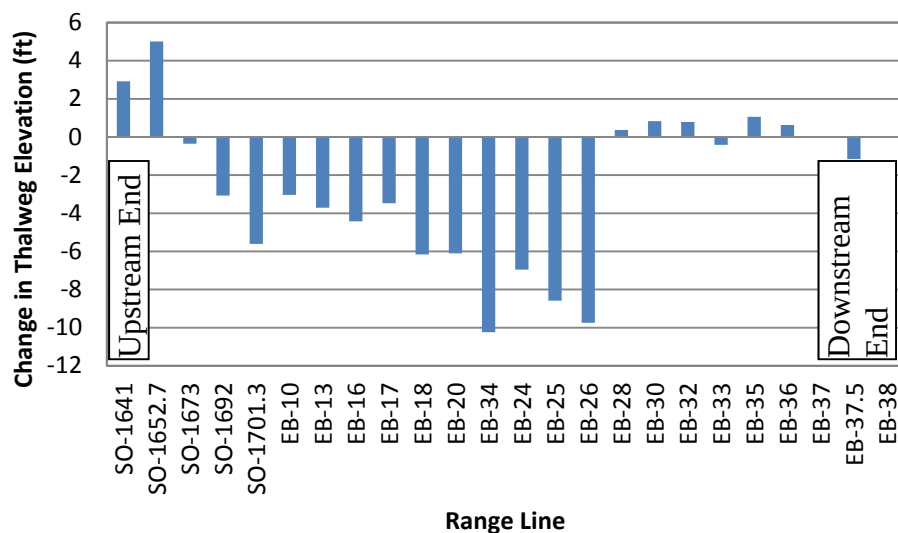
Figure 4.42 Magnitude of Aggradation and Degradation at Range Lines (2004-2005)

From 2004 to 2005, all of the thalweg elevations decreased between SO-line 1683 and EB-26; the decrease becomes more pronounced in the downstream direction between these range lines, as seen in Figure 4.42 and Figure 4.43. From 2004 to 2005, SO-lines 1641, 1652.7, and 1683 increased. The wave of degradation between SO-1683 and EB-26 (Wave 3) is in response to the drop in base-level (Reservoir WSE) by about 100 ft between 1995 and 2004. Figure 4.42 shows the magnitude of degradation from 2004 to 2005 at River Miles, which is represented by the following linear equation:

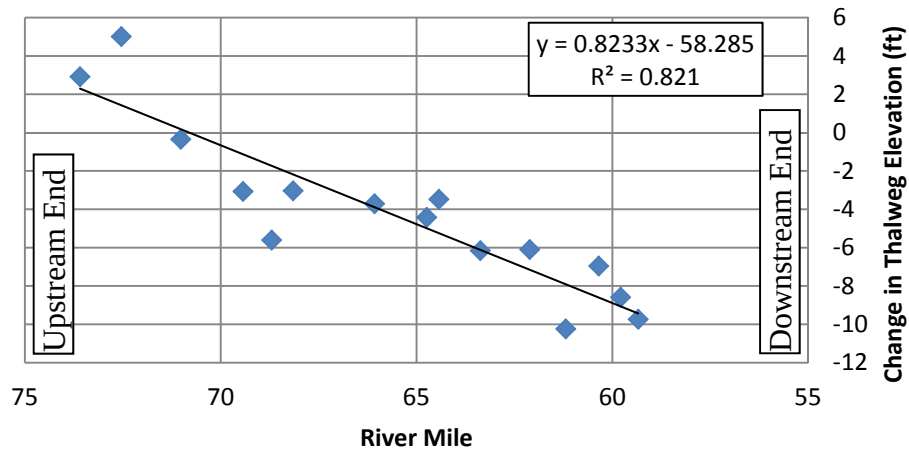
Figure 4.43 Magnitude of Aggradation and Degradation at River Miles (2004 to 2005)

Where,  $y$  is the magnitude of degradation and  $x$  is the longitudinal location along the reach in River Miles; this equation is appropriate for RM 59.34 to RM 73.59.

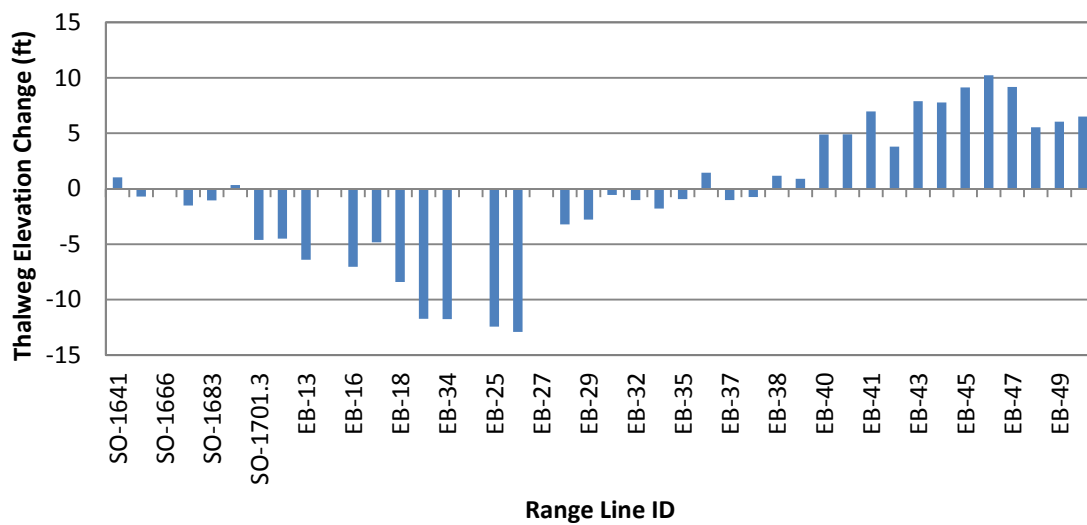
Figure 4.44 Change in Thalweg Elevation from 2004 to 2009

From 2004 to 2009, shown in Figure 4.44, degradation is observed from SO-1652.7 to EB-37.5, at which point aggradation is observed from EB-38 to EB-50. These two trends represent two distinct waves of thalweg elevation changes in response to base-level changes, Wave 3 and Wave 2, respectively.

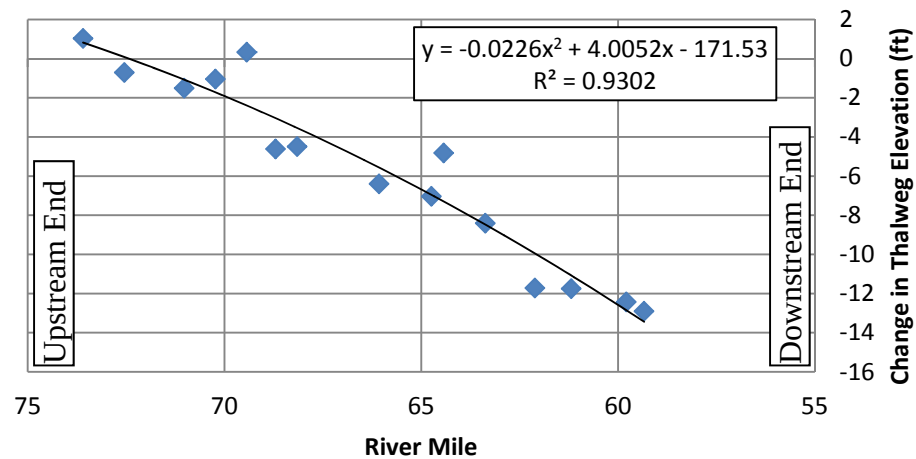
Figure 4.45 Magnitude of Degradation from 2004 to 2009

The wave of degradation between SO-1701.3 and EB-26 (Wave 3) is in response to the decrease in base-level by about 100 ft between 1995 and 2004. Figure 4.45 shows

the magnitude of degradation from 2004 to 2009, which is represented by the following second order polynomial equation:

Where, y is the magnitude of degradation and x is the longitudinal location along the reach in River Miles; this equation is appropriate for RM 45.21 to RM 52.03.

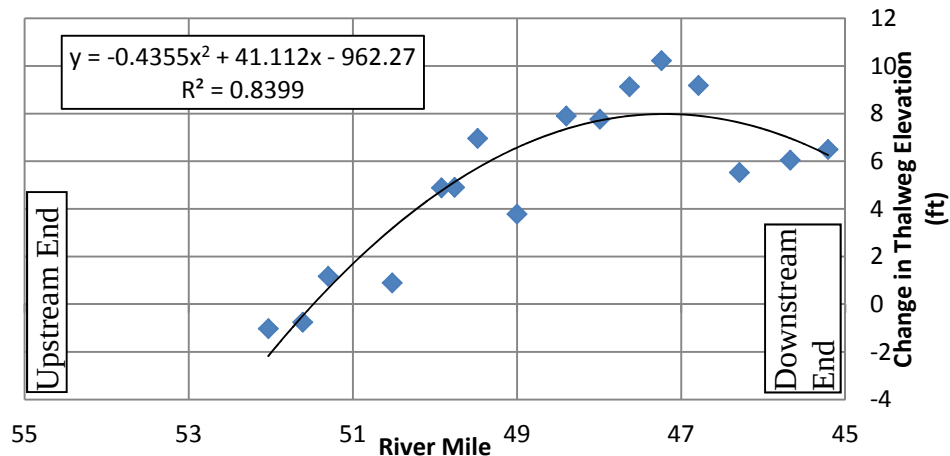
Figure 4.46 Magnitude of Aggradation from 2004-2009

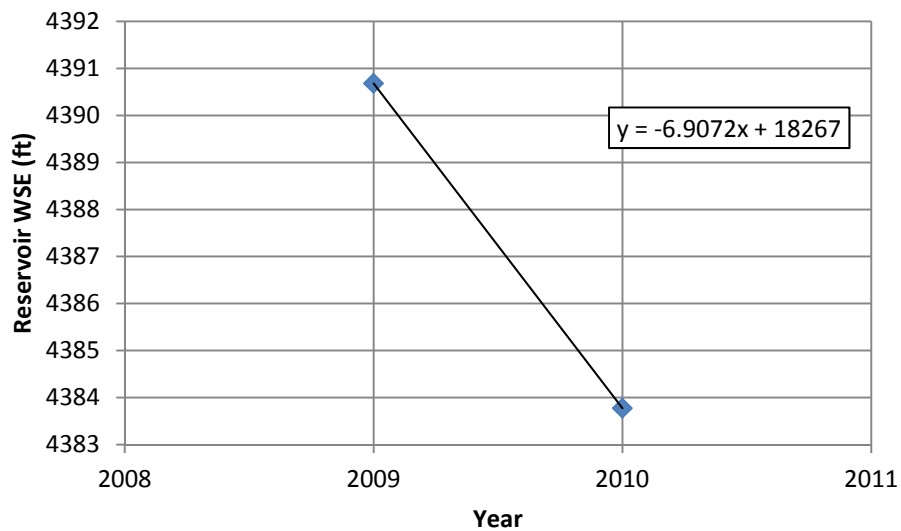
Figure 4.47 Reservoir Water Surface Elevation Change from 2009-2010 Resulting in Wave 1 Channel Degradation

elevation change from 2009 to 2010, which induces Wave 1 degradation. Figure 4.48 shows the rate of Wave 1 propagation upstream as a result of the decrease in WSE (base-level) from 2009 to 2010. The wave propagated upstream at a rate of 1.46 miles/year with a decrease in base-level of 6.9 ft/year, and the upstream extent of the reservoir receded 2.71 miles/year.

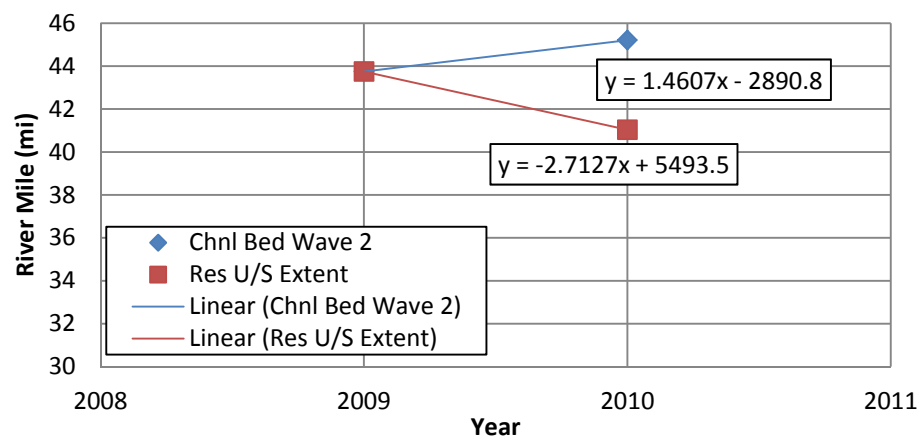
Figure 4.48 Rate of Wave 1 Propagation Upstream

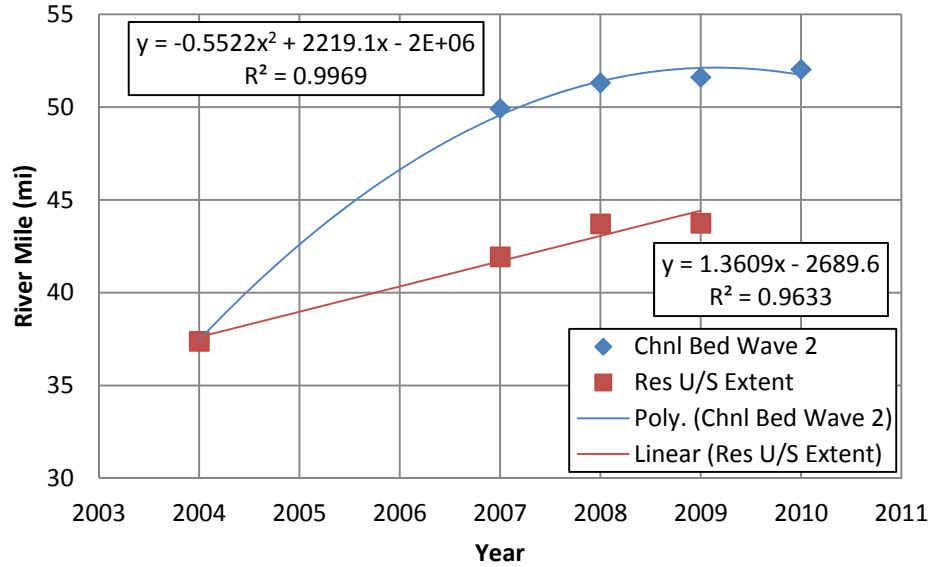
Figure 4.50 Rate of Wave 2 Propagation Upstream

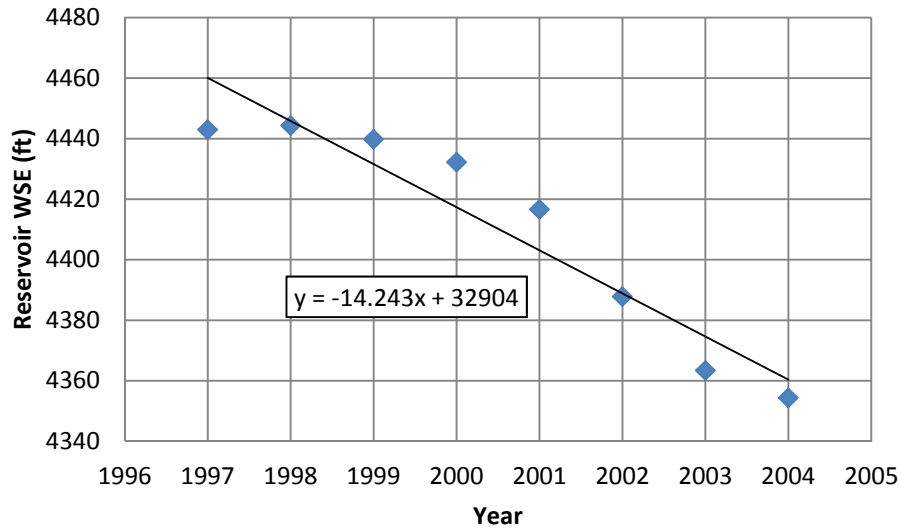
Figure 4.51 Reservoir Water Surface Elevation Change from 1997-2004 Resulting in Wave 3 Channel Degradation

Wave 3 resulted from a decrease in base-level from 1997 to 2004. Figure 4.51 shows the reservoir water surface elevation change from 1997 to 2004, which induced Wave 3 degradation. Figure 4.52 shows the rate of Wave 3 propagation upstream as a result of the decrease in WSE (base-level) from 1997 to 2004. With a decrease in base-level of 14.2 ft/year, Wave 3 propagated upstream according to the following second order polynomial:

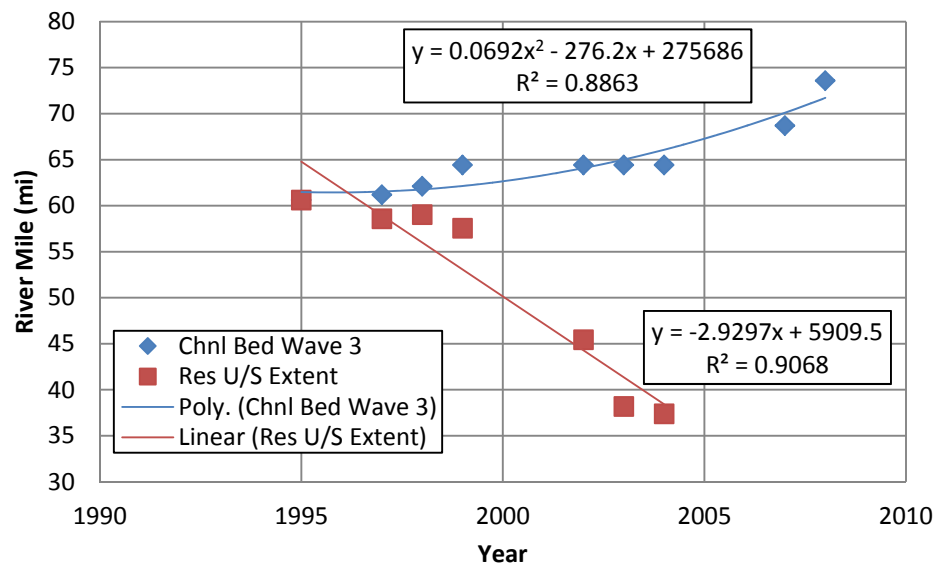
Figure 4.52 Rate of Wave 3 Propagation Upstream

Where,  $y$  is the upstream-most River Mile at which degradation occurs as a result of a decrease in base-level of 14.2 ft/year, and  $x$  is the year at which River Mile  $y$  begins to degrade. The upstream extent of the reservoir receded at a rate of 2.9 miles/year.

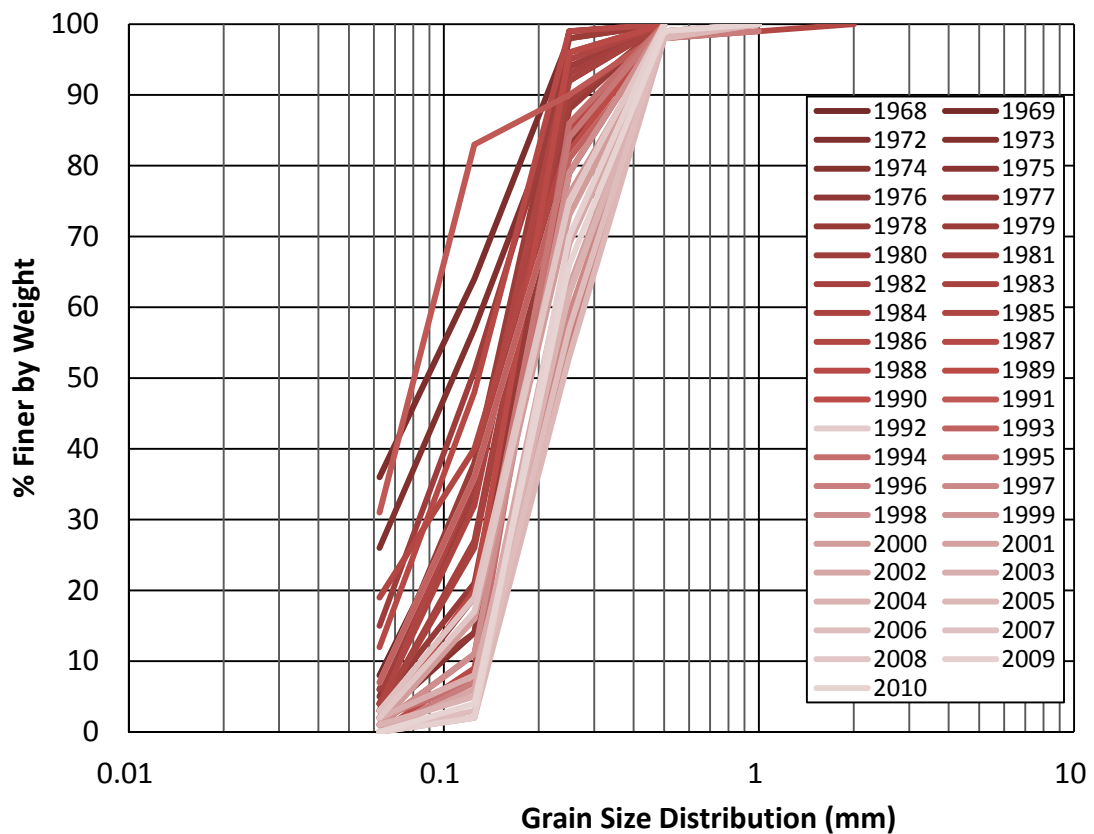
Figure 4.57 San Marcial Gauge: Annual Bed Material Grain Size Distributions

The San Acacia and San Marcial grain size distribution plots show that the bed material has become slightly coarser over time as indicated by the grain size distribution curves moving to the right with time. Note that the San Acacia gauge is 44 miles upstream of this study reach and is not representative of this study reach, while the San Marcial gauge is located at the upstream end of this study reach, and therefore represents this study reach very well. The grain size distributions of each subreach have experienced minimal changes throughout the years. It should be noted that in the case of San Acacia and San Marcial gauges, the sequences of data ranges from 1967 to 2008, while Subreaches 3, 4, 5, and 6 data range from 1986 to 2002; Subreach 1 only ranges from 2001 to 2005; and Subreach 2 only has data from 1999.

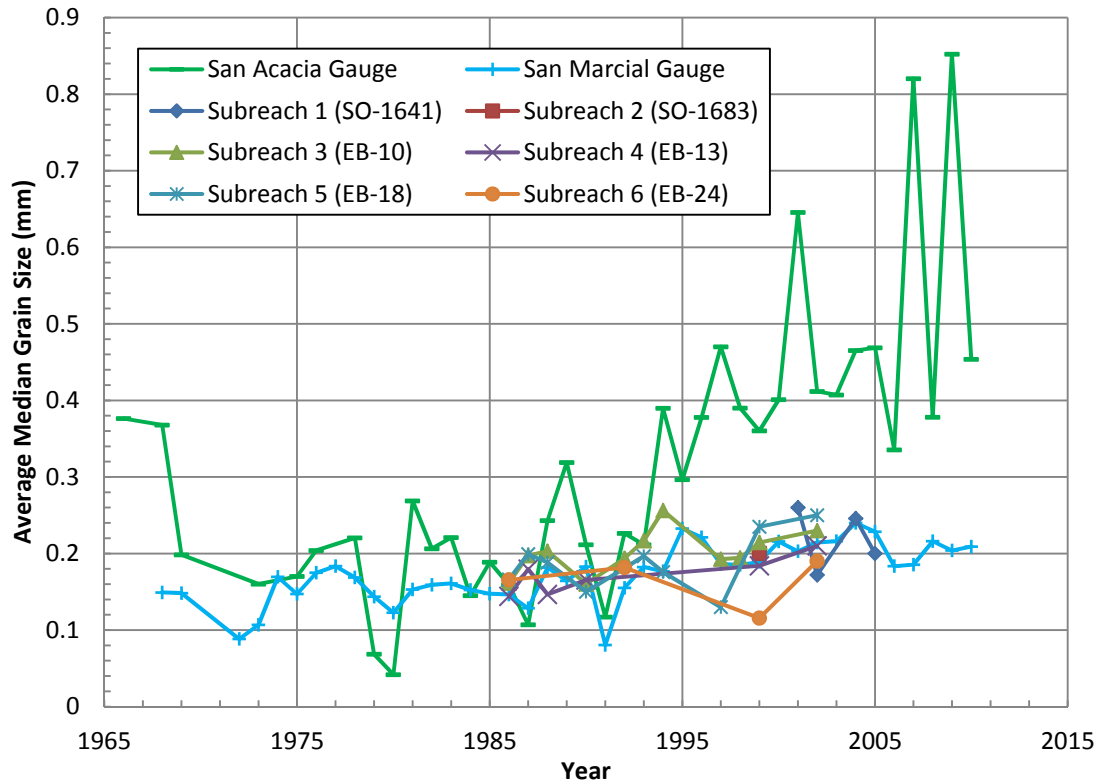
Figure 4.64 Average Median Bed Material Grain Size Temporal Trends

Figure 4.64 shows the change over time of the average median bed material grain size in each subreach and at the San Acacia and San Marcial gauges, located 44 miles upstream of the study reach and within the study reach, respectively. Figure 4.65 shows the average median bed material grain size trends for each subreach from 1986 to 2005.

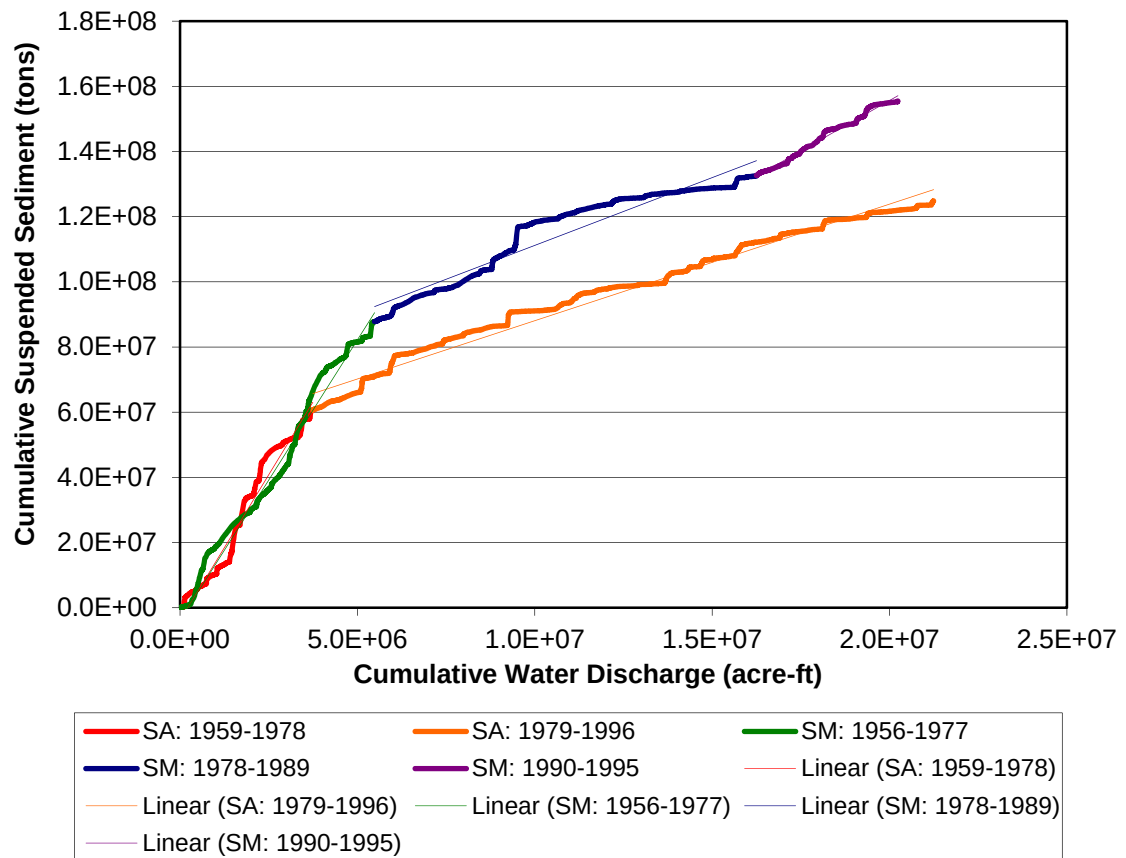
Figure 4.68 Suspended Sediment Concentration Double Mass Curves (Larsen et al. 2007)

Double mass curves were developed at each gauge to show the changes in suspended sediment concentration over time, as seen in Figure 4.68.
