## NDE investigation of the timber foundation in the historic Kennecott Mine Concentration Mill Building

**Abstract** The U.S. National Park Service acquired the National Historic Copper Mine at Kennecott, Alaska, in 1998. There was uncertainty about the condition of the timber-cribbing foundation supporting the concentration mill, the largest building in the mine complex. A comprehensive on-site evaluation of the timber cribbing foundation was performed in summer 2009. The inspection process included visual assessment, species confirmation, moisture content determination, stress wave scanning test, resistance micro-drilling/core-drilling, and decay testing. Extensive deterioration was found in the timber-cribbing foundation members at the lower floors of the mill building. The upper levels of the cribbing foundation exhibited much less deterioration, especially in areas where the timber cribbing was not filled with soil. Current efforts are focusing on a comprehensive structural evaluation of the Concentration Mill Building with the goal of stabilizing and preserving this historical mining building important to the cultural heritage of early 20th-century America.

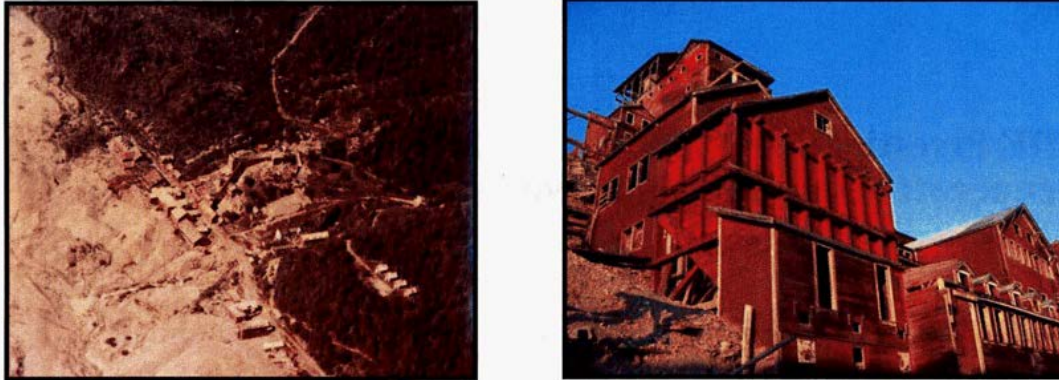
**Figure 1** –Aerial view of the Kennecott Mine complex (left) and a northwest view of the Concentration Mill Building (right).

The hallmark structure in the historic town is the massive Concentration Mill Building shown in Figure 1 (right). The 14-story timber building was constructed in many phases between the years 1910 and 1935, with new additions added as the copper concentration process became more complex (NPS 2008). The building foundation consists of a separate heavy timber box crib foundation for each Wdiug level that “stair-steps” up the mountainside. Copper ore processing began at the upper level ore bins, was gravity fed to each lower level for various concentration techniques, and culminated with packaging the copper ingets for their 131-mile (211-km) rail journey to the port of Cordova. As part of the overall effort to restore and stabilize the Concentration Mill Building, the initial focus was placed on the general condition of the foundation structural systems. A more up-to-date condition assessment of the building foundation using current nondestructive evaluation (NDE) inspection tools was needed to support a structural analysis of the building system

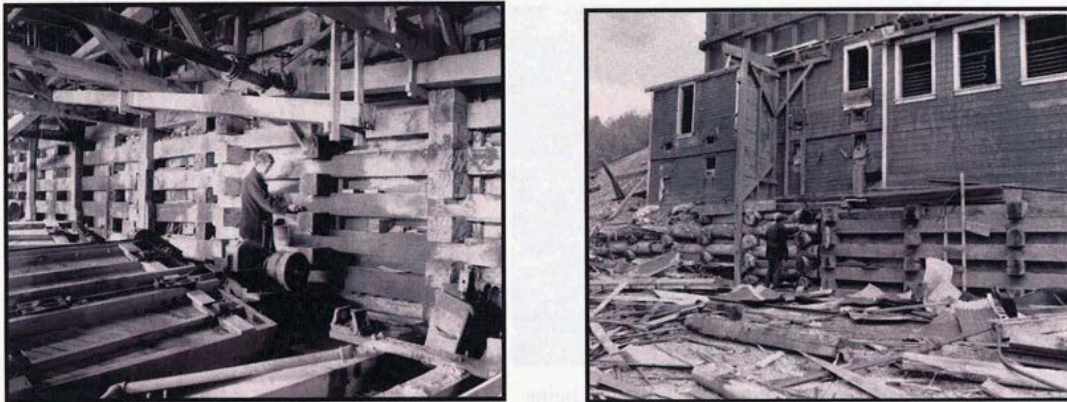
The Concentration Mill foundation walls (as they appeared in 1976) at level 3 are shown in Figure 2 and are open-cell type consisting of square timbers measuring 25 × 25 cm or 30 × 30 cm int-ed with saddle notching. The “headers” are notched members (designated as “8” members) that are alignmd perpendicular to the face of the wall. The “stretchers” (designated as “S” members) have no natching and are aligned parallel to the ace of the wall. Timber planking is attached at the backside of the stretchers at most locations to contain the soil fill material inside the timber crib cells.

Figure 2 - Timber crib foundation wall (level 3, left) and outside (level zero, right) during the 1976 building inspection.

Some foundation wall sections along the northern side of the structure were constructed after mining operations began in 1912 and utilized sound timber for the crib foundation as shown in Figure 2 (right).

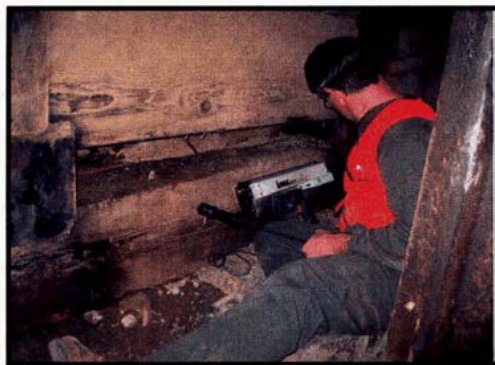
We used an electrical-resistance-type moisture meter (which automatically compensates for species and temperature) in conjunction with 76-mm-long insulated pins and a hammer probe (see Figure 3) to measure the in situ moisture conditions of timber crib members at each level of the building.

**Figure 3** - Moisture content measurements being collected with an electrical-resistance-type meter.

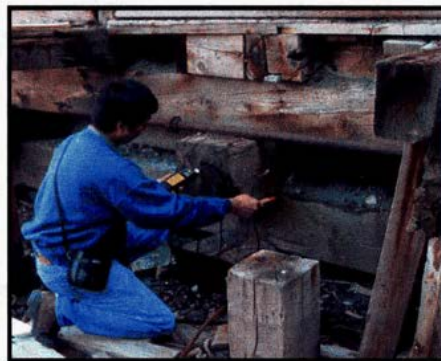
**Figure 4** - Stress wave measurements being collected using a microsecond timer device.

A stress wave timing device that measures the time it takes for sound waves to travel through the heavy timbers was used to locate internal decay pockets (see Figure 4). Spiked-transducers were carefully inserted into opposing faces (perpendicular-to-grain orientation) of the foundation timber. Then a hammer impact sent a sound wave through the member, with the timing device precisely measuring its time of flight through the targeted area. Expected readings for sound Douglas-fir timbers typically fall within the range of 457–914 microseconds per meter. We also took baseline reference readings in several sound 30- × 30-cm Douglas-fir timbers at the upper floors of the Concentration Mill Building, and they typically fell within the typical range for sound timbers. Readings above these baseline reference levels would indicate the presence of moderate to severe decay pockets or significant checking in members.

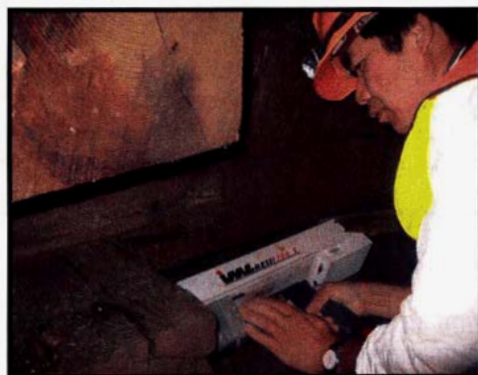
A resistance micro-drilling device that measures the relative density as a long steel drill bit (with a 3-mm bit diameter and a 1.5-mm shaft diameter) bores through the foundation timber (see Figure 5). The probe hole is very small and usually self-seals within a short time period. A true scaled plot of the relative resistance versus drilling depth is generated for each location (see Figure 6). The supplemental data assists the inspector in estimating the relative size and location of internal voids and decay pockets within timber-cribbing foundation members. Relative resistance profiles that have closely spaced peaks and valleys are associated with a radial drill path orientation. Relative resistance profiles that are flatter, but still well above zero drilling resistance, are associated with a tangential drill path orientation. Locations of internal checking or splitting usually are short distances of zero drilling resistance. Pockets of internal decay typically extend more than 25 mm with zero drilling resistance.

**Figure 5** –Resistance micro-milling being performed at a foundation member.

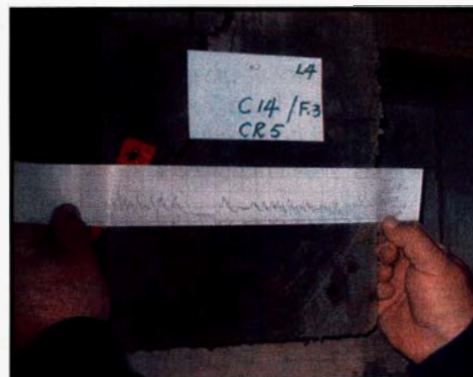
**Figure 6** - Relative density plot from the resistance micro-drilling device held aligned to the drilling path.
