## Chapter 1

# Introduction

Daniel G. Neary, John N. Rinne, Alvin L. Medina, Malchus B. Baker, Jr.

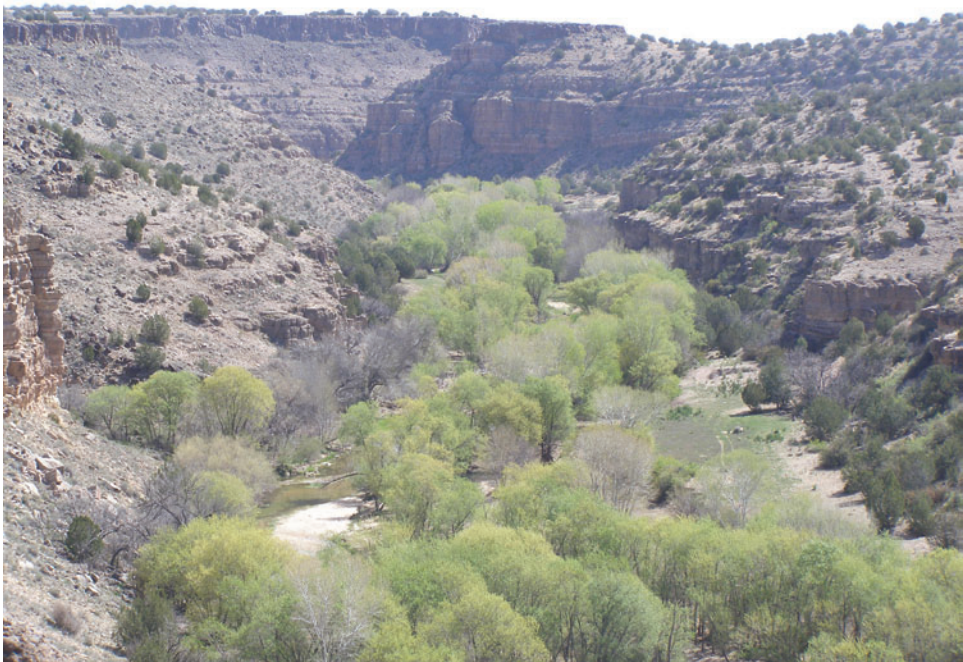
**Figure 1.4**—Typical UVR landscape, Prescott National Forest, Arizona.  
(Photo by Daniel G. Neary.)

The general condition of the UVR consists of a plateau with pinyon-juniper dissected by the entrenched Verde River (fig. 1.4). Some sections open out wider (e.g., Perkinsville and Burnt Ranch) before returning to the mostly canyon-bound condition.

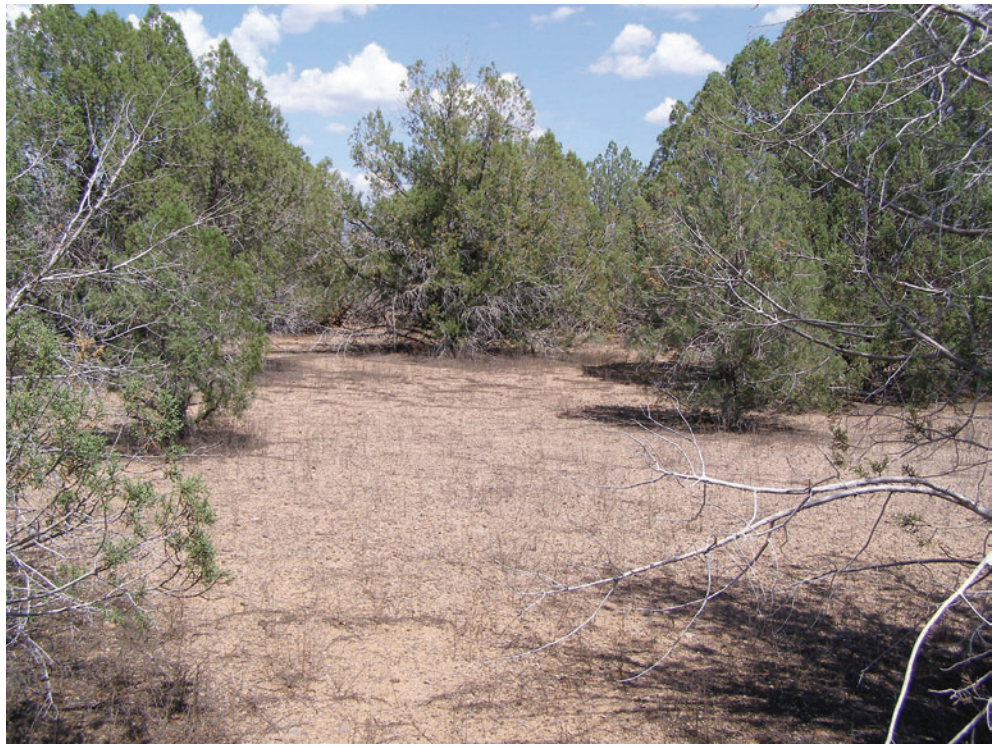
**Figure 1.8**—Pinyon-Juniper woodlands of the UVR region, Prescott National Forest. (Photo by Daniel G. Neary.)

**Conifer Woodlands**—Woodlands containing pinyon pine and juniper species constitute the majority of the vegetation of the UVR area (figs. 1.4 and 1.8). They are below the signature ponderosa pine forests, at elevations of 1,370 to 2,290 m (4,500 to 7,500 ft), and constitute the largest forest type in the Southwest (fig. 1.8). Colorado pinyon (*Pinus edulis*) is found throughout, with singleleaf pinyon (*Pinus monophylla*) occurring on limited areas (Baker 1999). North of the Mogollon Rim, Utah juniper (*Juniperus osteosperma*), Rocky Mountain juniper (*J. scopulorum*), and one-seed juniper (*J. monosperma*) are intermixed with pinyon, while alligator juniper (*J. deppeana*) and Utah juniper are found south of the Mogollon Rim. Annual and perennial grasses and grass-like plants, forbs, half-shrubs, and shrubs abound beneath the woodland overstories when the tree cover is not overly dense or when grazing intensity is moderate to low. Recreation, a resource in these woodland areas, is limited by summer temperature and the relative lack of water. These woodlands are also an important source of firewood. Livestock, which spend

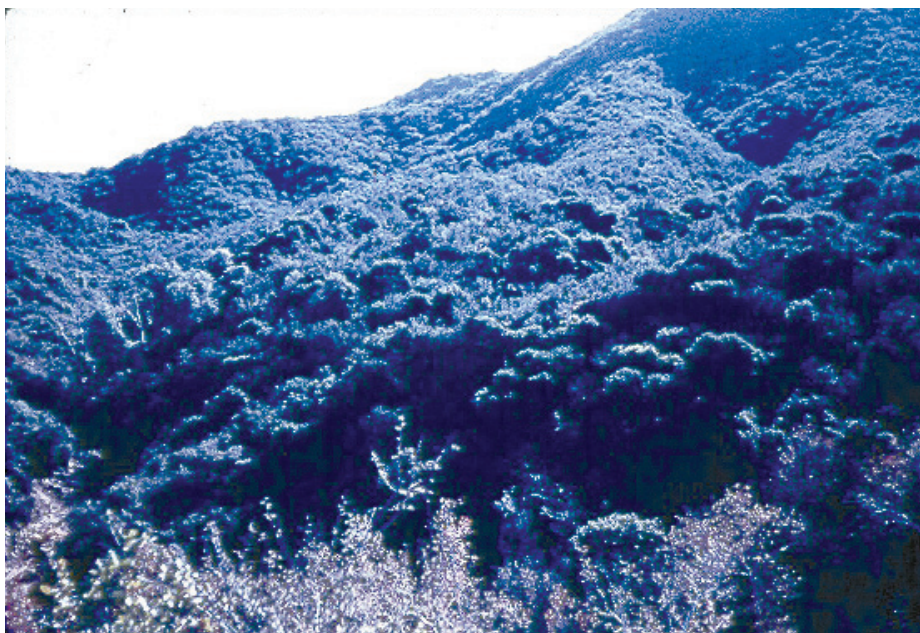
**Figure 1.9**—Chaparral shrublands of the UVR region, Prescott National Forest. (Photo by Malchus B. Baker, Jr.).

**Chaparral Shrublands**—Chaparral shrublands occur on rough, discontinuous, mountainous, terrain south of the Mogollon Rim (fig. 1.9; Baker 1999). Chaparral stands consist of a heterogeneous species mix in many locations, but often only one or two species dominate. Shrub live oak (*Quercus turbinella*) is the most prevalent species, while true (*Cercocarpus montanus*) and birchleaf mountain mahogany (*Cercocarpus betuloides*), Pringle (*Arctostaphylos pringlei*) and pointleaf (*A. pungens*) manzanita, yellowleaf (*Garrya flavescens*), hollyleaf buckthorn (*Rhamnus crocea*), desert ceanothus (*Ceanothus greggii*), and other shrub species can be included in the chaparral mixture of shrubs (Baker 1999). Annual and perennial grasses, forbs, and half-shrubs are present, particularly where the overstory canopy is open or only moderately dense. Although the recreational value (hiking, camping, and hunting) of chaparral is less than the higher-elevation vegetation types, its close proximity to major population centers gives it the advantage of providing a much larger recreation resource. Research has also determined that chaparral areas are marginal and intermittent sources of water supply for municipalities if vegetation control is employed to reduce tree densities (Baker 1984; Poff and Neary 2008). Chaparral rangelands are often grazed year-long by livestock and wildlife because evergreen plants common to the shrublands provide a continuous forage

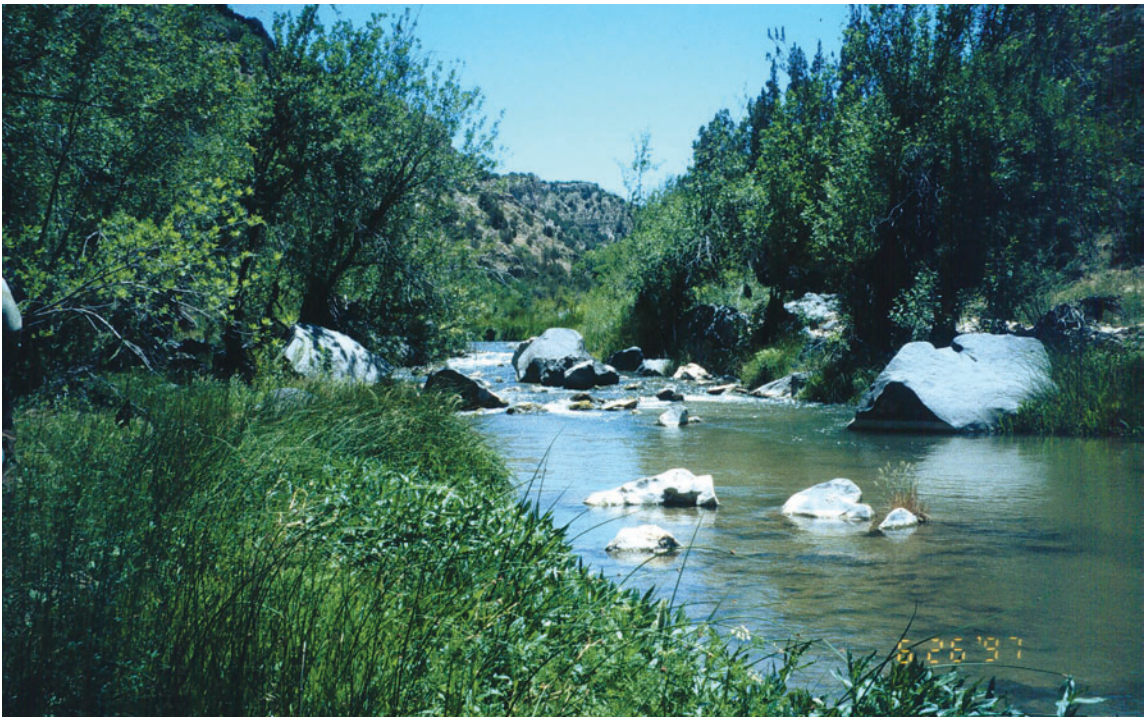
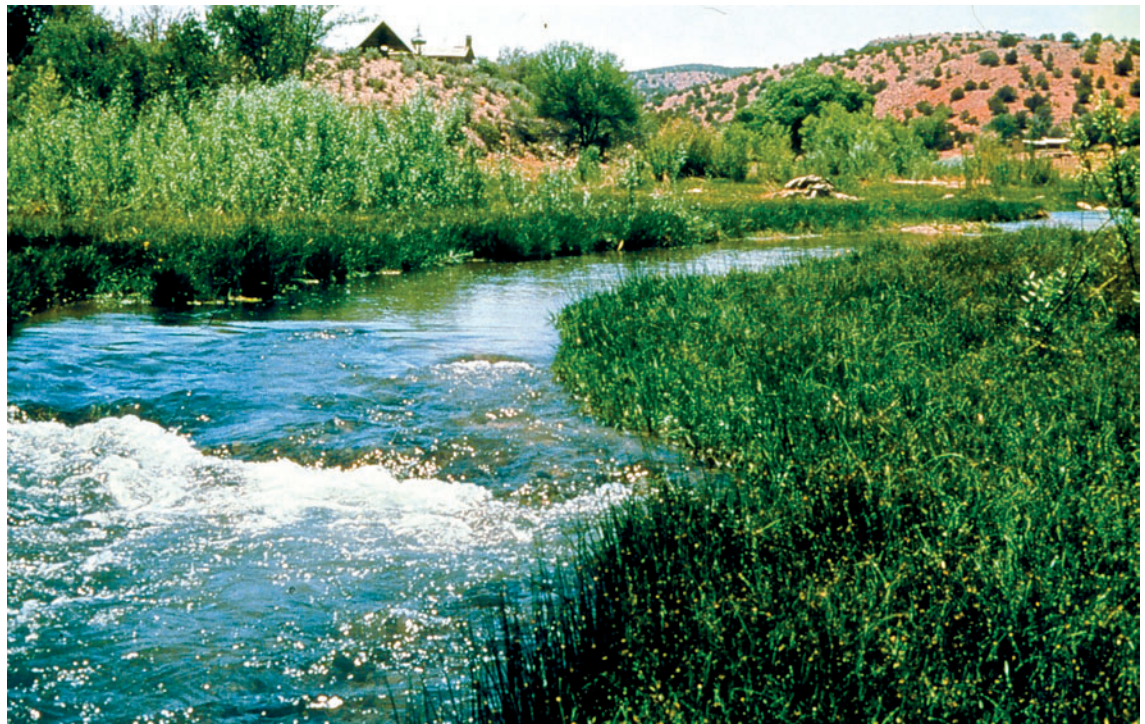
**Figure 1.10**—Riparian vegetation typical of the UVR region, Prescott National Forest: (a) Canyon-bound reach below Perkinsville, and (b) sedge-lined E-channel below the Verde River Ranch. (Photo by Alvin L. Medina.)

otherwise arid environment (fig. 1.10). Riparian ecosystems are “prime” habitats for many game and non-game species of wildlife and fishes.

and forth, it is quickly dampened by the channel characteristics and results in no major change in the central tendency toward maintaining a dynamic equilibrium. When the resilience, or elasticity, of the system is not violated, a different dynamic equilibrium condition can be quickly reestablished. Most important of these factors is the native riparian vegetation (Medina 1996). Native riparian species (i.e., sedges, rushes, and other aquatic plants) have long, thick, fibrous root systems that can resist flood flows and hold the soil. They also have flexible stems that can fall over in flood conditions and protect the soil surface. The healthy riparian area is also characterized by a shallow water table, which is necessary to sustain healthy riparian plant communities on nearby floodplains (fig. 1.10).

Aquic Ustochrepts are a minor inclusion on the river, but they exhibit strong soil development with stable non-eroding fluvial conditions. These soils are associated stable sinuous channels typical of the "E-type" (Rosgen 1994) and wetland sites with dense stands of sedges and rushes. These habitats were evident prior to recent floods and establishment of woody vegetation. Remnant habitats exist only in localized areas with gaining reaches, e.g., Verde Ranch and Duff Springs (fig. 1.10).
