# Slope-area thresholds of road-induced gully erosion and consequent hillslope–channel interactions

**ABSTRACT:** Pikes Peak Highway is a partially paved road between Cascade, Colorado and the summit of Pikes Peak. Significant gully erosion is occurring on the hillslopes due to the concentration of surface runoff, the rearrangement of drainage pathways along the road surface and adjacent drainage ditches, and the high erodibility of weathered Pikes Peak granite that underlies the area. As a result, large quantities of sediment are transported to surrounding valley networks causing significant damage to water quality and aquatic, wetland, and riparian ecosystems. This study establishes the slope/drainage area threshold for gully erosion along Pikes Peak Highway and a cesium-137 based sediment budget highlighting rates of gully erosion and subsequent valley deposition for a small headwater basin. The threshold for gully erosion along the road is  $S_{cr} = 0.21A^{-0.45}$  and the road surface reduces the critical slope requirement for gully erosion compared to natural drainages in the area. Total gully volume for the 20 gullies along the road is estimated at 5974 m<sup>3</sup>, with

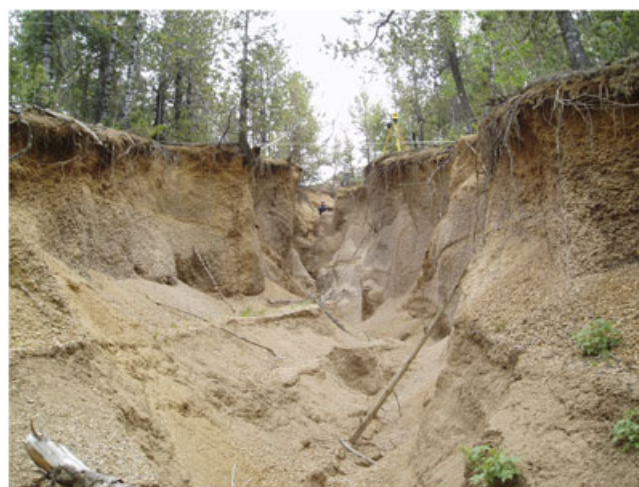
**Figure 2.** Gullying due to surface runoff discharge from the Pikes Peak Highway road surface. This site is the largest gully by volume in the study area. Source: Troendle *et al.*, unpublished report. 2010, pp 1–34. This figure is available in colour online at [wileyonlinelibrary.com/journal/esp1](http://wileyonlinelibrary.com/journal/esp1)

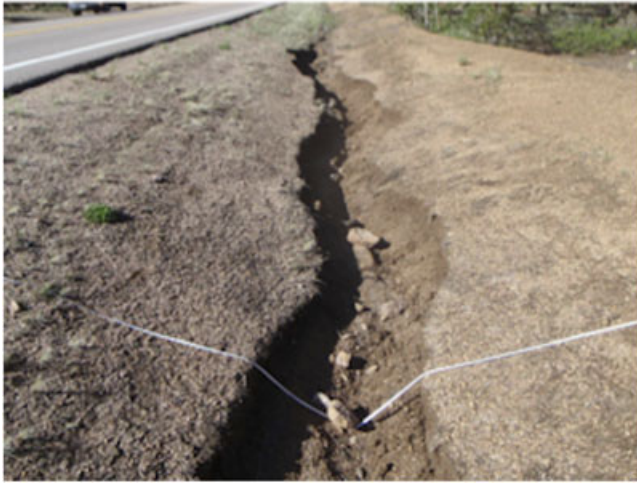
**Figure 3.** An incised drainage ditch associated with Pikes Peak Highway. Source: Troendle *et al.*, unpublished report. 2010, pp 1–34. This figure is available in colour online at [wileyonlinelibrary.com/journal/espl](http://wileyonlinelibrary.com/journal/espl)

The road is lined on its sides along the majority of its length with drainage ditches (Figure 3). Ditches drain either through culverts or directly onto slopes that deliver water and sediment to surrounding basins (Figure 4). Bedrock throughout the region is Pikes Peak granite, a plutonic igneous rock containing large amounts of coarse-crystalline orthoclase that weathers easily into highly erodible grus.

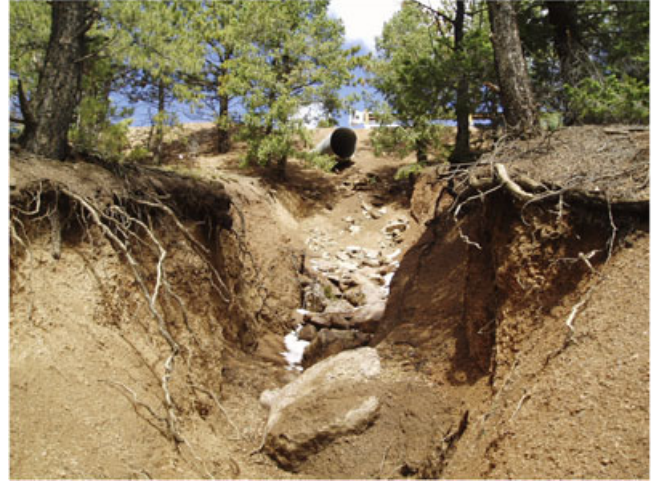
**Figure 4.** A gully formed at a culvert outlet. Gullies in the study area are developing in the downslope direction. Source: Troendle *et al.*, unpublished report. 2010, pp 1–34. This figure is available in colour online at [wileyonlinelibrary.com/journal/espl](http://wileyonlinelibrary.com/journal/espl)

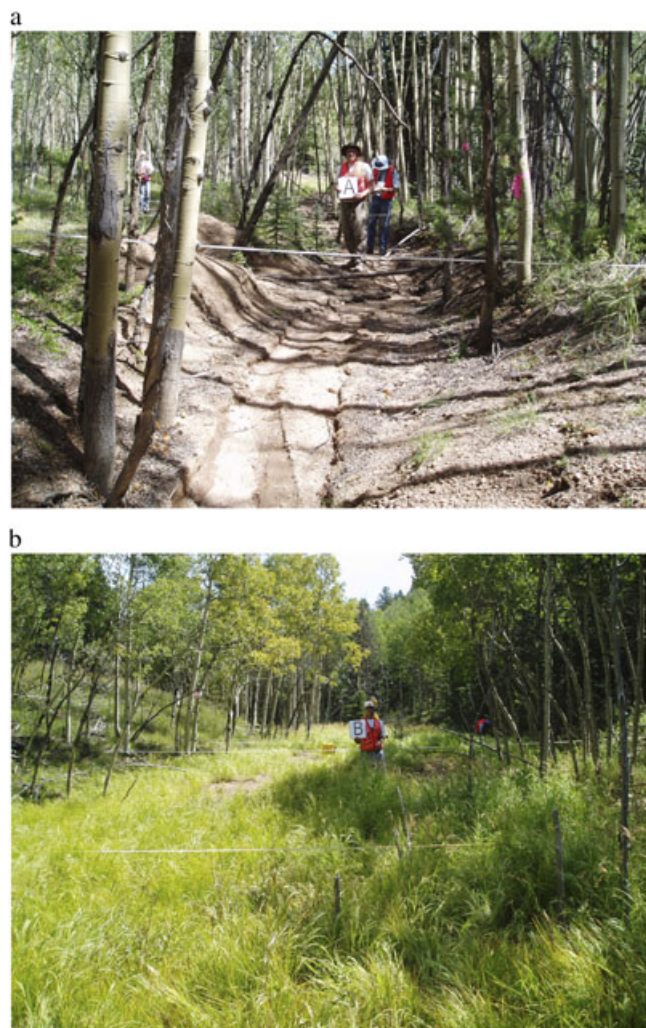
**Figure 8.** Representative portions of the upper (A) and lower (B) reaches of the North Fork Crystal Creek valley. Source: Troendle *et al.*, unpublished report. 2010, pp 1–34. This figure is available in colour online at [wileyonlinelibrary.com/journal/espl](http://wileyonlinelibrary.com/journal/espl)
