# Overview of the National Timber Bridge Inspection Study

FPL-GTR-226

# Proceedings 18th International Nondestructive Testing and Evaluation of Wood Symposium

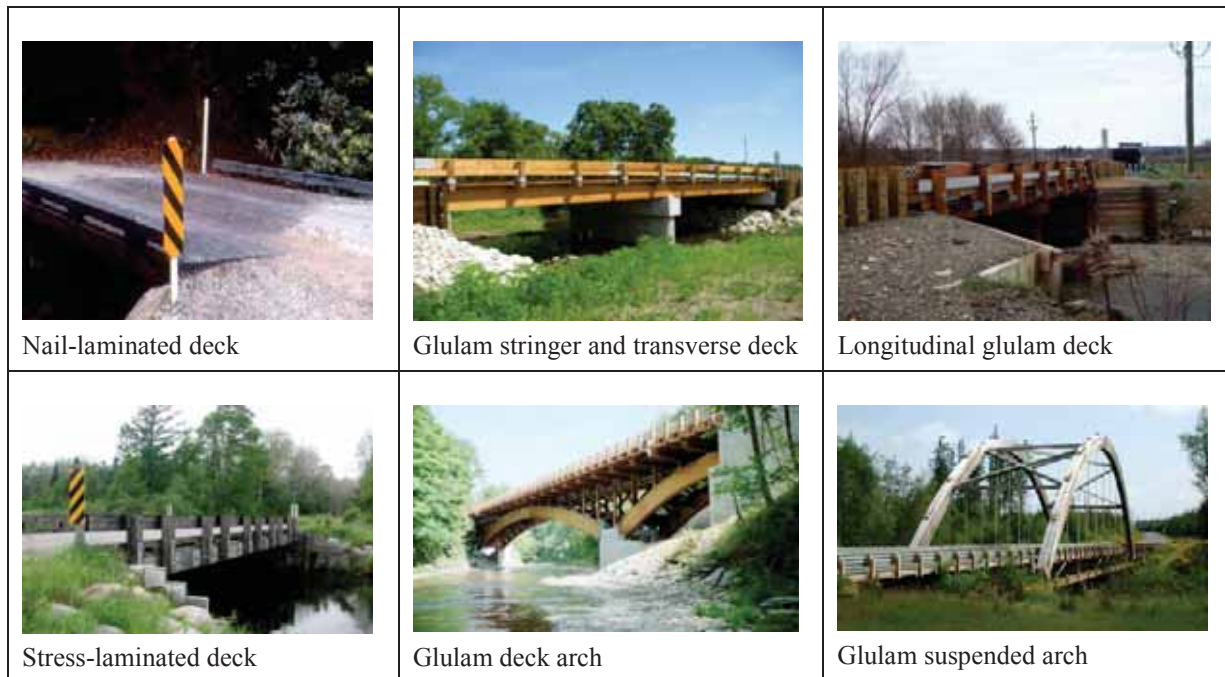
**Figure 2**—Examples of various timber bridge superstructures.

There are a variety of timber bridge superstructure types (Figure 2). The main categories are longitudinal decks, stringer systems, and others. Longitudinal decks include nail-laminated, spike-laminated, stress-laminated (using either sawn lumber or glulam laminations), and longitudinal glulam bridges. The spike-laminated and longitudinal glulam deck superstructures consist of partial-width panels that are interconnected with transverse stiffener beams attached at intervals along the bridge length. The total bridge span ranges typically between 6 and 31m (20 and 100 ft.).

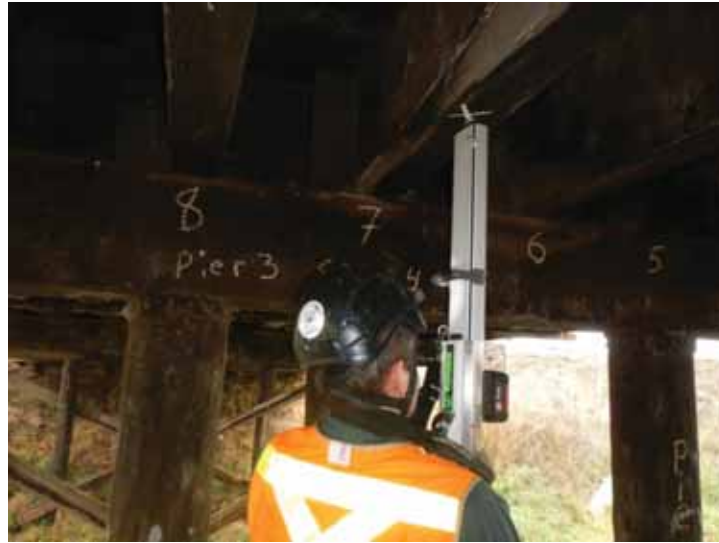
**Figure 4**—Inspection of a timber bridge superstructure located in Washington using a resistance micro-drilling unit.

At this time, field inspections have been completed and all data is being compiled for drafting a comprehensive final report. Table 2 provides a summary of the number and type of timber bridges inspected by each team. Typical inspection work being conducted at a field bridge is shown in Figure 4. A resistance micro-drill was utilized at locations where either high moisture contents were detected or other anomalies that were identified through visual inspection, hammer sounding, and/or stress wave timing investigations.
