**Laboratory investigation of fire protection coatings for creosote-treated timber railroad bridges**

Paper prepared for 45<sup>th</sup> Annual Meeting  
St George, Utah, USA  
11–15 May 2014

# Protective measures from fire for timber railroad bridges

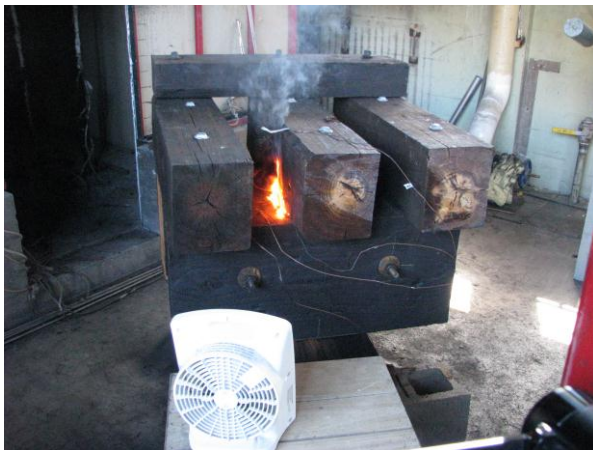
Figure 1: Flames in wood crib of creosote-treated timbers ~30 s after application of hot metal wafer

The exploratory tests included hot steel wafers at 1100°C being placed in different locations within a 0.91 x 0.91 m crib (Fig. 1 and 2). The timbers were creosote treated. The intent was to simulate hot metal becoming lodged in the joint of a crosstie and stringer. With application of the hot wafer in a crevice within the corner of two timbers (Fig. 1), the flames propagated to full involvement of the wood crib in about 8 minutes (Fig. 2). In a subsequent test with another wood crib, several attempts resulted in self-extinguishment with limited flaming. The second crib had timbers with a more “weathered” appearance.

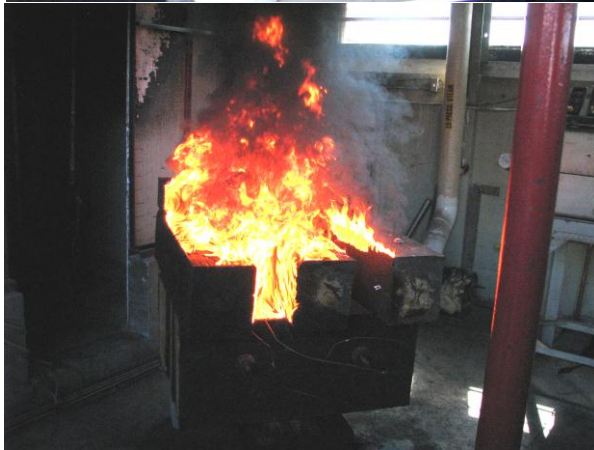
Figure 2: Flames in wood crib of creosote-timbers ~8 min after application of hot metal

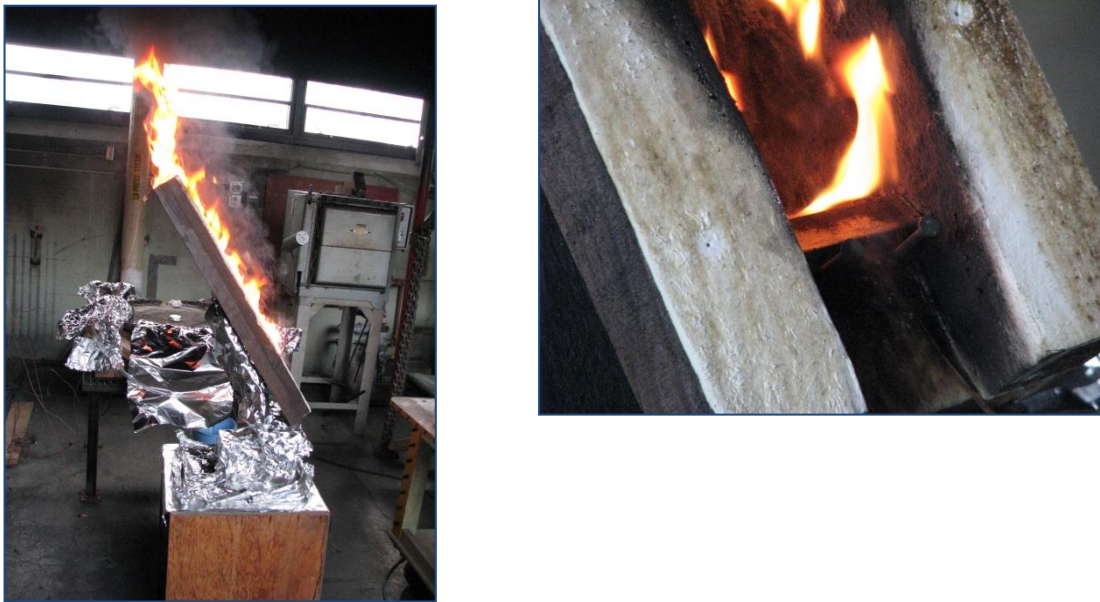
Figure 3: Hot metal test apparatus (left) and ignition source (right)

the ignition source. The new method is called the “hot metal test”. Specimens were 38 thick x 127 wide x 787 mm long with two spacers 38 x 38 x 787 mm attached to each specimen with a 50 mm separation. The specimen was cut from the creosote-treated crossties such that the original exposed surfaces of the crosstie were the interior U surfaces formed by the 38 mm square pieces and the 38 x 127 mm board. The barrier treatment being evaluated was applied to the top surface and U surfaces of the specimen. Two nails were placed in the U-groove 25 mm from bottom end when placed in the holder. The ignition source was a 09.5 x 12.7 x 50 mm piece of steel heated in a furnace/oven to 1093°C.

A thermocouple was placed on the top surface of the bottom board in the test specimen. A second thermocouple was placed 330 mm from the bottom end of the specimen. The third thermocouple was placed at the top end of the U-groove.

The specimen was placed on a supporting metal frame at a 60° angle. To perform the test, the hot metal was placed at the bottom end of the U-groove so it fit between the two 38 mm square pieces and was supported by the two nails. The 12.7 mm width of the hot metal was in contact with the wood surface (Fig. 3). A data acquisition system was used to record the temperature data and visual observations were made.
