# Simplified Analytical Model of a Covered Burr-Arch-Truss Timber Bridge

## Summary

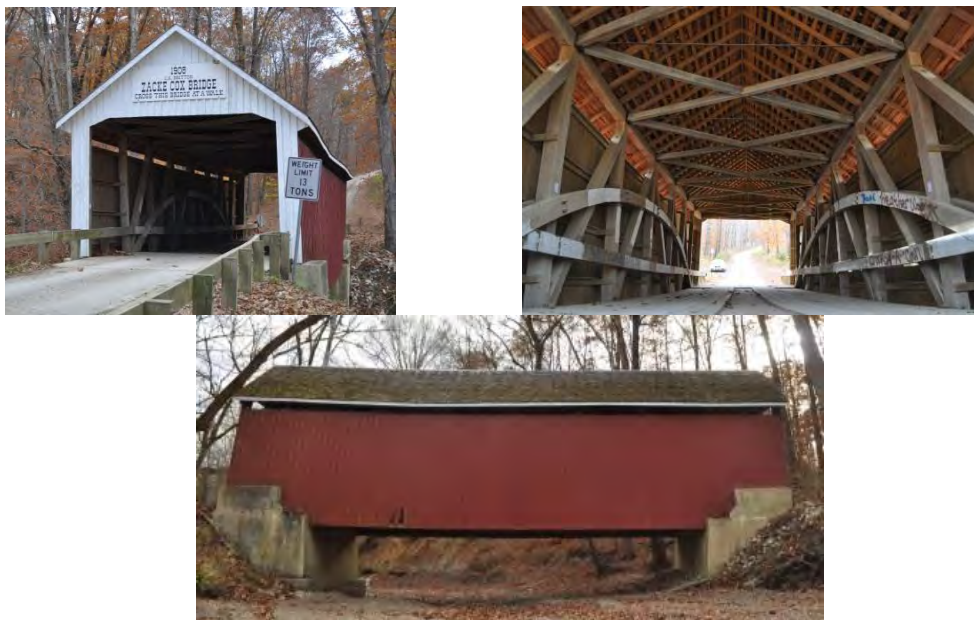
The Zacke Cox Covered Bridge is located in Parke County, Indiana. Elevation and end view photographs of the bridge are shown in Figure 1. The bridge was originally built in 1908 by Joseph A. Britton and its roof and deck were replaced in 1989. The deck was again replaced in 1991 and the bridge was restored in 2002 [7].

*Fig. 1 Different views of the Zacke Cox Bridge*

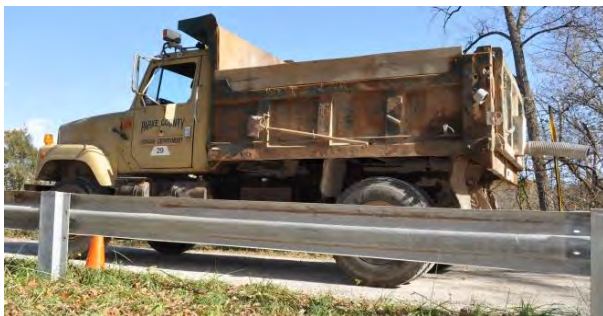
*Fig. 4 Picture of large test vehicle*

The two vehicles were used in the field testing but the analysis presented within will focus on the larger vehicle in Figure 4. This larger truck had a front axle weight of 447.5 kN, a rear axle weight of 68.7 kN, and a center to center axle spacing of 3.07m. The trucks were driven across the bridge down the center of the structure at a slow rate, approximately five miles per hour, to simulate static loading conditions.

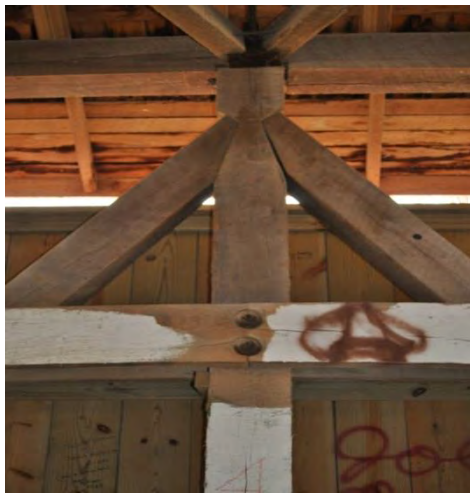
*Fig. 11 Connection between V4 and the two diagonal members at the center span of the bridge*

The differences in the strain magnitudes in the figures above are likely due to the inherent eccentricity within the joints at both ends of these members. The photo in Fig 11 shows a connection detail between vertical member V4 and the two diagonal members at the top chord panel point. Also, Fig. 11 shows that a gap exists between the vertical member V4 and the diagonal member located between vertical V4 and V5 resulting in an additional eccentricity at the joint. The eccentricity at these connections will induce bending moments at each end of these diagonal members. To include this type of detail in a finite element model, one needs to use 3-D solid modeling. Therefore, it was necessary to utilize beam-column strength of material formula to include the effects of the axial force and the bending moments that were induced by the eccentricity at each end of the diagonal member. This was accomplished using the aid of an Excel spread sheet to calculate the stresses and strains at the locations of the strain sensors.
