# Evaluation of Extended Wall OSB Sheathing Connection under Combined Uplift and Shear Loading for 24-inch Heel Trusses

Vladimir Kochkin  
Andrew DeRenzis  
Xiping Wang

Kochkin, Vladimir; DeRenzis, Andrew; Wang, Xiping. 2014. Evaluation of extended wall OSB sheathing connection under combined uplift and shear loading for 24-inch heel trusses. General Technical Report FPL-GTR-233. Madison, WI: U.S. Department of Agriculture, Forest Service, Forest Products Laboratory. 12 p.

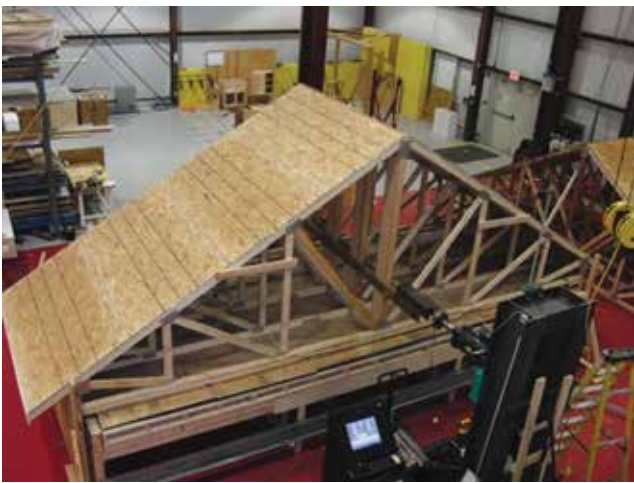
**Figure 1. Test specimen and setup.**

Figure 1 shows a photo of a roof-wall assembly specimen in a laboratory setup. Each specimen was constructed with five 24-ft span wood trusses with a 24-in. heel height, spaced at 24 in. on center. The overall size of the full roof system was 8-ft deep by 24-ft wide with additional 16-in. long overhangs on each side. Trusses were supported at the heel by 4-ft high by 8-ft long light-frame wood walls. The supporting walls were constructed with 24-in. on center framing and sheathed on the exterior with 4-ft wide OSB panels extending up past the top plate of the wall to capture

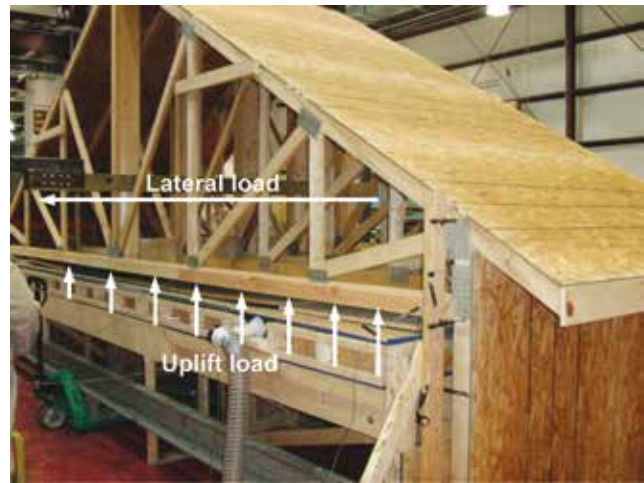
Figure 8. Translatable bearing surface.

monomer (EPDM) rubber and placed on a support structure underneath the test specimen (Fig. 8, Fig. 9). The support structure also isolated the air bag from the test specimen walls to prevent any restraint of the walls due to friction with the bag. The top of the air bag was isolated from the gypsum ceiling diaphragm by a translatable bearing surface constructed of a series of bearing plate rollers sandwiched between two layers of OSB panels; the rollers allowed the specimen to move independently of the air bag in the lateral direction under combined loading. Figure 9 provides a detail of the translatable bearing surface.

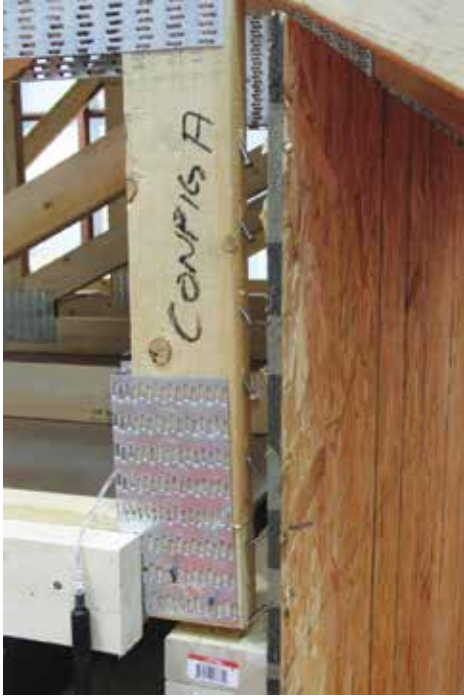
**Figure 11. Primary failure mode of Test A.**

Test A (100% uplift) provided a benchmark uplift capacity for the 24-in. energy truss heel connection system. Test A reached a unit uplift capacity of 890 lb/ft. The primary failure mode in Test A was a Mode 3<sub>m</sub> yielding followed by nail head pull-through at the OSB wall sheathing-to-truss heel

connection and a withdrawal of the toenails from the top plate (Fig. 11) (ANSI/AWC 2011).

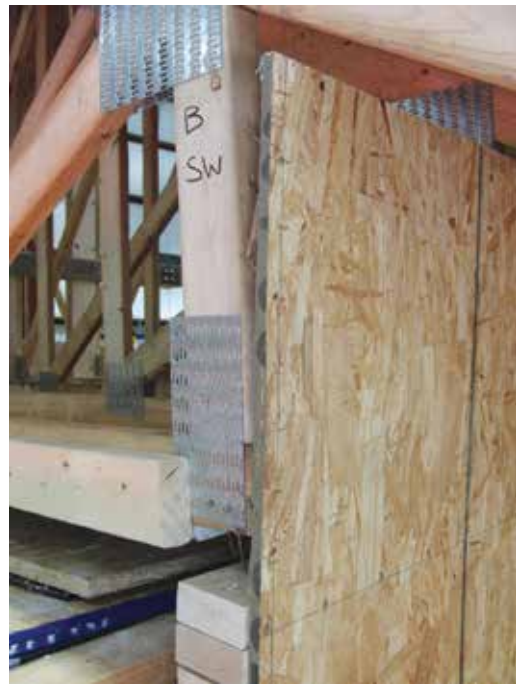
**Figure 12. Fastener yield and pull-through failure mode of Test B.**

Tests B, C, and D evaluated the shear load capacity of the connection system at various levels of uplift loading. The primary failure modes of Test B (85% uplift) were similar to those seen in Test A. The majority of the OSB to heel nail connections exhibited the Mode 3<sub>m</sub>. Yield failure followed by nail pull-through (Fig. 12), with the back trusses (trusses under tension from global overturning) reaching capacity first.

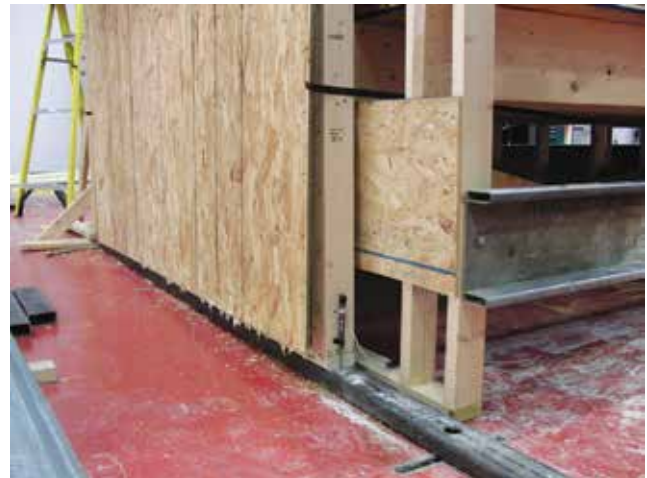
**Figure 13. Fastener pull-through failure mode of Test C and Test D.**

The primary failure mode of Test C (70% uplift) and Test D (45% uplift) was nail pull-through at the connection of the OSB wall sheathing to the wall bottom plates at the uplift ends of the supporting walls (Fig. 13).

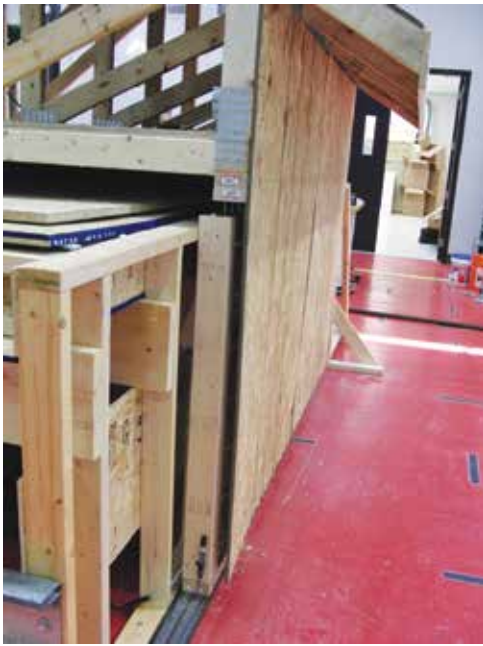
Figure 14. Fastener pull-through failure mode of Test E.

to achieve failure at the energy truss heel connection. Test E reached a unit shear capacity of 620 lb/ft, and also exhibited nail pull-through at the OSB-to-wall bottom plate connection as its primary failure mode (Fig. 14).
