# THE BLACK HILLS (South Dakota) FLOOD OF JUNE 1972: IMPACTS AND IMPLICATIONS

by Howard K. Orr

USDA Forest Service  
General Technical Report RM-2

March 1973

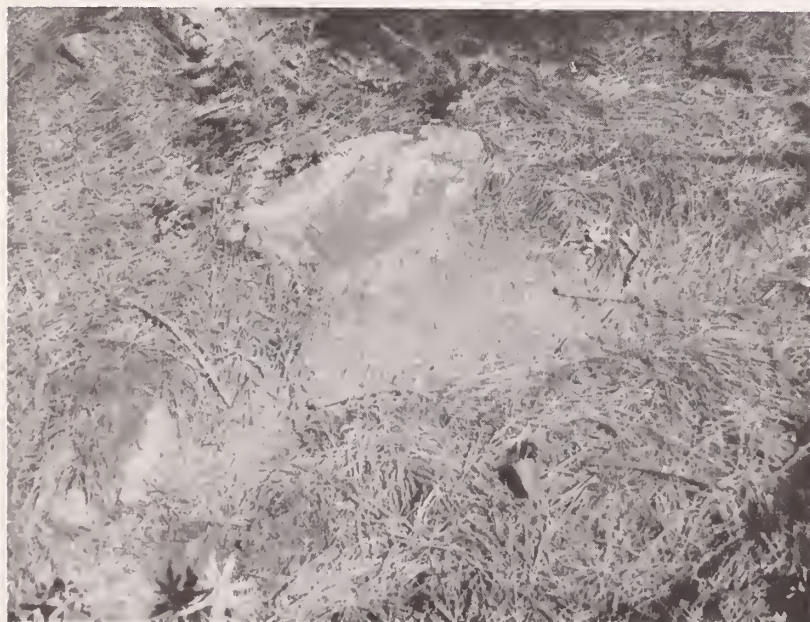
Figure 2.--Water apparently flowed through this thick forest floor without disturbance until it was diverted or ponded by stones. When this happened, the litter floated and moved downslope (right to left), leaving a small spot of bare mineral soil. Many such spots could be seen on some slopes.

In all of the most heavily flooded watersheds examined, there was consistent evidence of surface runoff from slope areas even where there were no clearly visible drainage patterns, and further upslope than in the case of more ordinary storms. The consistency of this kind of evidence, irrespective of site, is a key factor in analyzing the production of the flood flow. Surface runoff occurred from all types of areas, including dense forest and well-grassed slopes. In other words, classification in "good" hydrologic condition did not in this case preclude the production of excessive surface runoff. Surface runoff is here differentiated from overland flow in the sense that surface runoff was evident in shallow depressions of microtopography not ordinarily observed, but there was little evidence of sheet movement of water that resulted in sheet movement of soil or its protective cover of litter and humus. This is a generalization that applied across forest types and densities, other vegetation types, slopes, topography, parent materials, geology, and soils. Thick forest floor, where present, apparently acted as an efficient water conveyance system, but without displacement except where water was diverted or concentrated by stones, roots, or other obstacles (fig. 2). The storm and runoff produced were obviously of a magnitude that plays a major role in shaping topography as we see it today.

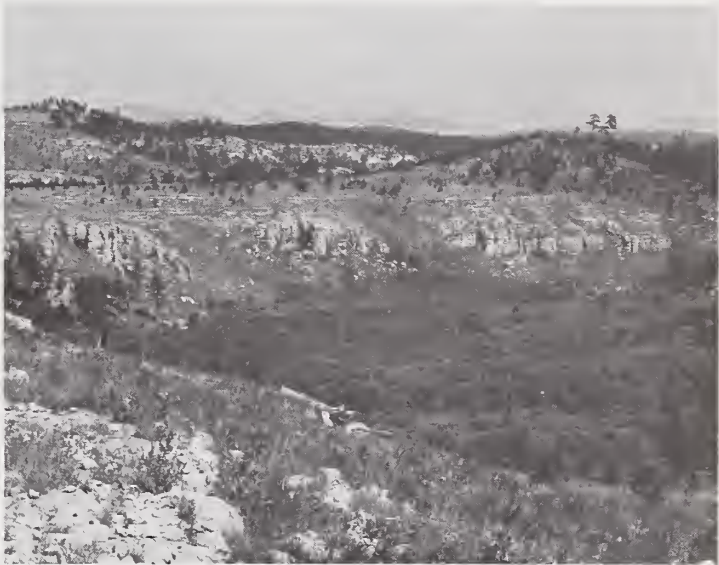
Figure 3.--A south-facing slope in the upper reaches of Wild Irishman Creek (Cleghorn Canyon). The area burned over 36 years ago, and much of it has not come back to pine forest. The rock outcrop is Pahasapa limestone, with darker Deadwood sandstone outcrop (D) about 1/4 of the way downslope. Vegetation is well established and the soils are stable. S indicates slide area closeup in figure 7.

Much of this old burn has not come back to pine (figs. 3, 4, 5). Aspen and birch are now abundant on the more moist slopes and in stream bottoms. Most of the remaining area is well vegetated with herbaceous species and shrubs. There is considerable private land and residential development in the lower reaches (Cleghorn Canyon). There was evidence of runoff from all types of areas, but slope damage was minimal, even on the kind of steep south-facing slope shown in figure 3. This is one of the slopes bared in the 1936 fire. Figure 6 is a closeup of the left portion of this same slope. Pine reproduction is sparse, but the site is well stabilized by herbaceous vegetation. One landslide, visible in figure 3 and shown closeup in figure 7, occurred on this slope. The slide was not large, about 32-35 feet long and about half as wide, and apparently resulted from a combination of water concentration from up-

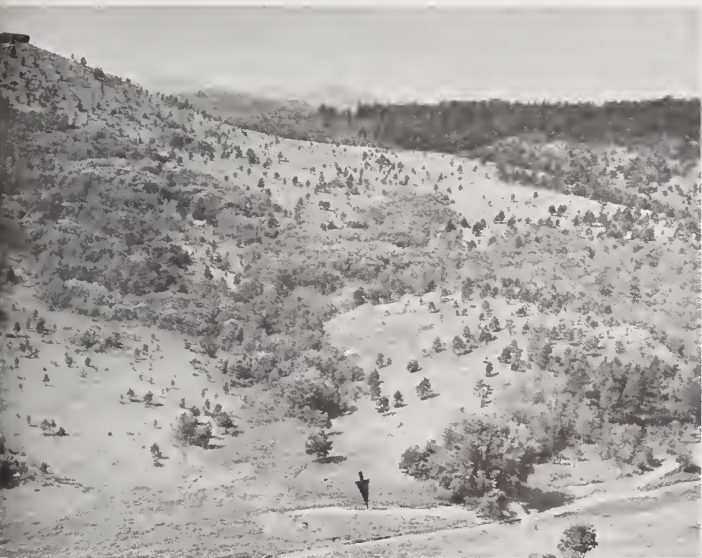
Figure 4.--Looking back southwest from high on the slope in figure 3. One of the main tributary channels of Wild Irishman shows in the lower portion of the photo, and flood-deposited material is visible (arrow), together with an old road.

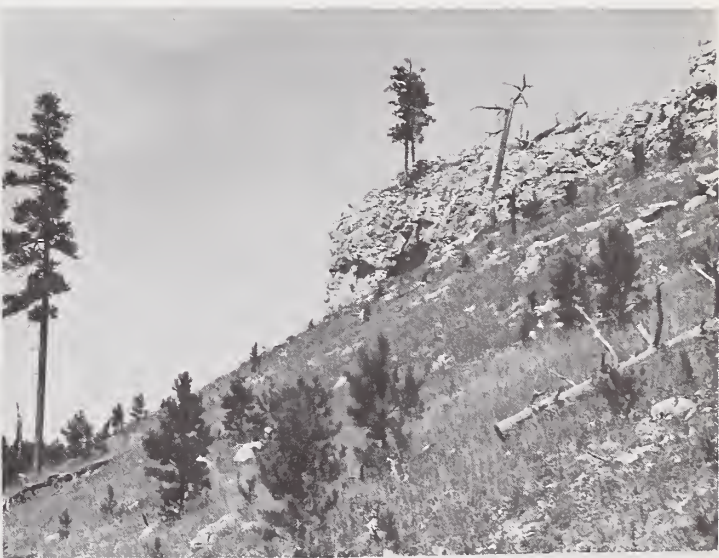
Figure 6.--Looking mostly west (left) across the left portion of the slope in figure 3. Vegetation is a well-established mixture of grasses and forbs. Soils are stable for the most part.

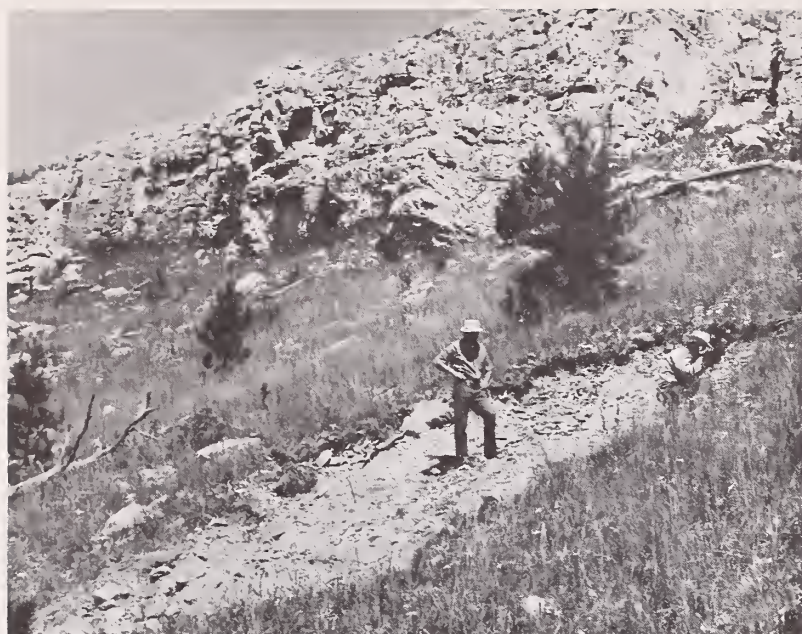
Figure 7.--To the right of the area in figure 6 is this small flow slide about 30 to 35 feet long and about half as wide. It was the only visible area on the entire slope where any appreciable amount of soil was displaced.

slope and liquefaction of shallow, stony soil on bedrock (possibly upper Deadwood sandstone) which was near but did not intersect the slope plane. The flow slide material moved all the way downslope to the main channel, and was no doubt the source of some of the water-deposited material in the lower portion of figure 4. Vegetation was not stripped from the slope in the slide path, however.

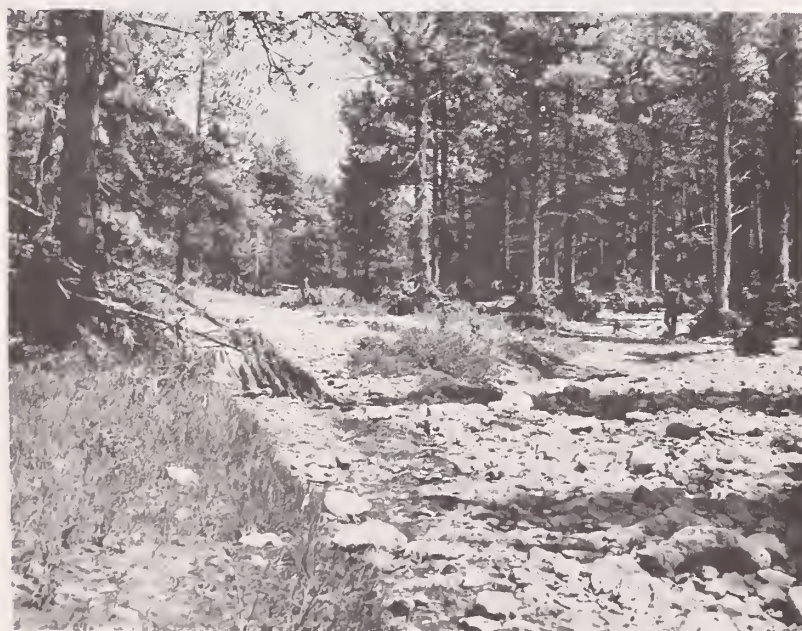
Figure 8.--Woods debris 8 to 10 feet high against the upstream side of trees in Wild Irishman (Cleghorn Canyon), downstream from the areas shown in figures 3 to 7. Here the channel has broadened and there is less gradient, but it steepens and narrows again before joining Rapid Creek at the west edge of Rapid City.

Much debris (including tree branches, limbs, and roots) lodged on the upstream side of trees (fig. 8). Several such deposits were examined closely. None of the debris originated as logging slash, as was at first thought. No axe or saw cuts were visible. The debris obviously came from trees close enough to the channel that record high flow literally tore them out and stripped them of limbs and foliage. Ring counts of some of the trees deposited in debris piles indicate they were 80-85 years old. In other words not since at least 1890 had any combination of storms, fire, timber stand conditions, grazing, or other land use produced such large floods. In Boxelder, and undoubtedly in other drainages, trees were downed that had been in place more than 100 years—long before settlement by white man.

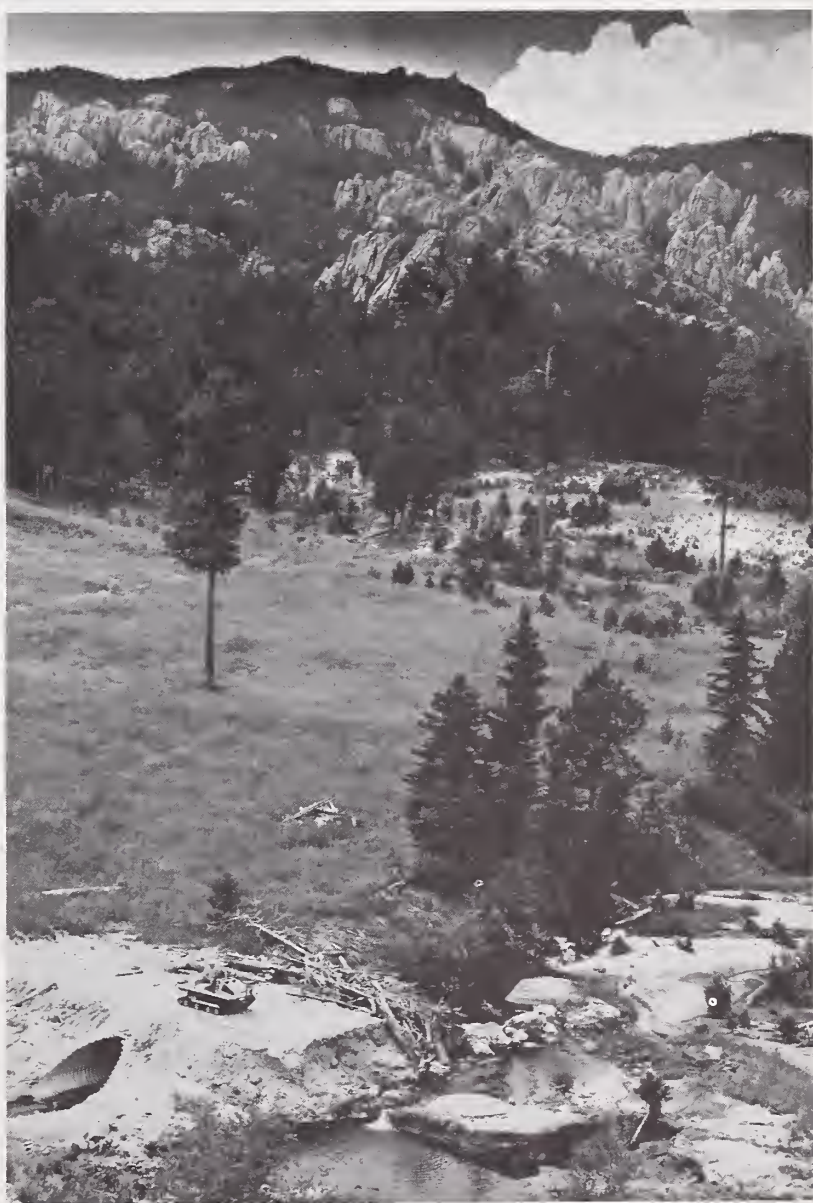
*Figure 9.--Channels eroded severely, even in areas that have received little use in many years. Shown here is Grizzly Bear Creek, draining out of the Pine Creek Natural Area in the Harney Range. Parent rock is granite, which here weathers to a coarse-textured shallow soil with low storage capacity.*

Another watershed of particular interest is Grizzly Bear Creek, which drains from a research natural area on the Precambrian granite of the Harney Range (fig. 9). This area has had little disturbance of any kind in many years. Yet the stream flooded inside as well as outside the boundary of the natural area, enough to drasti-

cally erode and alter some channel sections. Litter piles and associated upslope bare spots again attested to the production of significant surface runoff from a microtopography that would not ordinarily be noticed. There is evidence, however, that watersheds in this general area have low storage capacity due to coarse-textured parent material, and an obvious history of flooding, even during much lesser storms.

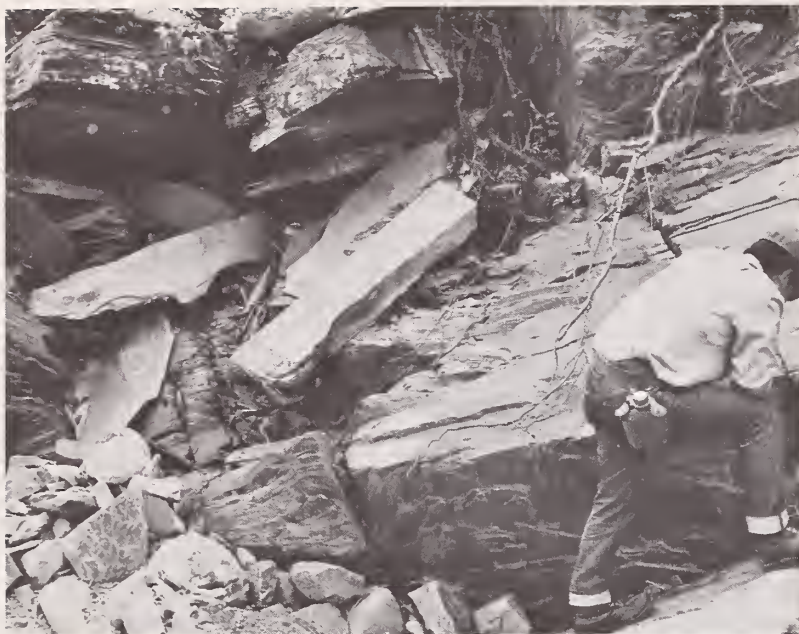
Figure 10.--Characteristic metamorphic parent material in part of storm area that received some of the heaviest rainfall. Flooding from a drainage no more than 1 mile long caused this channel damage, which was on the outside of a turn.

A large proportion of the most heavily flooded watersheds was in areas of metamorphic parent material of the general type shown in figure 10. Material of this type characteristically breaks down to loamy soils, often quite stony. The kind of erosion shown in figure 11 is typical of what happened to cut slopes in residual soil. Fines were washed out, leaving stones protruding. Slumping of steep road cuts was not uncommon in this kind of situation.

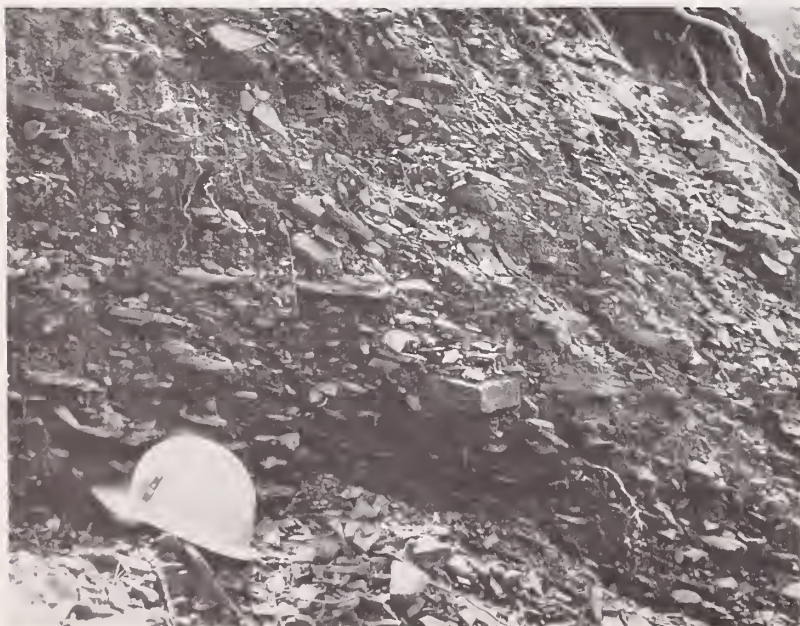
Figure 11.--An old road cut through residual soil, metamorphic parent material, after the June 9 flood. Fines were washed out. Platy rock was then either left protruding or it fell out and into an accumulation at the base of the slope. This sort of thing did not happen on newer back-sloped roads.

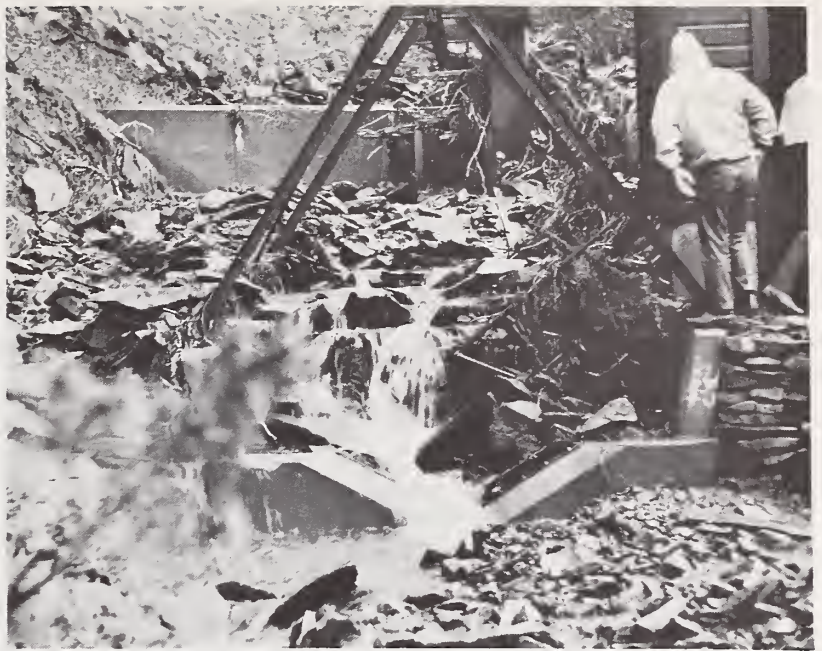
Figure 12.--Watershed 1 →  
gaging station nearly  
covered over with  
stone and other debris,  
and completely inoperable  
after the June 9 flood.

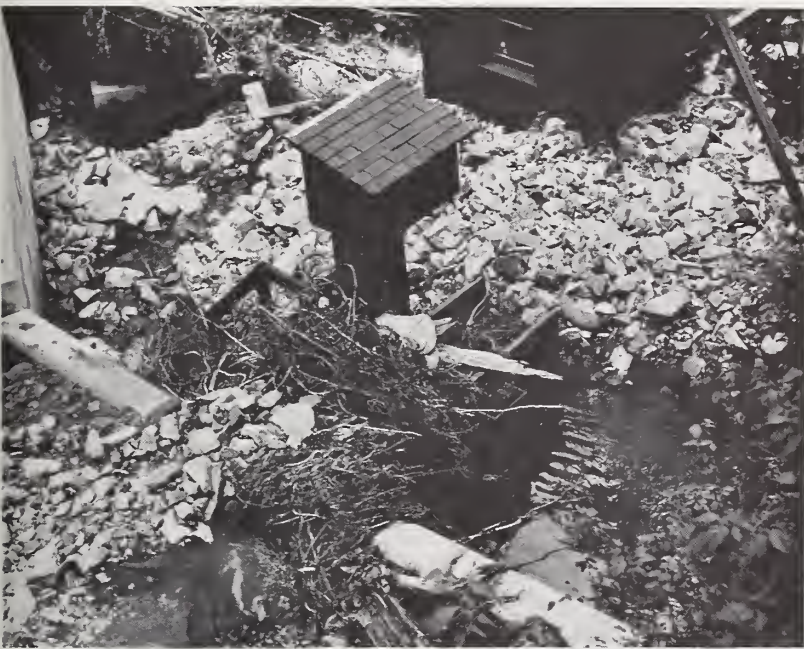
← Figure 13.--Watershed 2 gaging  
station after June 9 flood.  
San Dínas flume and channel  
is full of stone and other  
debris at left (upstream  
from headwall). Weir pond  
is completely obscured.  
Station was intact but  
inoperable.

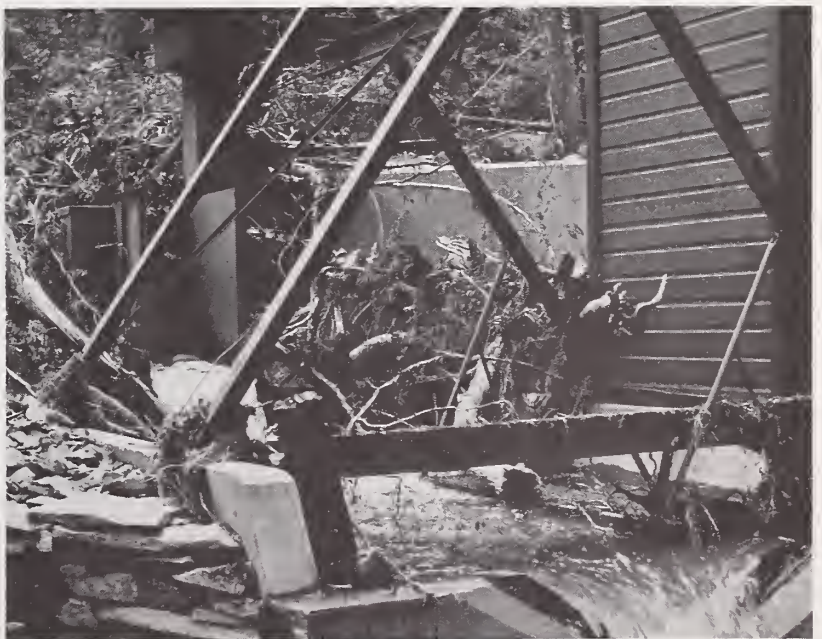
Figure 14.--Watershed 3 gaging →  
station after June 9 flood.  
The station continued in  
operation despite the debris  
pileup. Nearly 400 man-hours  
of labor were required to  
return all three gaging  
stations to temporary  
standby operation.

Watershed 3 (WS3) flume functioned through the entire storm, but flow figures are not reliable after debris started to pile up following the peak, and because some water crossed over from WS2 to WS3 just upstream from the gaging stations. At least up to the peak the WS3 record is judged the best.

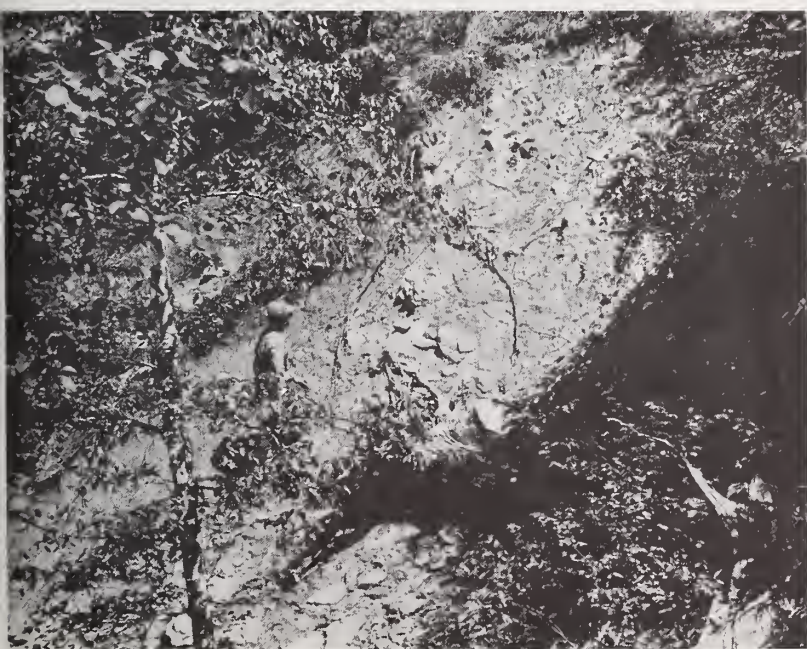
Figure 17.--Flow slide from channel bank in Sturgis WS1. A number of such slides blocked channels until enough water accumulated to overtop and cut through the debris. Debris in foreground is on near side of channel, which extends from right to left where man is standing.

Reasons for the two recorded peaks at WS1 are not clearly apparent. It may be that landslides (several occurred in WS1 and WS2, fig. 17) temporarily blocked flow. The debris dams then washed out, probably releasing enough surge of water to cause another peak at the gaging station. Several such slides may also have been one reason why the hydrograph in WS2 lagged behind both WS1 and WS3, particularly if the slides occurred at about the same time. Response times were opposite what might have been expected considering the fact that, in calculating design discharges, the concentration times were 12.6, 9.0, and 16.2 minutes for WS1, WS2, and WS3, respectively.

to have occurred as the result of liquefaction of the toe of a slope by water flowing more than channel deep. Most of the slides were of the flow type (versus the rotary type). None we have seen within the watersheds were large, but there were enough of them to no doubt contribute a substantial portion of the bedload that choked the gaging stations and deposited in water supply reservoirs downstream. Several larger flow slides occurred on talus slopes along the main access road, which appear to have started as moisture accumulated to low tension along a road cut. Debris flow appears to have started at the cut face and progressed upslope—to near the ridge crest in several cases. Several such slides blocked the main access road.
