# Assessing the Ability of Ground-Penetrating Radar to Detect Fungal Decay in Douglas-Fir Beams

This paper describes the testing plan and current progress for assessing the efficacy of using ground-penetrating radar (GPR) to detect fungal decay within Douglas-fir beams. Initially, the beams were assessed using a variety of physical, mechanical, and nondestructive evaluation (NDE) test methods including micro-resistance drilling, Janka hardness, ultrasonic transmission, and GPR. After initial baseline assessment, beams were inoculated with brown rot fungus, *Fomitopsis pinicola*, and exposed to above-ground conditions approximately 25 miles (40 km) north of Gulfport, Mississippi, USA. Beam specimens will be removed from the exposure site at six-month intervals and scanned using GPR to detect and assess interior rot. After GPR scanning, micro-resistance drilling and ultrasonic transmission testing will be performed. Finally, the beams will be cut into 2-in. segments for Janka hardness testing, which will give the most definitive information regarding the spread of the brown rot fungus throughout the beams. The GPR scans will be compared to the hardness testing, micro-resistance dril

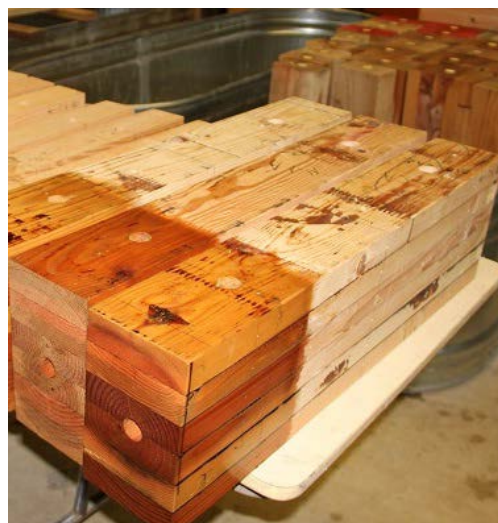
**Figure 2. Fungal cavity holes in specimens. a) Locations of the drilled holes. Units shown are inches. b) Image of the holes drilled in a six-laminate glulam.**

Holes were drilled into each specimen to serve as fungal growth cavities as shown in Figure 2a. The holes were nominally 1 in. (25 mm) in diameter and 3 in. (76 mm) in depth. The holes were located on the ends and top of each specimen. The hole on the end was centered at mid-height and mid-width of the specimen cross section and drilled parallel to the longitudinal axis. The holes on top were centered mid-width and drilled through the depth of the specimen. Figure 2b shows holes drilled into six-laminate glulam specimens.

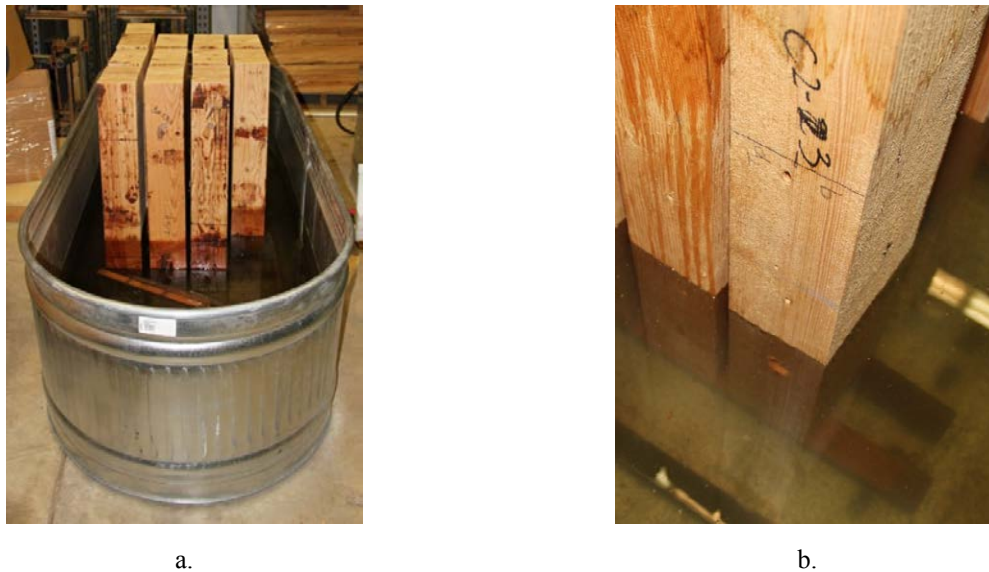
**Figure 4. Pre-soaking specimen prior to inoculation. a) Specimen placement in the soaking tanks. b) Water level at least 2 in. (51 mm) above drilled holes.**

After initial data collection, one end of each specimen was placed in a water tank for a period of 14 days. The water was sufficiently deep to cover the holes drilled near the ends of the specimens by no less than 2 in. (51 mm), as shown in Figure 4. At the end of that period, specimens were removed and a mixture of wet sawdust and *Fomitopsis pinicola*, a brown rot fungus capable of attacking Douglas-fir, was placed in each hole that had been below water level, as shown in Figure 5. The soaking supplied water to the wood that the brown rot would use to establish itself and promote fungal growth. The holes were then sealed with cork stoppers, and the specimens were placed back into the soaking tanks with the opposite end below water level. After a period of 14 days, the process was repeated with the holes on the opposite end of the specimen.

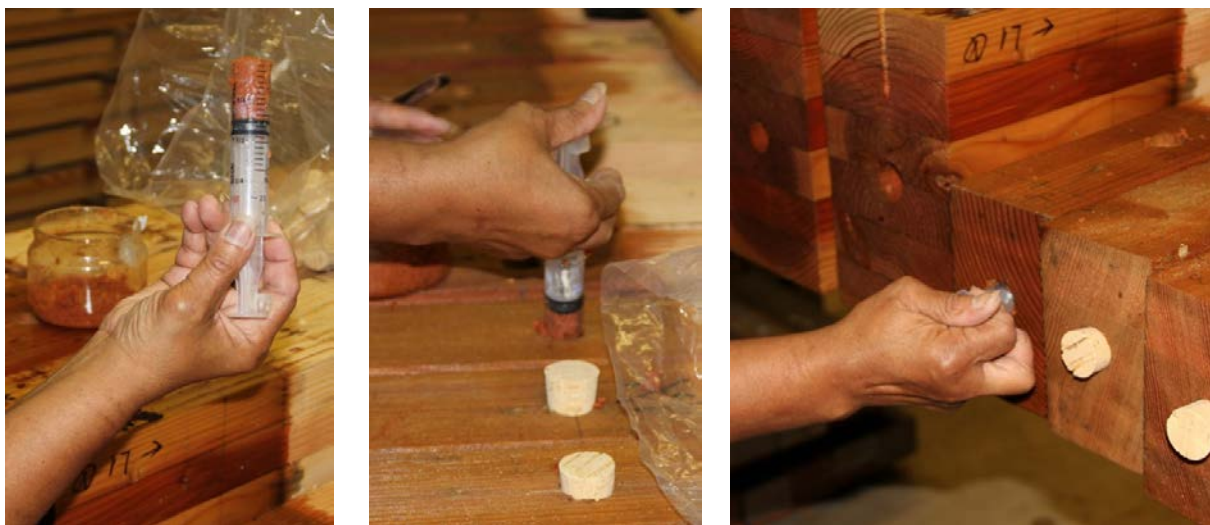
**Figure 5. Inoculating specimens with *Fomitopsis pinicola*, brown rot.**

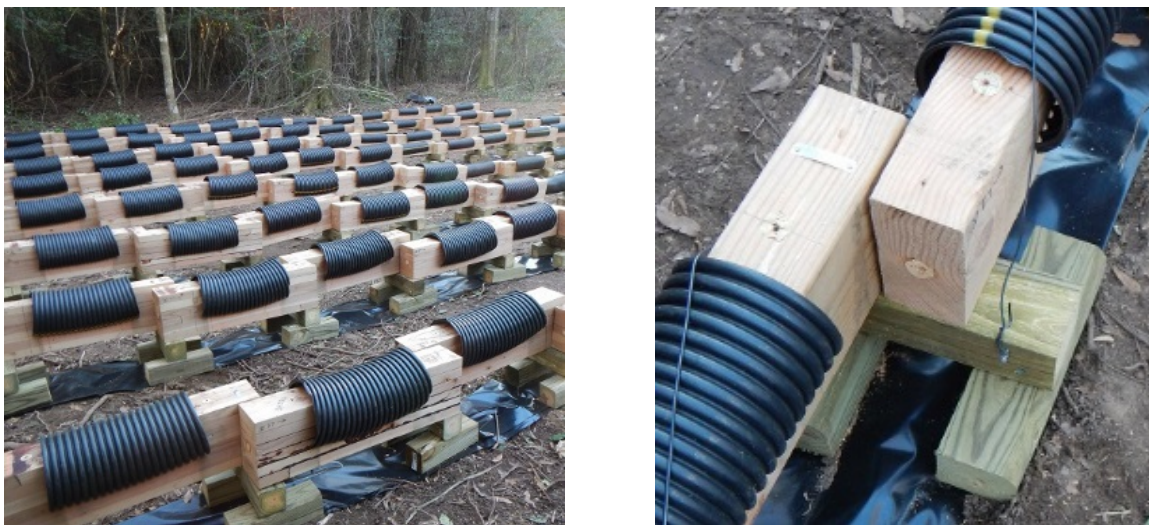
**Figure 6. Specimens as positioned on site.**

The covers were approximately 18 in. (457 mm) long to protect the area of the beam between the two inoculated holes. The specimens were placed outside on January 12, 2016, as shown in Figure 6. The covers will minimize rain contact with the middle portion of the beam and lower the possibility that surface decay will develop in that region. Small holes approximately 0.25 in. (6 mm) in diameter were drilled through each cork to allow moisture to enter the fungal cavities.
