## Information and tools to conserve and restore Great Basin ecosystems

### Assessing Impacts of Fire and Post-fire Mitigation on Runoff and Erosion from Rangelands

#### Fire Impacts on Infiltration, Runoff Generation, and Erosion

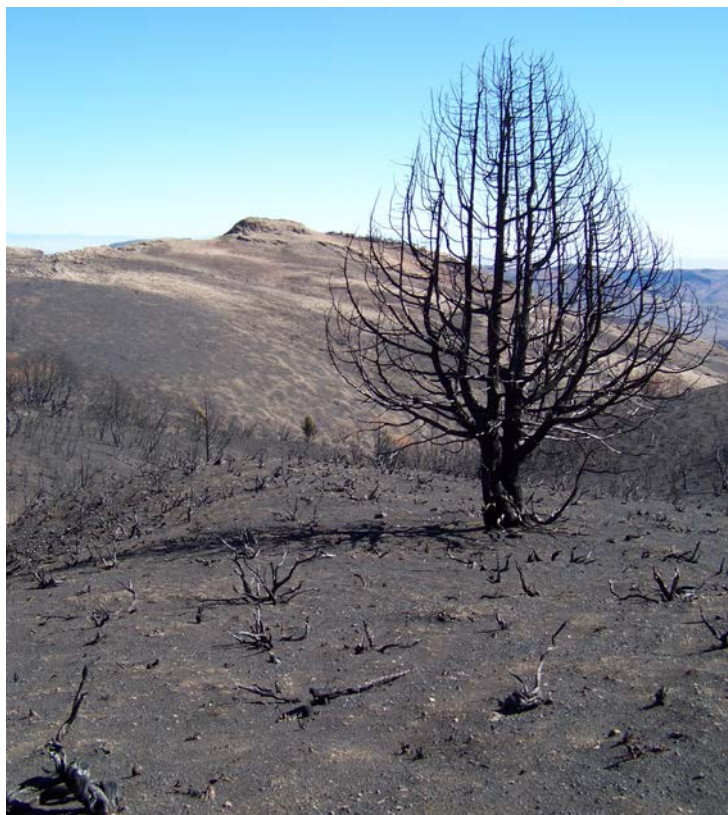
Sagebrush rangeland burned by the Soda Fire (2015) within the Reynolds Creek Experimental Watershed, southwestern Idaho. The photo shows extensive bare ground associated with high rates of surface runoff and formation of high velocity concentrated flows.

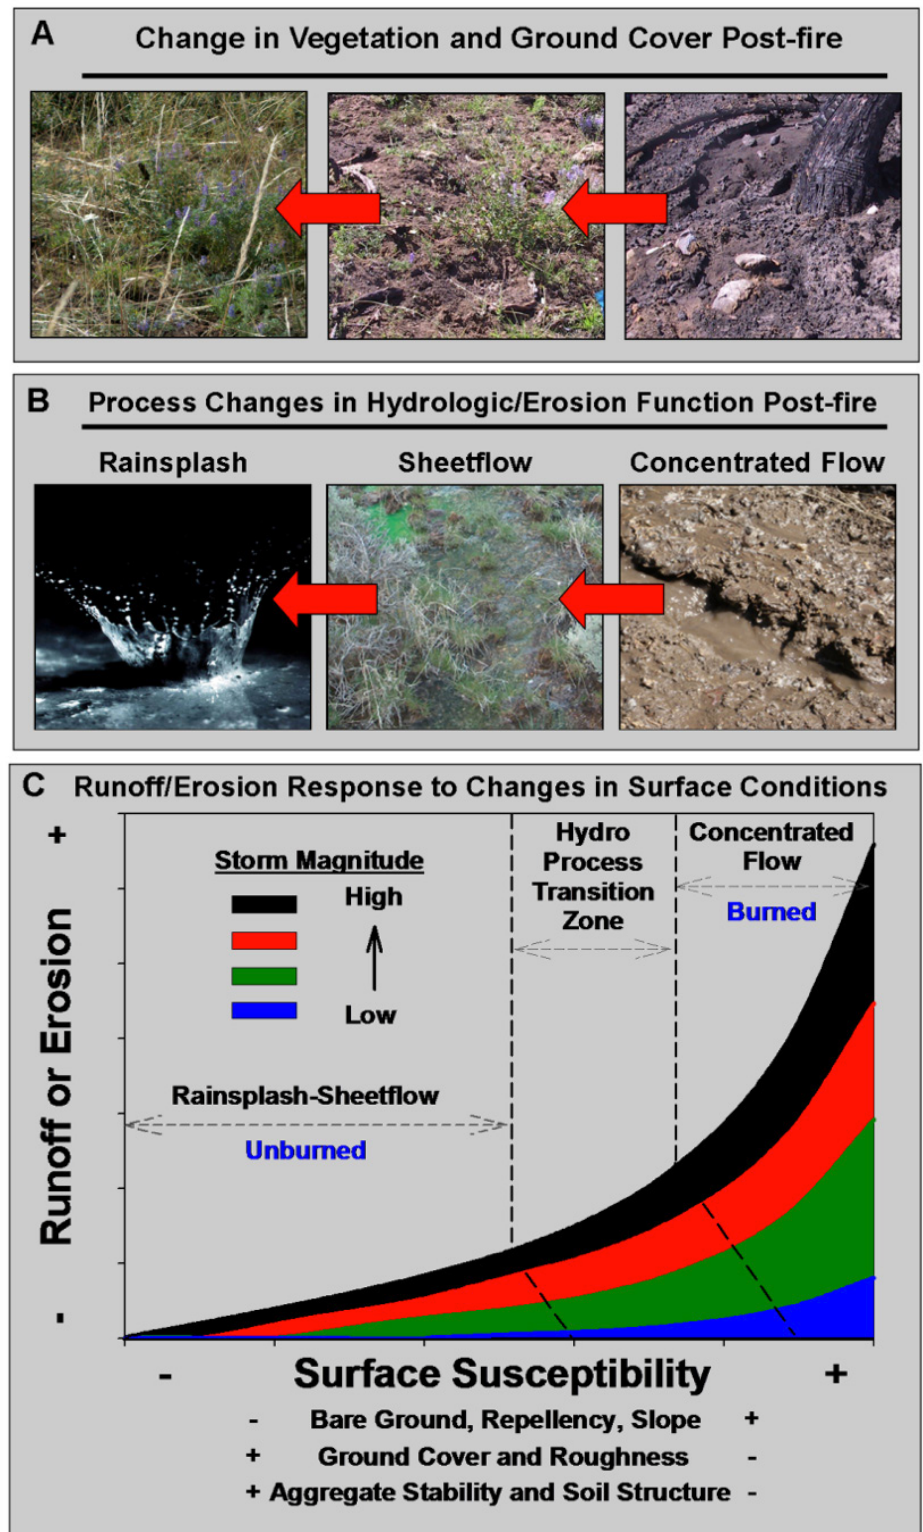
Figure 1. A) Change (recovery) in vegetation and ground surface conditions following burning; B) the shift in hydrologic processes from concentrated flow-dominated to rainsplash-dominated; and C) the decline in runoff or erosion response and shift in dominant erosion processes with decreasing surface susceptibility. Bare water repellent soil conditions in the immediate post-fire period facilitate runoff generation and promote formation of high-velocity concentrated flow. The decline in runoff or erosion response with time post-fire is strongly related to changes in ground surface conditions that trap and store water and sediment and inhibit concentrated flow. Modified from Williams et al. (2014a, b) and Miller et al. (2013).

Fire primarily alters hydrology and erosion processes by consumption of the protective ground cover and organic matter. The exposed bare soil becomes susceptible to increased runoff generation and sediment detachment and transport (Figure 1). The first order effect is increased water availability for runoff generation. Fire-removal of plants and litter reduces rainfall interception and surface water storage, promotes rapid runoff, and decreases ground surface protection against raindrop impact and soil detachment by overland flow. Fire effects on infiltration and runoff generation are increased where soil water repellency persists post-fire or is enhanced by burning. Soil water repellency is commonly found within the first few inches of soil underneath unburned sagebrush, and pinyon and juniper litter on rangelands and its strength may increase or decrease with burning (Pierson et al. 2008, 2009, 2013).

Increased post-fire runoff generally facilitates formation of highly erosive concentrated flow and increased soil erosion on hillslopes. Homogenous bare soil conditions (bare ground >50 to 60 percent) in the immediate post-fire period allow overland flow to concentrate into high velocity flows with greater erosive energy and transport capacity than processes occurring at the point scale (Figure 1). Concentrated flow moves soil detached by rainsplash and sheetflow downslope while also eroding sediment from within the flow path. Concentrated flow is the dominant water-based erosion process in the first one or two years post-fire and is accentuated by steep, bare hillslopes coming together. Accumulation of water and sediment on hillslopes can result in resource-, property-, and life-threatening erosion events. For example, a nine minute convective rainstorm on burned rangeland hillslopes along the Boise Front Range, Idaho, generated flooding and mud-flows in the City of Boise. The flooding was driven by intense rainfall and formation of concentrated flow on bare, strongly water repellent soils with reduced water storage capacity and low surface roughness. Similar hydrologic and erosion responses to convective storms have been reported for burned cheatgrass sites and woodlands in Utah and Colorado. The likelihood or risk of such large-scale flooding events is related to the spatial connectivity of susceptible surface conditions and the occurrence of runoff generating rainfall. Great Basin plant community conversions to invasive annual grass (e.g., cheatgrass and red brome) and climate trends that promote wildfire activity increase the likelihood that rangelands will be exposed to runoff and erosion generating storms and thereby likely enhance long-term soil loss associated with frequent re-burning.
