# Field Testing and Structural Analysis of Burr Arch Covered Bridges in Pennsylvania

**ABSTRACT:** The Federal Highway Administration sponsored a comprehensive research program on Historic Covered Timber Bridges in the USA. This national program's main purpose is to develop improved methods to preserve, rehabilitate, and restore timber bridge trusses that were developed during the early 1800s and, in many cases, are still in service today. One of the many ongoing research studies is aimed at establishing a procedure for safely and reliably load-rating historic covered bridges through physical testing and improved structural modelling. This paper focuses on recent field work and analysis of four Burr Arch through-truss-type covered bridges located in Lancaster County, Pennsylvania. An overview of field evaluation methods, loading testing, and structural modelling procedures are included along with a comparison of field measurements and structural model prediction of bridge behaviour.

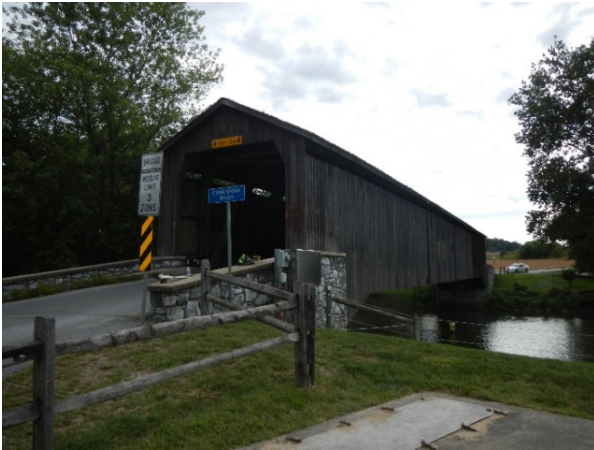
**Figure 3:** Profile view of Hunsecker Bridge

The Hunsecker Bridge is located on Hunsecker Road and allows residential vehicular traffic to cross the Conestoga River (Figures 3, 4, and 5). The original bridge was built in 1843 but was swept away by Hurricane Agnes. In 1973, a replicate design to the original bridge was rebuilt at the same location.

The bridge is a single-lane, single span, simply supported Burr Arch. The total height from the bottom of the bottom chord to the top of the top chord for the truss was measured as 5.22 m and center to center spacing of the truss was 4.61 m. Unlike all the other arches studied, the arch consist of “twin” stacked arches on either of the built up post. At every other post the arches were butt spliced using metal and wood side plates with bolts while at the middle post the arch also bolted. The truss consisted of rectangular parallel chord members connected top and

bottom with a single diagonal and built up spaced post, except the middle panel section consisted of cross diagonal members. In total, 17 truss panels exist. The top and bottom chords consist of two parallel rectangular beams member connected with a wood block side plate and bolts. Most connection between members used conventional bolts. The total length of the structure is 54.9 m and is currently posted for a load limit 2.72 t (3 ton).

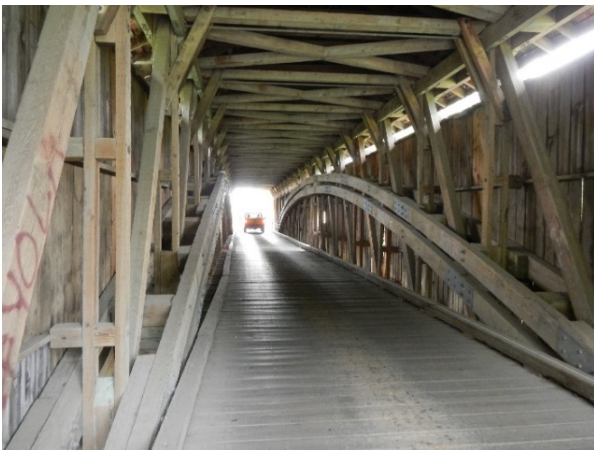
**Figure 4:** Interior view of Hunsecker Bridge

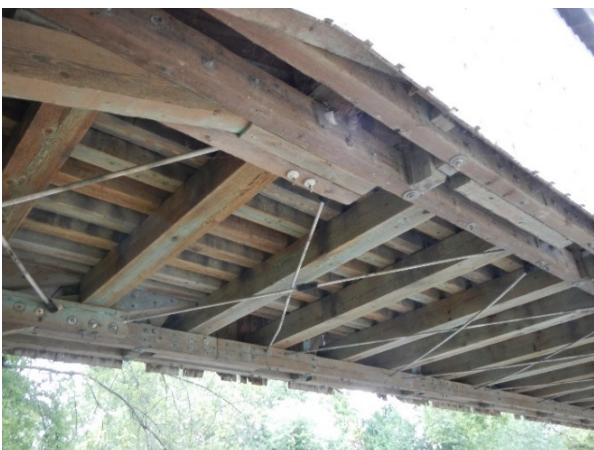
**Figure 5:** Floor System of Hunsecker Bridge

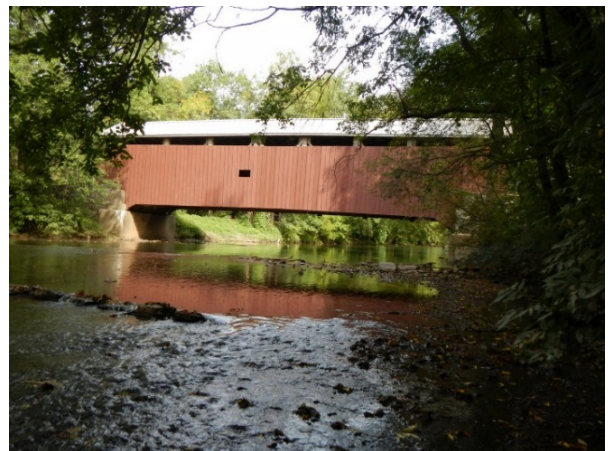
**Figure 6:** Profile view of Zooks Mill Bridge

The Zooks Mill Bridge is located near the intersection of Log Cabin and Rose Hill Roads and allows vehicular traffic to cross Cocalico Creek (Figures 6, 7, and 8). The original bridge was built in 1848, and unlike other bridges in the area, it survived the effect of Hurricane Agnes despite being awash in water.

The bridge has a single span, wooden, double Burr arch bridge with six additional steel rod hangers that connected the truss to the arch in the 2nd, 4th, and 6th panels. The total height from the bottom of the bottom chord to the top of the top chord for the truss was measured as 4.92 m, and center to center spacing of the truss was 4.61 m. The truss consisted of rectangular parallel chord members connected top and bottom with a single diagonal and chord, except middle panel section consisted of cross diagonal members. The top chord consisted of a single member connected at three locations using single lap joints. The bottom chords consisted of two parallel rectangular beams. When a lap joint was used on one of the single members, the bolts went through the entire chord width. Butt jointed connection that bolted through the vertical and sister arch were used to fabricate the double arch. The total length of the structure is 25.5 m, and it is currently posted for a 2.72 t load limit.

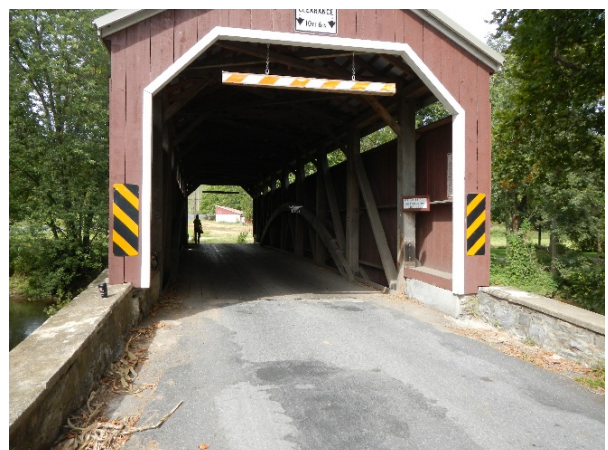
**Figure 7:** Interior view of Zooks Mill Bridge

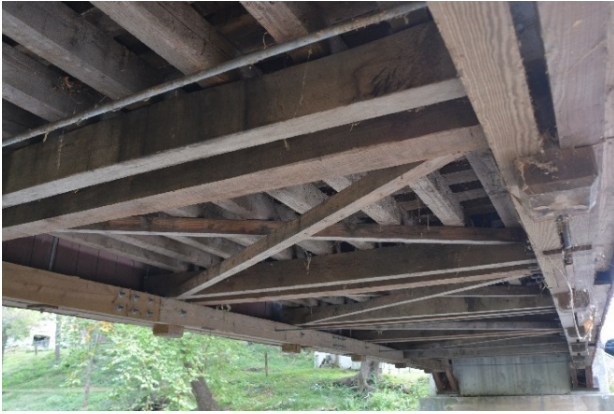
**Figure 8:** Floor System of Zooks Mill Bridge

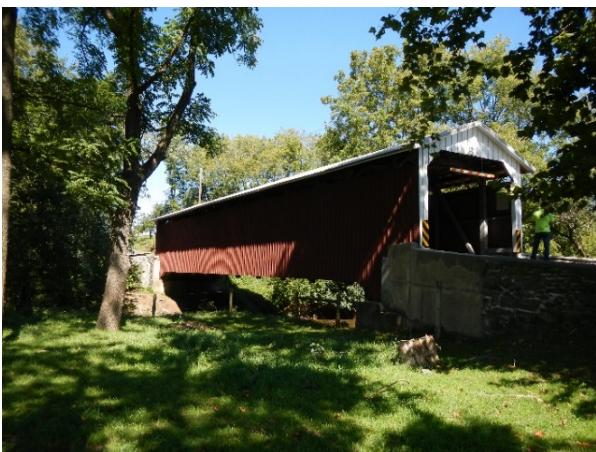
**Figure 9:** Profile view of Eshleman Bridge

The Eshleman's Bridge, also known as Leaman's Place, is located on Belmont Road, north of U.S. Route 30, and allows significant vehicular traffic to cross Pequea Creek as (Figures 9, 10, and 11). The original bridge was built in 1845 and rebuilt in 1983.

The bridge has a single span, wooden, double Burr arch trusses design with additional steel hanger rods that connect arch to the bottom chord and the top chord to the bottom chord in all 11 truss panels. The total height from the bottom of the bottom chord to the top of the top chord for the truss was measured as 4.94 m and center to center spacing of the truss was 5.11 m. The truss consisted of rectangular parallel chord members connected top and bottom with a single diagonal and post, except middle panel section consisted of cross diagonal members. The top chord consisted of single member connected at five locations using single lap joints. The bottom chords consisted of two parallel rectangular beams attached to the post with a double notch. A third rectangular beam sistered to the other beams with through bolts. When a chord was spliced, an oblique tabled scarf joint with key was used and the bolts went through the entire chord width. Arch sections were butt together at on one side of the post, while the arch on the other side was bolted to the post. The total length of the structure is 37.5 m and is currently posted for a 2.72-t load limit.

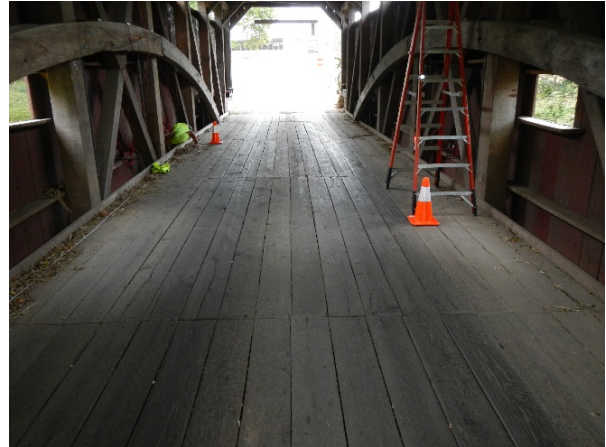
**Figure 10:** Interior view of Eshleman Bridge

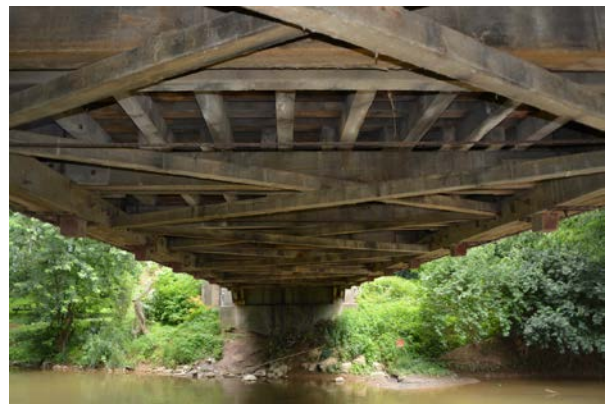
**Figure 11:** Floor System of Eshleman Bridge

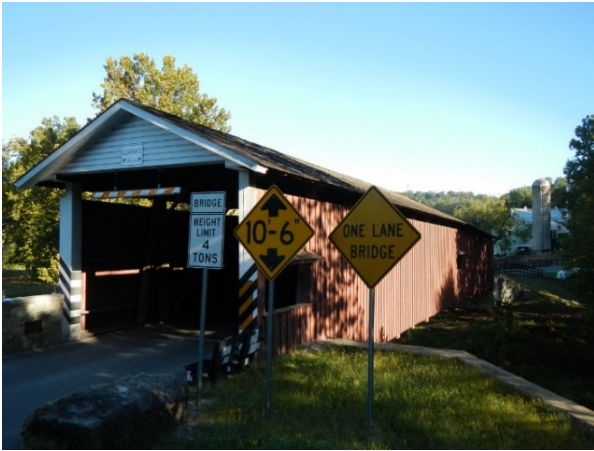
**Figure 12:** Profile view of Jackson Sawmill Bridge

The Jackson Sawmill Bridge is at the intersection of Mount Pleasant and Hollow Roads and allows vehicular traffic to cross West Branch of the Octoraro Creek (Figures 12, 13, and 14). The original bridge was built in 1878, but in 1985 it was destroyed by flooding and subsequently rebuilt and removed from the National Register of Historical Places. The most recent rehabilitation occurred in 2005.

The bridge has a single span, wooden, double Burr arch design with the addition of steel hanger rods connecting the arch to the bottom chord in the middle of 10 panels and near the post in the remaining 6 panels. The total height from the bottom of the bottom chord to the top of the top chord for the truss was measured as 4.75 m and center to center spacing of the truss was 4.76 m. The truss consists of rectangular parallel chord members connected top and bottom with a single diagonal and post. The top chord consists of single member connected at five locations using scarf lap joints with two bolts. The bottom chords consist of two parallel rectangular beams attached to the post with a double notch and spliced with wood fish plate. On the either side of these chords, additional rectangular beams were sistered with through bolts. These sistered beams were spliced with an oblique tabled scarf joint. Arch sections were butted together with a

metal plate at every other post and attached middle post with a single through bolt. The total length of the structure is 43.6 m and is currently posted for a 3.63-t load limit.

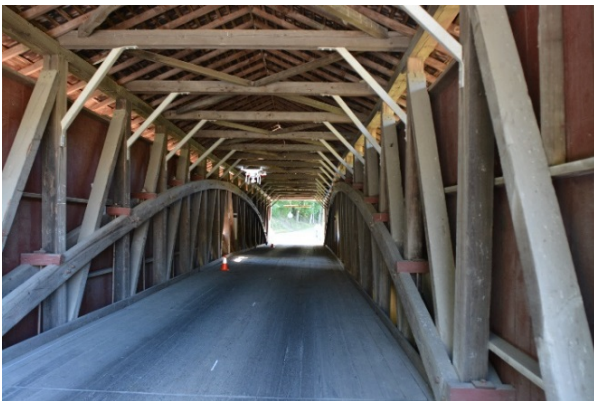
**Figure 13:** Interior view of Jackson Sawmill Bridge

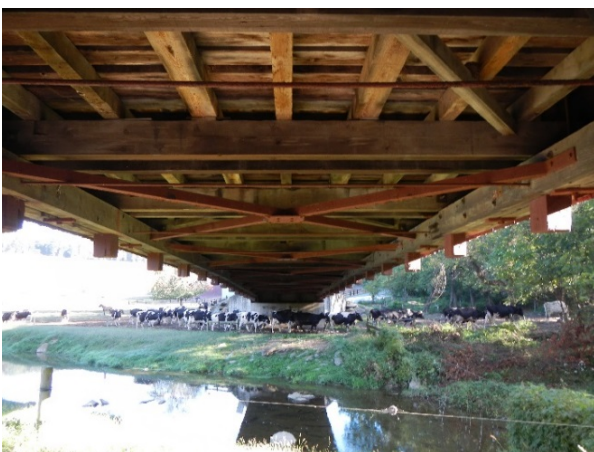
**Figure 14:** Floor System of Jackson Sawmill Bridge

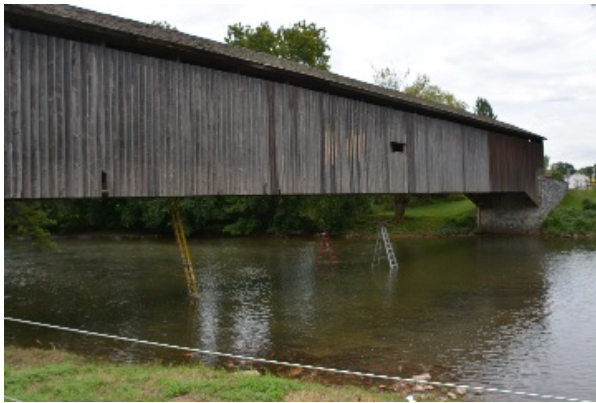
**Figure 15:** Global displacement measurements with transducers supported by aluminium ladders for Hunsecker Covered Bridge.

Field testing of the covered bridges involved installing displacement and strain transducers on the structures at various cross sections and loading the structure with a vehicle of known weight. Global displacements of the structure, specifically the trusses, were measured at different locations along the bridge length relative to the bottom chords of truss. These displacements were recorded with ratiometric displacement transducers mounted on tripods connected to the bridge via aircraft grade steel cable extensions or aluminium step ladders and recorded with an Optim Megadac data acquisition system (DAS) along with a Dell laptop computer running software. Figure 15 shows the setup for the measurement of global deflection of the Hunsecker Bridge. For this bridge, deformations were measured at midspan and quarter points. Member strains were recorded at various locations on one truss using Bridge Diagnostics, Inc. (BDI) DAS and BDI strain transducers [10]. The strain transducers were attached to the timber members with hex-head screws and washers. Due to the limited number of gages available, time constraints, and symmetry, a majority of the gages were also placed on mostly on one side of the bridges. Unlike previous studies, a limited number of gages were placed on the opposite side of the bridge to assess the distribution of load to each bridge side, and some gages were placed on the transverse stringers to investigate how the plank deck distributed the load. In Figure 16, the outside strain transducers are attached to the top of the double arches and the middle strain transducer is attached to the diagonal member of the truss.

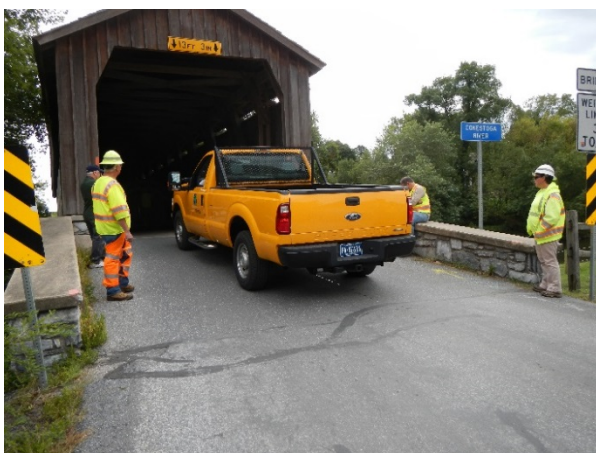
**Figure 17:** Pennsylvania Dept. of Transportation light truck loading of Hunsecker Bridge

The load vehicle was driven slowly across the bridge in the middle of the roadway and with a wheel line as close to the arch and truss with the greatest density of instrumentation (Figure 17). Data were recorded continuously as the vehicle crossed the bridge. The location of the load vehicle is recorded into the data acquisition systems every 3.05 m along the bridge deck beginning from the abutment the vehicle first crosses.

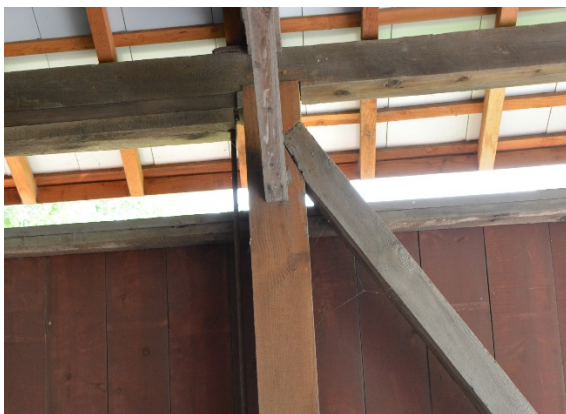
**Figure 20:** Simple angled bearing joints connection the diagonals t the vertical post for Eshlemann Bridge.

Figure 19 shows the strains developed in the diagonal member's one truss panel south of the mid span and highlights the complexities of the bridge systems. While one would believe little or no tensile strain should be transferred through this member due to the end connections being simple angled bearing joint (Figure 20), significant tensile strain is developed. With the model, both compression and tensile behaviour will need to be addressed.
