# Live-Load Performance Evaluation of Historic Covered Timber Bridges in the United States

**Abstract:** The National Historic Covered Bridge Preservation Program (NHCBP), sponsored by the Federal Highway Administration (FHWA), was established to preserve the covered timber bridge structures that were constructed in the early 1800s. Today, many of the approximately 880 covered timber bridges still in existence in the United States are closed to vehicular traffic; furthermore, a large percentage of the remaining bridges open to traffic are restricted by load postings. Unfortunately, there are no current load-rating standards for covered timber bridges, so engineers do not have many resources at their disposal to reliably understand the behavior of these complex structures. As a result, the estimated load postings and/or ratings are often too conservative. To better understand the live-load performance of covered timber bridges and to develop improved criteria for their load ratings, a series of live-load tests were performed on 11 single-span, historic covered timber bridges. This paper explains the field testing conducted on all of the bridges, and makes recommendations for the co

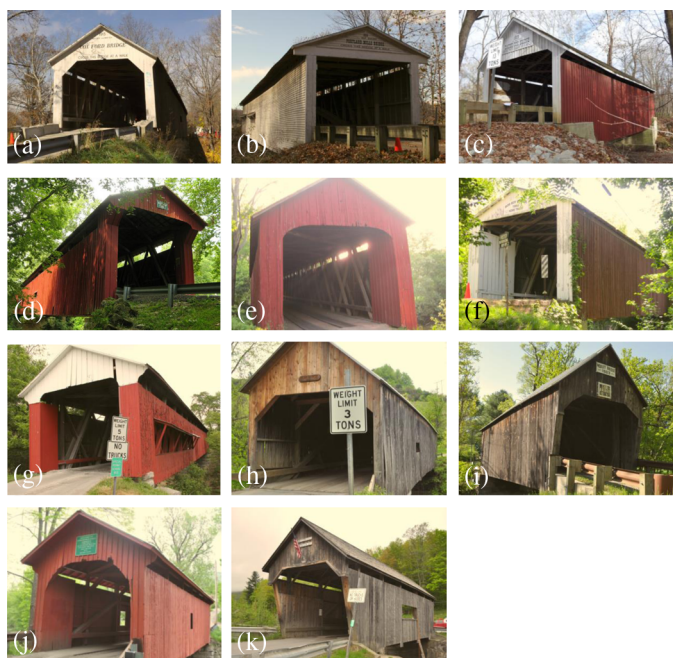
**Fig. 2.** Representative photographs for each of the historic covered bridges: (a) Cox Ford; (b) Portland Mills; (c) Zacke Cox; (d) Dick Huffman; (e) James; (f) Rob Roy; (g) Scipio; (h) Flint; (i) Moxley; (j) Slaughterhouse; (k) Warren (images by Travis K. Hosteng)

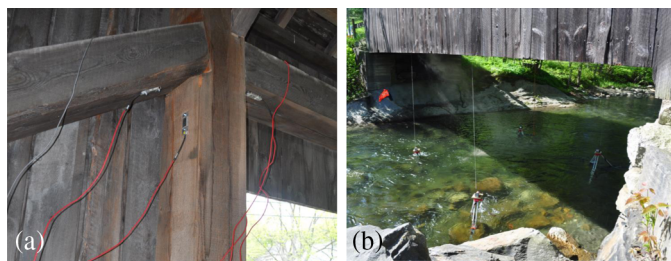
**Fig. 4.** Representative live-load-response measurement instrumentation setup: (a) member strains; (b) global deflections (images by Travis K. Hosteng)
