# LATERAL TESTING OF GLUED LAMINATED TIMBER TUDOR ARCH

Douglas R. Rammer<sup>1</sup>, Philip Line<sup>2</sup>

**ABSTRACT:** Glued laminated timber Tudor arches have been in wide use in the United States since the 1930s, but detailed knowledge related to seismic design in modern U.S. building codes is lacking. FEMA P-695 (P-695) is a methodology to determine seismic performance factors for a seismic force resisting system. A limited P-695 study for glued laminated timber arch structures highlighted the lack of lateral load testing; therefore, critical modelling information was not available and assumptions based on available research were used. In this study, full-scale lateral load testing of the glued laminated timber arch is used to fill in gaps in test-based information and assess the following characteristics: damping, deformation behaviour, and failure modes.

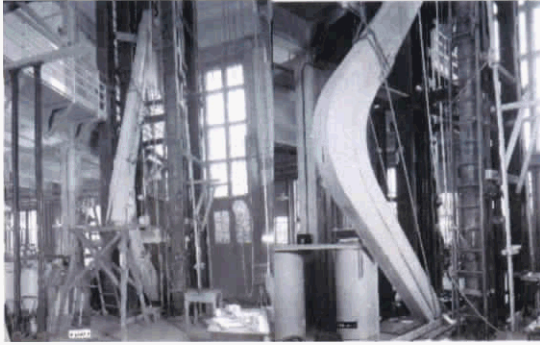
**Figure 1:** Arch in testing frame

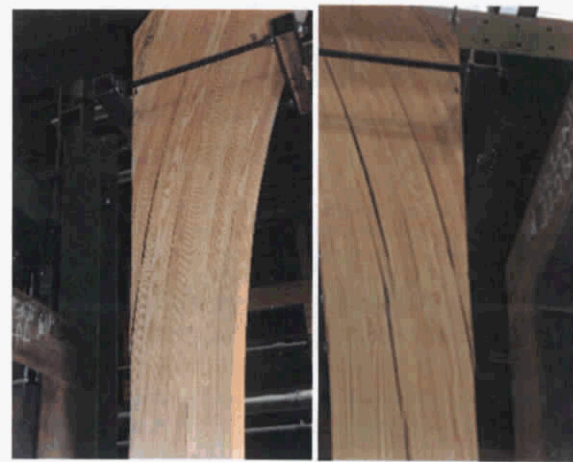
Arch 1 failed in the curve portion due to radial stress and a split emanating from the peak connection in the west arch (Figure 9). A detailed review of the video showed

that the radial failure occurred first. For the final loading to failure of Arch 1, the lateral load actuators were driven in displacement control due to safety concerns. The actuator control profile was generated using displacements recorded in the loading to 150% design level. For actuator displacements beyond the 150% design load level, the displacement rate of each actuator was set based on the previous 30 s of loading. Unfortunately this loading approach led to the west actuator applying a load 10% greater than the east actuator at the time of failure. The implications of this will be discussed later in the paper. At failure, the total applied load to the arch was 77.0kN, 40.7kN for the west actuator and 36.4kN for the east actuator. Load versus horizontal displacement of the west knee was linear to failure, whereas the load versus east knee displacement was nearly linear until the last inch of applied deformation.

**Figure 9:** Radial tension failure for first tested arch

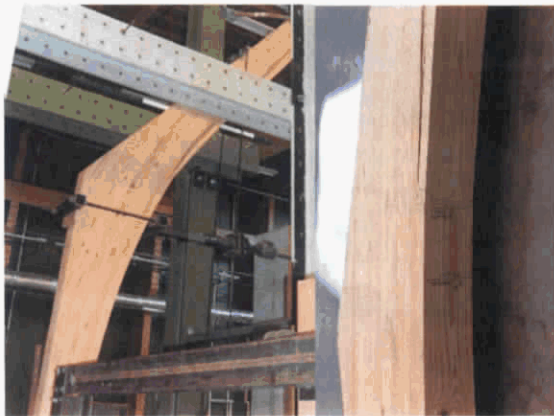
Arch 3 failed below the 150% reference load level in the west arch at a finger joint located approximately 3.85 m above the base and within the radius of the knee (Figure 11). Figure 11 also shows that the failure crack progressed along the arm toward the arch peak. Arch 3 was loaded in force control to maintain the lateral force requirements to failure. The total laterally applied force was 60.9kN, 30.5 kN for the west actuator and 30.4kN for

the east actuator. The plot of each actuator load versus the horizontal displacement of the corresponding knee was nearly linear until to failure. During the 100% of reference loading, the east haunch section began delaminating and 102-mm self-tapping screws were inserted from the top side of the arch to arrest the crack formation.

Figure 11: Failure of west arch at finger joint during third test
