# Investigation of Early Timber–Concrete Composite Bridges in the United States

## Summary

The use of timber–concrete composite (TCC) bridges in the United States dates back to circa 1925. Two different TCC systems were constructed during this early period. The first system included a longitudinal nail-laminated deck composite with a concrete deck top layer. The second system included sawn timber stringers supporting a concrete deck top layer. Records indicate that most of the TCC highway bridges were constructed between 1930 and 1960. The current U.S. National Bridge Inventory (NBI) database indicates that there may be well over 1,000 of this bridge type still in service. This paper will review and discuss the current conditions of several TCC bridges that remain in service today. This will be based on the information given in the NBI and other relevant documents, complemented with information provided by 25 field inspections undertaken during June 2016 in the Pacific Northwest states of Oregon and Washington.

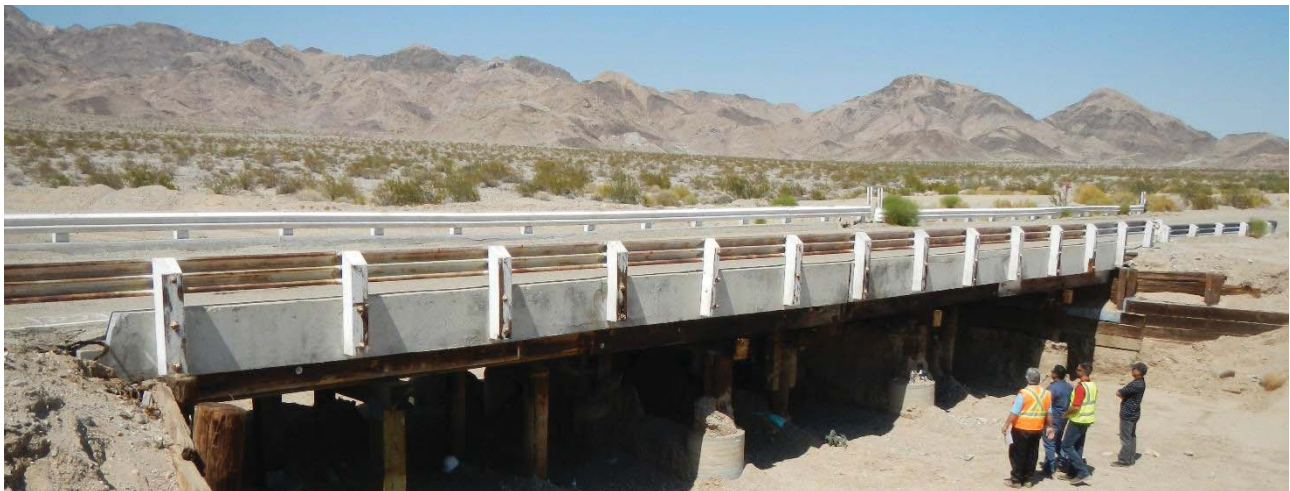
The use of TCC for bridges was motivated by different reasons. Among those, some of the most relevant were connected to the need for rehabilitation and improvement of the existing timber bridges to allow their continuation in service or even to upgrade their load capacity because of new load requirements. The deck could be a new composite or a concrete deck overlaid on top of the existing nail-laminated deck, as was done for a large number of bridges in U.S. Route 66 (Figure 3).

*Fig. 3 TCC bridge along US Route 66 in California*

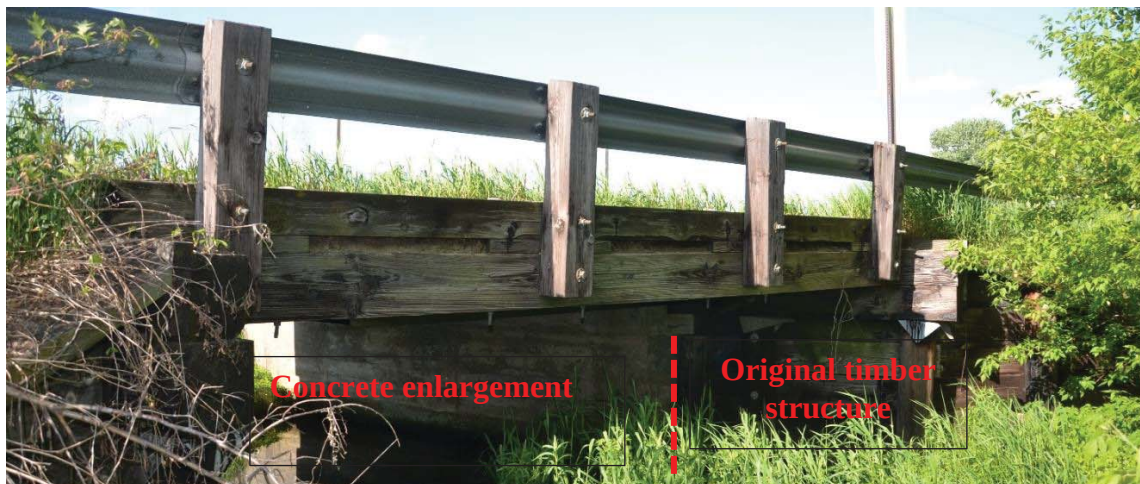
The discussion from this section is based on information provided by NBI from 2016 [21]. The total number of timber bridges still in service and codified as TCC in the United States is 1,644. Some bridges may appear in the database as TCC structures but were originally constructed as narrow timber stringer bridges and were later widened with concrete components to achieve double-lane roadways. These enlarged bridges that combine timber and concrete in a noncomposite manner are sometimes mistaken for true TCC bridges (Figure 4) within the NBI. Additional field bridge studies will help clarify these discrepancies in the future.

*Fig. 4 Timber bridge enlarged with concrete members that has been wrongly codified as a TCC bridge*

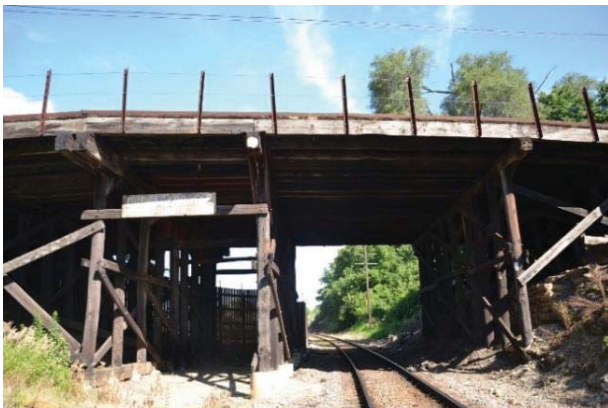
As previously mentioned, the TCC bridges started to be built in the early 20th century, and the information available indicates 1924 as the year of construction for the oldest TCC bridge. In the NBI, there are a few bridges built before the 1920s decade that were codified as TCC, but these were probably mistakenly entered into the NBI as being true TCC structures. One example is located in Rockford, Illinois, and was reportedly constructed in 1901. This bridge was inspected, and it was indeed a timber bridge but had a small concrete deck extension added later and had no signs of the TCC system (Figure 8).

Fig. 8 Bridge in Rockford, Illinois, built in 1901 codified in the NBI as TCC

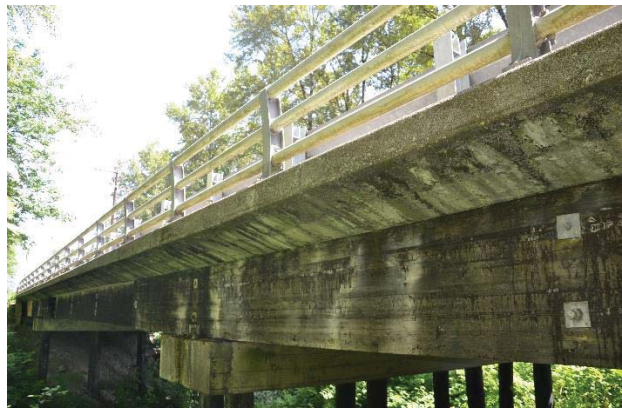
Fig. 9 Modern TCC bridge built in Singbboet Slough, Washington

Although most of the TCC bridges were built between 1930 and 1970, they were still built in more recent decades as well. Modern motivations and bridge characteristics are rather different, but the use of composite systems to improve mechanical performance and durability is still a driving wheel to the adoption of this bridge solution (Figure 9) [15].

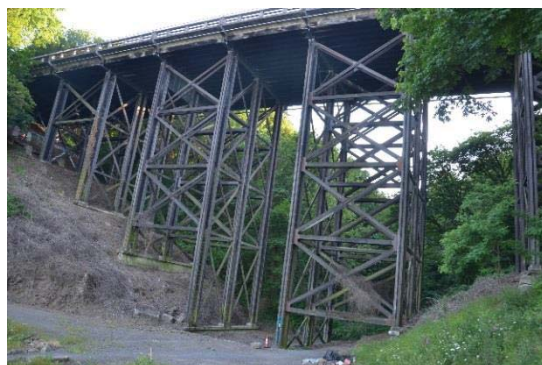
Fig. 13 TCC bridge in a high traffic road, built in 1934 in the city of Portland, Oregon

In spite of this fact, it is important to mention bridges such as the Vermont viaducts in Portland (Figure 13) that carry an average daily traffic of 16,000 vehicles per day, have been in service for 83 years, and

are in good condition without significant intervention. This fact clearly shows that this type of bridge offers a robust and highly durable solution even in highly demanding traffic situations.
