# Assessing Ability of Ground-Penetrating Radar to Detect Internal Moisture and Fungal Decay in Douglas-Fir Beams

# 20th International Nondestructive Testing and Evaluation of Wood Symposium

General Technical Report  
FPL-GTR-249

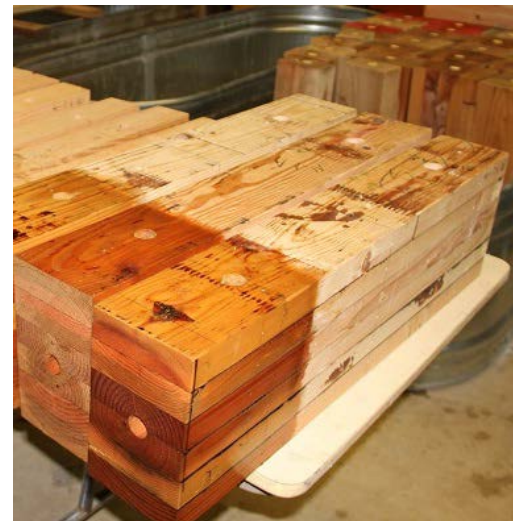
Partial-depth circular holes were drilled into each specimen to serve as fungal growth cavities as shown in Figure 2a. The holes were nominally 1 in. (25 mm) diameter and 3 in. (76 mm) deep. The holes were located on the ends and top of each specimen. The hole on the end was centered at the midheight and midwidth of the specimen cross section and drilled parallel to the longitudinal axis. The holes on top were centered midwidth. Figure 2b shows holes drilled into six-laminate glulam specimens.

**Figure 2.** Fungal cavity holes in specimens: (a) locations of the drilled holes (units shown are inches); (b) holes drilled in a six-laminate glulam.

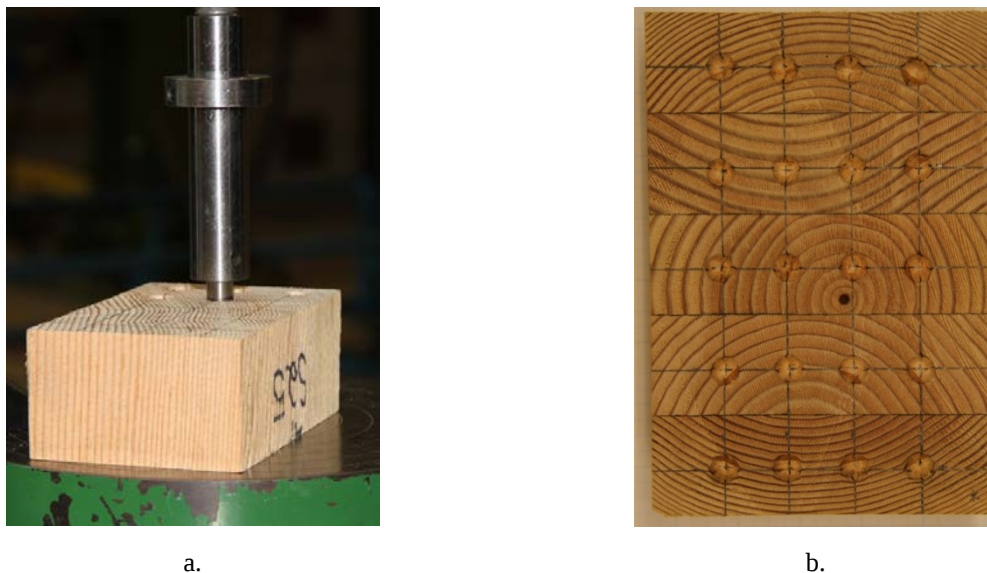
**Figure 3.** Janka hardness testing: (a) sawn timber remnant undergoing Janka hardness test; (b) hardness test impressions across glulam remnant cross section.

Instrument Company (Towaco, New Jersey, USA). Stress wave time was measured using the Fakopp Microsecond Timber from Fakopp Enterprises (Agfalva, Hungary). Microresistance drilling was performed on selected specimens using the PD 400 Resistograph from IML Wood Testing Systems (Moultonborough, New Hampshire, USA). Several GPR scans were taken of each specimen using a SIR 4000 GPR data acquisition system (Geophysical Survey Systems, Inc., Salem, New Hampshire, USA) with a 2.0-GHz palm antenna. The center frequency of the palm antenna was 2.0 GHz, but the frequencies emitted and received ranged between 500 MHz and 4 GHz. During post-collection data analysis, narrower frequency ranges were explored to determine what, if any, frequency range was particularly sensitive to the presence of brown-rot. The data acquisition system and antenna were purchased from Geophysical Survey Systems, Inc. A 2-in.- (51-mm) thick piece was cut from each beam remnant, and Janka hardness tests were performed using an Instron 5587 testing machine (Instron, Norwood, Massachusetts, USA). Measurements were taken across the cross section (parallel to grain) as shown in Figure 3; however, additional measurements were taken on the sides of each specimen (perpendicular to grain). It was assumed that beams were sufficiently consistent that the hardness profile obtained from the Janka tests of the remnant was representative of the hardness profiles of all specimens cut from that beam.

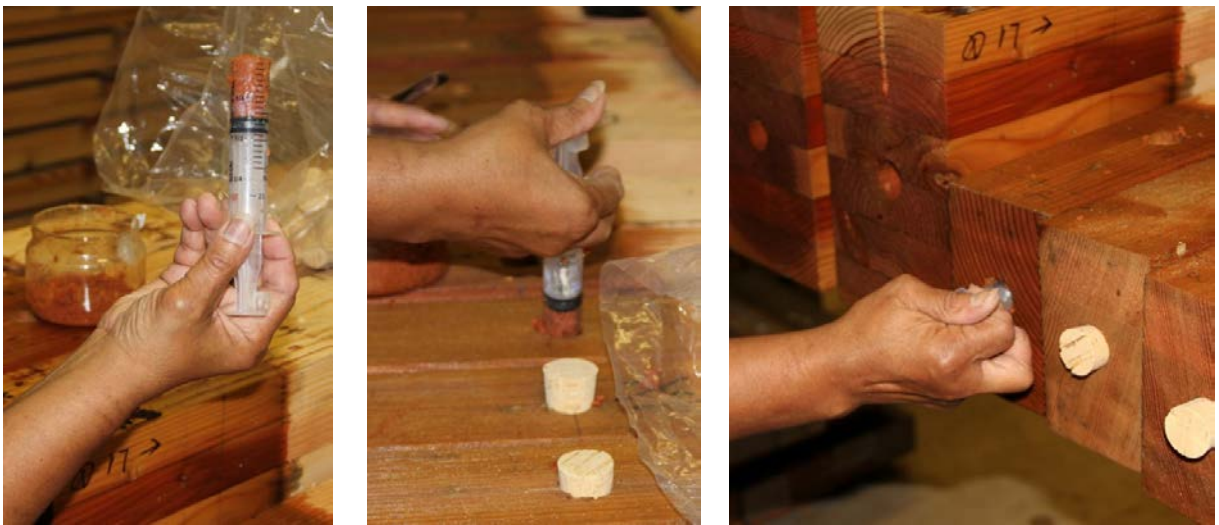
**Figure 4.** Inoculating specimens with *Fomitopsis pinicola*, brown-rot.

After initial data collection, one end of each specimen was placed in a water tank for 14 days. The water was sufficiently deep to cover the holes drilled near the ends of the specimens by no less than 2 in. (51 mm). At the end of the soaking period, the specimens were removed and wet sawdust previously inoculated with *Fomitopsis pinicola*, a brown-rot fungus capable of attacking Douglas-fir, was placed in each hole that had been below water level (Fig. 4). The soaking supplied water to the wood that the brown-rot would have used to establish itself and promote fungal growth. The holes were then sealed with cork stoppers. The specimens were then placed back into the soaking tanks with the opposite end below water level. After 14 days, the process was repeated with the holes on the opposite end of the specimen.

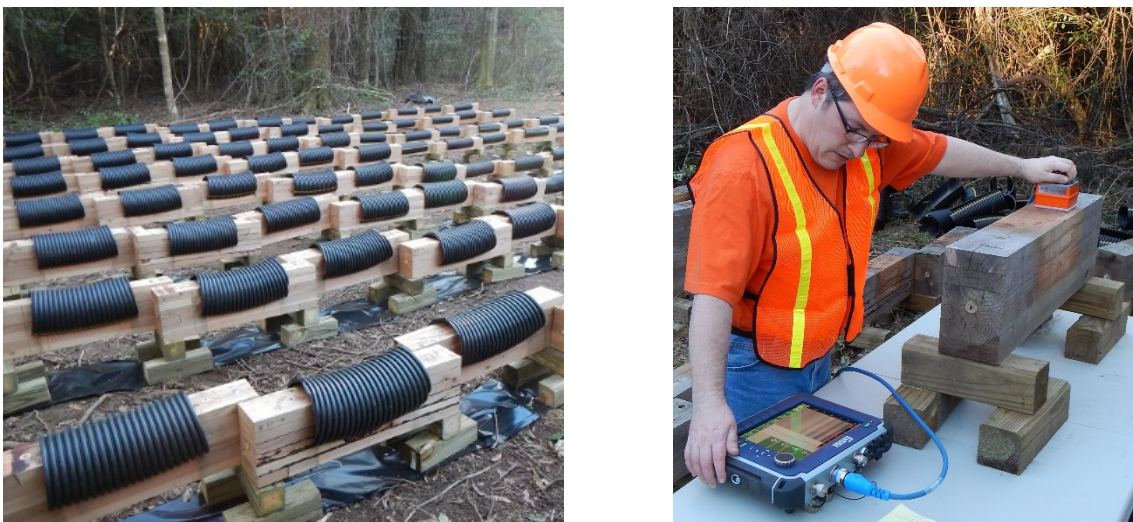
**Figure 5.** Specimens as positioned on site, and GPR scanning of specimens.

other than midday when the sun was directly overhead; otherwise, sun–shade was not a controlled variable. Two layers of ultraviolet resistant, 8 mil black landscaping plastic were placed on the ground to prevent plant growth under the specimens. The specimens were raised off the ground approximately 7 in. (178 mm) using treated wood blocks to prevent external decay caused by ground contact. Once in place, each inoculated specimen was scanned with the GPR unit to provide a baseline against which post-exposure scans were compared. Black plastic covers were then placed over each specimen. The covers were approximately 18 in. (457 mm) long to protect the area of the beam between the two inoculated holes. The covers minimized rain contact with the middle portion of the beam, lowering the possibility that surface decay developed in that region and increasing the likelihood that when decay occurred within the center region, it grew internally from the fungal cavities rather than from the external surface. Small holes approximately 0.25 in. (6 mm) wide were drilled through each cork to allow moisture to enter the fungal cavities. The specimens were installed in the field on January 12th, 2016. Specimen placement as well as specimen scanning using the GPR tool is shown in Figure 5.
