# Chapter 8. Arizona as a Watershed—Then and Now: Case Studies of Changed Management of Rivers and Habitat in the Lower Colorado River System

*William E. Werner*

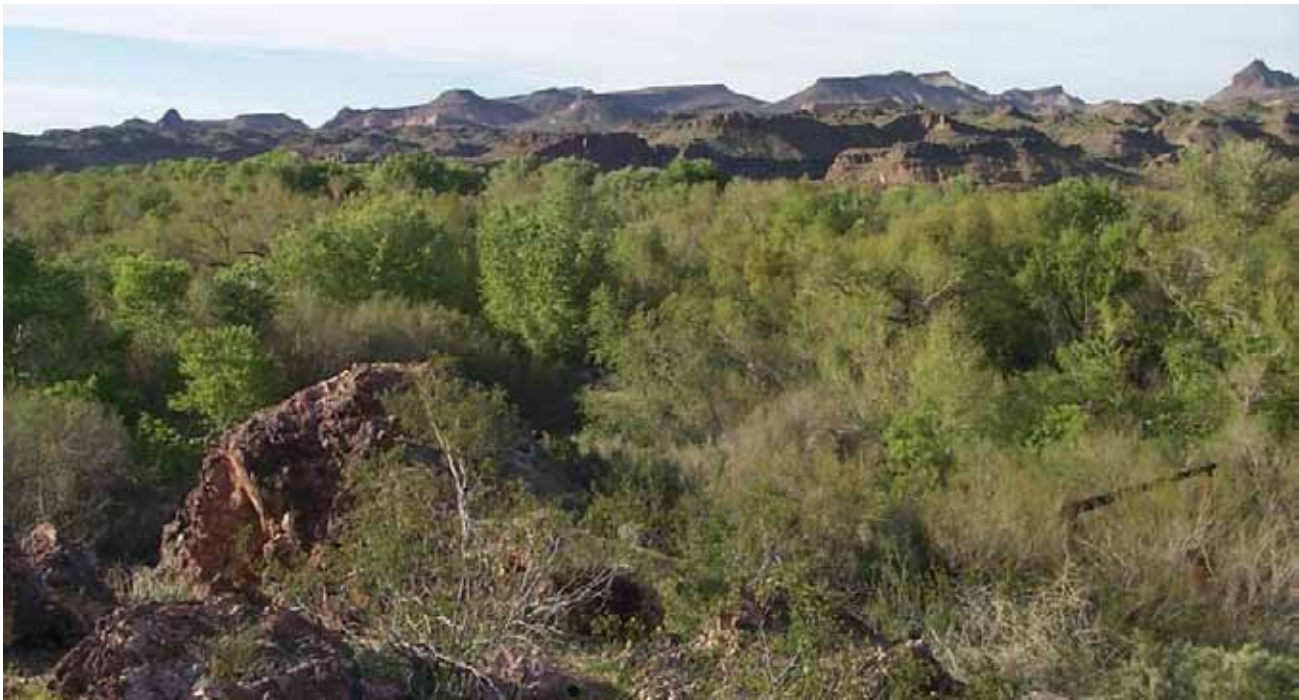
**Figure 24**—Riparian vegetation on Bill Williams River near Narrows on Bill Williams River NWR (photo by W.E. Werner).

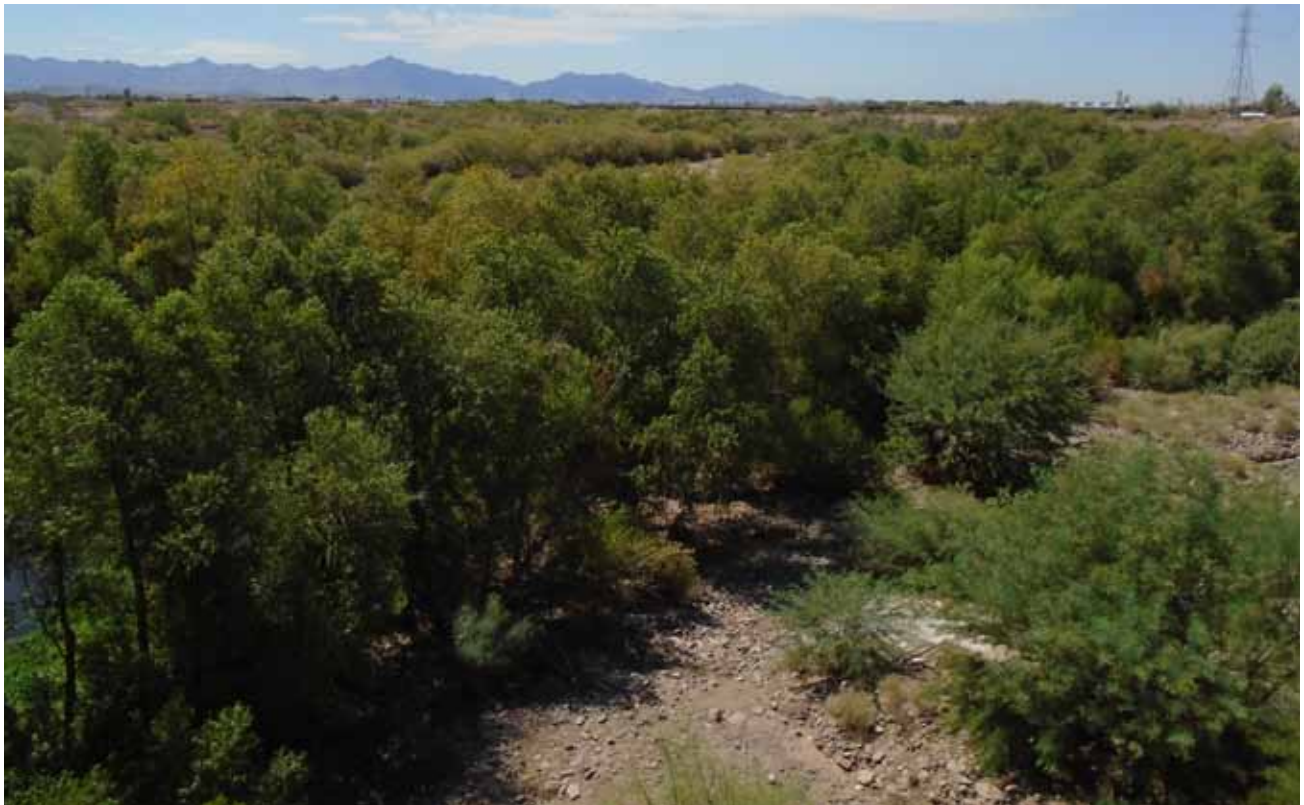
**Figure 25**—Riparian vegetation on Salt River at Central Avenue, Phoenix Arizona (photo by W.E. Werner).

Within the Rio Salado Environmental Restoration Project water to sustain riparian vegetation (fig. 25) is either pumped to higher areas or is drainage water entering the Salt River from the local storm drain system. While storm drain flow isn't predictable it has been consistent and supports habitat in the low-flow channel. Apparently sump pumps pumping high groundwater from the basement levels of some high rise buildings in downtown Phoenix discharge into the storm drain system, providing some of the consistent flow. Efficacy of managing channel size to benefit riparian resources through time will depend on the frequency of flood flows and availability of water to sustain vegetation. An unanticipated high flow through the Rio Salado Environmental Restoration Project occurred in July 2010 when one of the bladders of the inflatable dam at the downstream end of Tempe Town Lake failed, releasing a flood down the Salt River. The low-flow channel through the Rio Salado reach appeared to perform as intended based on high-water marks and flood deposits.
