# Chapter 9. Evaluating Riparian Vegetation Change in Canyon-Bound Reaches of the Colorado River Using Spatially Extensive Matched Photo Sets

*Michael L. Scott, Robert H. Webb, R. Roy Johnson, Raymond M. Turner, Jonathan M. Friedman, and Helen C. Fairley*

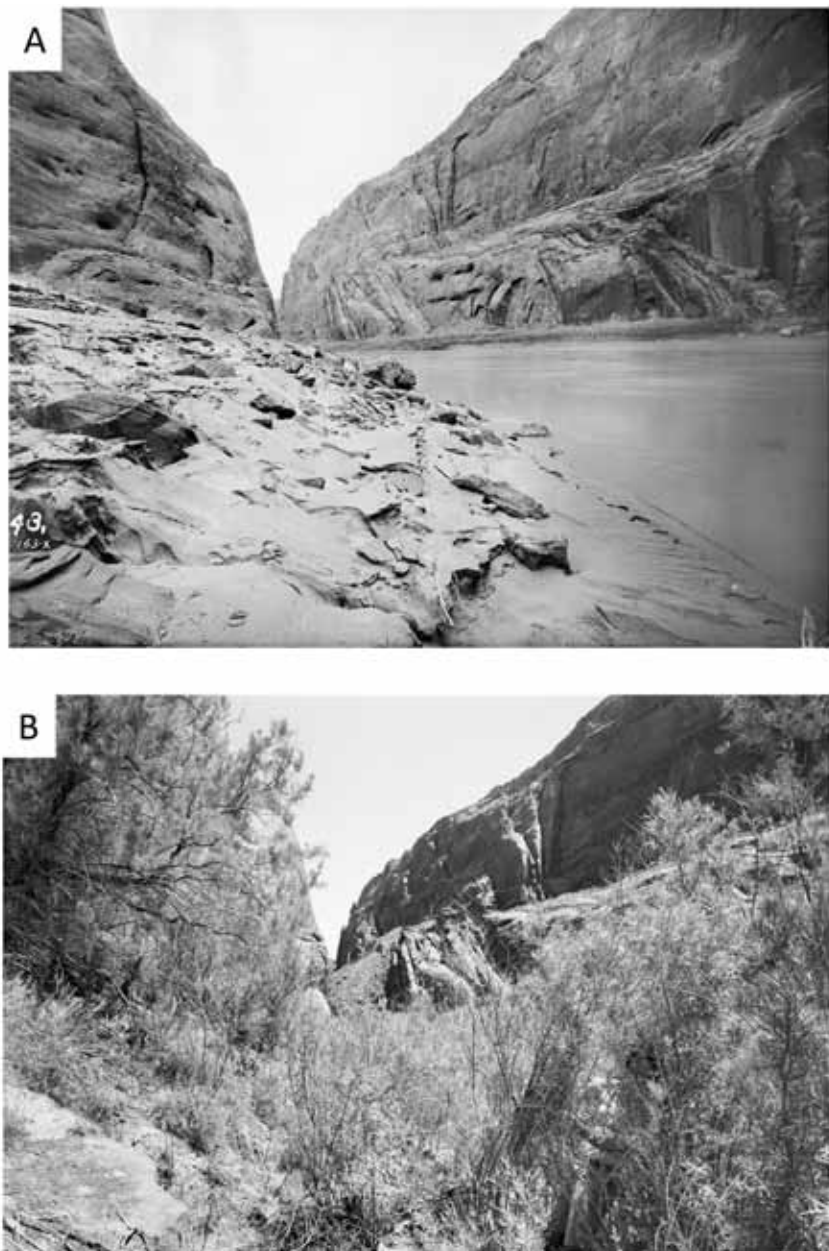
**Figure 29**—Tamarisk in Glen Canyon (photo 751; online Appendix, <http://dx.doi.org/10.5066/F76W988R>).

**(a) (top)** (1889) This downstream view, 11 river kilometers above Lees Ferry, shows a remarkably clear view of fine-grained alluvium draped over talus. Except for a few scattered plants near the top of the bank, the deposit is largely free of vegetation.

**(b) (bottom)** (1975) Within 12 years following closure of Glen Canyon dam, the bank is heavily vegetated with primarily tamarisk and sand-bar willow. The large tamarisk stem, high on the bank, may have established during high flows before the dam.

**(c) (next page)** (1989) Near-shore stands of tamarisk and willow appear to have been removed or killed-back by flooding a few years preceding this view. **(d) (next page)** (2011) Woody riparian vegetation, including tamarisk, seep-willow, and sand-bar willow, have reestablished near shore and a diversity of grasses, herbs, and small shrubs fill spaces in between. The large tamarisk on the high bank is still alive but has many dead branches in the crown.

The flooding in 1983-1986 killed or removed up to 10 percent of all riparian vegetation (Waring 1996), particularly at lower river stages (fig. 29), and vegetated cover below 1,274 cms (~45,000 cfs) showed little or no increase over the interval from 1973 to 1984. Presumably, any increases prior to the flood were offset by mortality from the flood (Sankey et al. 2015). Because of species-specific differences in flood mortality and early differences in post-flood reestablishment patterns, Stevens and Waring (1985) suggested that post-dam flooding from 1983 to 1985 had the potential to shift composition in favor of species like tamarisk and catclaw acacia and away from species like seep-willows and longleaf brickellbush (*Brickellia longifolia*). By the 1990s, tamarisk remained a prominent component of the new riparian assemblage and it appeared in 71 percent of the views of the river corridor taken by Webb (1996).

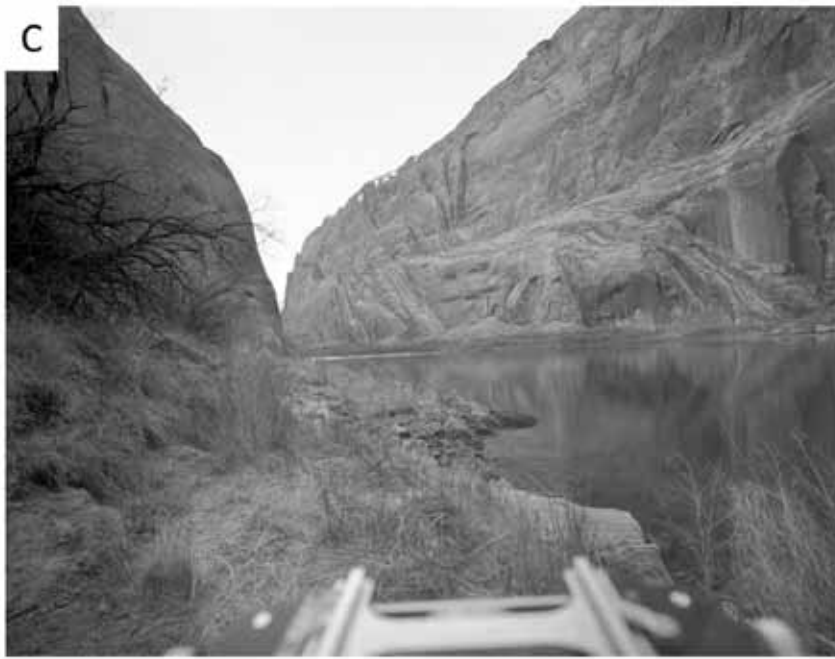
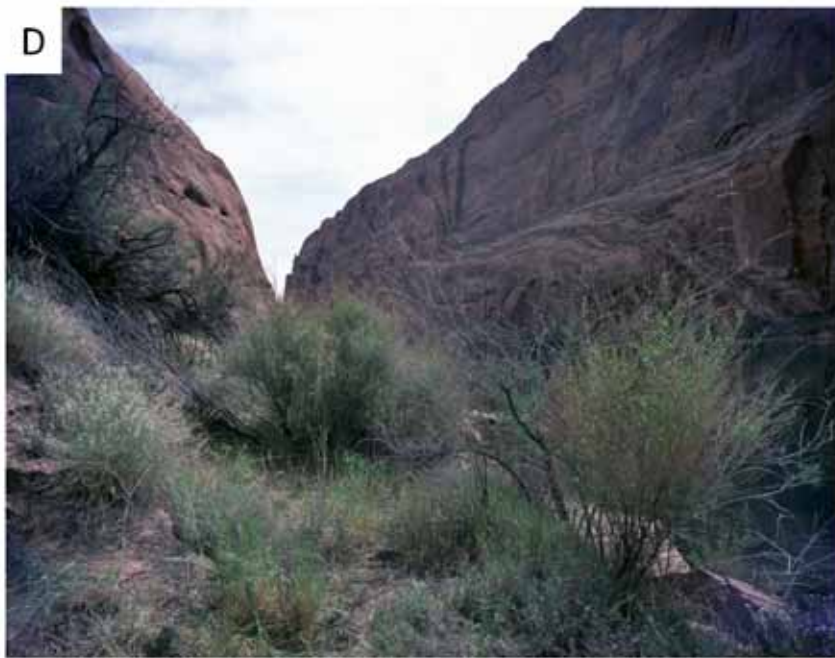
**Figure 30**—Channel narrowing in Marble Canyon (photo 2526; online Appendix, <http://dx.doi.org/10.5066/F76W988R>).

**(a) (top)** (1889) View upstream into still water from the upstream edge of the South Canyon debris fan (river kilometer 51). A channel margin deposit of fine alluvium along the near wall is devoid of vegetation and is marked by a series of flow recession lines.

**(b) (bottom)** (1992) The channel margin deposit has expanded and is now stabilized by tamarisk, sand-bar willows and grasses. Leafless, small stems of what may be sand-bar willow or tamarisk grow along the edge of a secondary channel adjacent to a cobble bar with small tamarisk lining the stream ward edge.

**(c) (next page)** (2010) A dense stand of tamarisk, sand-bar willow, and seep-willow now flank the narrowing secondary channel and the cobble bar is largely covered by vegetation and fine sediment.

occurred in near-shore locations (figs. 30 and 31). Sankey et al. (2015) found that vegetation expansion into lower elevations of the riparian zone occurred during periods when peak flows were lower and base flows higher and when inundation duration fell below about 5 percent.

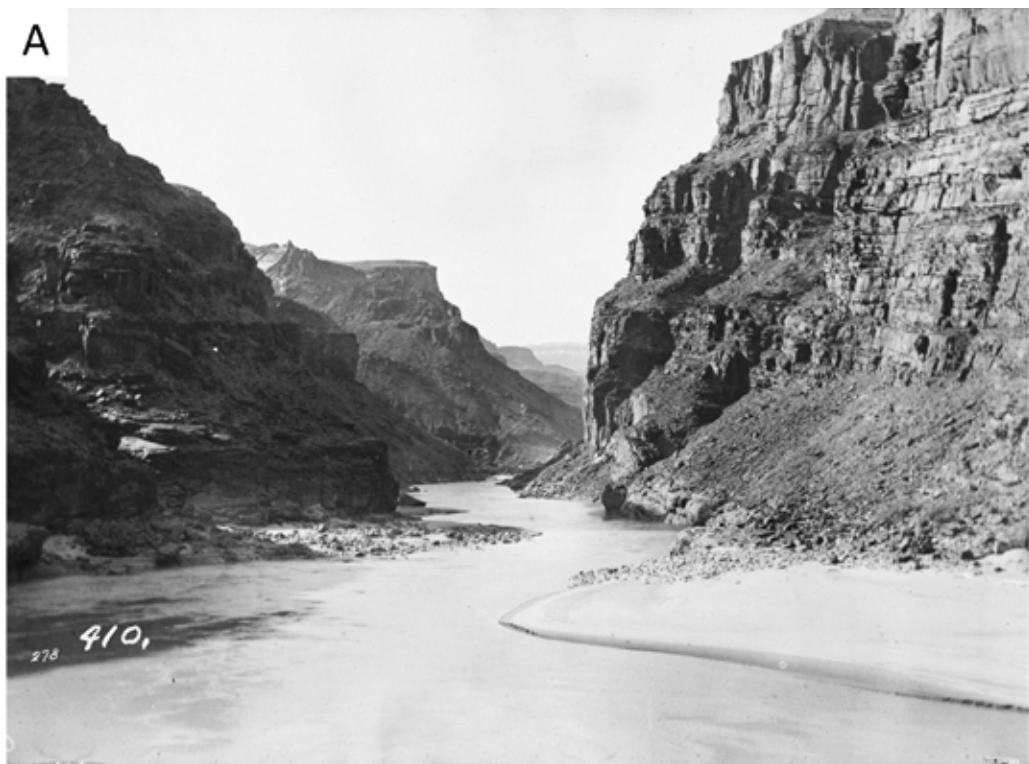
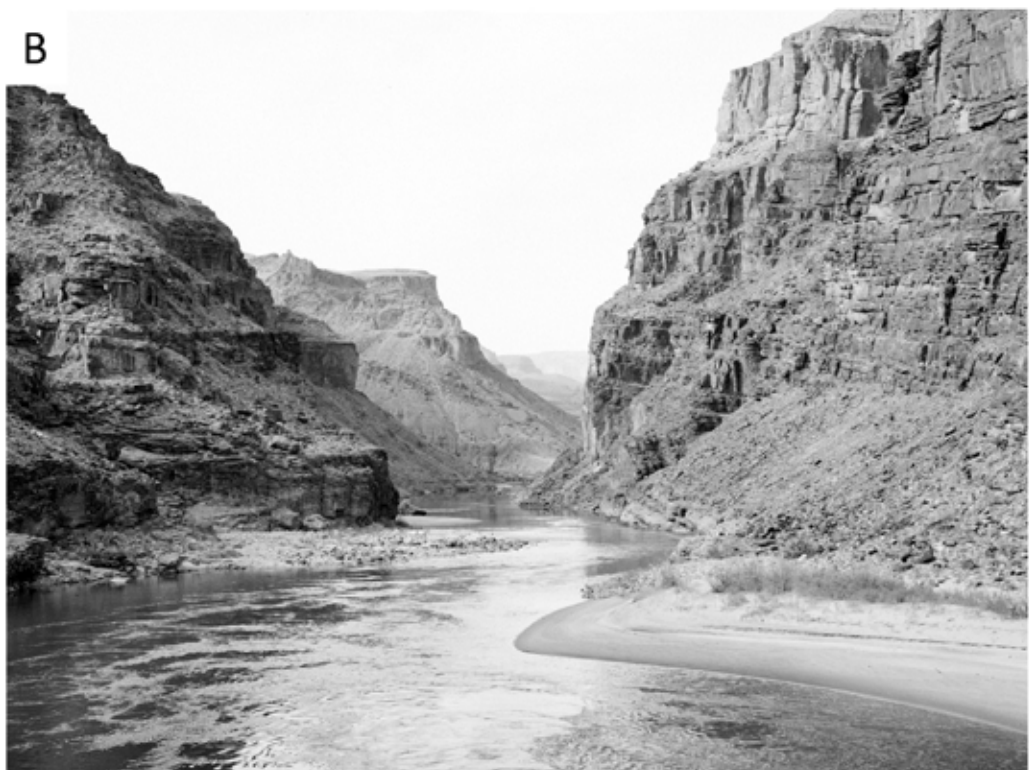
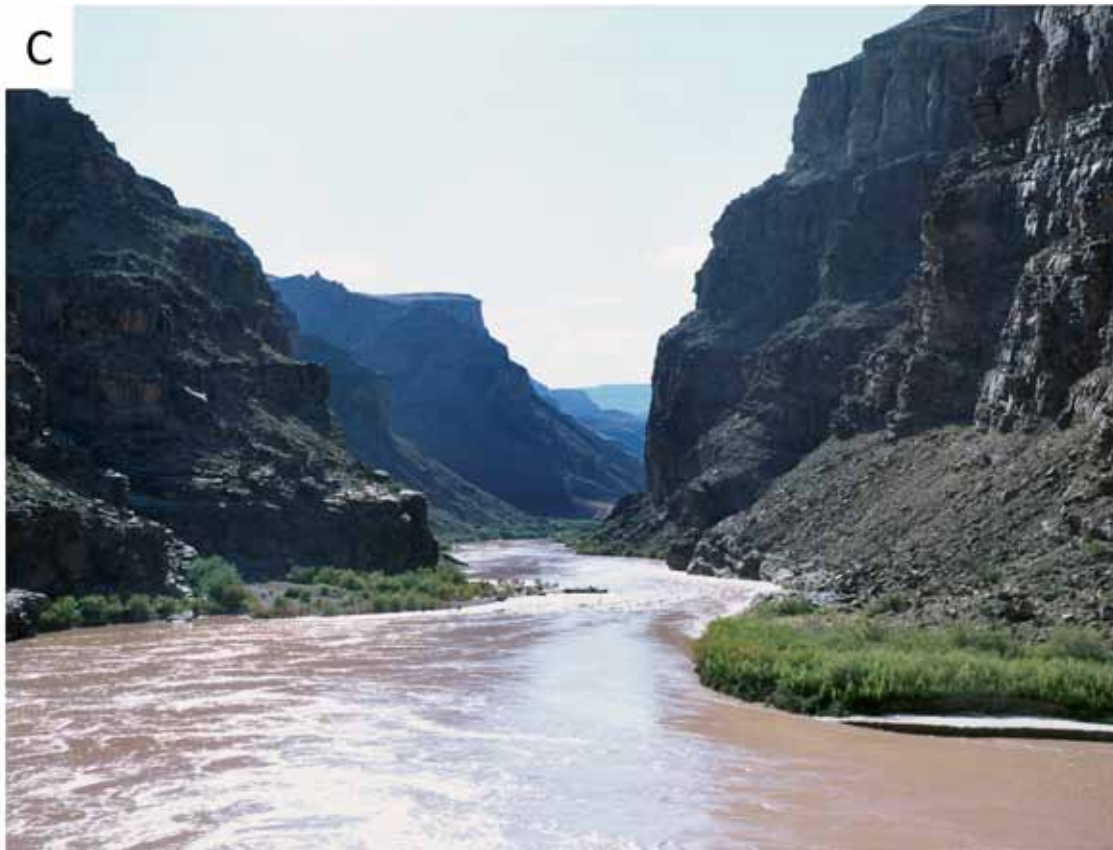
**Figure 31**—Vegetation encroachment, upper Grand Canyon (photo 1749 b; online Appendix, <http://dx.doi.org/10.5066/F76W988R>).

(a) (1890) Looking downstream to a sand and gravel bar on river right, upstream of the Papago Creek debris fan, upper Grand Canyon (river kilometer 123). Both fan and bar features are low and devoid of vegetation. (b) (1991) Tamarisk has colonized the higher portions of the sand bar and the Papago Creek fan, which appears to have increased slightly in elevation. (c) (2011) Tamarisk has increased in size and number on both the bar and debris fan. On the bar, dense stands of tamarisk, sand-bar willow, arrow-weed, and seep-willow have filled in between the older, higher tamarisk and the channel bank. Tamarisk and seep-willow also line the channel margin upstream of the fan as well as the upstream edge of the debris fan.

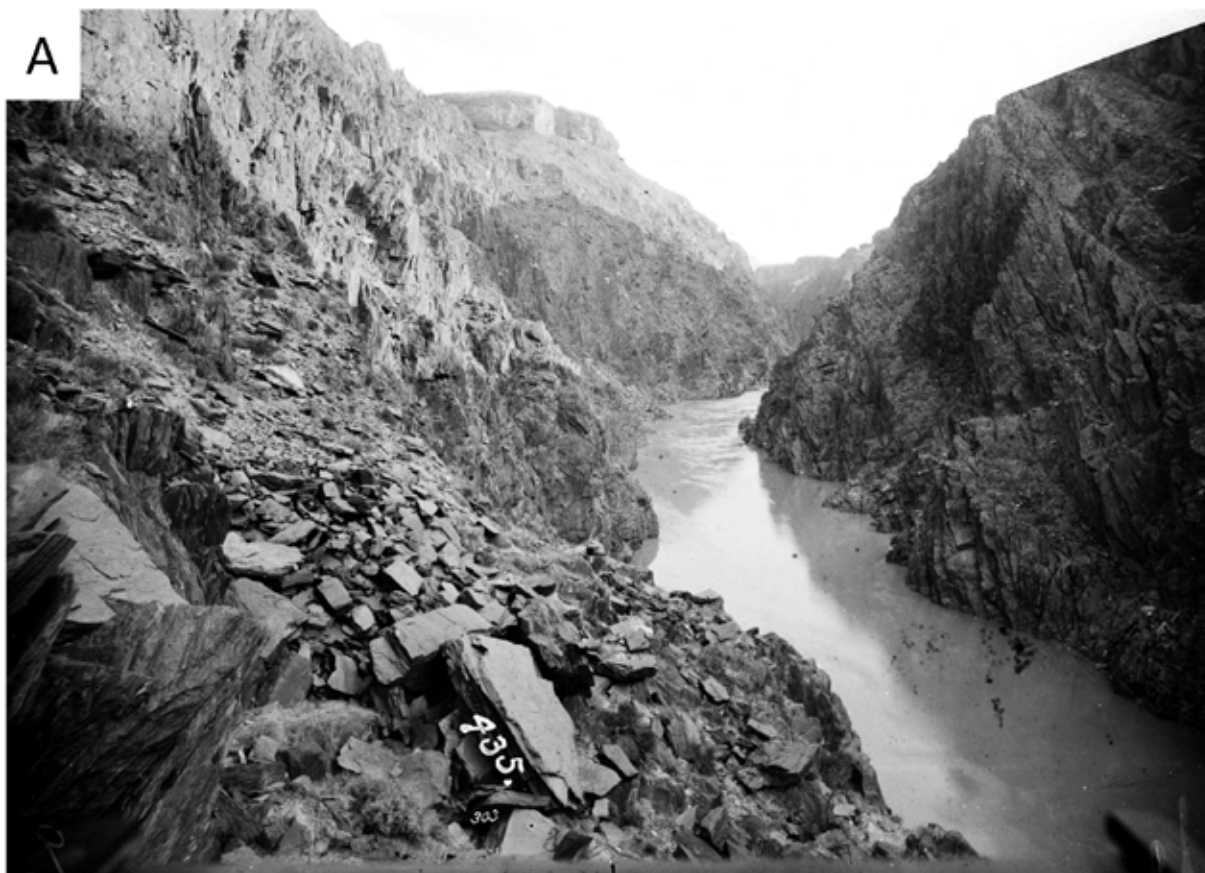
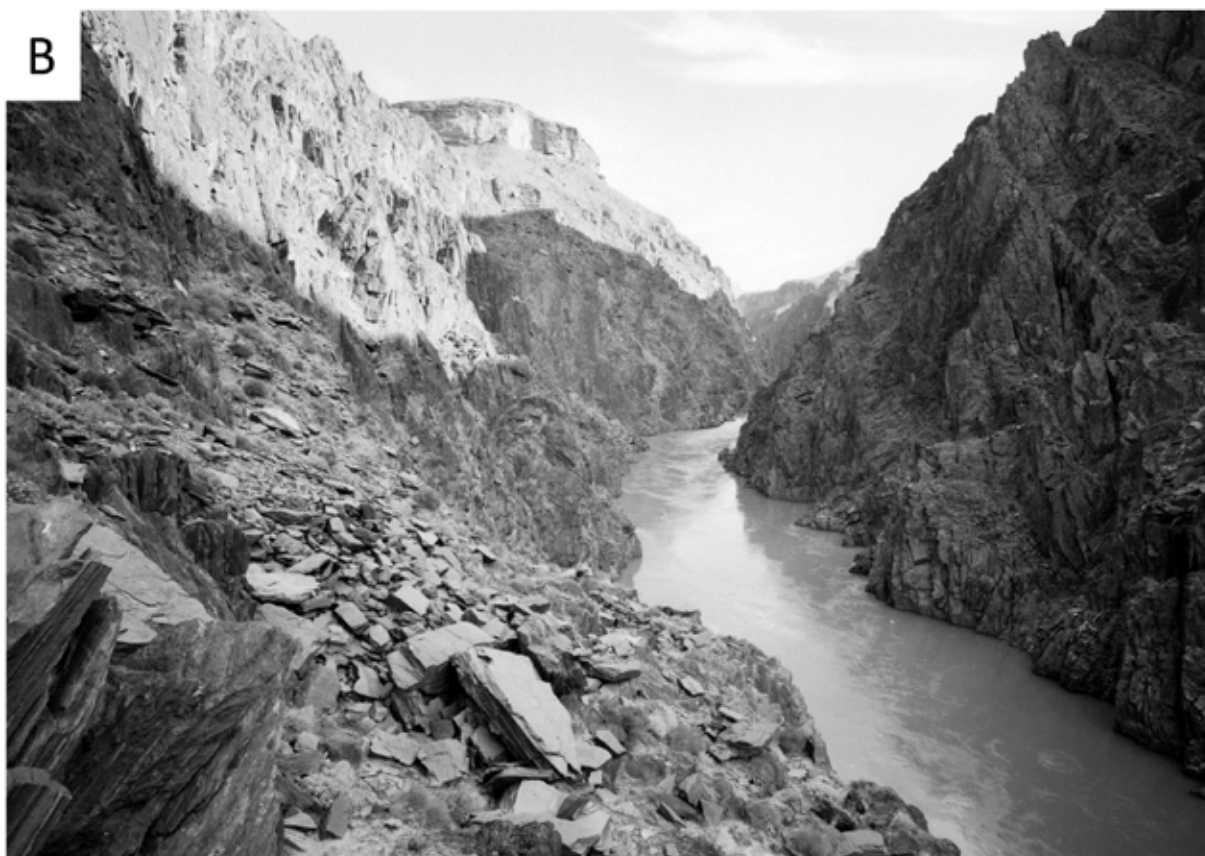
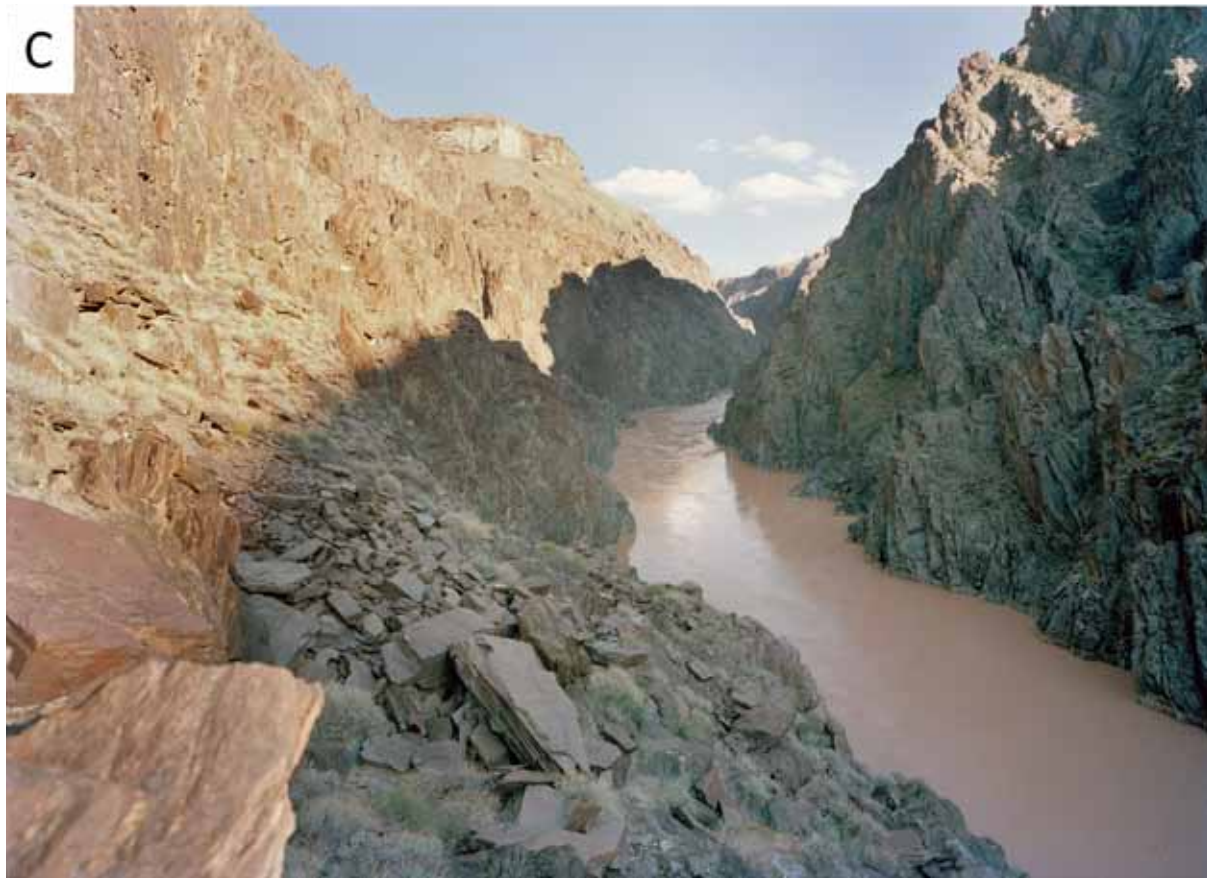
**Figure 32**—Stasis in upper Granite Gorge (photo 2319; online Appendix, <http://dx.doi.org/10.5066/F76W988R>).  
**(a)** (1890) Upstream view of the Granite Gorge from Clear Creek (river kilometer 136). The walls of Vishnu schist and Zoroaster granite are too steep and narrow to support any riparian vegetation. **(b)** (1991) After a century and the closing of Glen Canyon dam, the inner gorge appears little changed. **(c)** (2011) In spite of large increases in riparian vegetation in wider canyon reaches, some steep, narrow canyon settings are not likely to provide conditions for establishment and persistence, even under current regulated flow conditions.

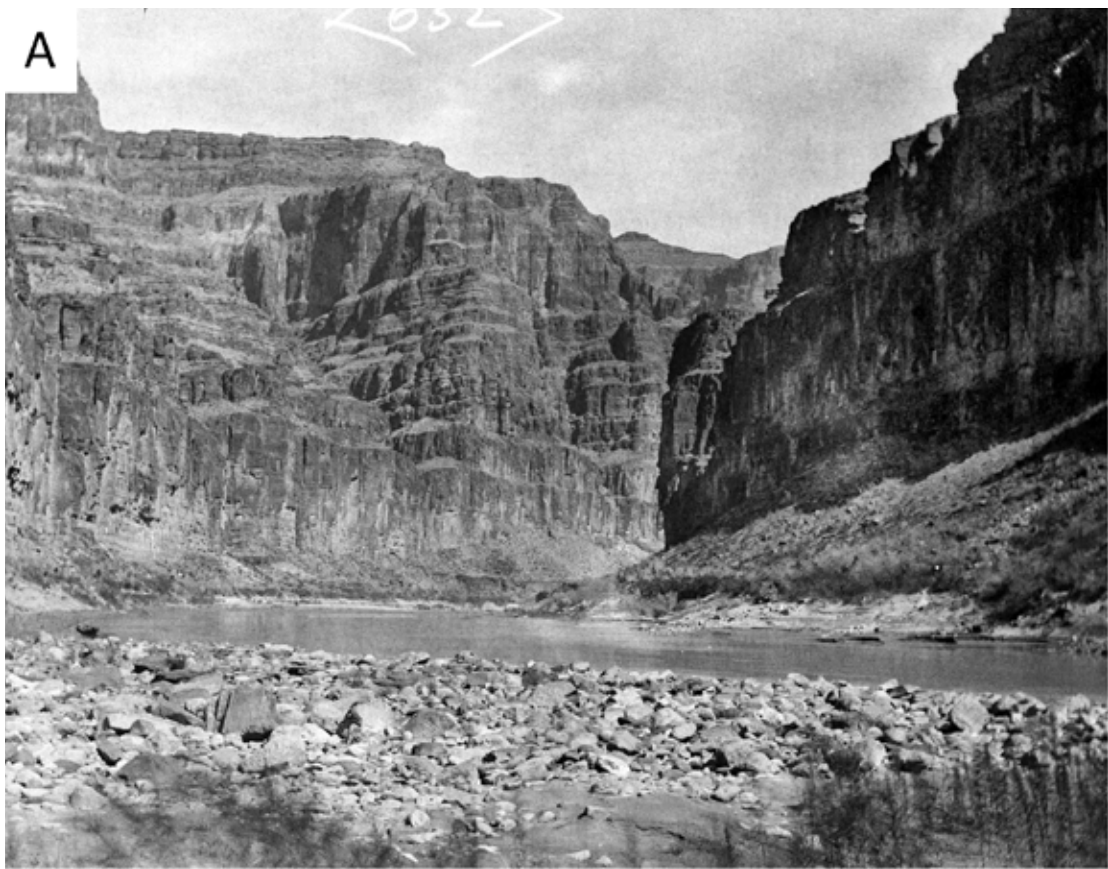
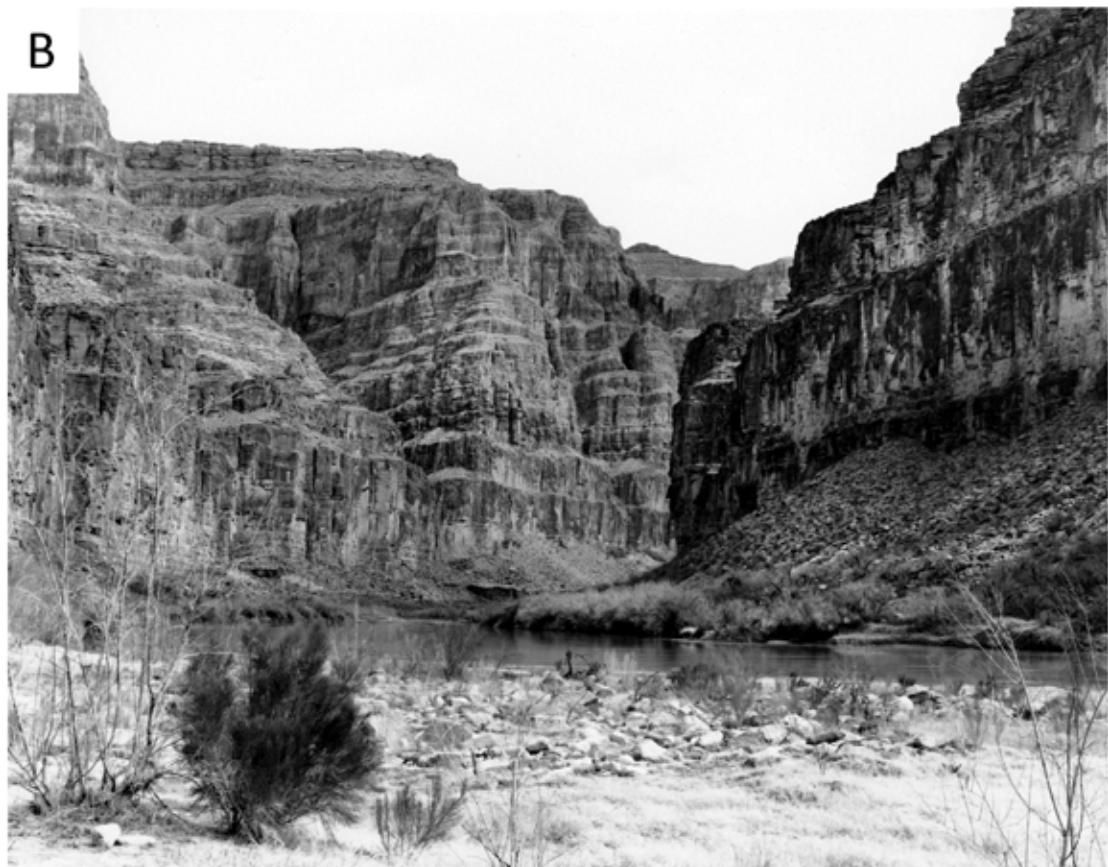
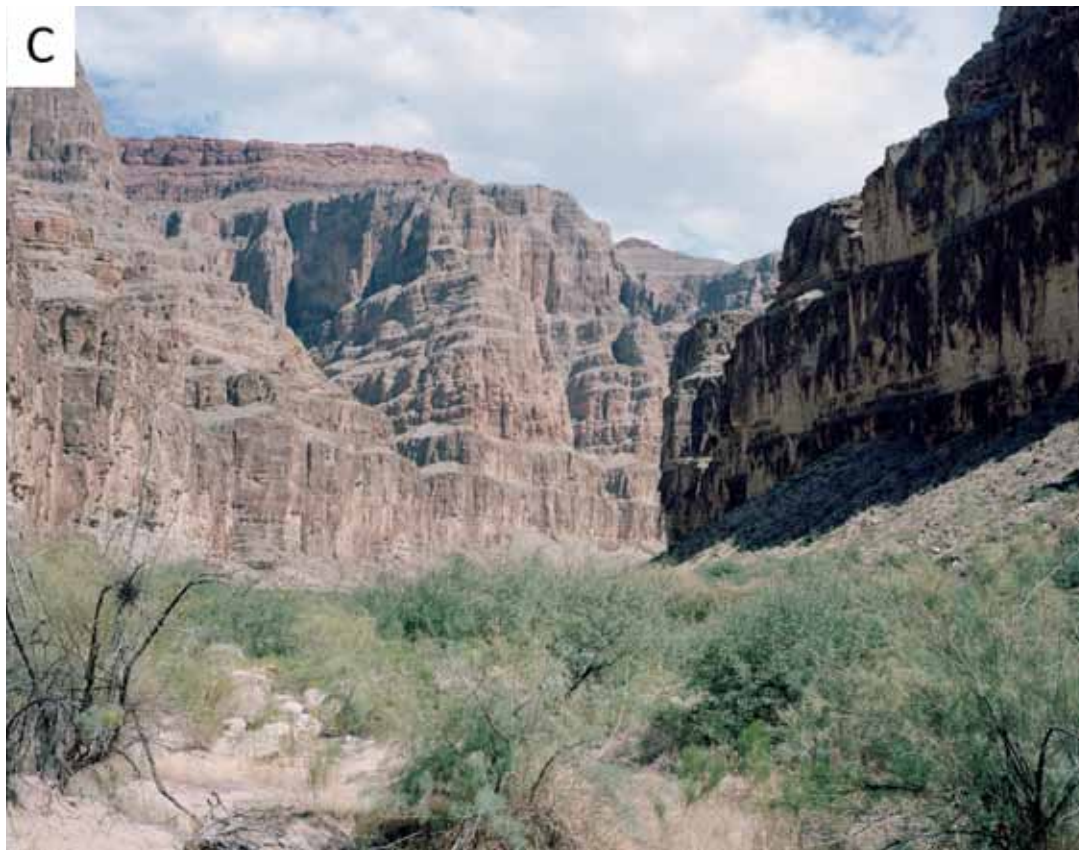
**Figure 33—(left and above)** A new high water line in lower Grand Canyon (photo 1772 a; online Appendix, <http://dx.doi.org/10.5066/F76W988R>).

**(a)** (1890) Looking upstream and across the upper portion of the fan at Parashant Wash (river kilometer 320). A depression filled with fine sediment at the lower right of the image has a patch of sizable vegetation, which is not identifiable. Upstream, and on both sides of the river, a distinct and largely continuous band of woody vegetation can be seen above the old high water line. **(b)** (1991) Bermuda grass dominates that portion of the fan, which contained fine sediment and vegetation in the previous image. Scattered, taller tamarisk and desert broom occur on the upper portion of the fan. Stunted and dead tamarisk occupy lower portions of the fan, possibly reflecting flood mortality from the mid-1980s floods. Across the river, a dense line of tamarisk occurs below the band of old high water vegetation, which appears to have thinned and some dead stems are apparent. **(c)** (2011) Tamarisk higher on the bar appears stressed and is dying back and the desert broom is gone. Closer to the river, a dense band of woody vegetation, dominated by mesquite, is tall enough to obscure the river.
