## Evaluation of Cross Laminated Timber Resistance to Termite Attack

**Tamara S.F.A. França**  
**C. Elizabeth Stokes**  
Mississippi State University  
Mississippi State, Mississippi

**Juliet D. Tang**  
USDA Forest Service, Forest Products Laboratory  
Starkville, Mississippi

França, T.S.F.A., Stokes, C.E., Tang, J.D. 2018. Evaluation of cross-laminated timber resistance to termite attack. Proceedings of the American Wood Protection Association Annual Meeting. 114:266-271

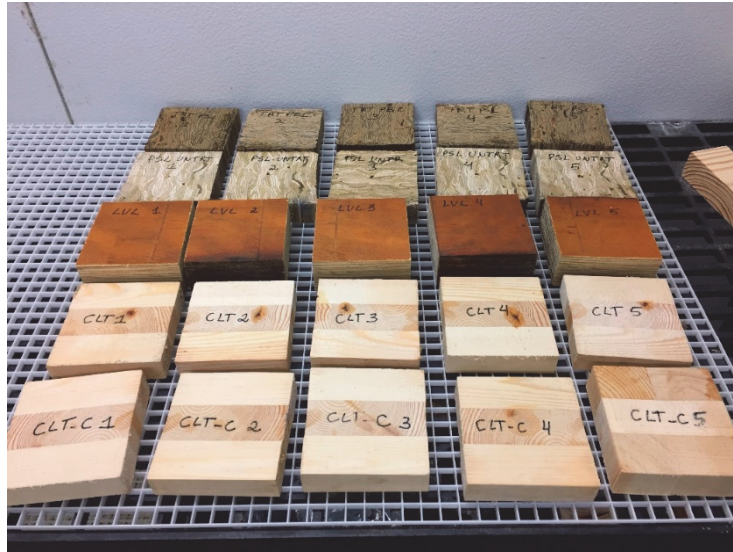
Figure 1. Conditioning test blocks to 12% EMC in an environmental chamber.

All samples were autoclaved and conditioned in an environmental chamber (70°F, 64% RH) to an EMC of 12% (equilibrium moisture content) with conditions adjusted to prevent mold growth and promote termite survival. Native subterranean termites (*Reticulitermes sp.*) were collected from one log found in the Sam D. Hamilton National Wildlife Refuge and used within two weeks of collection.

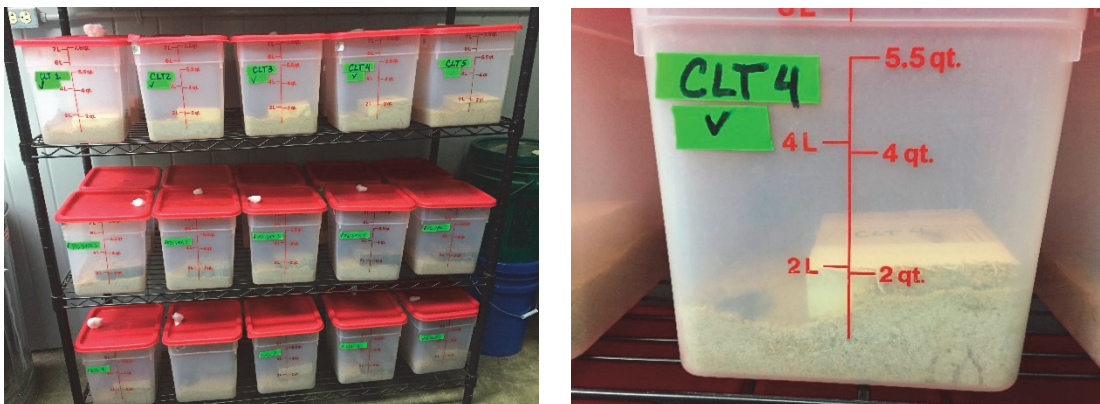
Figure 2. Test containers for *Reticulitermes sp.* lab scale test (left) and mud tube construction on the vertical face of CLT test block (right).

Test containers were eight-liter food-grade clear plastic containers. For the test, sterilized containers with sand substrate (1715 g sand per container) were labeled according to treatment and moistened with 180 mL of sterile distilled water. Once conditioned to a stable weight, a weighed test block was added to each of the 25 containers. Cleaned termites were counted to a total of 1000 three times and an average weight was taken. Approximately 1000 termites (3g of termites per container) with less than 10% soldiers were added to each of the 20 containers requiring termite exposure. Treatment containers were sealed (with a lid that had a hole plugged with sterile cotton for air exchange), weighed, and held at 70°F, 64% RH, 12% EMC for the duration of the test (Figure 2).
