## Ongoing Termite Studies on Cross Laminated Timber (CLT) Panels

**C. Elizabeth Stokes**  
**Tamara S.F.A. França**  
 Mississippi State University  
 Starkville, Mississippi

In: Proceedings of the American Wood Protection Association, May 5-7, 2019 in Orlando, FL, pp. 173-178; 2019

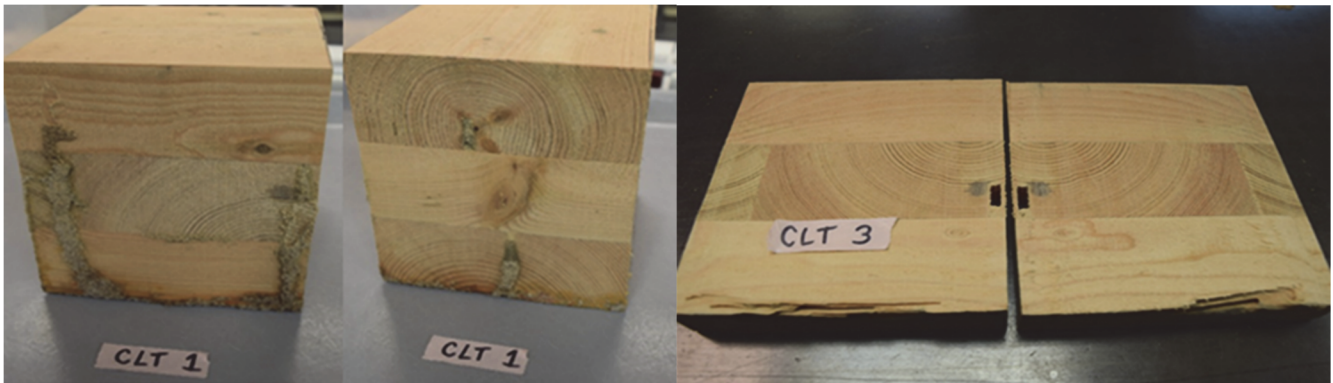
Figure 2. 4-inch cubes after eight weeks of testing. Left – immediately after testing, with mud tubes intact; Right – test block sliced open to determine depth and location of termite tunneling.

Initial tests were conducted on 3-ply CLT segments that were cut into 4-inch x 4-inch x 4-inch cubes and tested in 8-liter food safe containers. CLT has been tested in samples that maintain the full thickness of the product in all iterations. Tests of the 4-inch cubes were allowed to run four to eight weeks, as long as populations of *Reticulitermes* sp. could be maintained. Samples were evaluated visually after the tests were broken down, and selected samples were sliced open using a band saw. Depth and location of termite tunneling was determined as possible (Figure 2).

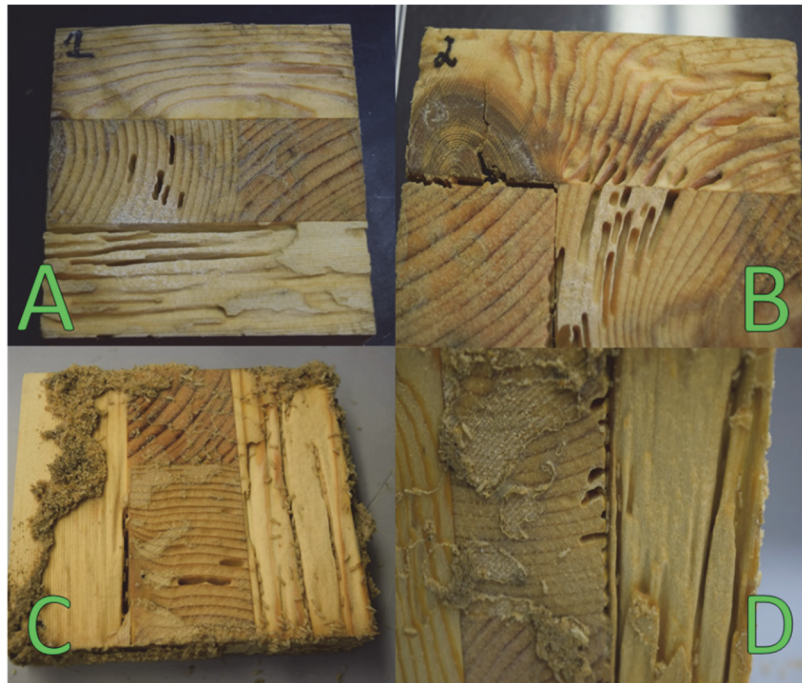
Figure 3. Revised test blocks of smaller thickness (1-inch) following exposure to *Reticulitermes* sp. Excavations can be seen on the exposed surfaces of blocks A and B post-cleaning. Blocks C and D show active termites immediately after removal from test containers, with intact shelter tubes.

Blocks of this size were used in the remaining tests for termite exposure. Tests included variation of the amount of sand provided in the containers for termite habitat, variation in the number of termites in the population, and variation in the type of mass timber product in a no-choice test. Using test blocks of this size, it was also possible to select for more or less direct exposure of end-grain to the termite population during testing, as blocks may be cut to have 1 or 2 layers of end-grain exposure on the wide faces (Figure 3).

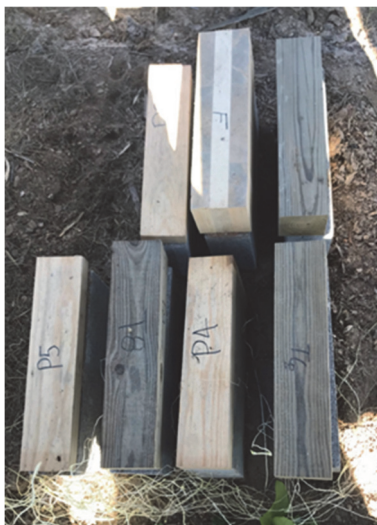
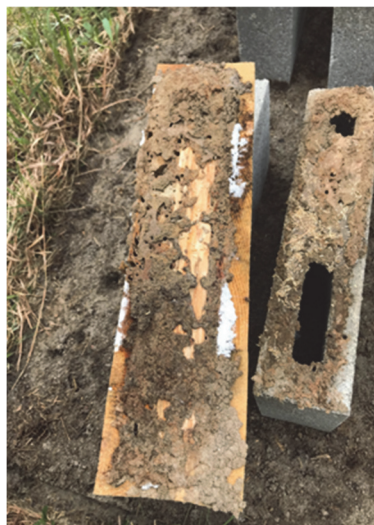
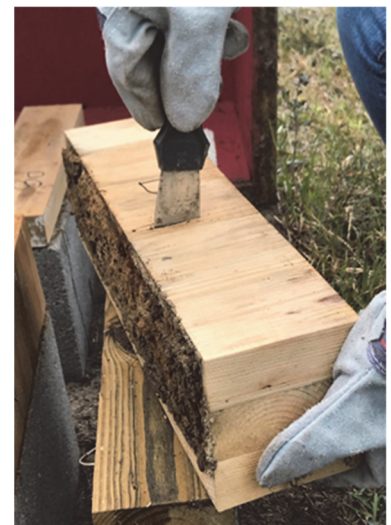
Figure 6. Field testing of CLT sections in AWP E21-18 setups. Left - initial setup of test pieces and controls on concrete blocks with internal feeder stakes; Middle - 24 months of exposure, exhibiting shelter tube formation between concrete support block and CLT test block; Right - hollowed CLT test block, with apparently sound exterior, after 24 months of exposure.

Field testing of CLT was based on AWP A E21-18, and blocks of CLT were cut to approximately 16 inches, 4 inches wide, and 3-ply. Blocks were placed as recommended by the standard and allowed to stay in the field for 12 months to 24 months. Samples were periodically examined visually to determine the presence of *Reticulitermes* sp. and/or *Coptotermes formosanus*. Test blocks were placed on top of vertically oriented concrete blocks into which untreated southern yellow pine stakes were inserted as bait. Within each grouping, there were CLT test blocks, treated southern yellow pine controls, and untreated southern yellow pine dimensional lumber (Figure 6).

CLT in field tests exhibited high levels of attack by native *Reticulitermes* sp. after 12 months, and even more attack after 24 months. When tapped with a putty knife in field evaluations, the dull knife blade easily pierced the side of the block, indicating that while the exterior appeared intact, and would have received a high visual grade, the interior had been completely perforated by tunnels.
