# Chapter 10. Intended Versus Unintended Effects During Riparian Restoration Create High Quality Recreation Habitat

*Bo Shelby and Doug Whittaker*

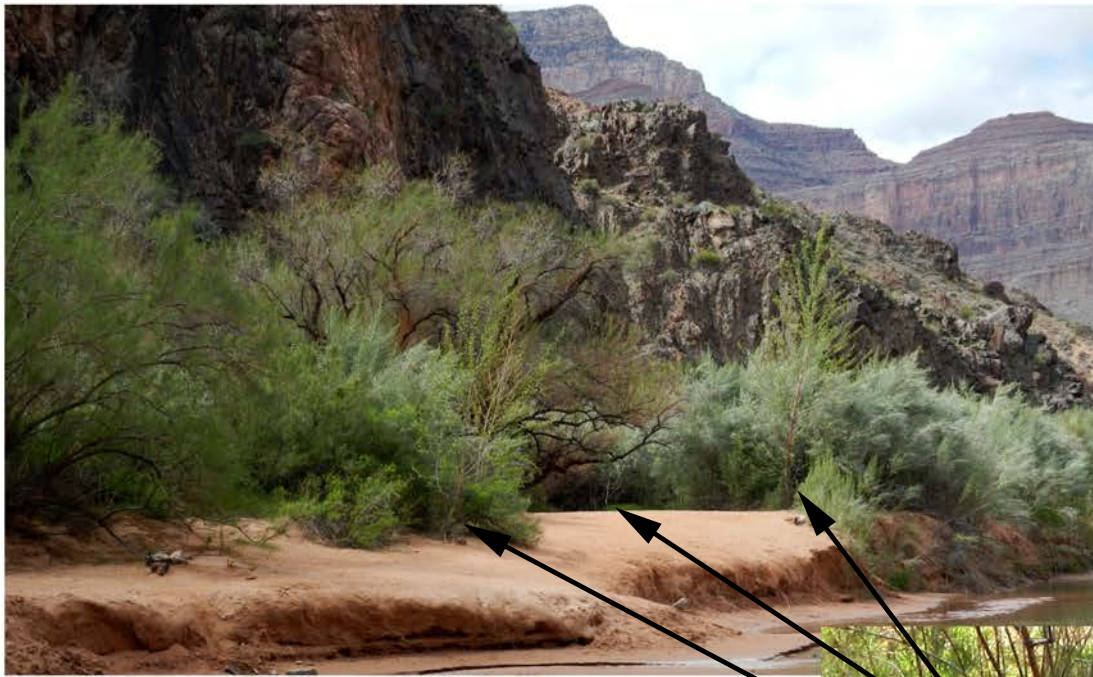
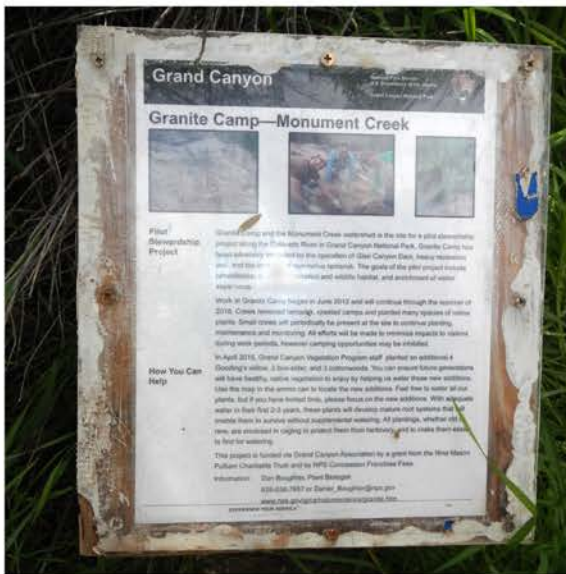
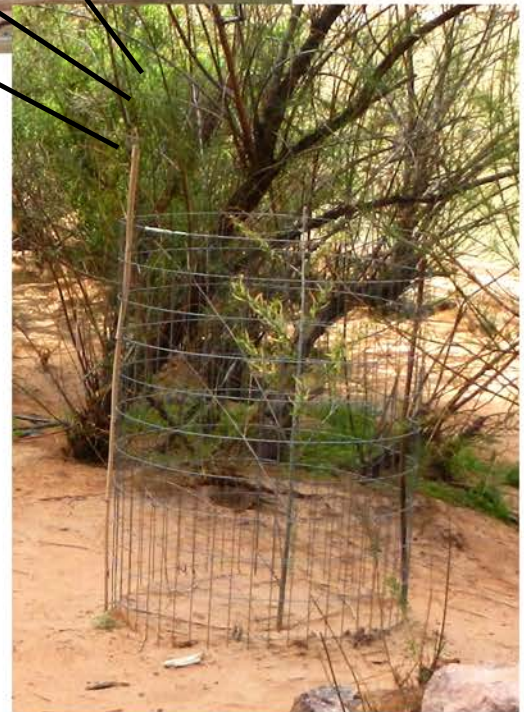
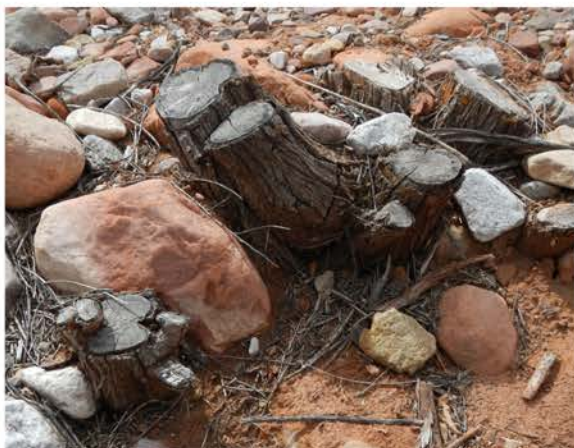
**Figure 43**—Granite Camp on the Colorado River (top) is a heavily-used “tamarisk camp,” where trees have been pruned over the years to provide shade and screened sleeping areas. The restoration project described by this onsite sign (center left) is one of the few places in Grand Canyon where trees have been extensively planted and cultivated (center right, and in top photo) to replace tamarisk dying from introduced beetles (some trees have been cut and removed, bottom left). But it will be some time before these new trees reach the maturity of “old growth” tamarisk or replace its recreation benefits in terms of shade, shelter, or screening.

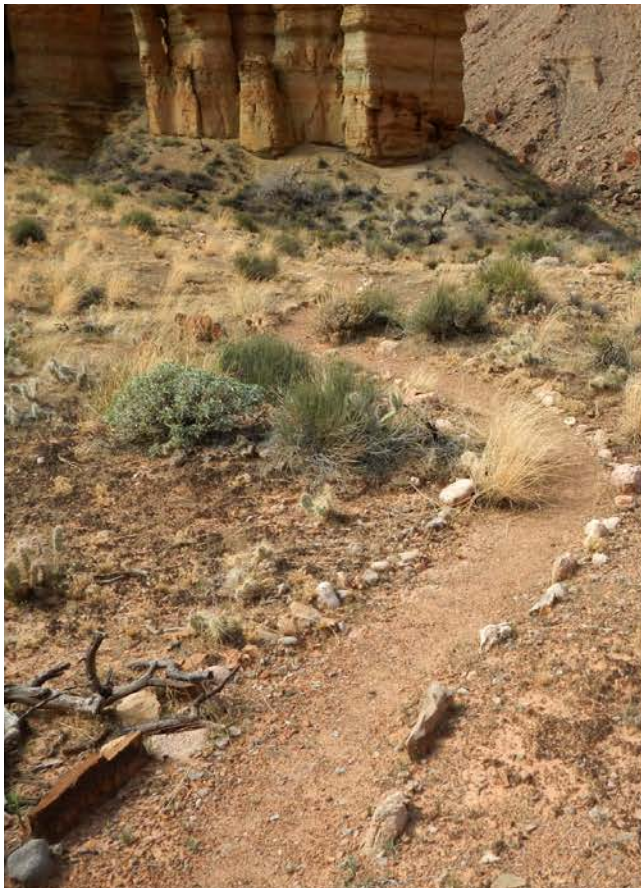
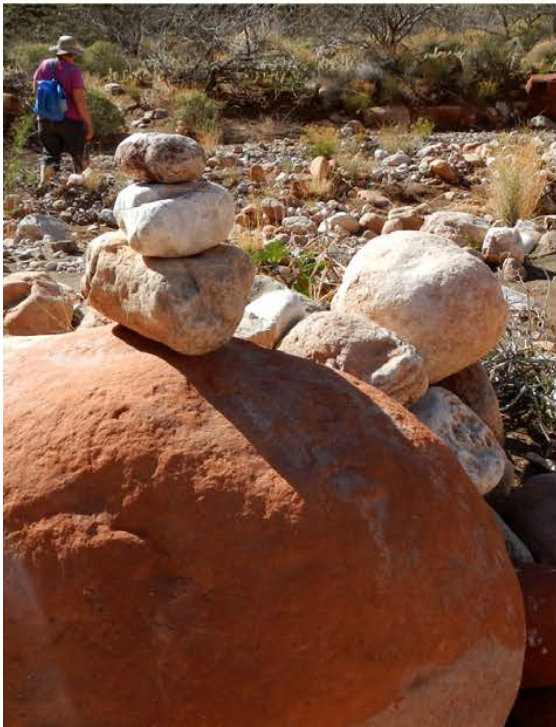
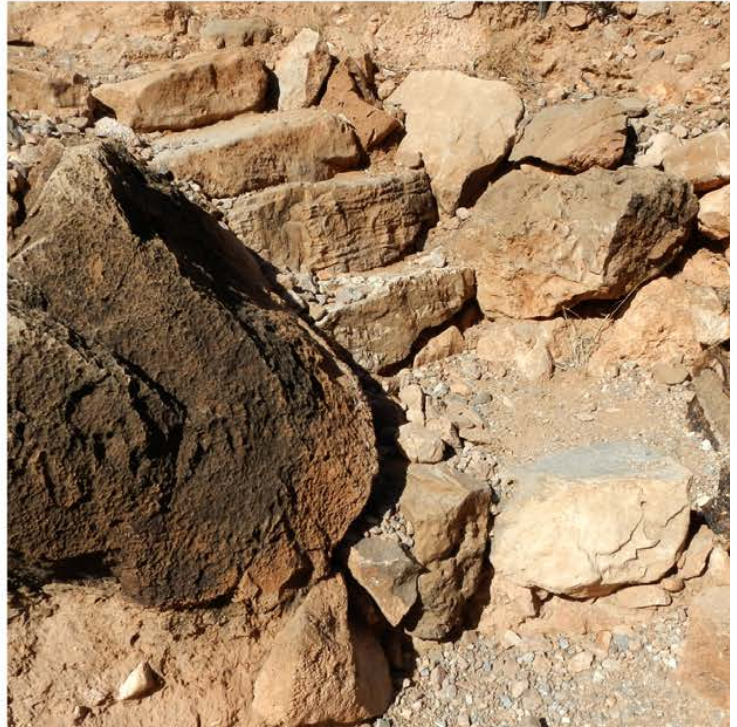
**Figure 50**—Techniques for identifying trails, keeping people on them, and minimizing impacts include those shown here: border rocks (top left), marking routes with cairns (top right and bottom left), and steps in steeper segments (bottom right). Photos are from Nankoweap and Carbon Creek areas in Grand Canyon.

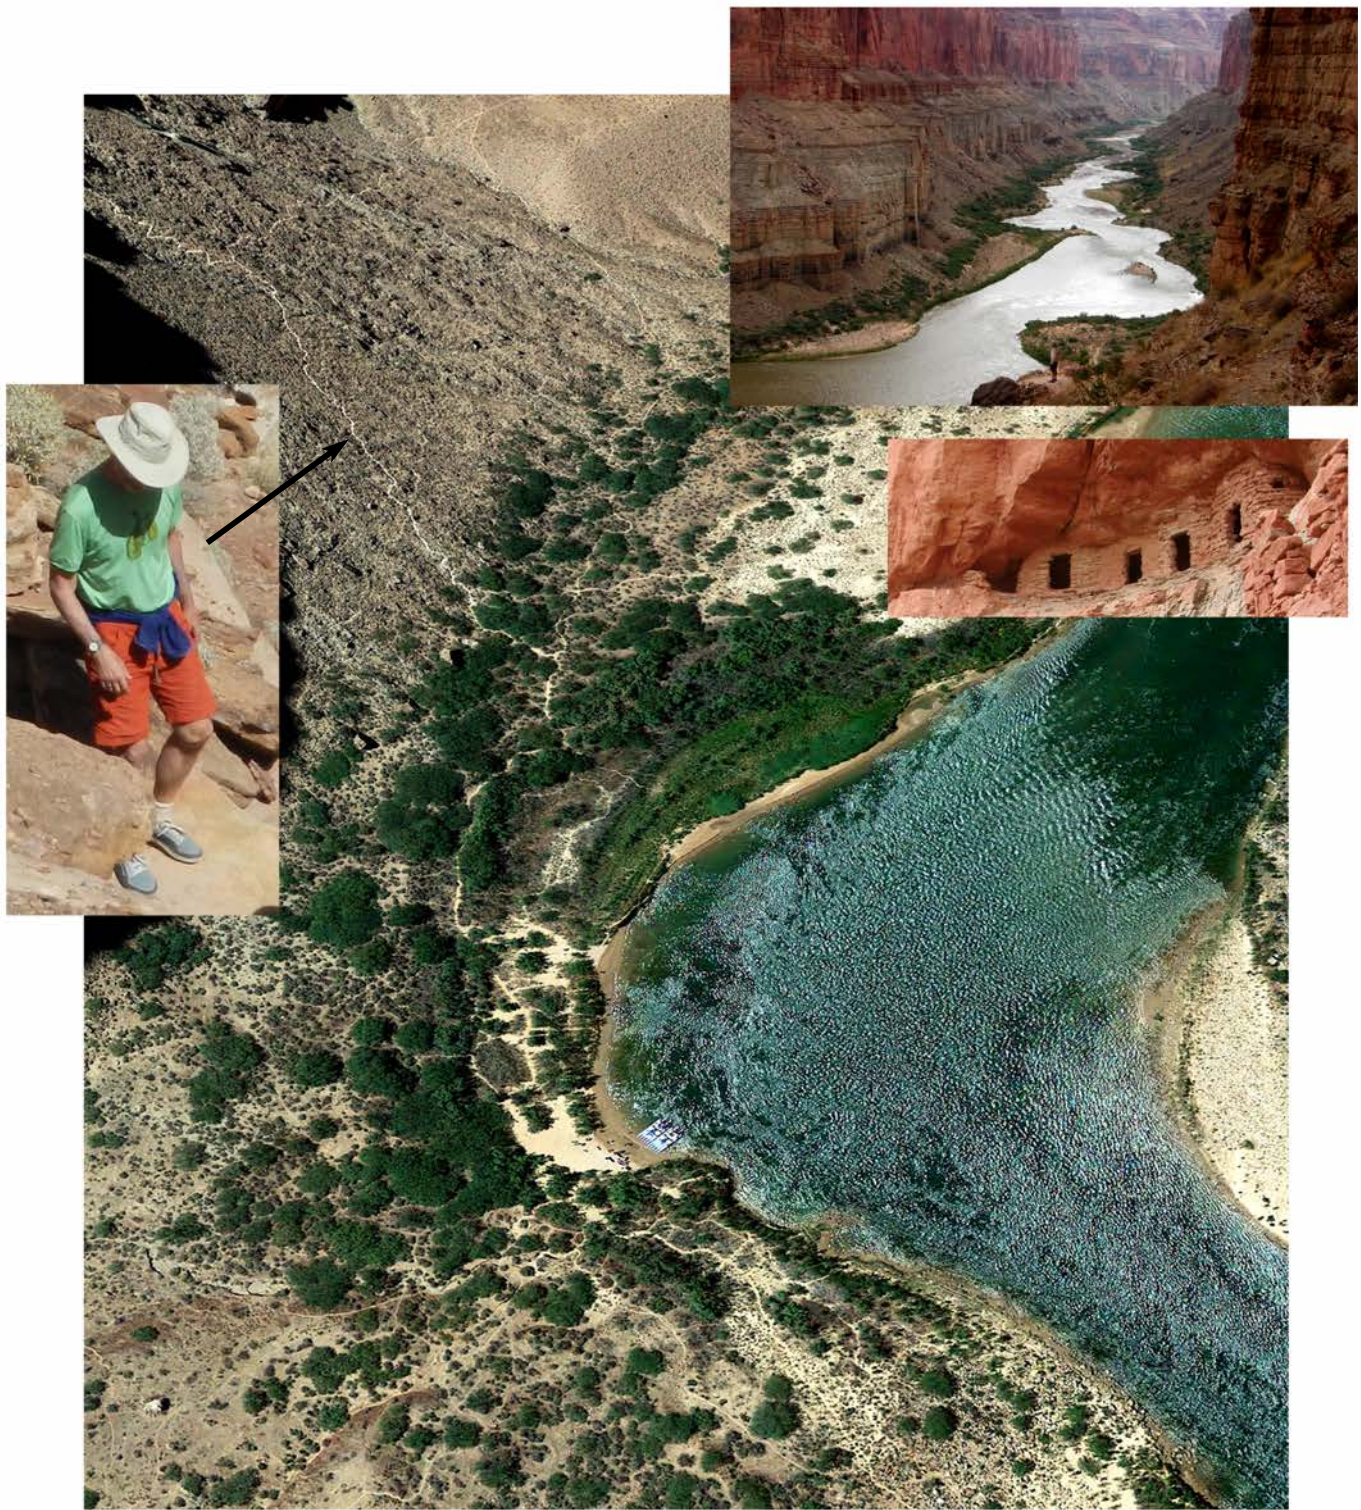
**Figure 51**—This Google Earth satellite image of Nankoweap on the Colorado River in Grand Canyon shows where the Park Service developed and clearly marked a “best” trail for the popular hike to the Anasazi granary high on a cliff (lower inset), with a spectacular view down the Canyon (upper inset). Before this restoration, which included designating camps and day use areas, river runners created a web of dozens of trails.

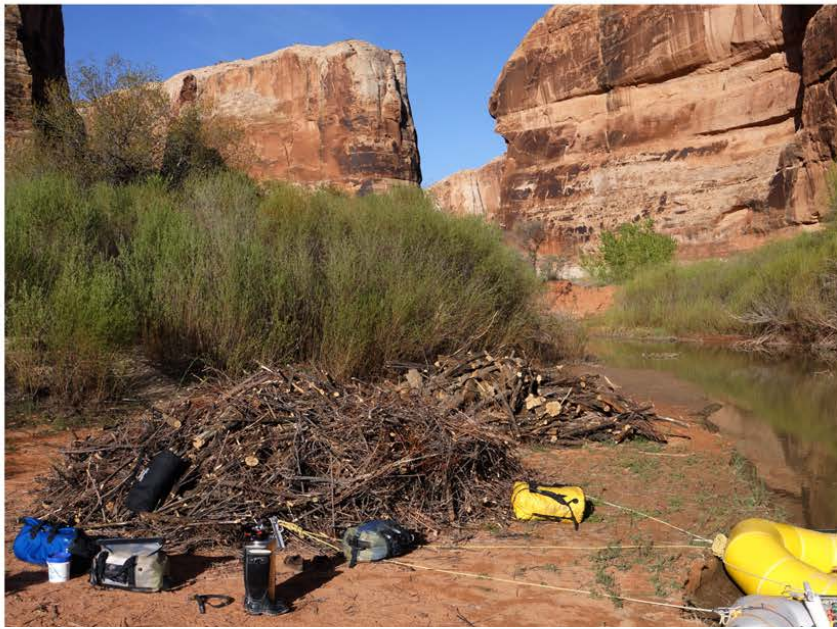
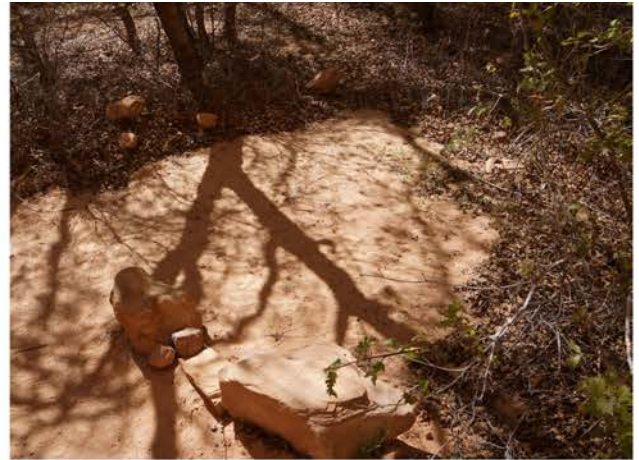
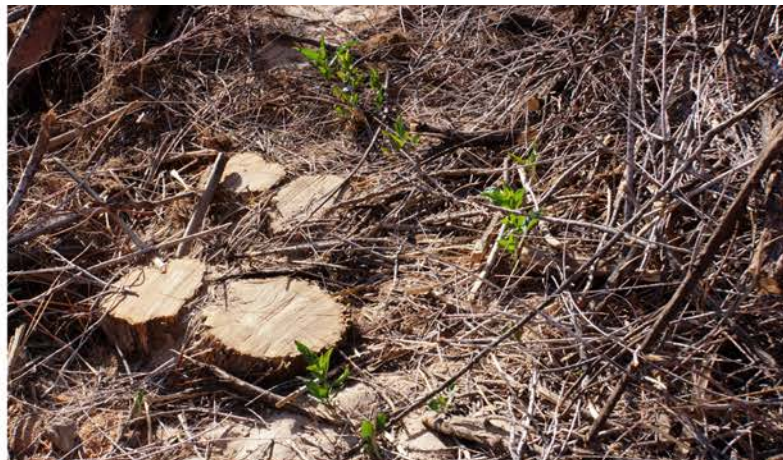
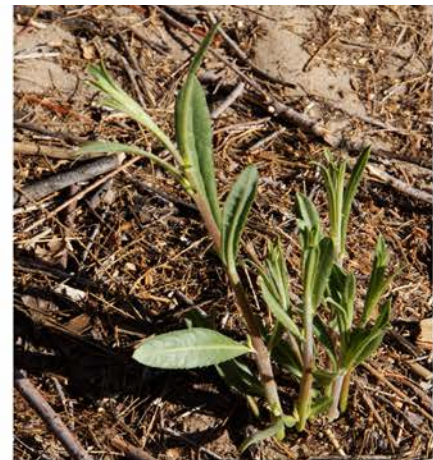
**Figure 53**—Piles of cut tamarisk (top photo) in Three Canyon camp at Trin Alcove Bend in the Green River's Labyrinth Canyon. Despite the extensive restoration effort, remaining stumps and uneven ground (bottom left) interfere with good camping habitat, and dense willow may quickly take over the area (bottom right). Some tent spots have been cleared in nearby oak uplands (center) and future high water may deposit enough sand to reduce the problem.

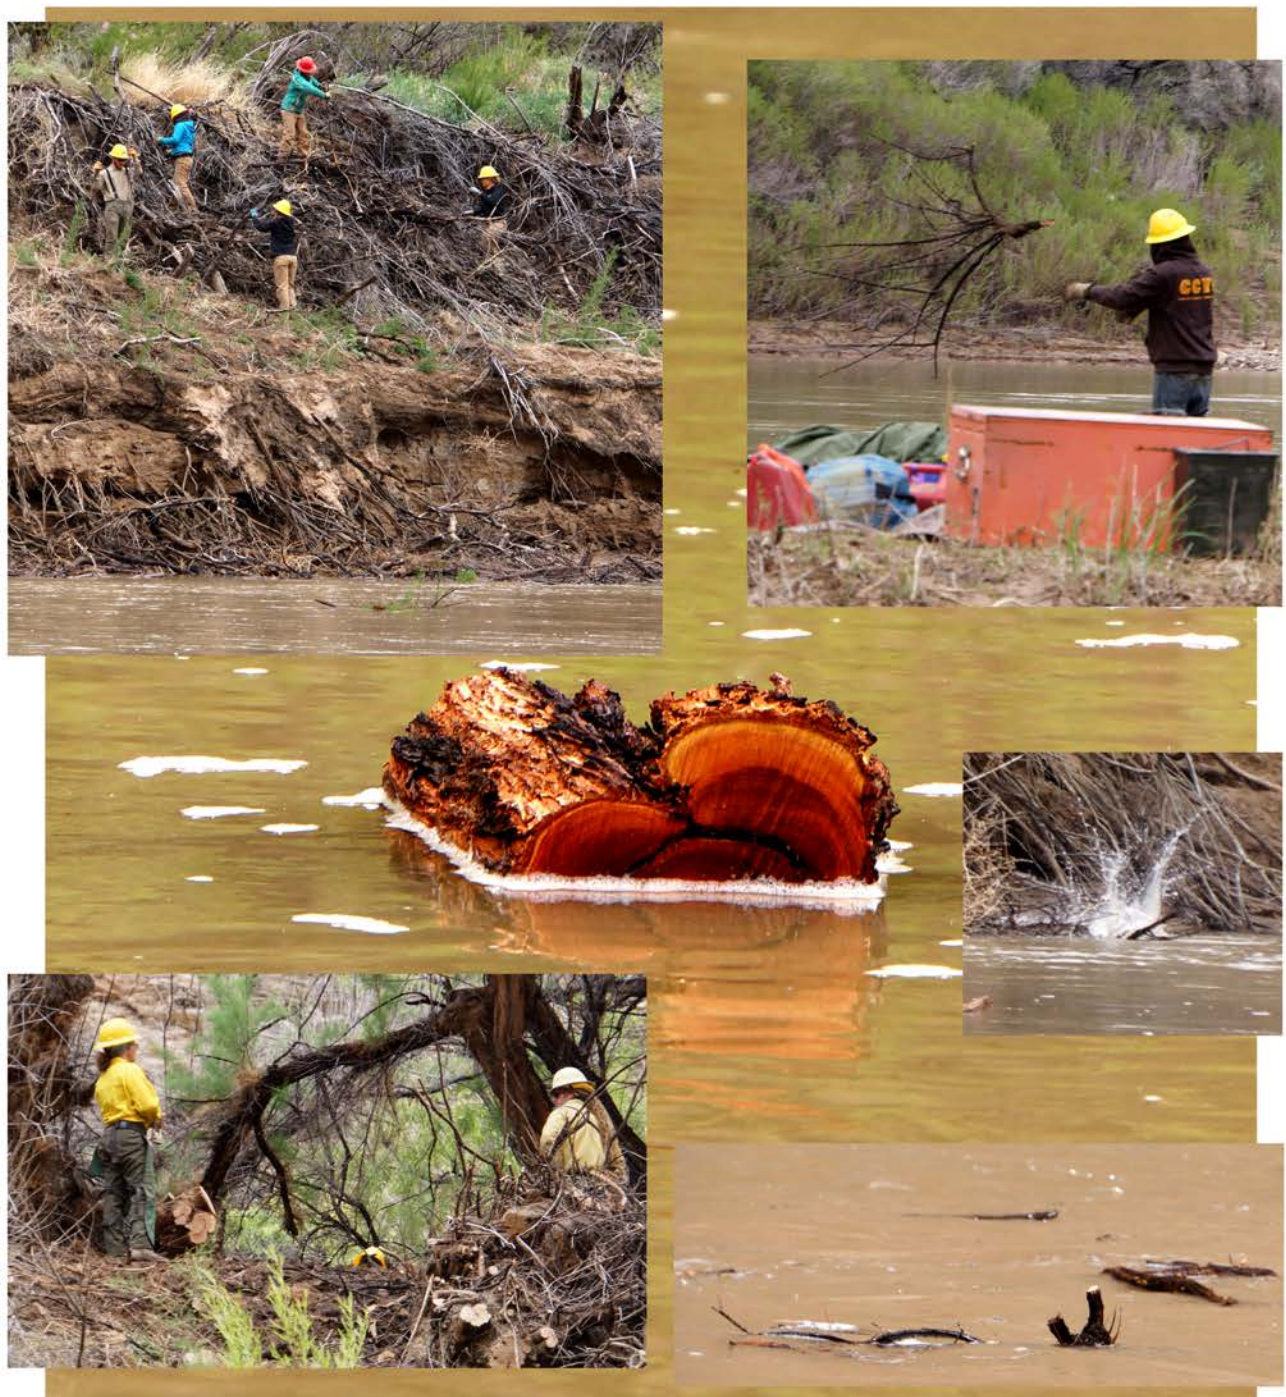
**Figure 54**—A Park Service/Canyon Country Youth Corps crew removes thickets of beetle-killed tamarisk at the confluence of the Green and Colorado Rivers (top left), part of what one crew-member described as a career goal to rid the area of this invasive. Trees up to 12-inches in diameter were cut with chainsaws (bottom left) and thrown in the river (top right and center right). Downstream, driftwood with saw-cut ends float on the river (center and bottom right), piles up on shore, or eventually winds up in Lake Powell. It is not clear whether this “new” form of driftwood is considered good, bad, or just a tradeoff of clearing invasive tamarisk, but regulations in some jurisdictions prevent river runners from using slash for firewood.

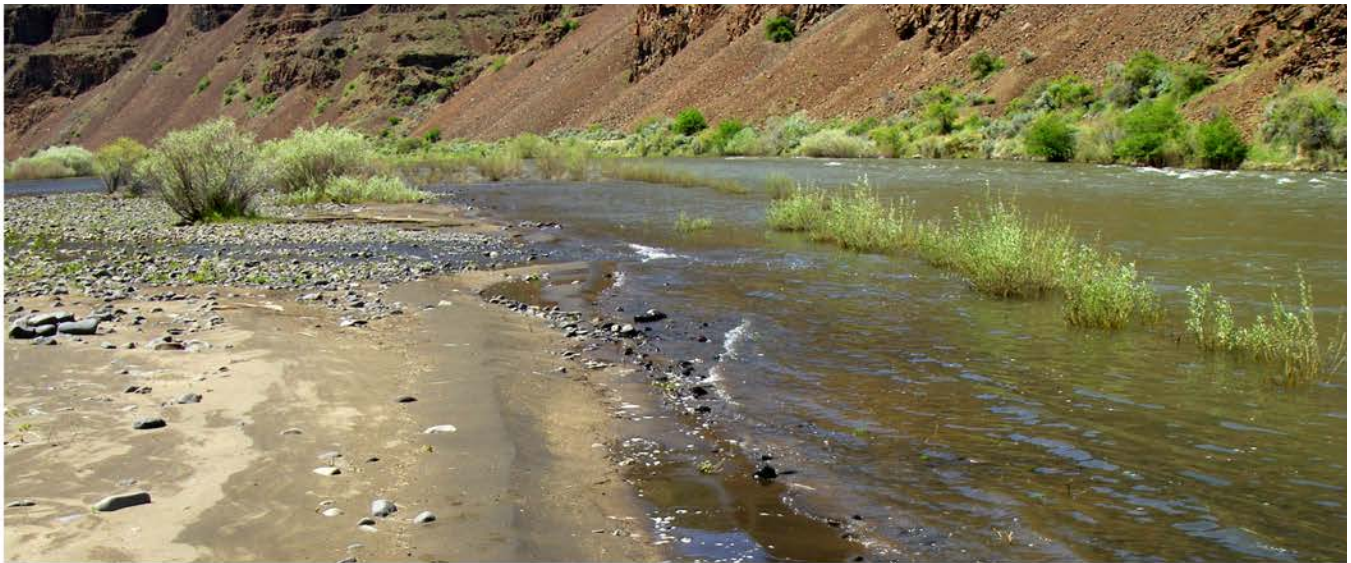
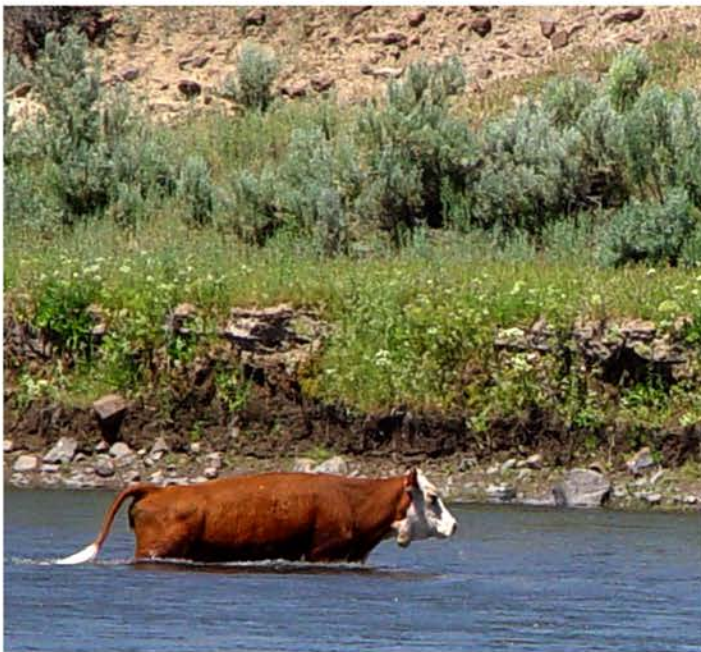
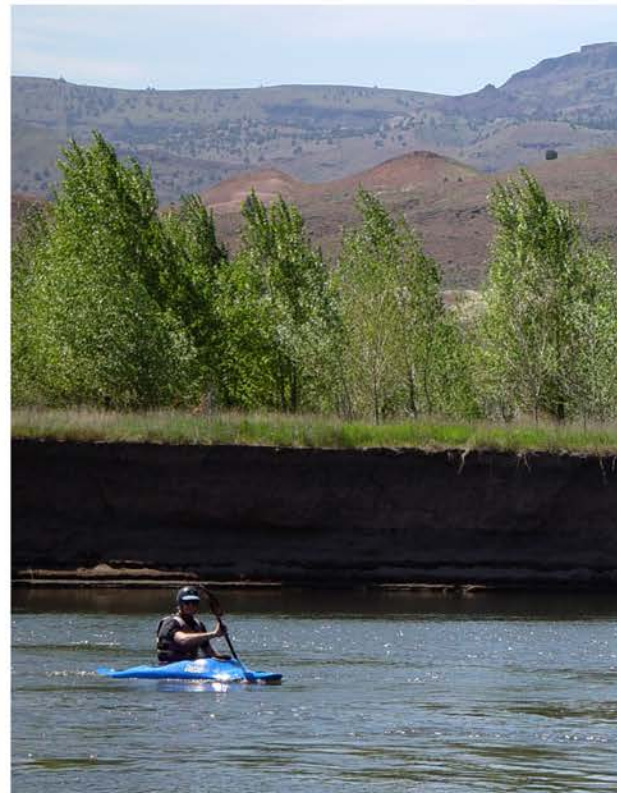
**Figure 56**—A beach area recently protected from grazing on Oregon’s John Day River (top photo, taken at a higher spring flow) shows willows establishing along the lower summer water line: willows may eventually take over or cut off access to the beach, decreasing recreation habitat. Mitigation for such effects can be included in riparian engineering during restoration projects. Pioneering restoration research has been done in the John Day and Deschutes River watersheds east of the Oregon Cascades. This work showed how riparian vegetation in historically grazed locations (center left) was markedly different from areas protected from grazing by roads or railroads (center right). Cottonwood plantings (background of lower right photo) are part of the effort, but a pleasant surprise has been dramatic recovery after removing livestock or simply installing watering tanks (on trailers with solar-powered pumps) higher in the riparian zone.

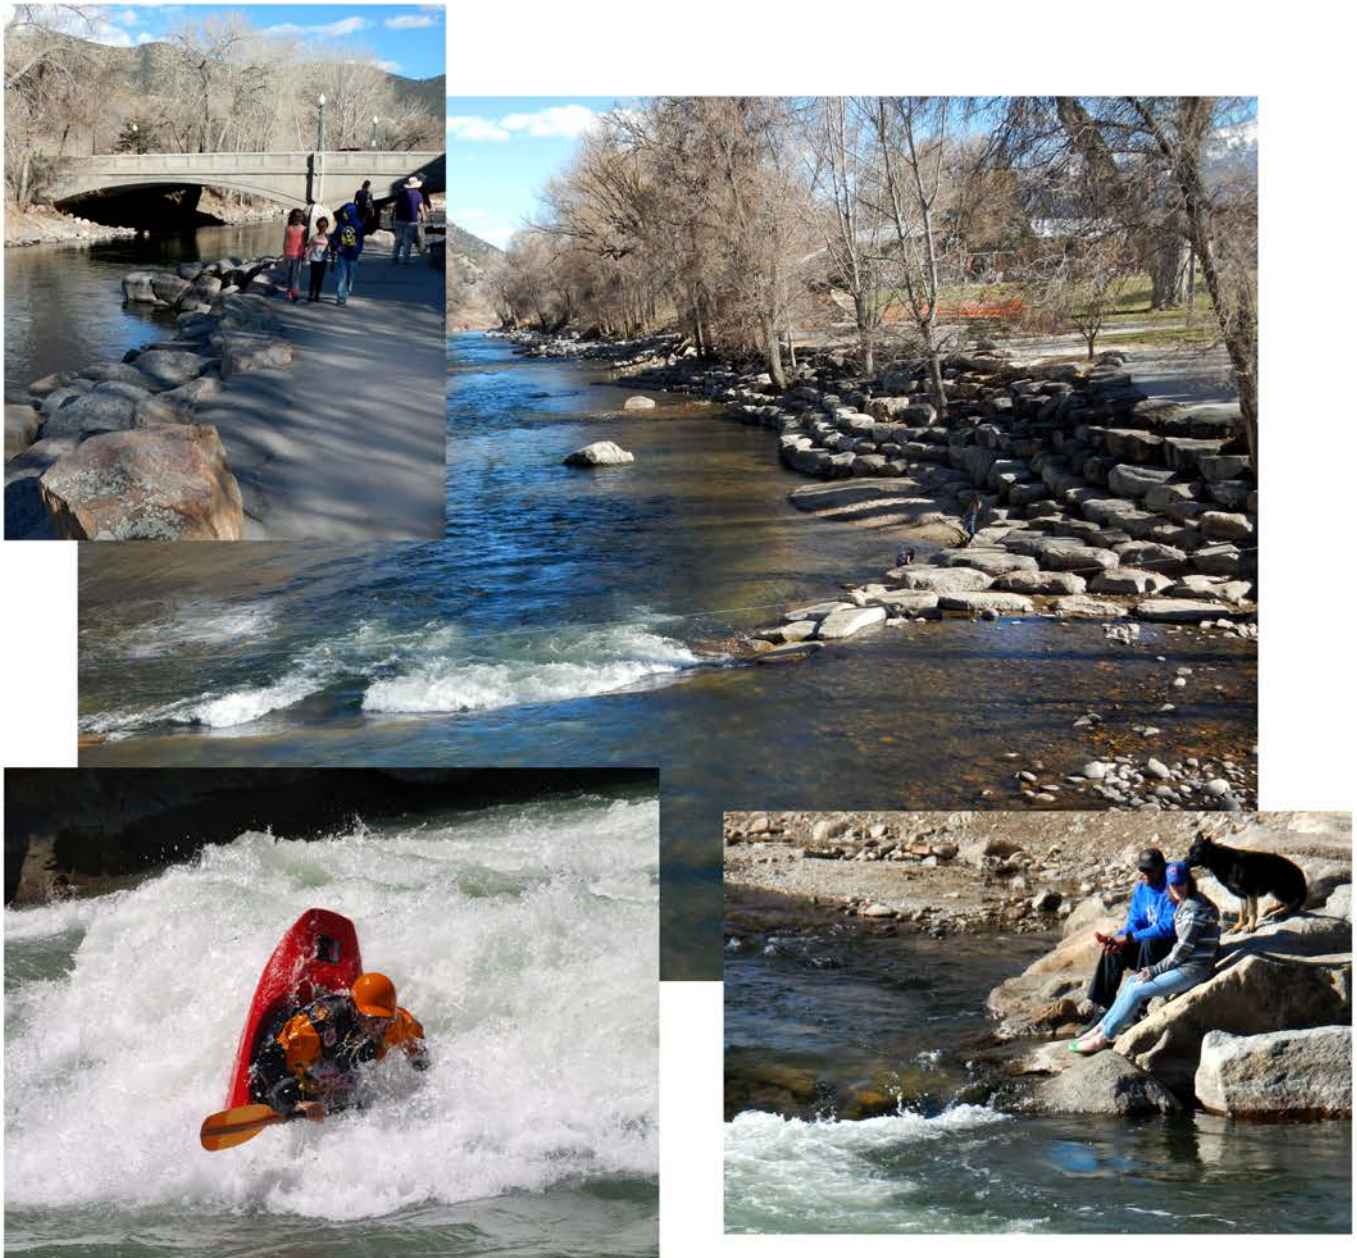
**Figure 57**—This whitewater park in Salida, Colorado, is a large-scale river restoration that includes extensive channel modifications as well as bank improvements. Specifically designed to provide hydraulic features for whitewater boating (ColoradoKayak.com photo, bottom left), the park creates diverse recreation habitats on and off the water, including pathways (top left), seating areas (top right and bottom right), and a “downtown restoration” setting for shops and restaurants (out of sight upstream on river right). Ironically, on-shore areas provide for much larger numbers of recreation-days, compared to boating and other water activities.
