# An Examination of the Summerhaven, Arizona Home Destruction Related to the Local Wildland Fire Behavior during the June 2003 Aspen Fire

Jack D. Cohen  
Research Physical Scientist  
USDA Forest Service  
Rocky Mountain Research Station  
Missoula Fire Sciences Laboratory  
406-329-4821    jcohen@fs.fed.us

August 1, 2003

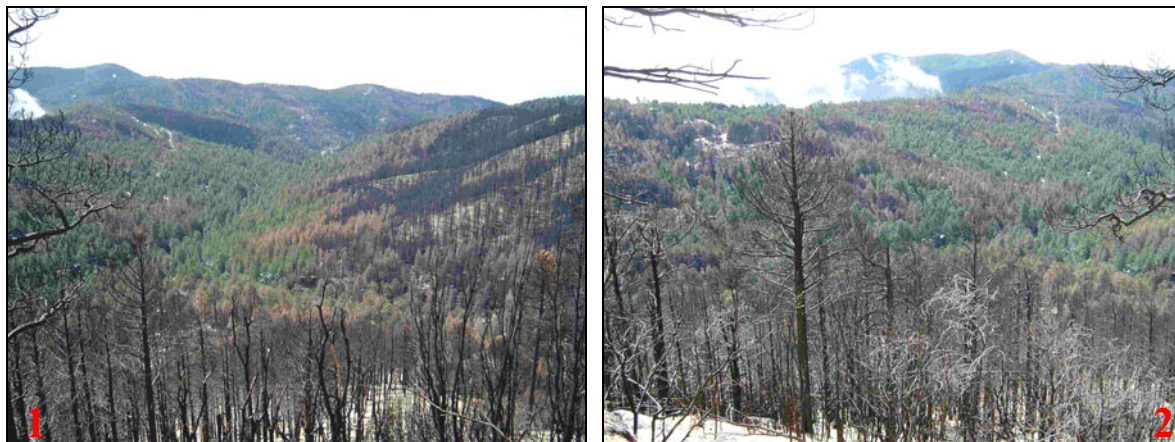
Photos 1,2—active spreading crown fire occurred above and to the west of Summerhaven but did not spread into the residential area.

The Aspen Fire started on June 16, 2003 in the Santa Catalina Mountains north of Tucson, Arizona. On June 19 the fire spread into the mountain community of Summerhaven. Over 300 homes and cabins burned in association with the wildfire. Photos 1 and 2 show the character of the wildfire. Crown fire occurred in limited patches and on the slopes to the west and above the residential area.

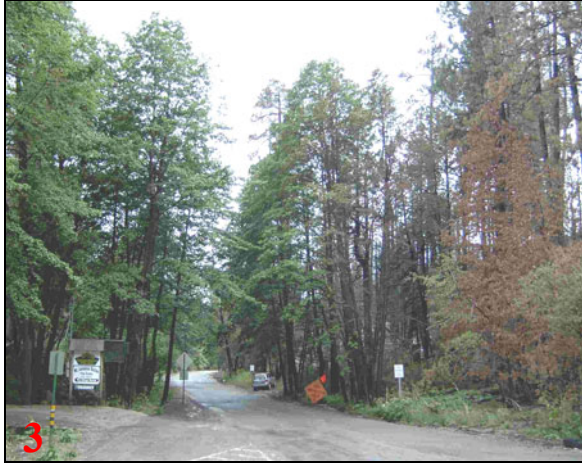
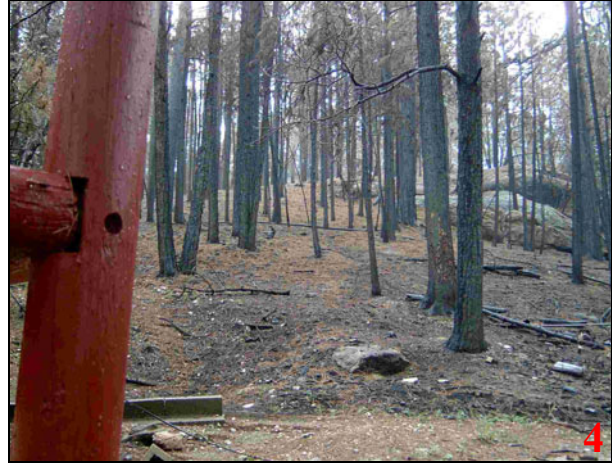
**Photos 3,4—surface fire spread principally occurred within the Summerhaven residential area without burning in the tree canopies (crown fire).**

High intensity crown fire spread did not occur in the bottom of the main gulch where Summerhaven resides. Photo 3 shows the post burn situation along the main road down slope and up-wind from structure locations. Photo 4 shows surface fire spread that was typical under the conifer canopy. Although the surface fire spread does not produce high intensity burning, the intensities and durations produced significant canopy needle kill.

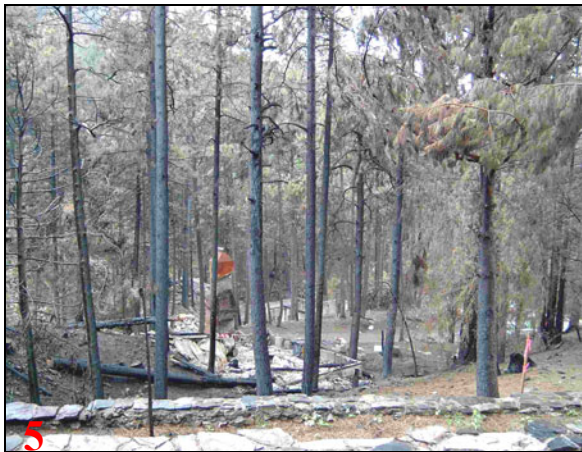
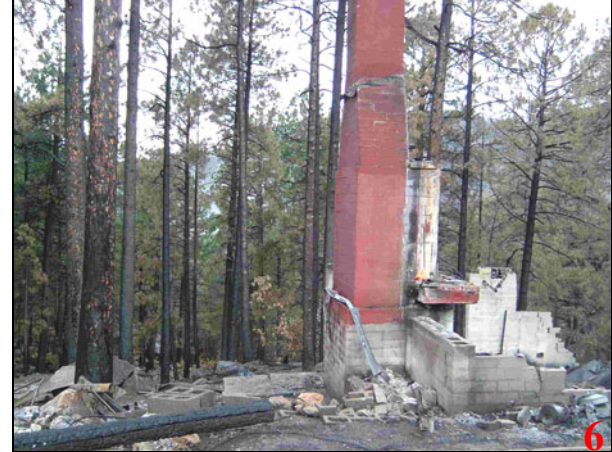
**Photo 5,6—totally destroyed homes surrounded by unconsumed tree canopies indicate that lower intensity surface fires burned in the structures' surrounding areas.**

The surface fire spread does not produce direct flame heating sufficient to ignite the wood exteriors of structures beyond about 10-15 feet. Photos 5-9 provide examples from various locations within Summerhaven that represent the destruction of the entire area.

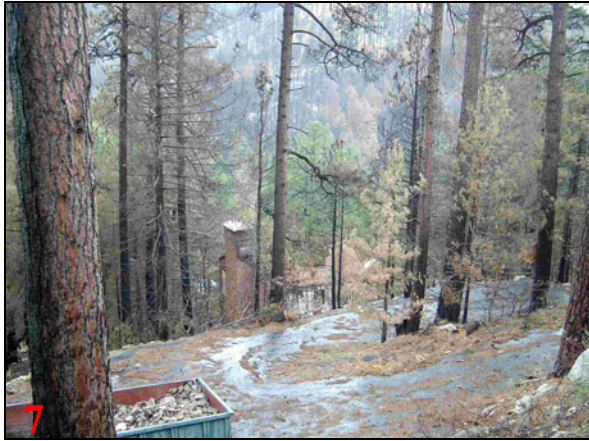
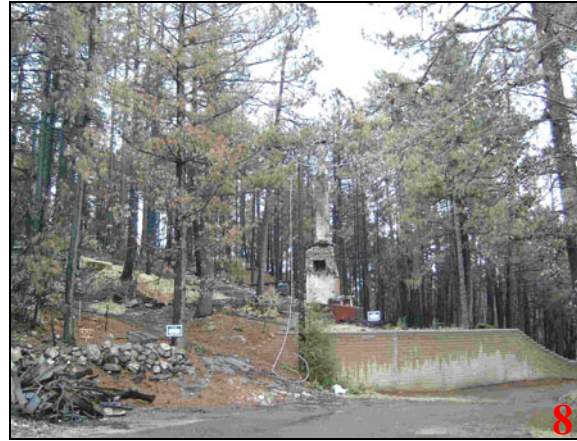
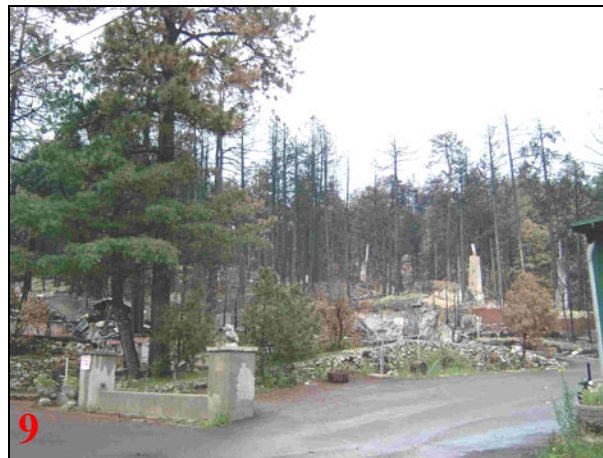
**Photos 7,8,9—totally destroyed homes surrounded by unconsumed tree canopies indicate that lower intensity surface fires spread to the structures' surrounding areas.**

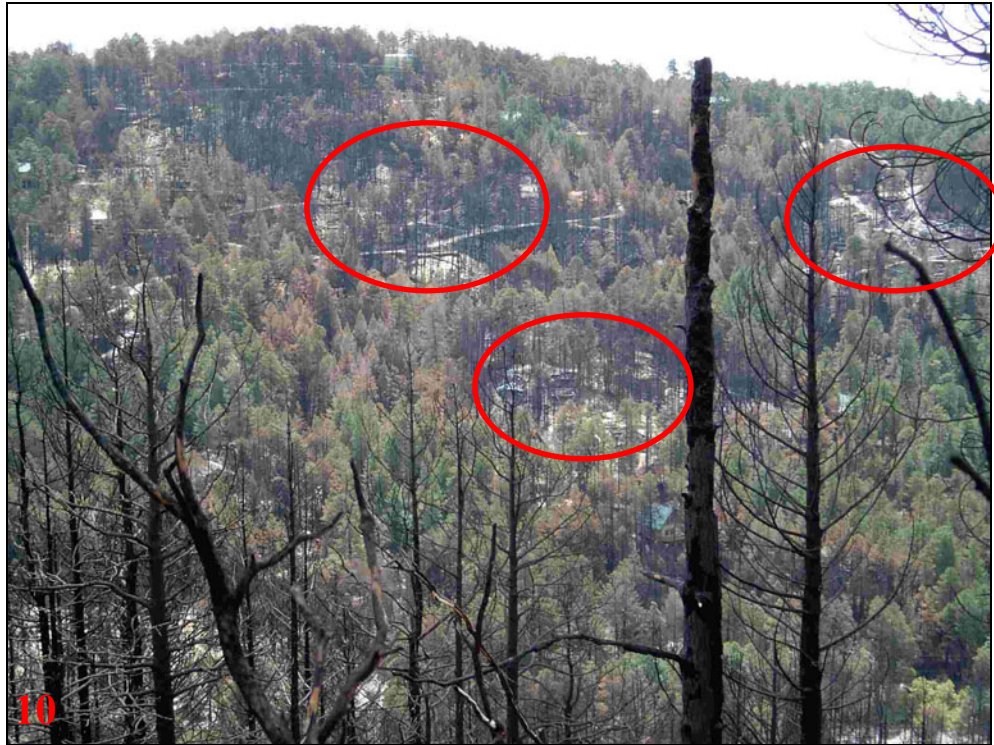
**Photo 10**—patches of burned trees that are associated with multiple totally destroyed homes break the largely unconsumed forest canopy. The red ovals show 3 examples of this burn pattern.

The evidence indicates that burning homes commonly burned the adjacent and overhanging trees. Tree canopy burning began at totally destroyed structures. In several areas of higher structure density, the evidence suggests that burning homes ignited the tree canopy that subsequently carried into adjacent structures. As each structure ignited more canopy ignited. The hillside burn pattern indicates that the ignited tree crowns originated at burning home locations. Photo 10 shows the patched pattern of destroyed homes and associated burned trees surrounded by unconsumed tree canopy. The crown fire originates and ends in association with home destruction. Photos 11-12 show the home destruction and canopy consumption within such a patch. Photos 13-14 show evidence of decreasing consumption and the charring of tree trunks and canopies as the distance away from a structure increases. Note the mottled char pattern on the tree trunks. The mottled portion is where all bark was consumed facing the burning house. The side away is charred but bark remains. Without examining the large scale patterns of home destruction associated with tree crowning and the small scale patterns of consumption, one might get the impression that the high intensity crown fire spread into the residential area and caused the destruction rather than the likely sequence of a home or homes burning leading to tree canopy fire involvement.

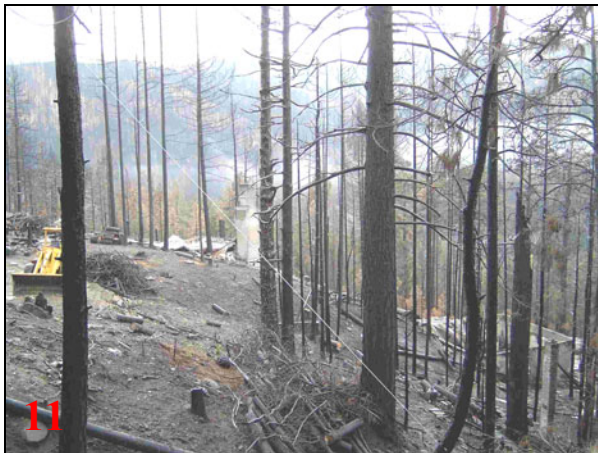
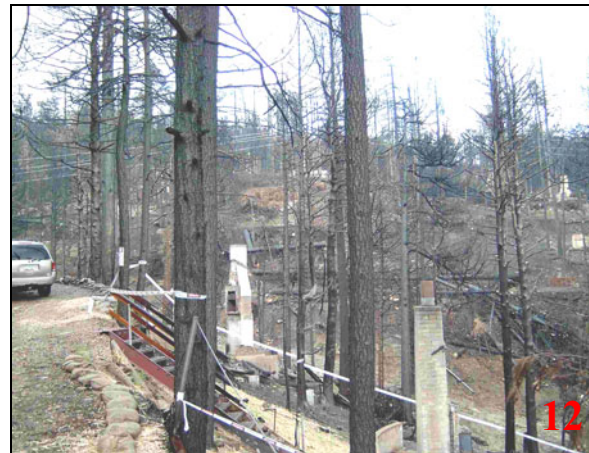
**Photos 11,12**—burning homes commonly burn the trees in close proximity. Where homes are close together, the trees burn around and between the homes producing areas of totally destroyed homes and associated burned tree canopies. Note the multiple homes present in each photo.

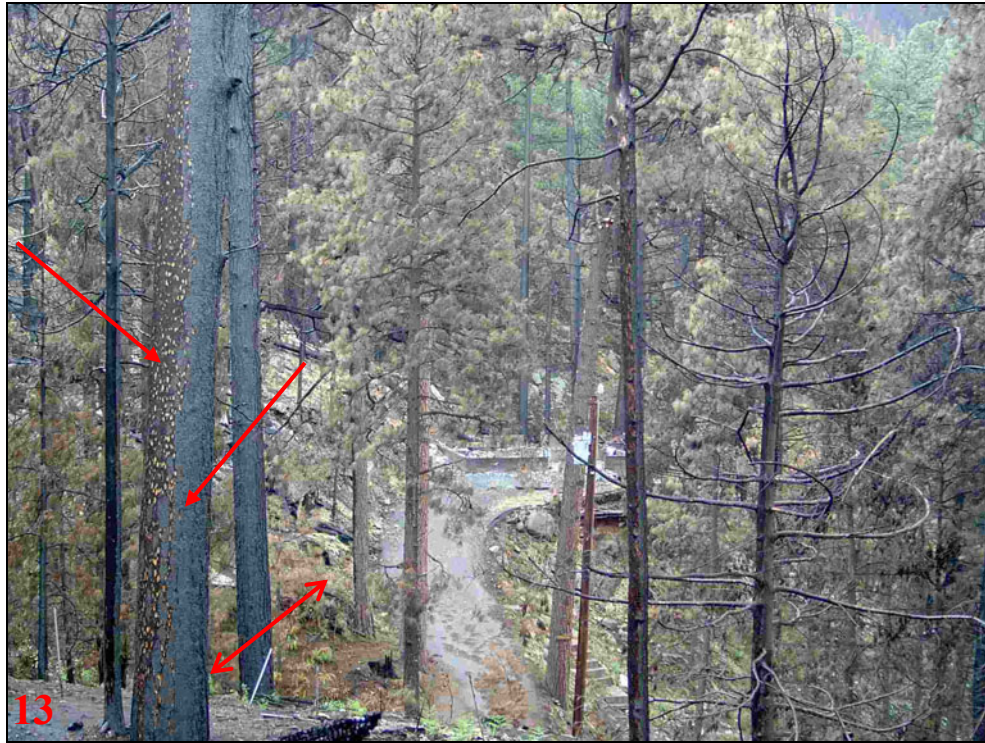
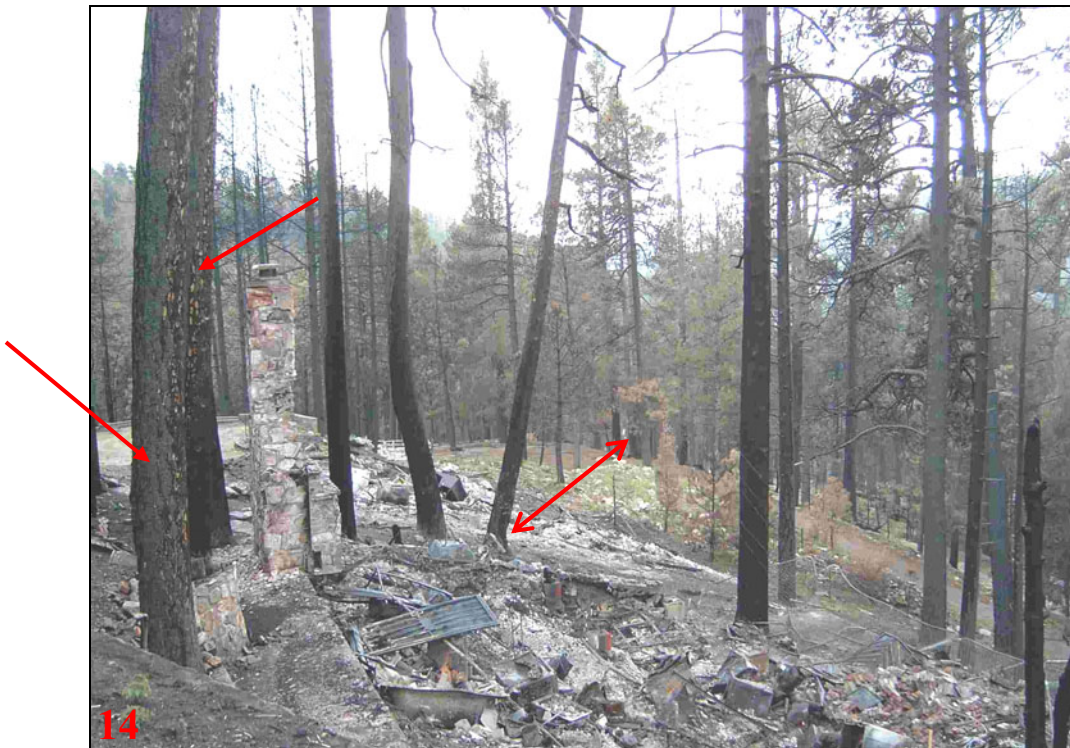
Photos 13,14—the red arrows indicate the complete bark consumption (mottled) on the side facing the burned home and char with remaining bark on the side facing away. The double ended arrow indicates the decreasing consumption and char as the distance from the burned home increases.

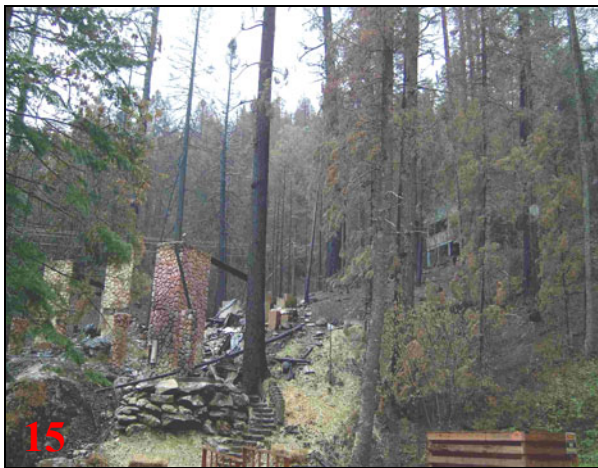
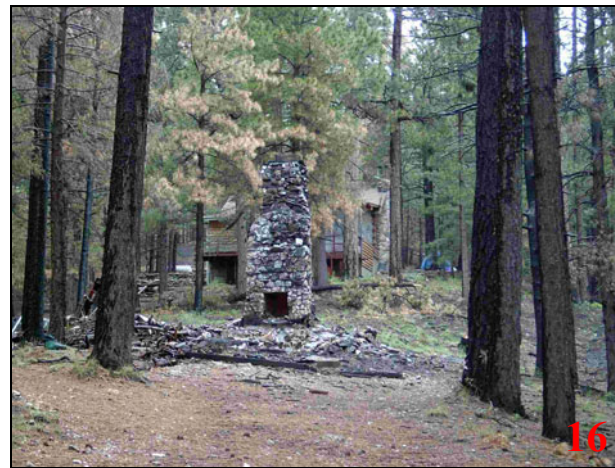
**Photos 15,16—homes destroyed adjacent to homes survived indicates that significant differences existed in the fire and home characteristics necessary to meet the requirements for home ignition.**

That leaves the question of how one home can survive adjacent to total home destruction. Photos 15-16 show such a situation. Fire does not behave capriciously; it either meets the requirements for combustion or not. If a high intensity crown fire had spread through the entire residential area then the distances between structures would not have made significant differences in the requirements for combustion. But even crown fires do not have the ability to directly ignite wood at distances greater than 100 feet. Thus, when surface fire principally occurs, the ability to directly ignite a home must occur within a few feet of or in contact with the flammable parts of the structure. A structure may ignite directly from firebrands that have come from an intense wildland fire at over ½ mile away, but these ignitions are dependent on the materials and design of the structure. Thus, significant differences in the requirements for combustion can occur from one house to an adjacent house. These differences in the direct flame and firebrand exposures related to the home characteristics result in one house surviving next to its destroyed neighbor.
