# DEVELOPMENT OF A REUSABLE TIMBER-CONCRETE-COMPOSITE SYSTEM FOR BRIDGE DECKS

In: Proceedings of the World Conference on Timber Engineering, August 9-12, 2021, Santiago, Chile.  
Paper No: TE0414-1.

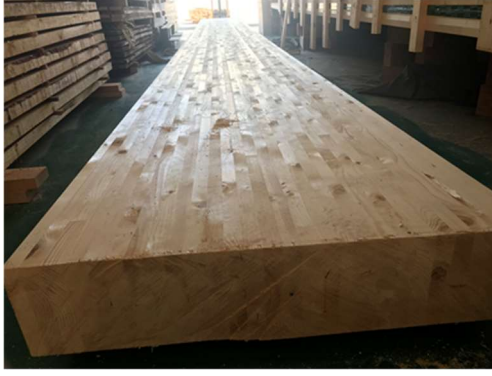
The dynamic MOE was determined through a longitudinal vibration test. The average dynamic MOE of the timber beam was 11699 N/mm<sup>2</sup>, Figure 9 shows a timber beam in the test position.

**Figure 9:** Timber beam of the composite in position to perform the dynamic assessment

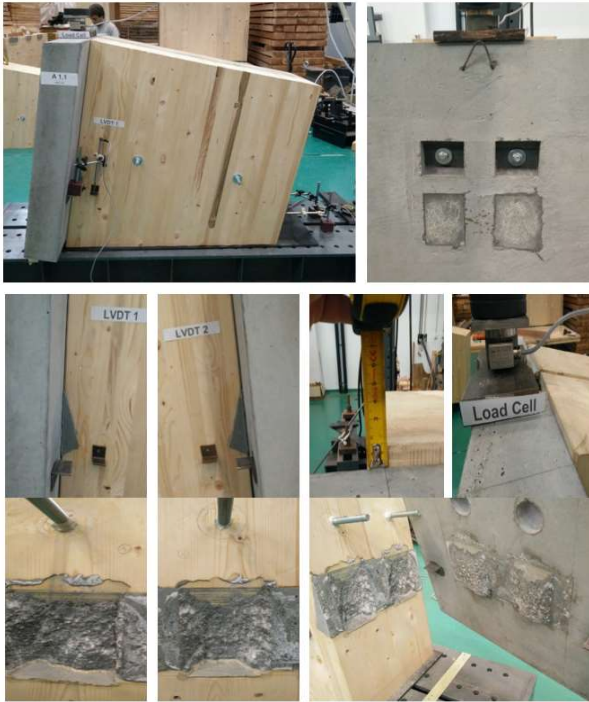
In all the tests performed, the combination of two possible types of failure was consistently observed: failure by shear in grout (*Sika Grout-218*) and failure by compression parallel to grain in the timber. Figure 11 shows the specimen and the failure obtained.

**Figure 11:** Test specimen (before and after failure)

The set of tests performed revealed that the failure mode was the same in all specimens, independent of the type of test performed (solo static, cyclic, or fatigue) and thus the application of cyclic loads or the number of cycles in the connection does not influence the type of collapse of the connection system. However, in the cyclic and fatigue tests, cracking on the concrete surface was additionally observed.
