## ***Chapter 2***

# **SOIL CONSERVATION AFTER WILDFIRES: CHALLENGES, FAILURES, AND SUCCESSES**

***Daniel G. Neary\****  
***and Jackson M. Leonard***

USDA Forest Service, Rocky Mountain Research Station,  
Flagstaff, Arizona, US

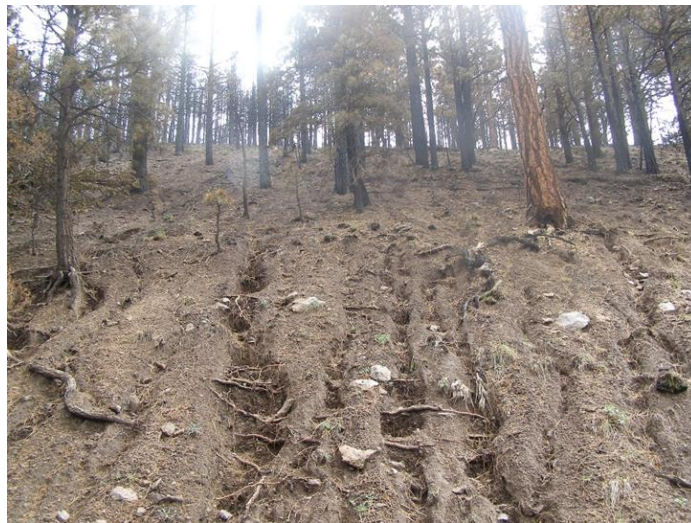
Figure 2. Severe soil erosion showing major rills and A horizon removal after the Schultz Fire, Coconino National Forest, Arizona (Photo by Daniel G. Neary, USDA Forest Service).

desertification process (Neary, 2009; Walker, 1997). Although desertification is commonly considered to be land degradation that is mainly a problem of arid, semi-arid, and dry sub-humid regions of the world, humid regions are now undergoing desertification because of wide-scale fire occurrence, deforestation, and accelerating erosion. A perfect storm of drought, climate change, fuel accretion, and a host of ignition sources have delivered ideal settings for fire-induced desertification and deterioration of soils (Neary, 2009; Neary et al., 2005a; Neary and Leonard, 2015). This situation sets up the need for wildland fire managers to consider conservation measures to limit or repair soil damages produced by fires and their associated management (Figures 2 and 3).

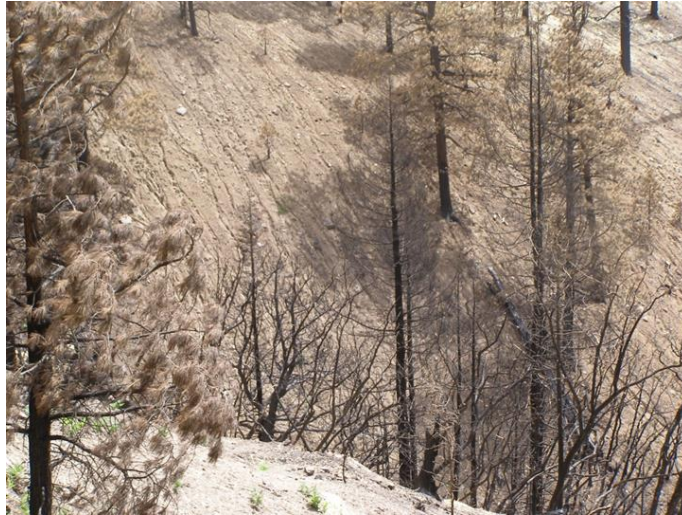
Figure 3. Widespread rill system development on steep slopes (>60%) after the Schultz Fire, Coconino National Forest, Arizona (Photo by Daniel G. Neary, USDA Forest Service).

Soil conservation measures can be implemented at two different stages in the wildfire suppression and management process. The first involves incorporation of conservation techniques into planning and operations directives during the active fire suppression or management phase. The second occurs after a fire is declared controlled and extinguished. Rehabilitation plans may be drawn up separately as part of the fire closeout or may be generated by a formal analysis such as the Burned Area Emergency Response (BAER) program in the USA, and recommendations made during post-fire reviews that include mitigation of soil erosion and vegetation impacts (Figure 3).

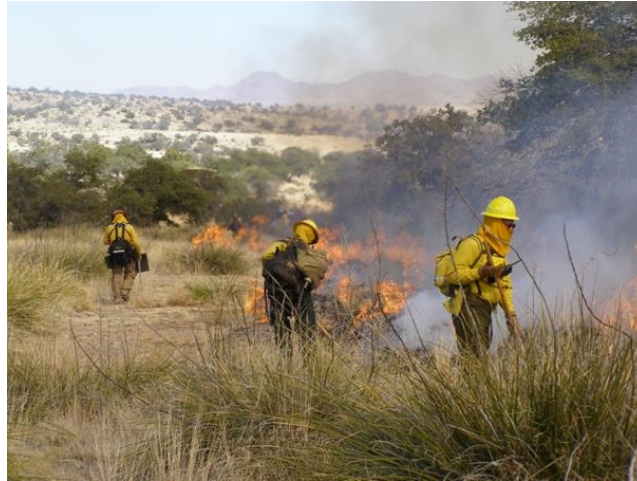
Figure 4. Igniting a prescribed fire along a constructed fireline, Cascabel Prescribed Fire, Coronado National Forest, Arizona. (Photo by Daniel G. Neary, USDA Forest Service).

(DeBano et al., 1998). Target levels should be set for desired ground cover remaining after burning based on slope, soil type, and risk of soil and hillslope movement. Burn areas plans should be designed to use natural or in-place barriers that reduce or limit fire spread, such as roads, canals, utility rights-of-way, barren or low fuel hazard areas, streams, lakes, or wetland features, where practicable, to minimize the need for fireline construction. The types, widths, and locations of firebreaks or firelines need to be identified and documented. Ignition techniques, control methods, and access locations should be used that minimize potential effects to soil, water quality, and riparian resources (Figure 3). Specific soil conservation guidelines for prescribed fire operations are aimed at conducting fire operations in such a manner as to achieve the burn objectives without damaging soil resources (Figures 4 and 5).

- Construct fire lines to the minimum size and standard necessary to contain the prescribed fire and meet overall project objectives.
- Locate and construct fire lines to minimize erosion and runoff from directly entering water resources.
- Consider slope and soil conditions, and use and maintain suitable water and erosion control measures.
- Maintain firebreaks in a manner that minimize exposed soil to the extent practicable.
- Rehabilitate or otherwise stabilize fire lines in areas that pose a risk to water quality.
- Construct streamside management zone (SMZ) fire lines to minimize the amount of area and soil disturbed.
- Consider alternatives to ground-disturbing fire line construction such as using wet lines, rock outcrops, or other suitable features.

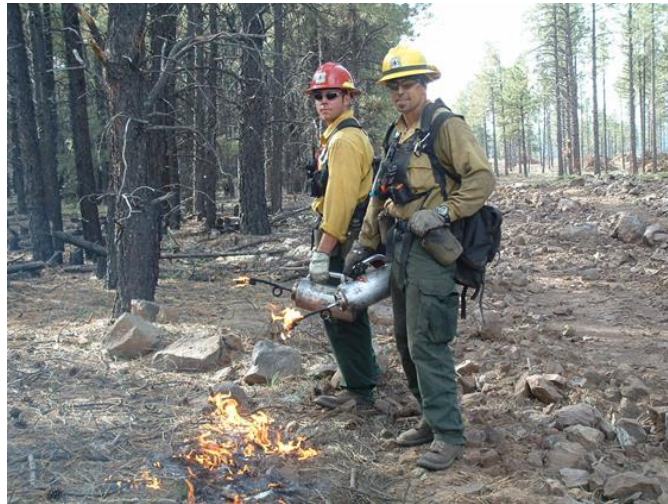
Figure 5. Igniting a prescribed fire along a constructed fire line, Coconino National Forest, Arizona. (Photo by Daniel G. Neary, USDA Forest Service).

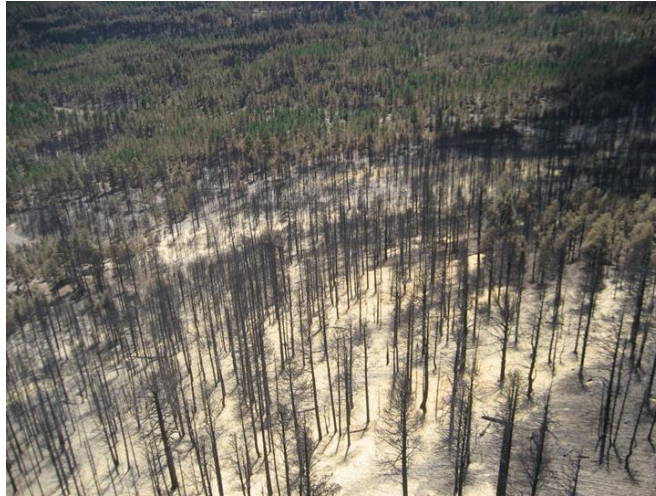
Figure 6. Straw mulched area showing up as a golden color on the 2010 Schultz Fire, Coconino National Forest, Arizona, USA (Photo courtesy of the Peaks Ranger District, Coconino National Forest).

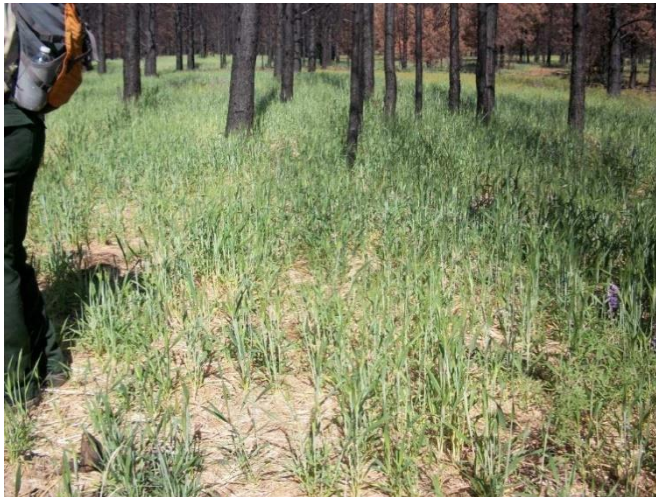
Figure 7. Straw mulched area on the 2010 Schultz Fire showing sterile wheat germination for soil conservation (Photo courtesy of the Peaks Ranger District, Coconino National Forest).

Most successes in soil conservation after wildfires occur when rainfall is delayed or of low intensity and longer duration (DeBano et al., 1998). This gives an opportunity for ecosystem recovery and moderation of hydrologic response. For instance, grass and grain seeding is only effective after plant germination and growth (Figure 7).

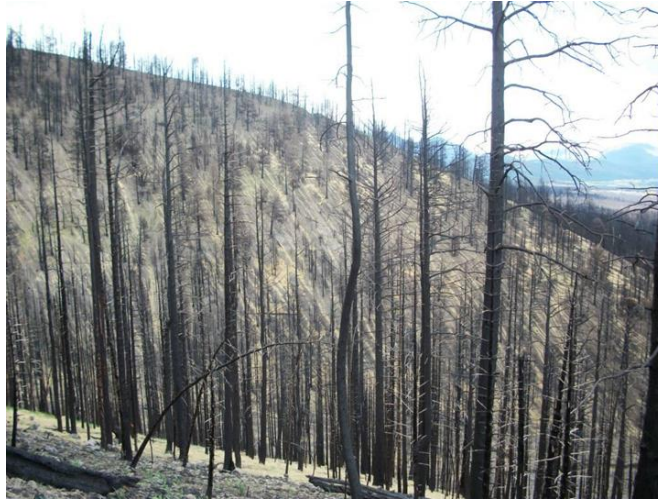
Figure 8. Straw mulch (yellow-gold streaks) in the process of being washed off slopes >60% (Photo courtesy of the Peaks Ranger District, Coconino National Forest).

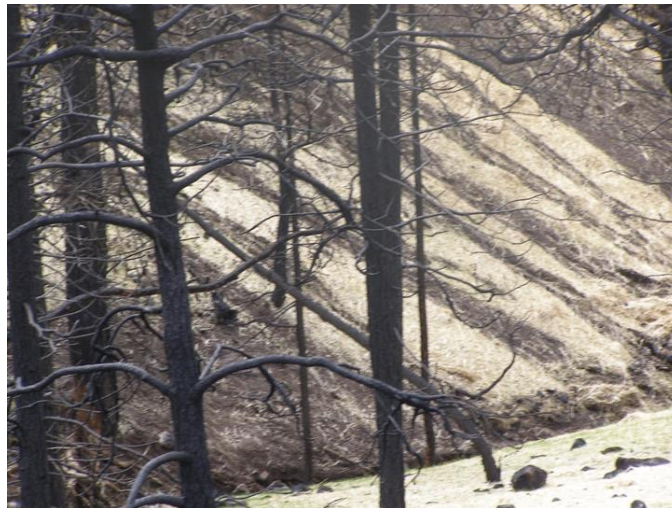
Figure 9. Wood mulch on a slope >60% showing the effects of runoff in developing gullies, Schultz Fire, 2010, Coconino National Forest, Arizona, USA. (Photo by Daniel G. Neary, USDA Forest Service).

Slope is a key factor that produces failures in soil conservation measures (Robichaud et al., 2000; Robichaud et al., 2003). Although mulching can be successful in reducing soil erosion after wildfires, it is slope limited (Robichaud et al., 2010). Even heavy mulches like wood chips fail at reducing erosion on slopes in excess of 60% (Robichaud et al., 2000). Runoff velocities on slopes above that threshold can easily wash off wood mulch and develop rills and gullies that contribute to substantial soil erosion (Figure 9) (Neary et al., 2012). The overwhelming effect of high velocity runoff flow on steep slopes can easily undo mulch applications designed to reduce erosion. Runoff from developing gullies can then lead to major gully development and even more significant erosion (Figure 10).

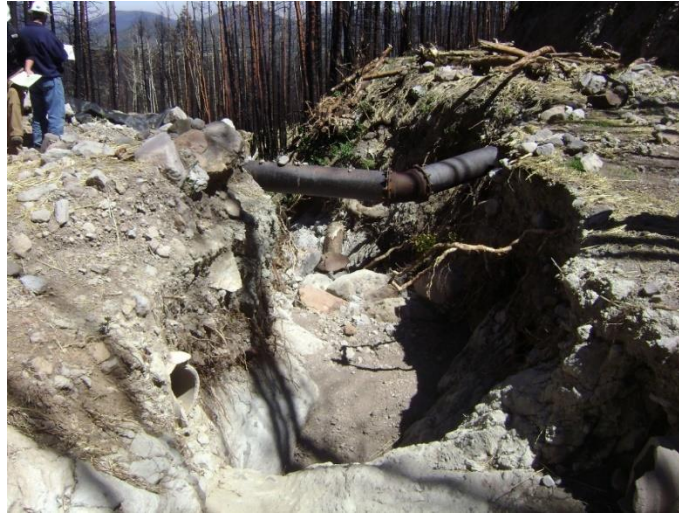
Figure 10. Major gully development after the initial rain event on the Schultz Fire, 2010, Coconino National Forest, Arizona, USA. (Photo by Daniel G. Neary, USDA Forest Service).

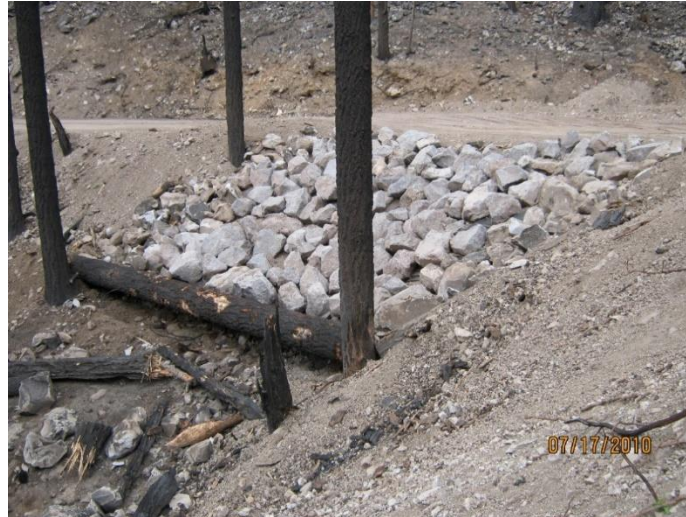
Figure 11. Large rock and boulder rip-rap structure on a road drainage channel immediately after the 2010 Schultz Fire, Coconino National Forest, Arizona, USA (Photo courtesy of Andy Stevenson, Coconino National Forest).

Two other examples of engineering failures occurred after the 2010 Schultz fire in Arizona (Neary et al., 2012). An attempt to armor a channel with large rock after the fire and before any runoff events was a complete failure because of high velocity runoff (Figures 11 and 12). The post-fire soil conservation plan was for 30 – 60 cm rocks and boulders armoring the down-slope portion of a road segment. Slopes in this vicinity were in excess of 100%. Runoff in the first major storm was high velocity – high flow despite relatively low rainfall amounts (Neary et al., 2012). The nexus of steep slopes, high water repellency, high burn severity, and intense, short duration rainfall was sufficient to produce extreme amounts of erosion. The erosion was estimated to be over 1300 Mg ha<sup>-1</sup> (Neary et al., 2012).

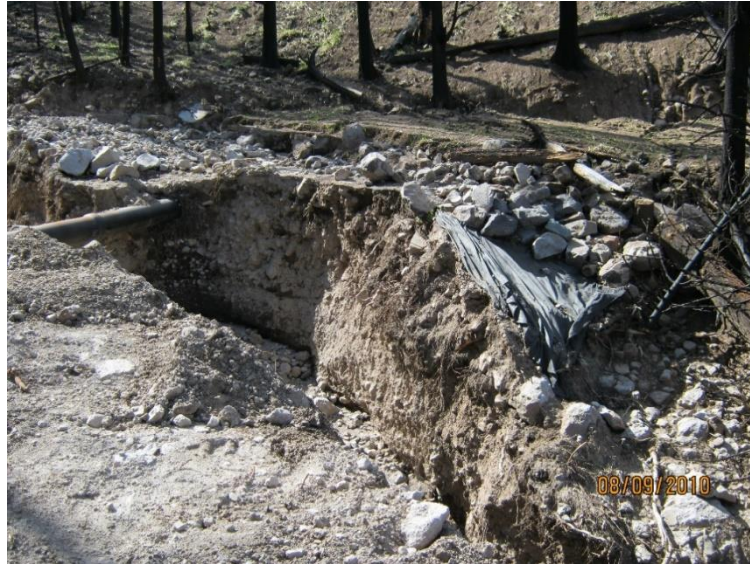
Figure 12. Remnants of a failed structure similar to that shown in Figure 11. The large rocks and boulders, and black plastic sheeting remnants can be seen to the right of the newly incised gully. The gully depth is about 3 m below the original road grade. (Photo by Daniel G. Neary, USDA Forest Service).

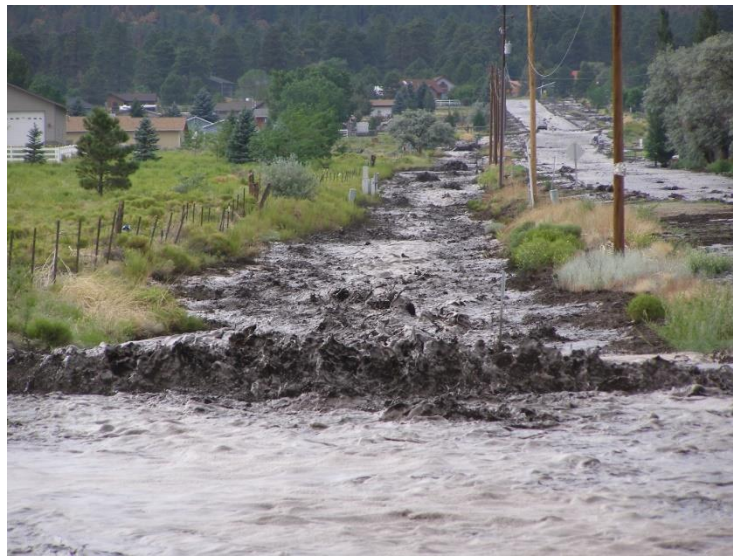
Figure 13. Flood flows in the ditch along Campbell Avenue on 21 July 2010 immediately after the 2010 Schultz Fire, Coconino National Forest, Arizona, USA. (Photo by Daniel G. Neary, USDA Forest Service).

Another type of soil conservation engineering failure can occur when construction basics are ignored. An example occurred on the 2010 Schultz Fire in Arizona. A decision was made to construct a series of rock-wire gabions along a road after the first large runoff (Figure 13). The runoff was scouring laterally and threatening above- and below-ground utility lines (Figure 14). A series of 26 rock-wire gabions were constructed long Campbell Avenue to reduce flow velocities and bank erosion (Figure 15). However, in the rush to get the gabions in place before the next rain event, three critical details were overlooked. First, the gabion wing walls were not embedded far enough into the ditch banks to prevent flow around the structures. Second, the gabions were not constructed in a u-shaped design to force flows to the center of the channel. Third, adequate splash pads were not built on the downstream side of the gabions to prevent undercutting scour. The results of the oversights were failure of all 26 gabions and continued lateral migration of the ditch (Figure 16). Another approach was tried to protect the adjacent utilities by means of rock-wire bank protection

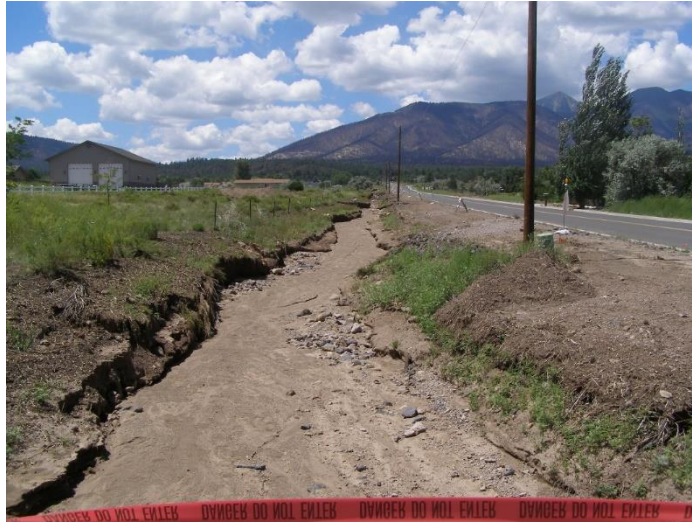
Figure 14. Condition of the Campbell Avenue ditch after the 21 July 2010 storm runoff. Burned runoff source area on the San Francisco Peaks is in the background (Photo by Daniel G. Neary, USDA Forest Service).

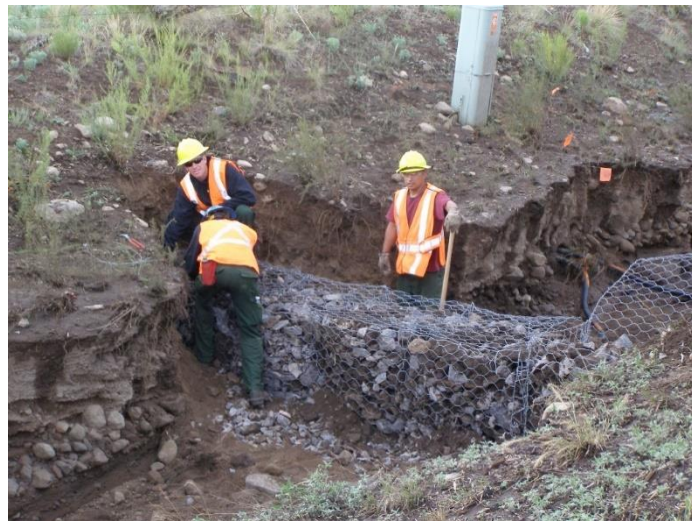
Figure 15. Construction of rock-wire gabions in the Campbell Avenue ditch after the 2010 Schultz Fire, Coconino National Forest, Arizona. (Photo by Daniel G. Neary, USDA Forest Service).

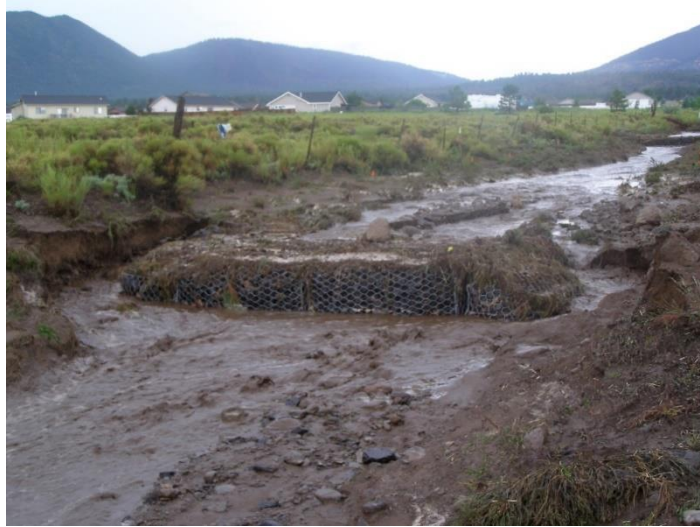
Figure 16. Failure of rock wire gabions in the Campbell Avenue ditch due to design and installation errors after the channel had been upgraded to prevent excessive erosion, 2010 Schultz Fire, Coconino National Forest, Arizona. (Photo by Daniel G. Neary, USDA Forest Service).

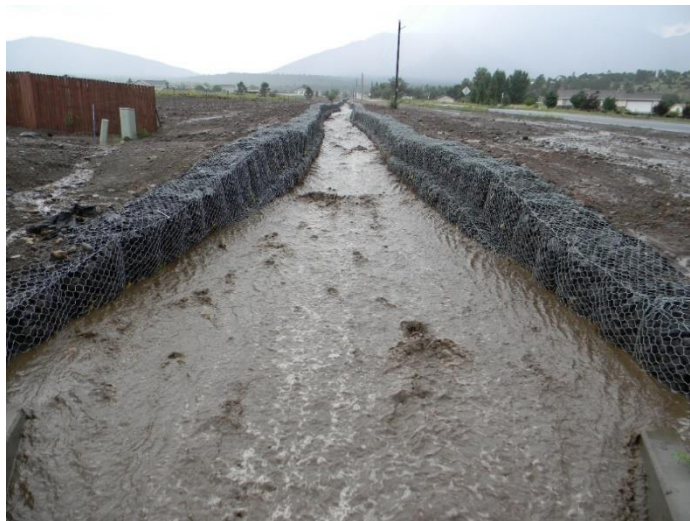
Figure 17. Second attempt at stabilizing the Campbell Avenue ditch using rock-wire gabions to stabilize the banks. (Photo by Daniel G. Neary, USDA Forest Service).

(Figure 17). This worked for a short period of time until another significant storm destroyed part of the vertical bank protection (Figure 18). Stormflow filled the channel, undercut the vertical gabions causing them to lean, and then eroded out soils causing the gabions to lean into the flow. The error from this attempt was corrected by reconstruction of failed segments and pouring of a cement floor along the entire channel distance to prevent undercutting.

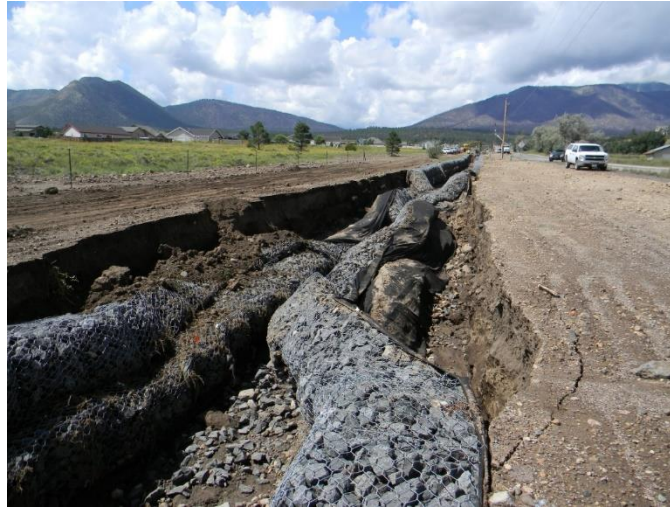
Figure 18. Failure of sections the bank rock-wire gabions in the Campbell Avenue ditch after another storm runoff event. (Photo by Daniel G. Neary, USDA Forest Service).

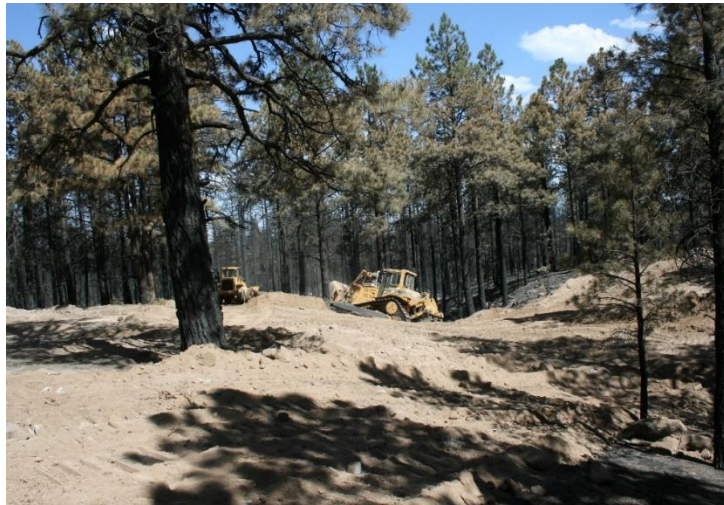
Figure 19. Culvert removal and low-water crossing construction on the Schultz Pass Road after the 2010 Schultz Fire, Coconino National Forest, Arizona (Photo courtesy of Dick Fleishman, Coconino National Forest)

the approach to culvert removal (Wagenbrenner et al., 2006; Robichaud et al., 2000). Culvert removal was conducted on 30 drainage crossing on the Schultz Pass road within the 2010 Schultz Fire perimeter (Figure 19). This created a series of low-water crossings instead of culverted crossings. After the first large storm of 21 July 2010, all low water crossings were passable for vehicles. Passage of vehicles was feasible until late in August when storm runoff incised one crossing to the point where reconstruction was warranted (Neary et al., 2012).

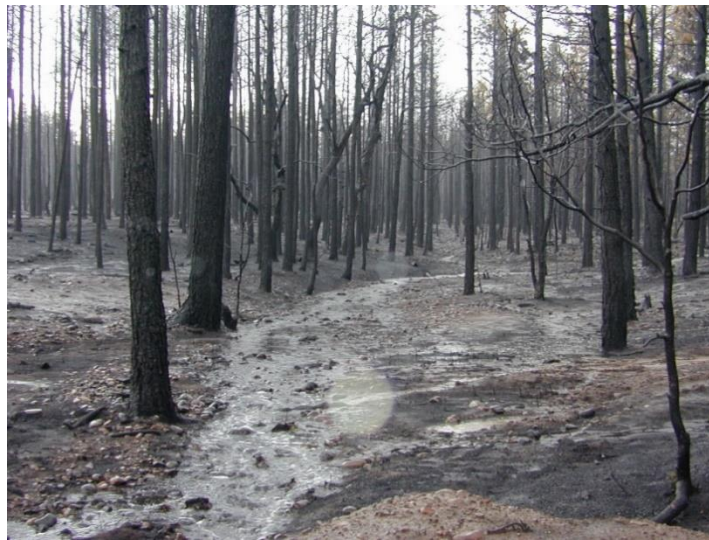
Figure 20. Low velocity runoff after rainfall on the 2002 Rodeo-Chediski wildfire, Apache-Sigreaves National Forest, Arizona. (Photo by Daniel G. Neary, USDA Forest Service).

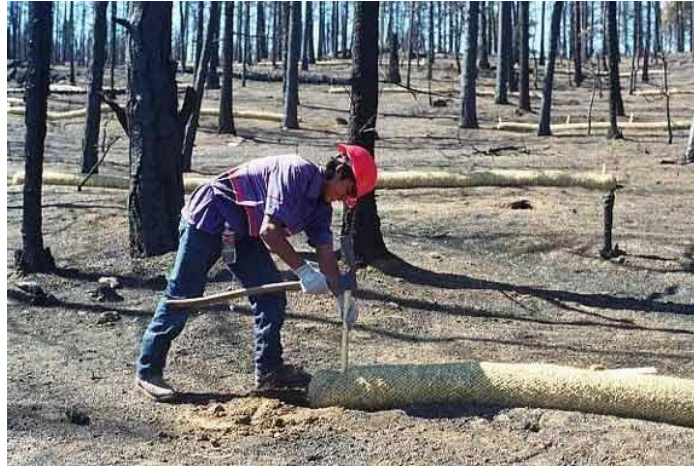
Figure 21. Straw wattles deployed on low gradient slopes to trap sediment in runoff. (Photo courtesy of the USDA Forest Service).

Soil conservation techniques are usually the most successful in terrain with limited relief even with high severity fire (Neary, 2019). Since erosion is driven by water velocity, in low relief conditions water will eventually drain off during storm events but the erosive power is reduced to transporting fine-textured soil particles (silts and clays)(Figure 20). Low gradient slopes also allow the effective use of machinery to implement soil conservation techniques at lower costs. Techniques such as straw wattles are easier to deploy and trap more sediment if slopes are minimal (Figure 21) (Robichaud et al., 2000).
