Article

# Impacts of Hurricane Michael on Watershed Hydrology: A Case Study in the Southeastern United States

**Citation:** Worley, E.; Liu, N.; Sun, G.; Norman, S.P.; Christie, W.M.; Gavazzi, M.; Boggs, J.; McNulty, S.G. Impacts of Hurricanes on Hydrology: A Case Study in a Coastal Plain Watershed in the Southeastern United States. *Forests* **2022**, *13*, 904. <https://doi.org/10.3390/f13060904>

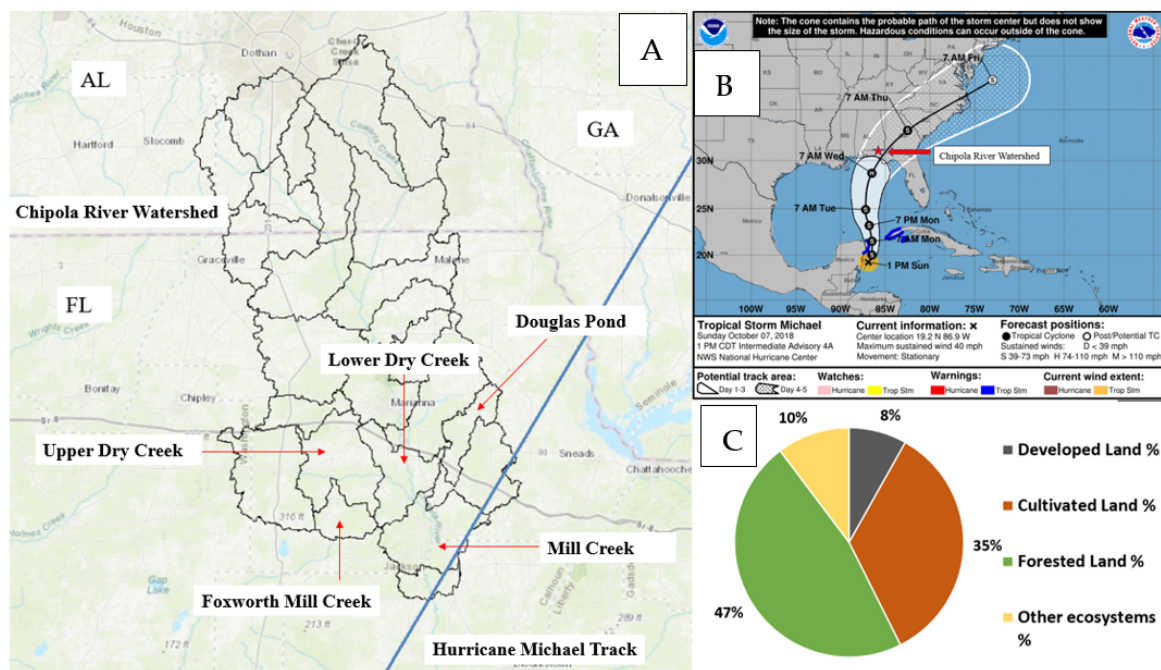
**Figure 1.** Location of Chipola River watershed (A) in association with hurricane track (blue line), hurricane track and categories over time (B) (<https://www.weather.gov/tae/HurricaneMichael2018>) (accessed on 15 February 2022), and breakdown of land use and land cover of the study watershed (C).

The Chipola River watershed (2023 km<sup>2</sup>) was chosen as the area of interest for this study due to its location within the track of Hurricane Michael, the availability of pre-disturbance and post-disturbance streamflow data, and the large fractional forest cover (47%) of the watershed (Figure 1). The Chipola River watershed includes a portion of the northern panhandle of Florida and southeastern Alabama and includes the city of Marianna, Florida, and southern portions of Dothan, Alabama. Most forested areas within this watershed are in low gradient areas with water table levels close to the surface. Small streams' drainage is characterized, and coastal wetlands aid in surface water retention [13]. The average annual precipitation for this area is approximately 1360 mm/yr. The annual temperature across this watershed ranges between 10 and 28 °C. Based on the 2016 National Land Cover Database (NLCD) data product, the Chipola River watershed includes 47% forested land, 35% cultivated land, 8% developed land, and 10% classified as other ecosystems (Figure 1). The majority of forested areas within the watershed are classified by the NLCD as evergreen forest (24%) or woody wetlands (21%). Aerial and ground photographs shown in Figure 2 depict severe forest damage from Hurricane Michael across the Chipola River watershed.

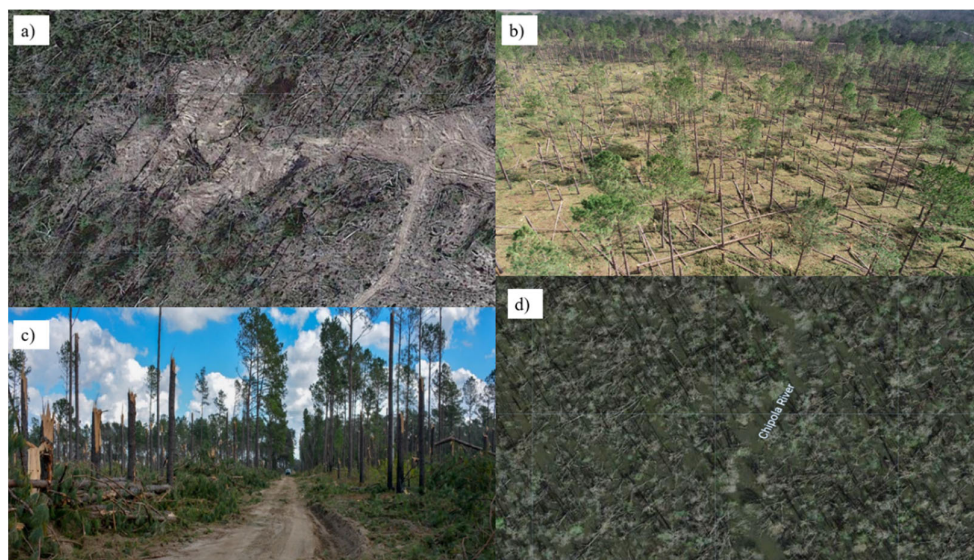
**Figure 2.** Aerial and ground imagery of Hurricane Michael damage to both plantation and natural forests. Salvage harvesting efforts within the Chipola River watershed (a), aerial (b) and ground (c) imagery of Hurricane Michael damage from the Alabama Forestry Commission Initial Damage Report [27] (reprinted/adapted with permission from the Alabama Forestry Commission. 2018, Elishia Ballentine), and (d) downed stems and canopy damage to riparian forests surrounding the Chipola River.

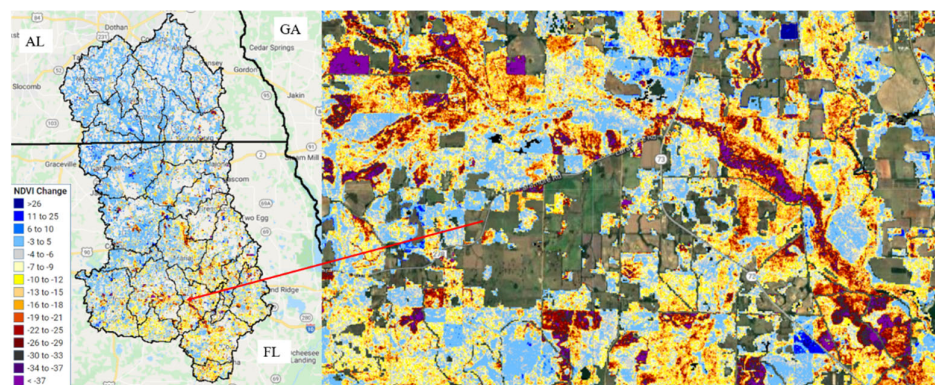
**Figure 3.** Change in growing season NDVI of forested lands between pre-storm (2018) and post-storm (2019–2020) periods within the Chipola River watershed using Google Earth Engine Sentinel 2 Level-2A data. NDVI change output is calculated as absolute change (NDVI value multiplied by 100). Satellite RGB images illustrate post-storm conditions, salvage harvesting, and riparian zone destruction. Within the highlighted areas NDVI levels of 0.77 before the storm dropped to 0.22 within the severely impacted (purple) areas following Hurricane Michael.

Utilizing the capabilities of Earth Engine and Sentinel 2 imagery data, we found severe and large-scale forest disturbance within the southern portion of the Chipola River watershed (Figure 3). High-resolution satellite images depict broken stems, damaged crowns, and other impacts on managed forest stands and bottomland riparian systems buffering the Chipola River. These impacts correspond with the timber damage estimates listed in the reports issued by the Alabama, Florida, and Georgia Forestry Commissions. An overall shift in the frequencies of NDVI values between the 2018 and 2019 growing seasons is shown in Figure 4. The average NDVI value dropped from 0.64 to 0.59, illustrating a significant shift to lower values ( $p < 0.0001$ ). From the 2019 to 2020 growing season, a positive NDVI change was observed ( $p < 0.0001$ ). This recovery could be explained by the regrowth of early successional species, natural regeneration of previous overstory species, and artificial regeneration efforts by land managers within the area.

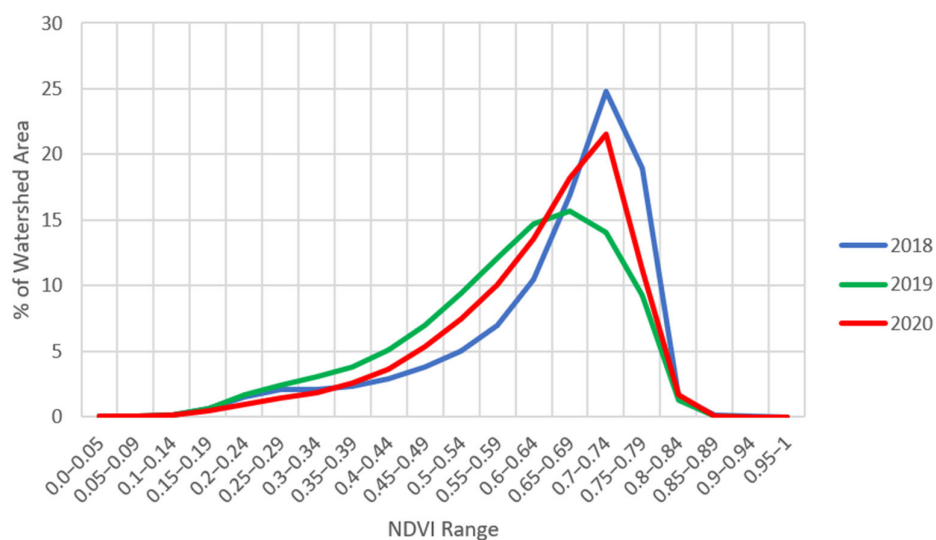
**Figure 4.** Growing season Sentinel-2 NDVI distribution between 2018, 2019, and 2020 within the Chipola River watershed. Average NDVI values were approximately 0.64, 0.59, and 0.62 for 2018, 2019, and 2020.

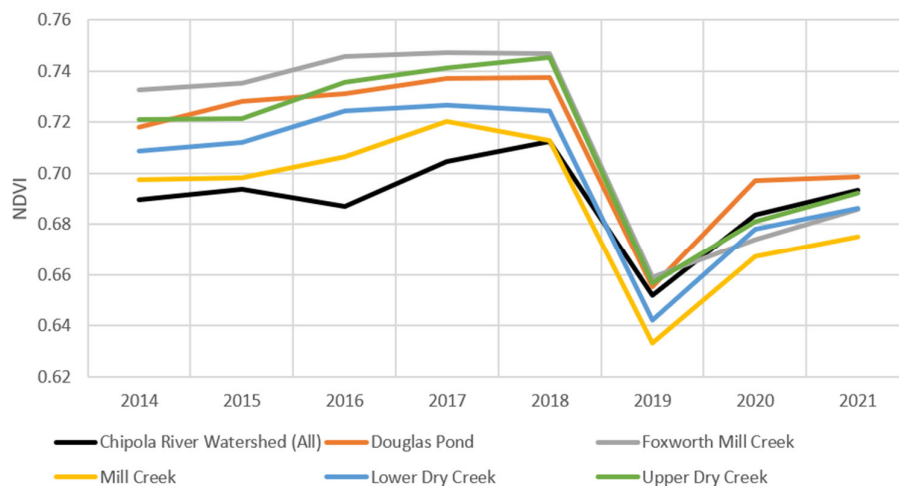
**Figure 5.** Changes in average growing season MODIS NDVI of severely impacted HUC12 sub-watersheds by Hurricane Michael located in the southern portion of the Chipola River Watershed. Growing season for this analysis was defined as May through October.

Pronounced changes in the growing season MODIS NDVI occurred in five of the HUC12 sub-watersheds close to Hurricane Michael's path (Figure 5). A significant decline ( $p$ -value = 0.04) in NDVI (>10%) was observed for those sub-watersheds in 2019 compared to 2018, and a slight vegetation recovery was seen in 2020. A sharp decrease in growing season NDVI between 2018 and 2019 is illustrated in Figure 5 using the MODIS remote sensing product.

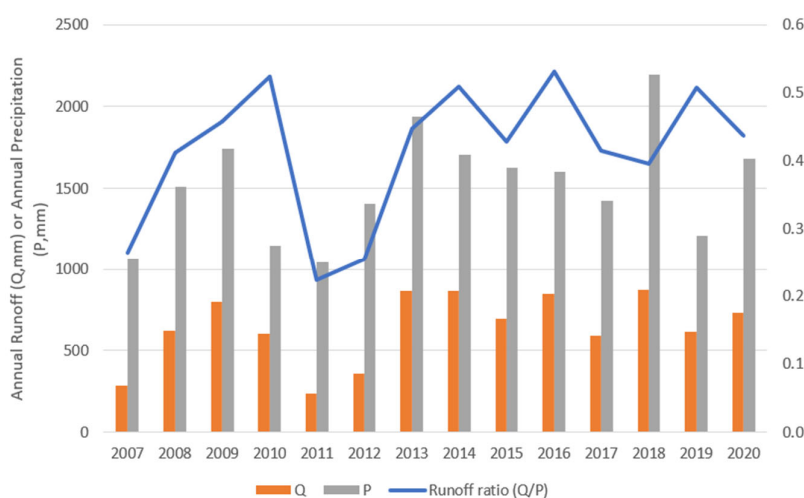
**Figure 6.** Total annual runoff and precipitation and runoff–rainfall ratio for the Chipola River watershed 2007–2020.

During the ten years before Hurricane Michael (2007–2017), the Chipola River's mean daily watershed discharge was approximately 1392 cubic feet per second or 1.7 mm/day. During this period, the average gauge height was approximately 11 ft (3.4 m). During 2018, the daily average discharge increased to 1971 cubic feet per second or 2.4 mm per day; however, this increase was not significant ( $p > 0.05$ ). In the month of the hurricane event (October 2018), streamflow rates were 230% higher than the 10-year pre-hurricane flow values. These discharge rates were sustained into November 2018. Streamflow rates decreased by an average of 18% in 2019 compared to the 10-year average rates. Near-normal discharge rates were recorded over the majority of the 2020 year until observed streamflow were recorded at above-average rates from September through December. At the annual scale, the 2018 streamflow (870 mm) was much higher, but not significant, compared to 10-year "normal" values (642 mm) ( $p > 0.05$ ). During the following two years, streamflow values were lower (614 mm in 2019) and higher (733 mm in 2020) than the long-term mean but were not significantly different from this mean ( $p > 0.05$ ). However, the runoff–rainfall ratio (Q/P) (0.40) in 2018 was similar to the long-term mean (0.42). The Q/P for 2019 was 0.51, close to the record high (0.53) that occurred in 2016 after a tropical storm and a category 1 hurricane, both tracked near the Chipola River watershed, but Q/P was recorded at 0.44 in 2020. Measured discharge, precipitation, and corresponding runoff–rainfall ratio for 2007–2020 are shown in Figure 6.

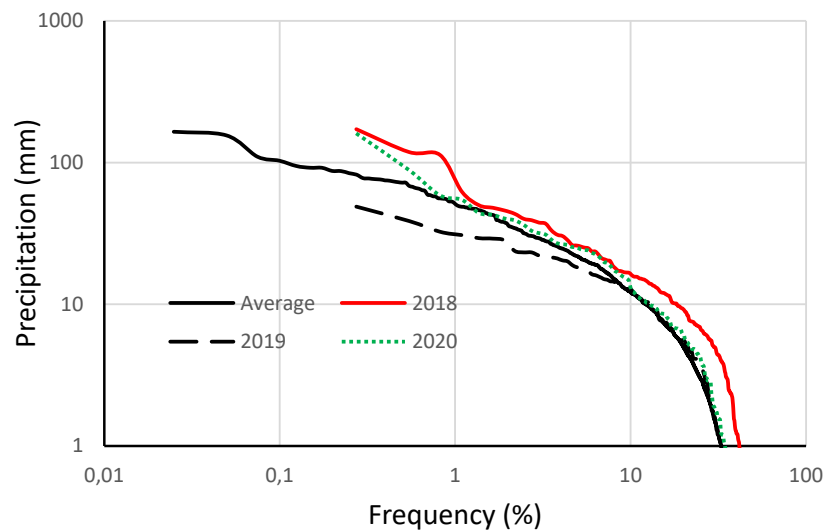
**Figure 7.** Precipitation flow curves for the 11-year (2007–2017) pre-Hurricane Michael and the individual years following the disturbance event in 2018 in Chipola River Watershed.

Daily rainfall in 2018 was much above the historical daily average. Additionally, the 2018 storm frequency (all degrees of intensity) was much above the historic storm frequency, Figure 7). Daily rainfall distributions in 2019 and 2020 were close to the historical means for over 95% of rainfall events. However, fewer storms produced less than 20 mm of precipitation during 2019 and 2020 compared to the historic period.

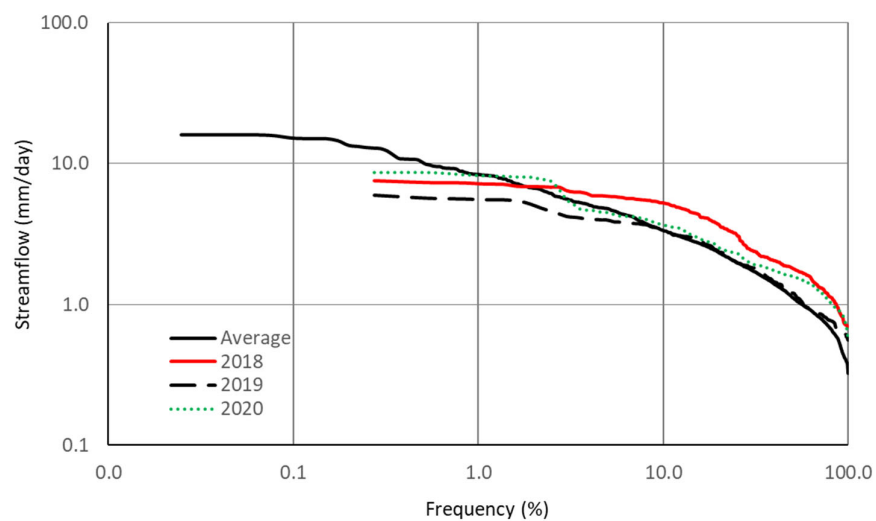
**Figure 8.** A comparison of streamflow flow duration curves for pre-Hurricane Michael (2007–2017) and the individual years following the disturbance event in 2018 in Chipola River Watershed.

Daily streamflow rates in 2018, similar to precipitation patterns, were higher than the 10-year average for all categories (Figure 8). However, most 2020 streamflow rates (exceedance  $> 10\%$ ) were higher than historical data. For 2019, streamflow distribution was similar to historical patterns but was lower in high flow categories (exceedance  $< 10\%$ ).

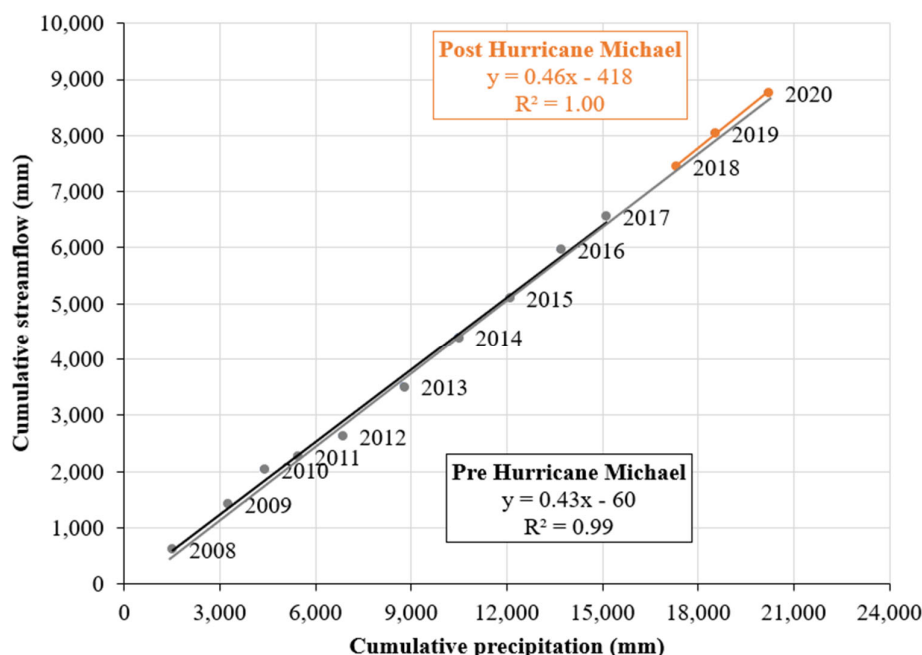
**Figure 9.** Double Mass Curve (Accumulative annual precipitation vs. streamflow for the period from 2007 to 2020) for Chipola River Watershed for detecting streamflow change during 2018–2020 due to Hurricane Michael in October 2018.

The DMC curve (Figure 9) shows that 2018 had the expected flow, but 2019 had no significant departure from the regression line developed using 2007–2017 ( $p > 0.05$ ). Based on the DMC for pre-Hurricane Michael, the expected accumulative flow was 8371 mm in 2019 compared to the measured flow of 8249 mm, suggesting a negative accumulative flow deviation of 121 mm. Because the accumulative deviation in 2018 was −215 mm, the actual flow change in 2019 was determined as 94 mm. Similarly, the change in streamflow of 11 mm was detected for 2020. DMC theory attributed these changes to factors beyond precipitation, such as vegetation change that affected ET. Therefore, the detected

magnitudes of increased flow (11–91 mm) were considered within the modeling errors and not significant statistically. From 2007 to 2017, flow change due to factors beyond precipitation by the DMC model varied from +163 mm to −246 mm. Therefore, the slopes of the regression models (0.43 vs. 0.46) for the two periods were not significant ( $p > 0.1$ ).

September 2020 (Figure 9). Other studies have shown how coastal plain forested watersheds previously impacted by hurricane events have recovered quickly despite substantial damage to forest canopies, suggesting that these ecosystems possess some hydrologic resiliency to storm impacts [13]. Coastal plain forests support high levels of biomass production due to climate and nutrient factors [13]; therefore, the resurgence in NDVI values is expected from flourishing understories. Furthermore, other ecosystem types, such as the salt marshes that line the coasts of the Southeastern US and are crucial for storm surge protection and water quality, share some degree of resistance or resilience to hurricane impacts. For example, a post-storm analysis of coastal salt marshes along the Florida panhandle after Hurricane Michael showed that only 2% of the total ecosystem was damaged (e.g., deposition, vegetation loss, erosion, conversion to open water) [28]. Ecosystem recovery may have been affected by lagging impacts from Hurricane Michael. These impacts are primarily due to a hurricane's ability to alter soil processes. As previously stated, hurricanes influence the nutrient export of an area through erosion and soil leaching and can severely strip soils of nitrogen and phosphorus [49]. This leaching may have drastically reduced nutrient concentrations leading to a longer recovery time.

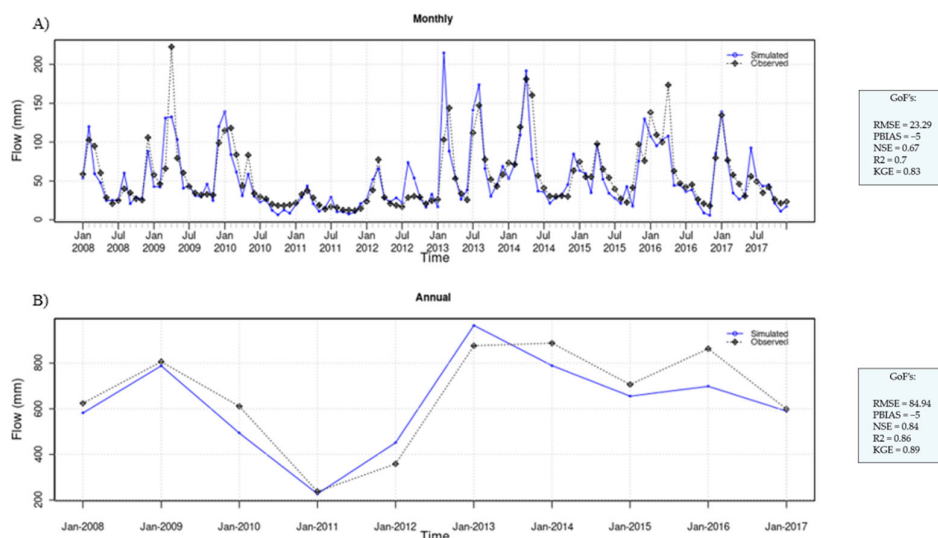
**Figure 10.** The WaSSI model validation with (A) monthly and (B) annual measured streamflow at the USGS gauging station Chipola River near Altha, FL, USA, ID No. 02359000.

The WaSSI model was validated against observed streamflow data for the period before the 2018 Hurricane Michael. The WaSSI model performed satisfactorily at monthly and annual scales from 2008 to 2017. The model was evaluated with  $R^2$ , percent bias, and KGE [45], which were 0.7, −5%, 0.83, and 0.86, −5%, and 0.89 on the monthly and annual scales, respectively (Figure 10).

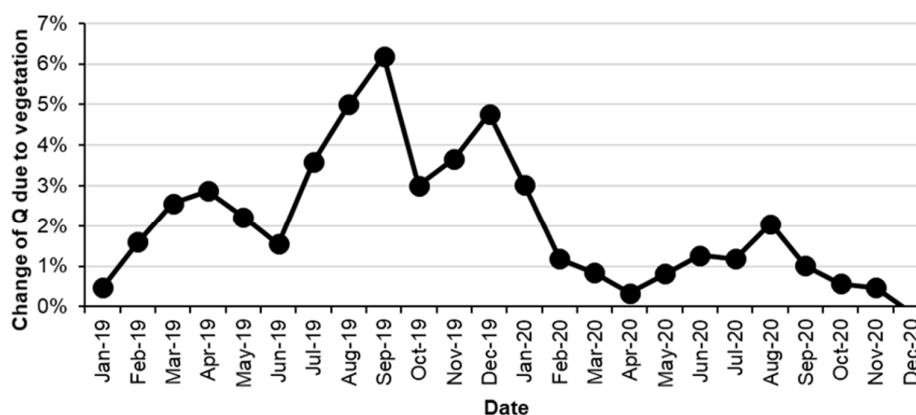
**Figure 11.** The monthly impact of vegetation damage on streamflow after Hurricane Michael from 2019 to 2020.

Consistent with the DMC method, the WaSSI scenario run did not detect significant increases in streamflow during 2019 and 2020 ( $p > 0.05$ ). At the annual scale, LAI change from vegetation damage on streamflow was small, resulting in 12 mm (2.6%) and 7.3 mm (1.0%) increases in inflow in 2019 and 2020. However, the effects of LAI decline were much stronger on the monthly scale in 2019, which led to a more than 5% increase in flow during August and September of 2019 (Figure 11).

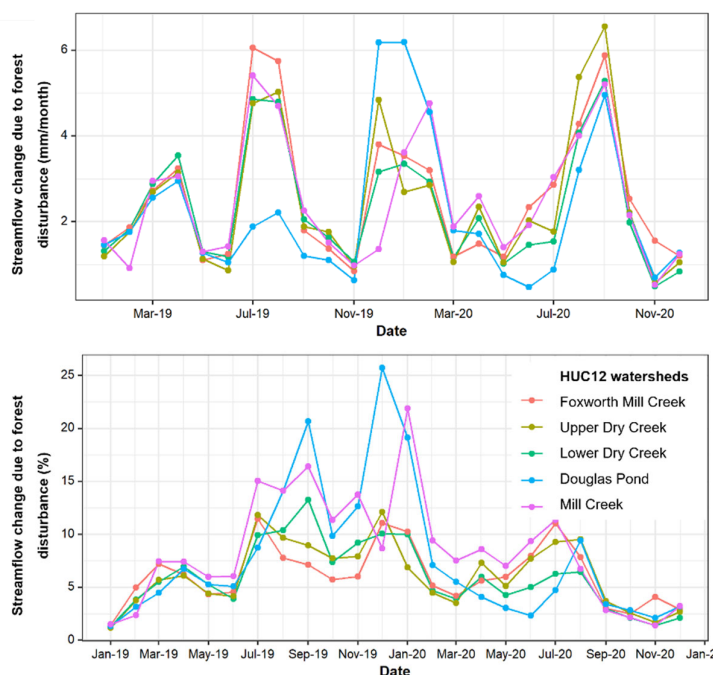
**Figure 12.** WaSSI modeled effects of Hurricane Michael on monthly flow for five HUC12 due to a decline in NDVI and vegetation damage in the Chipola River Watershed.

The impacts of forest disturbance from Hurricane Michael on streamflow were much higher in the southern part of the Chipola River Watershed, as represented in the five HUC12 sub-watersheds where a considerable decline in NDVI after the disturbance was detected (Figures 3–5). The vegetation damage resulted in an average increased flow of 29 mm (6%) (24 mm to 32 mm) during 2019 and 2020. The impact was highest from July 2019 to August 2020 but almost diminished after August 2020 (Figure 11). For example, the NDVI on the Mill Creek subwatershed reduced by an average of 14 % after Hurricane Michael (Figure 12), which resulted in a 27 mm (8%) and 32 mm (6%) increase in

streamflow in 2019 and 2020, respectively. Moreover, the forest disturbance increased streamflow by an average of 12% (7–22 %) in July 2019 and July 2020.
