## Assessment of Termite and Decay Damage to Mass Timber Elements in AWP Ground Proximity and Above Ground Field Tests in Southern Mississippi

### ABSTRACT

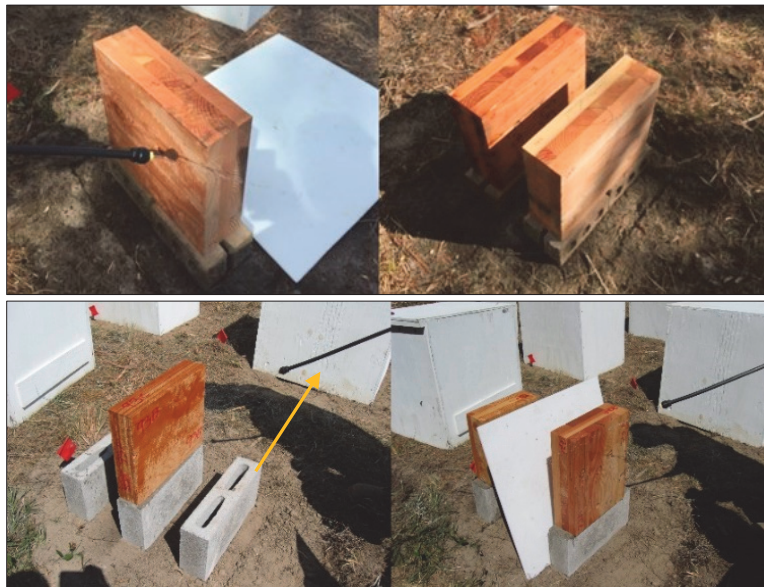
**Figure 2. Photographs showing arrangement of ground bricks or cinder blocks and mass timber in subplots. Treatment with spray-on borate (23% DOT; arrow shows tip of spray nozzle) in the preventative and remedial treatments. Ground proximity test (top), above-ground test (bottom).**

2. Preventative borate spray: (Nisus, Knoxville, TN); 23% disodium octaborate tetrahydrate (DOT) in glycol was applied to one of the two CLT samples; the other was left untreated. A plastic shield was placed over the adjacent sample on the bricks before spraying to minimize excessive borate application to the adjacent untreated sample (Figure 2, top).

2. Preventative borate spray: (Nisus, Knoxville, TN); 23% disodium octaborate tetrahydrate (DOT) in glycol was applied to each mass timber sample of the six subplots. A plastic shield was placed over the adjacent sample on the cinder block before spraying to minimize excessive borate application to already sprayed samples (Figure 2, bottom).

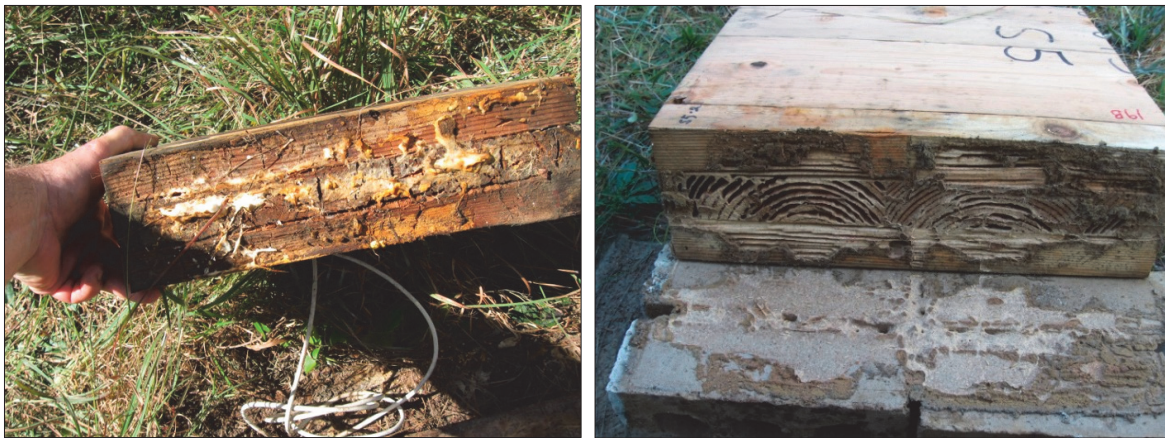
**Figure 5. Examples of fungal decay (left) and termite damage (right) to 3-ply Douglas-fir CLT in a covered ground proximity test after four years.**

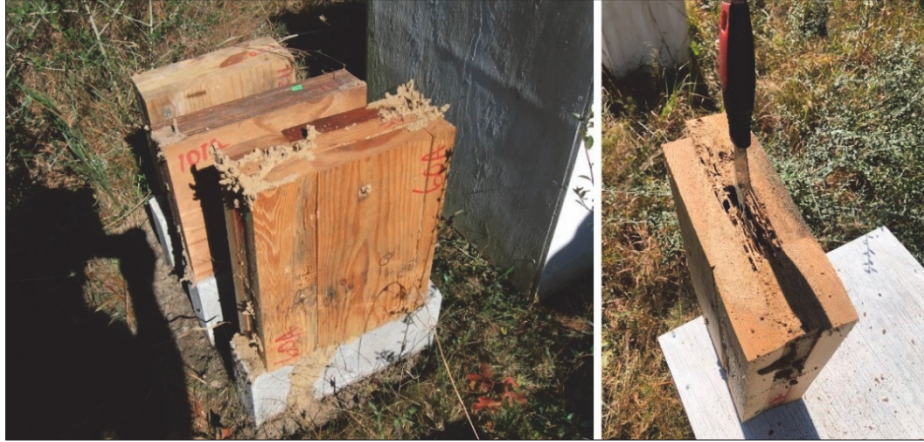
**Figure 7. Example of termite attack and damage to 3-ply Douglas-fir CLT in a covered above-ground test after two years.**
