# FIELD EVALUATION OF PHYSICAL BARRIERS AGAINST SUBTERRANEAN TERMITES AND AMBROSIA BEETLES IN A CLT WALL ENVELOPE SYSTEM

**Abstract.** The effectiveness of physical barriers against subterranean termites was evaluated in a 34-wk field test in coastal Mississippi by installing Obex11, a commercial polyethylene flashing, and Termimesh, a stainless-steel mesh in 3-ply 280 mm (width) × 450 mm (length) cross laminated timber (CLT) walls. Damage showed that both barriers performed significantly better than the no barrier control with respect to termite damage as evaluated by visual rating and mud tube length. Obex11, however, like the no barrier

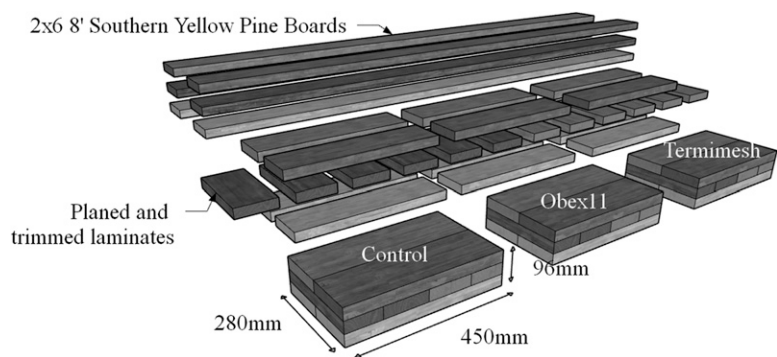
Figure 1. Lumber layout to manufacture one batch of cross laminated timber (CLT) specimens.

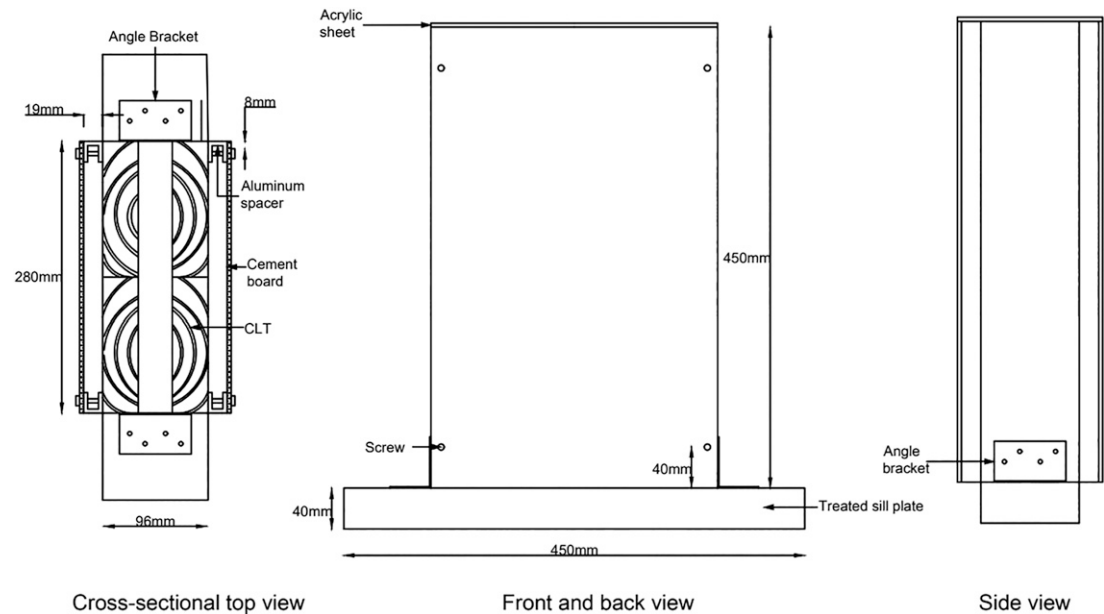
Figure 2. 2D drawing of a CLT envelope specimen.

The lumber boards were planed twice by 1.6 mm on each flat surface to a final dimension of 31.75 mm  $\times$  140 mm (1.25''  $\times$  5.5'') and subjected to the application of primer within 6 h of planing. Primer was applied at a rate of 21.53 g/m<sup>2</sup> (2 gm/ft<sup>2</sup>) to the gluing faces of the laminates. After 10 min of primer application, glue was spread to the primed laminates at a rate of 129.17 g/m<sup>2</sup> (12 g/ft<sup>2</sup>). The assembled CLT laminates were pressed under 0.75 MPa (110 psi) for 150 min following the adhesive product specifications (Loctite 2020). Three CLT panels (1 per treatment) were made per batch by dividing lumber boards as shown in Fig 1. Laminates with same color indicate that they were obtained from same board resulting in identical CLT specimens across the treatment groups. The surface laminates were assembled such that the sapwood (as opposed to the pith) was exposed on both sides of the panel as shown in Fig 2.

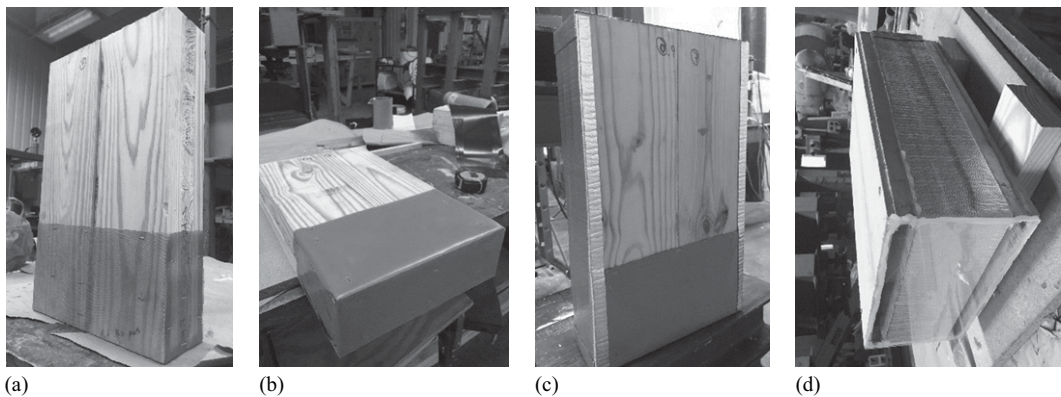
Figure 3. Envelope installation (a) CLT with Termimesh barrier, (b) CLT with Obex11 barrier, (c) CLT edges sealed with aluminum tape, and (d) a complete CLT envelope specimen with spacers and cement board cladding.

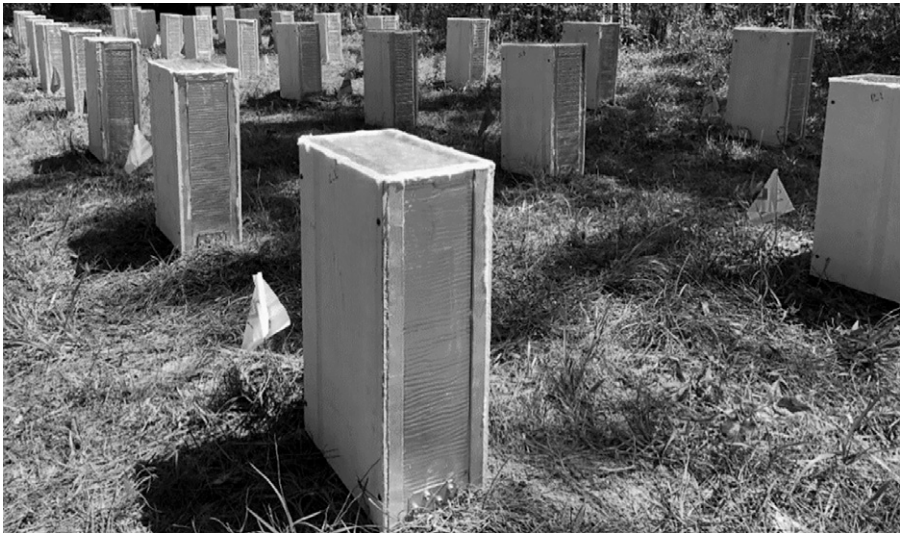
Figure 4. Field installation of CLT specimens in an RCB design ( $3 \times 10$  rectangular array with 1200 mm spacing between specimens and rows) at the test site in Saucier, MS.

A timeline of field activities is depicted in Table 1. The finished CLT envelope specimens were anchored to the ground using edge metal stakes and deployed at the USDA Forest Service Harrison Experimental Forest, Saucier, MS, near the Gulf Coast, where risk hazard for subterranean termite infestation is typically severe (Peterson et al 2006). The CLT specimens ( $n = 10$  per treatment) were laid out in a randomized complete block (RCB) design as shown in Fig 4. Surface investigations were carried out during each inspection to look for damage to physical barriers and the presence of mud tubes. Specimens were also overturned to evaluate termite activities at the soil level. As there was no evidence of termites or mud tubes on specimens at 18 wk, sill plates were removed, and specimens were reinstalled in their original positions. For the final inspection at 34 wk, specimens were taken back to the laboratory, and envelope layers were carefully dismantled. Physical barriers were visually examined for wear and tear, and the CLT was evaluated for attack from subterranean termites and wood-boring beetles.

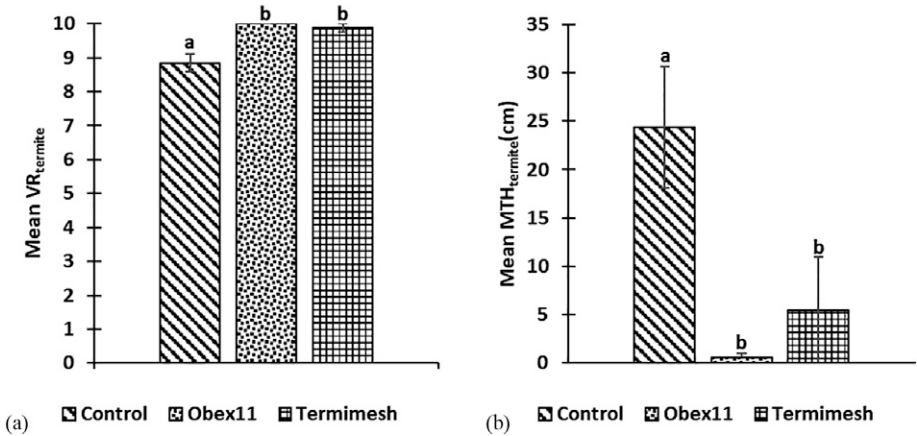
Figure 5. Mean termite (a) VR and (b) MTH. Different lowercase letters within a plot indicate significant differences among treatments. Bars denote  $\pm$  SE.

and 9.9, respectively, with Obex11 and Termimesh showing significantly less damage than the control (Fig 5[a]). All control specimens except one showed signs of termite damage indicating greater susceptibility of CLT panels without physical barriers to termite infestation. Summing mud tube length provided another measure of the differences in termite activity among the three treatments. The average  $MTH_{termite}$  of the control, Obex11, and Termimesh groups were: 24.5, 0.5, and 5.5 cm, respectively (Fig 5[b]). This suggests that there was little to no termite activity on the Obex11 compared with the Termimesh treatment, and the greatest termite activity on the controls. Statistical analysis, however, only detected significantly lower  $MTH_{termite}$  in the control group with no significant difference between Obex11 and Termimesh treatments. Since nonparametric statistics tends to have lower sensitivity, it is possible that differences between the Obex11 and Termimesh may have been resolved with more replication and longer field exposure.

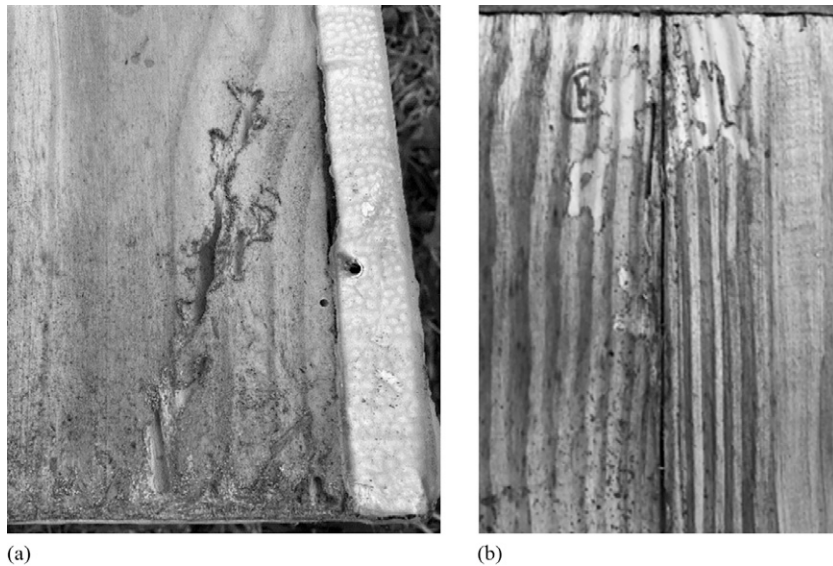
Figure 6. Damage (a) from a typical control specimen and (b) in one Termimesh specimen, where termites had constructed a mud tube from the soil line up to the top of the panel and attacked the wood at the top of the CLT.

Figure 6(a) shows typical termite damage seen on the CLT from the control treatment. After scraping

away the mud tubes (traces of the mud tube outline remain in the photo), the wood damage was revealed and began at the bottom of the CLT near the soil line and progressed upward with channels eaten through the sapwood. Damage was quite conspicuous in almost all of the control specimens but because of the large size of the panels, the assigned visual rating values were always less than 10% of surface area affected.

Figure 6(b) shows one Termimesh specimen that was found with a mud tube that ran from the soil line all the way to the top of the CLT panel, a distance of 55 cm. This was atypical since no mud tubes were found on any of the other Termimesh specimens. Therefore, even though termites could not penetrate Termimesh, they were capable of finding their way to the wood—in this case, by climbing 150 mm across the barrier upwards to the unprotected wood. The wooden specimens tested in Hawaii showed that the termites were able to make their way to the wood through a gap created by a fold in the corner of a wooden specimen wrapped with Termimesh (Grace et al 1996). However, the termite attack was due to an

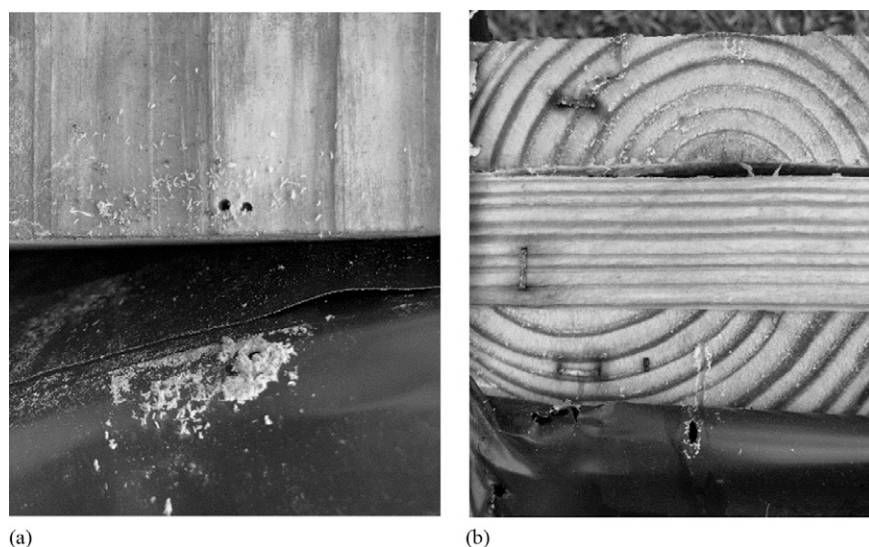
Figure 7. Damage seen in a typical Obex11 specimen showing (a) two beetle puncture holes through the membrane (accumulating sawdust below) and into the face of the CLT near the soil line, and (b) one beetle puncture through the membrane, a bored trail along the CLT base, and laminate separation caused by swelling from trapped moisture.

Obex11 membrane. Even though the chemicals and plastic membrane of the Obex11 successfully repelled termites and kept them off the exposed faces of CLT, the Obex11 failed to deter these wood-boring beetles. The three collected adult beetles were identified as *Ambrosiodmus minor* (Stebbing). These beetles have heavily sclerotized mouthparts that chewed through both the membrane and wood to create round-shaped entry holes that led to bored trails within the wood (Fig 7[a]) or sandwiched between the wood and the panel base, which was wrapped first with the membrane and an outer band of aluminum flashing (Fig 6[b]). Sawdust from bored trails was also often observed accumulating between the membrane and the wood near the soil line (Fig 7[a]). In addition, a few CLT specimens in the Obex11 group showed delamination (Fig 7[b]) due to swelling from moisture trapped by the membrane. This moisture accumulated due to rainfall and higher humidity inside the air cavity.

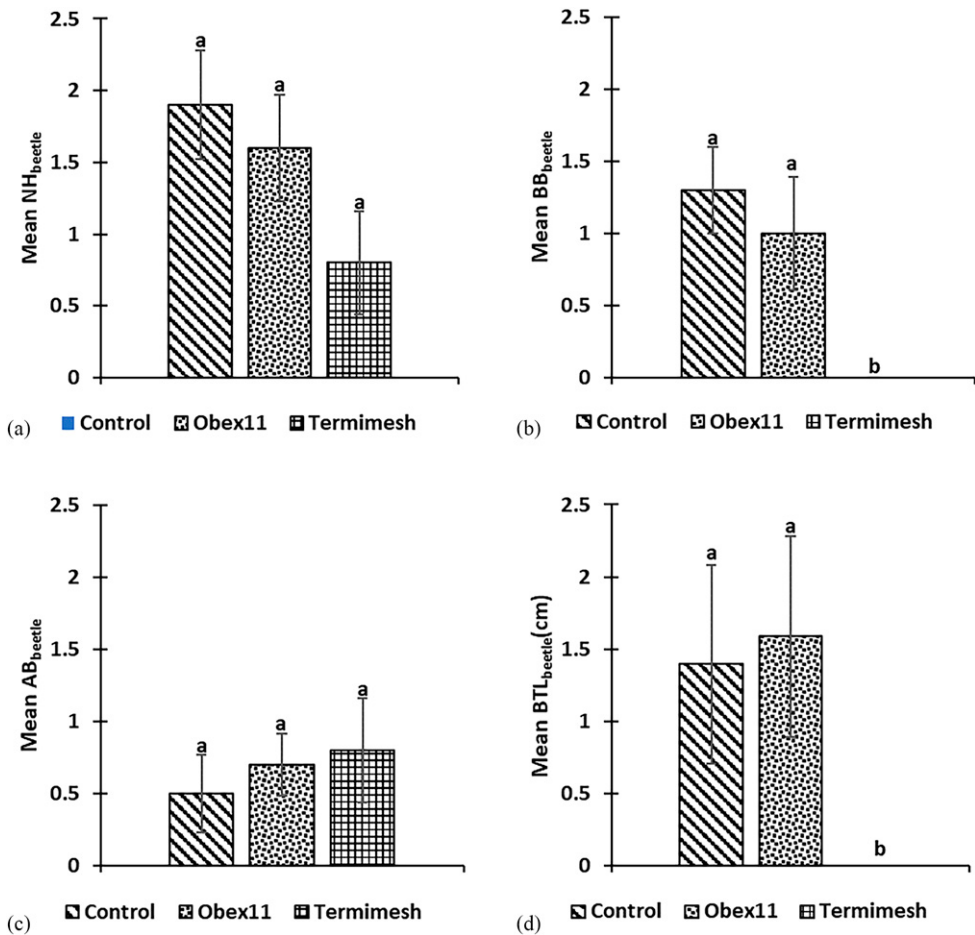
Figure 8. Mean beetle (a) NH (b) BB (c) AB and (d) BTL. Different lowercase letters within a plot indicate significant differences among treatments. Bars represent  $\pm$  SE.

Averages of  $NH_{\text{beetle}}$  were 1.9, 1.7, and 0.8 for control, Obex11, and Termimesh with no significant difference among totals for treatment groups (Fig 8[a]), although a difference was apparent when hole position was taken into account.

Control and Obex11 groups had significantly higher  $BB_{beetle}$  averages (1.3 and 1.0 holes, respectively) near the bottom edge or below the barrier height compared with 0 holes for Termimesh (Fig 8[b]). Number of holes above the barrier height ( $AB_{beetle}$ ), however, was not significantly different among the three treatments (0.5, 0.7, and 0.8 for control, Obex11, and Termimesh, respectively) (Fig 8[c]). Thus, these wood-boring beetles could not chew through or otherwise penetrate the Termimesh wherever it covered the wood, but neither Termimesh nor Obex11 protected the wood above the barrier. Nearly all beetle holes were no more than 75 mm above the barrier, suggesting that there is a requisite

minimum wood MC for attack by *A. minor*, as there is for subterranean termites and decay fungi (Nakayama et al 2005; Wang et al 2018). The significant difference in beetle hole positions below the barrier also explains the differences in bore trail length, which were only visible at the base of the CLT panels. The averages of  $BTL_{beetle}$  were 1.4, 1.6, and 0 cm for control, Obex 11, and Termimesh, respectively, with Termimesh significantly less than either control or Obex11 (Fig 8[d]).
