**Performance of Douglas-fir cross laminated timber (CLT) subjected to elevated humidity in a ground proximity field test for 6 years**

Paper prepared for the IRG55 Scientific Conference on Wood Protection  
Knoxville, Tennessee, USA  
19 - 23 May 2024

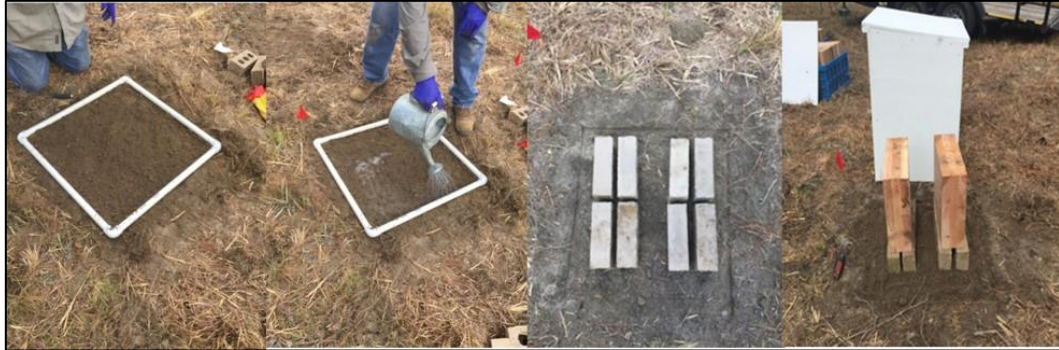
Figure 2: Treatment with fipronil soil termiticide showing arrangement of ground bricks or cinder blocks and CLT in soil termiticide subplots.

*Reticulitermes* sp. We did not use in-ground feeder stakes as the E26-15 standard suggests because one of the test treatments was a soil chemical barrier treatment and the use of in-ground feeder stakes would breach the chemical barrier. The test area consisted of a large plot measuring 7.6 x 7.6 m with twenty-five subplots measuring 0.76 x 0.76 m that were 1.5 m apart (Fig. 1). A total of twenty subplots were used for four treatment sets of the study. Five subplots were not used. The 20 subplots were tilled by hand to a 50 mm depth with a pickaxe and any roots or stones were removed. Two CLT samples were set on four bricks on the 0.76 x 0.76 m cleared square in each subplot. The samples were approximately 75 mm from the ground and approximately 200 mm apart (Fig. 2).

1. Soil termiticide only: A 0.61 x 0.61 m area of the 0.76 x 0.76 m subplot was drenched with a 0.125% fipronil [5-amino-3-cyano-1-(2, 6-dichloro-4-trifluoromethylphenyl)-4-fluoromethylsulfinyl pyrazole] solution (applied as one gallon mixed with water per subplot). Bricks and CLT samples were placed on the treated area with as little soil disturbance as possible (Fig. 2).

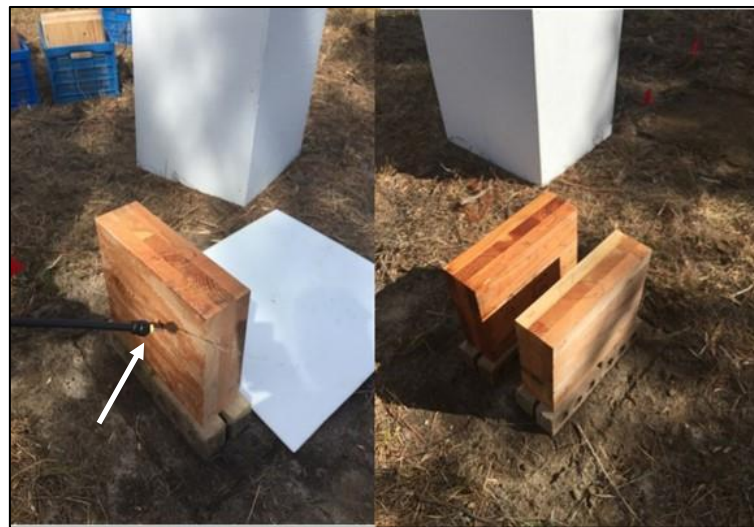
Figure 3: Photographs showing the arrangement of ground bricks and mass timber samples in subplots. Treatment with spray-on borate (23% DOT; arrow shows tip of spray nozzle) in the preventative and remedial treatments.

2. Preventative borate spray: (Nisus, Knoxville, TN USA); 23% disodium octaborate tetrahydrate (DOT) in glycol) was applied to one of the two CLT samples; the other was left untreated. A plastic shield was placed over the adjacent sample on the bricks before spraying to minimize excessive borate application to the adjacent untreated sample (Fig. 3). All sides of the treated samples were sprayed except the bottom of the sample. Treated samples were sprayed twice with applications 30 minutes apart.

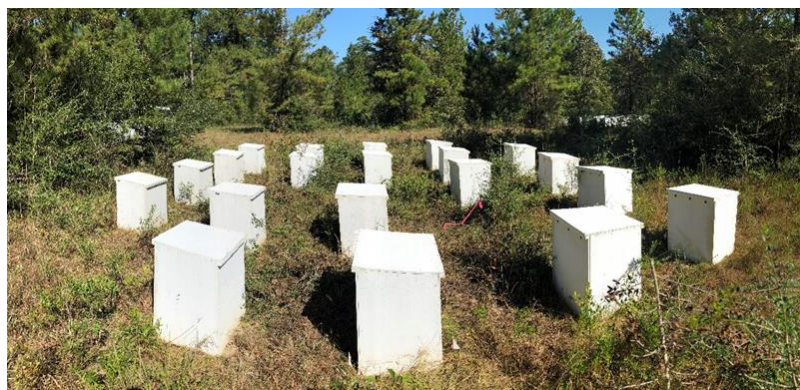
Figure 4: Photograph of all test assemblies at the experimental plot after covers were applied.

After placement and treatment, the samples were covered with pre-constructed ventilated plywood covers. The covers measured 559 x 495 mm at their base and were 737 mm high in front and 686 mm high in back creating a sloped roof for rain runoff (Fig. 4). The covers were constructed from treated plywood and painted white to minimize heating. The front and back of each cover had three 25 mm diameter ventilation holes covered with mesh. Samples remained undisturbed for six years except for annual moisture readings and damage ratings. A total of four moisture readings were taken by taking two moisture readings on the top and bottom of the two broad faces of each sample using the Wagner meter, then the four moisture readings per sample were averaged and compared to pre-test initial (dry) moisture readings.

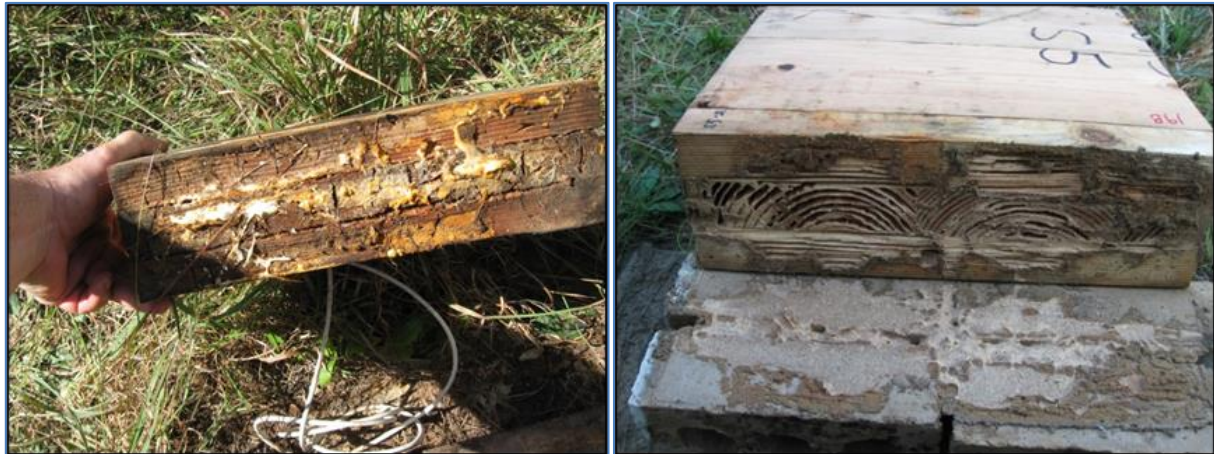
Figure 6: Examples of fungal decay (left) and termite damage (right) to 3-ply Douglas-fir CLT in a covered ground proximity test after six years (picture taken at year 4).

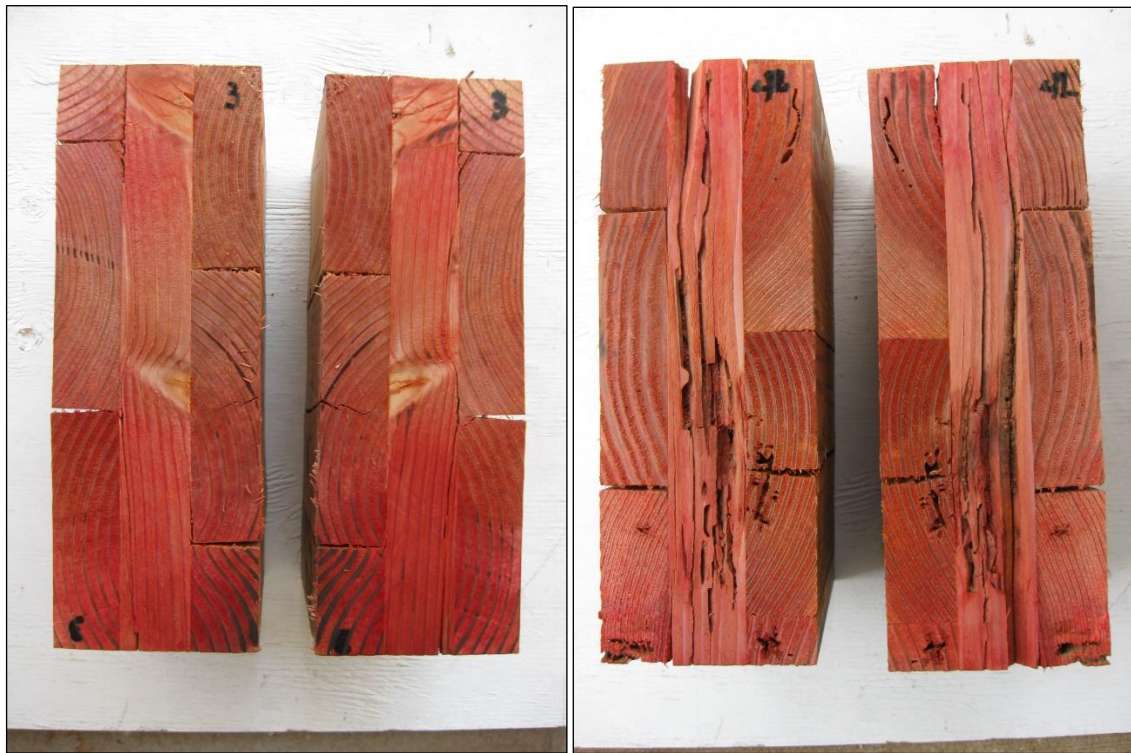
Figure 9: Cross-cut curcumin-stained samples treated with borates at test initiation (preventative) (left) after six years and remedial treatment (right) after five years showing boron diffusion (red) surrounding dormant termite galleries.

Dark red colour indicates that boron was present across the entire CLT sections (Fig. 9). It must be stressed that the samples were treated on the outer surfaces only and that the observed presence of boron was from diffusion. The excellent diffusion of boron into the center ply of the CLT is indicative of the high moisture levels in the covered boxes and suggests that using this preservative in high moisture, worst-case scenario, water ingress situations may be advantageous. The preventive borate treatment showed excellent boron diffusion at six years (Fig. 9, left). The remedially treated CLT samples also showed good boron diffusion. The termite attack shown in the center ply of these samples occurred in the first year of exposure before the treatment (Fig. 9, right). No activity was observed in this subplot after the remedial treatment.
