# Condition Assessment of Historic Wooden Ships

This paper summarizes work conducted to assess the condition of members in historically significant timber sailing vessels. Four ship assessments are described, the *USS Constitution*, the *USS Cairo*, and the *Wapama*. Launched in 1797, the *USS Constitution* was nicknamed “Old Ironsides” and was a combat vessel used by the US Navy. “Old Ironsides” is a three-masted heavy frigate with a hull primarily constructed of live oak. The *USS Cairo* is a city class ironclad river gunboat. It was built in 1861 and commissioned in January 1862. It was used in combat by Union forces during the American Civil War along the Mississippi River and connected waterways and sunk in December 1862. It remained submerged for 100 years and was recovered in 1964. Currently the *USS Cairo* is on display at the Vicksburg National Military Park. The *Wapama* was launched in 1915 and was used for the Pacific Coast lumber trade and coastal service. It was declared a National Historic Landmark in 1984. It is a wooden steam-powered schooner. Given the historical significance of the vessels, it is important that inspection methods employed do not degrade their co

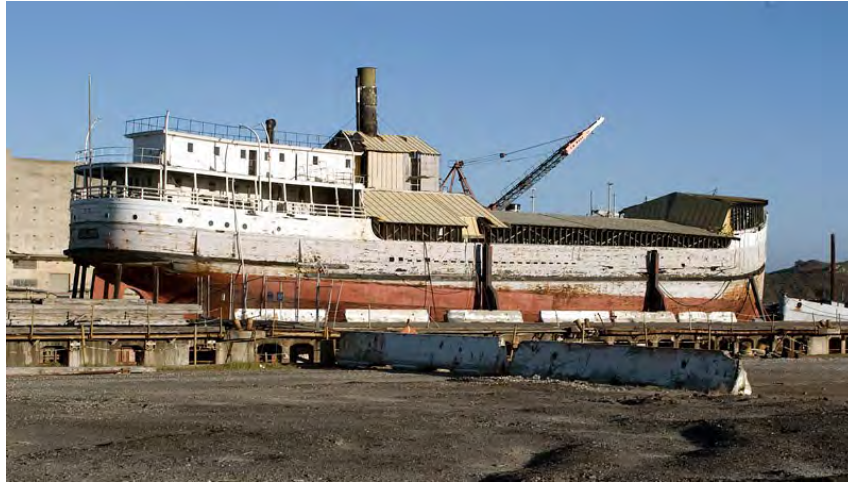
**Figure 1**—Wapama placed on a barge at the Richmond Reserve Shipyard in Richmond, California.

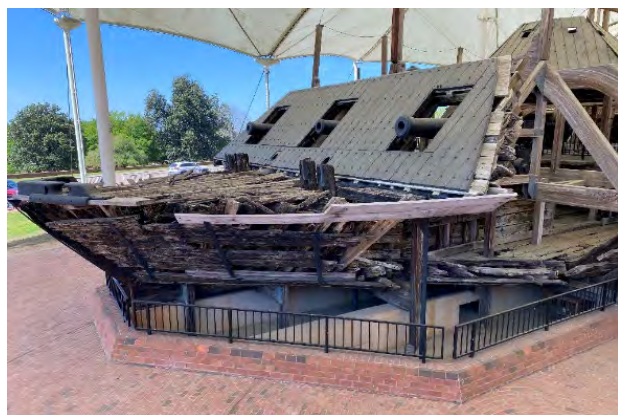
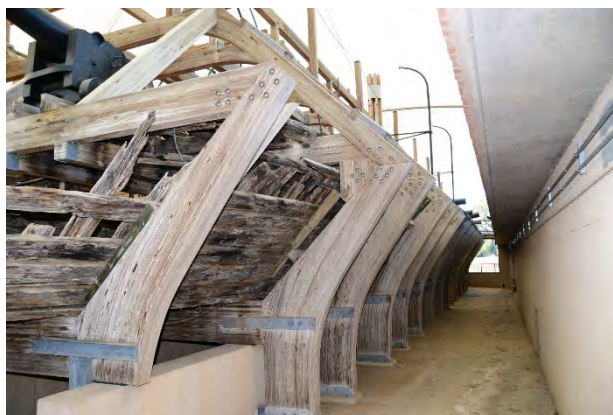
Figure 4—USS Cairo a) Displayed at Vicksburg National Military Park b) Timber crib support

The Forest Products Laboratory (FPL), and Mississippi State University were contacted in 2023 by Vicksburg National Military Park to assist in assessing the condition of a timber crib built to support the *Cairo*. The assessment did not include the *USS Cairo* itself as it is preserved in its current condition because of its historical significance. An inspection utilizing visual, acoustic-based and probing nondestructive testing techniques was conducted on October 24 and 25, 2023 (Senalik et al. 2024). Condition assessment of the *USS Cairo* glulam crib began with a visual inspection to identify obvious areas of decay within the glued laminated (glulam) structure. Overall, the condition of the glulam crib supporting the remains of the *USS Cairo* is in good condition. No areas of surface decay were identified.
