Forest Products Laboratory | General Technical Report FPL–GTR–299 | March 2025

# Wood and Timber Condition Assessment Manual

Third Edition

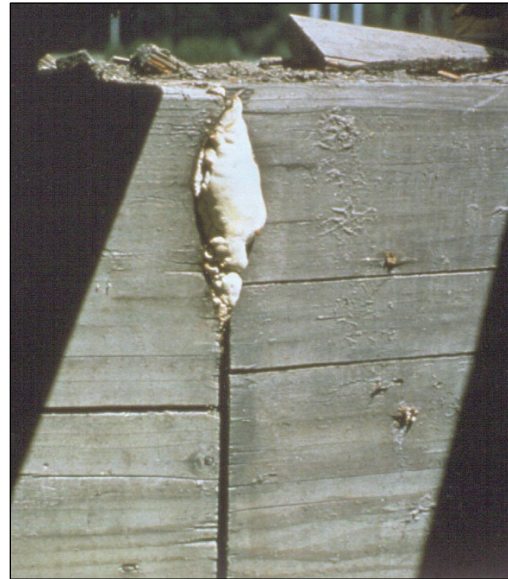
**Figure 1.1—Fruiting body between two beams.**

Figures 1.1 and 1.2 show fruiting bodies that were observed during inspection of Washington State University's football stadium. Figure 1.2 shows the extent of deterioration inside the beam. Note that in Figure 1.1, the fruiting body is located where two timber beams (placed end-to-end) rest on a column. This situation allows for moisture accumulation and subsequent absorption by the timbers. Figure 1.3 illustrates the potential extent of deterioration in both beams.

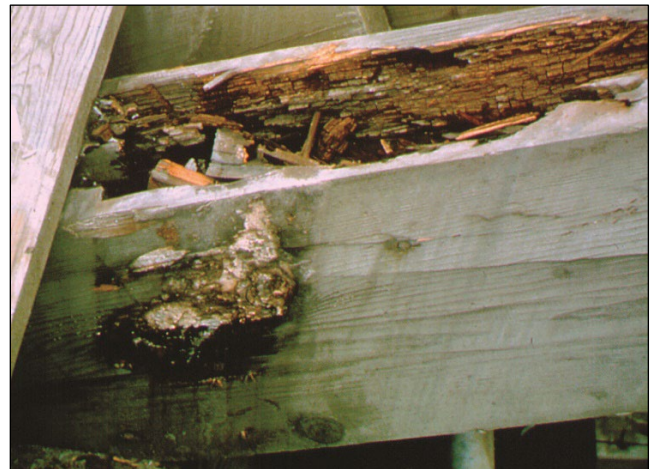
**Figure 1.2—Fruiting bodies can indicate extensive damage inside the beam.**

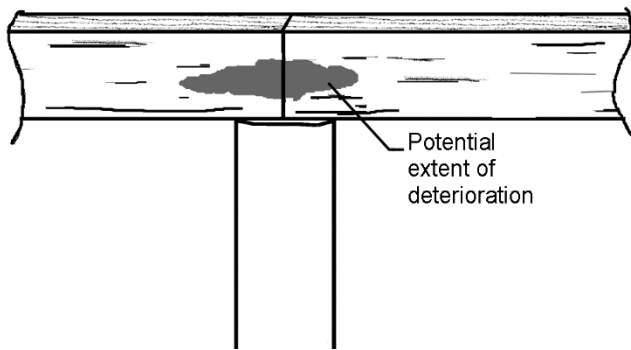
Figure 1.3—Potential deterioration in both beams.

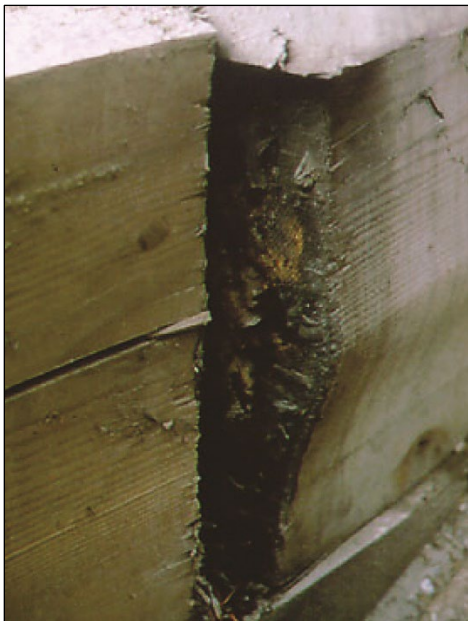
Figure 1.4—The timber beam's outer shell buckled as a result of interior deterioration.

Figure 1.4 shows a timber beam that failed in bearing (compression perpendicular to grain). Such collapse indicates that the inner portion of the timber is severely deteriorated. Figure 1.5 illustrates that when the inner portion of the timber is severely deteriorated, the outer shell can collapse when the timber is stressed in bearing.

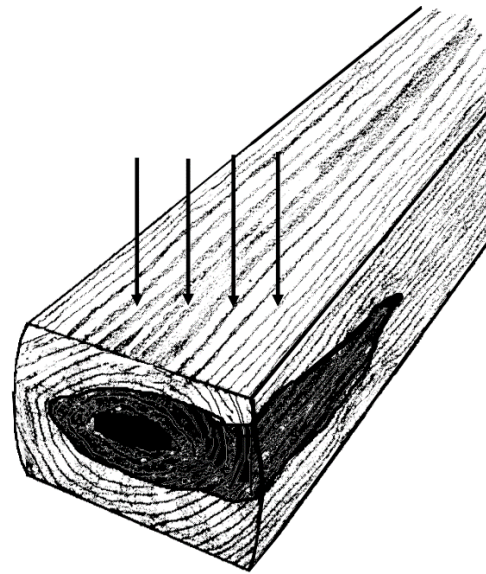
Figure 1.5—Because of interior deterioration, the outer shell can collapse when the timber is stressed in bearing.

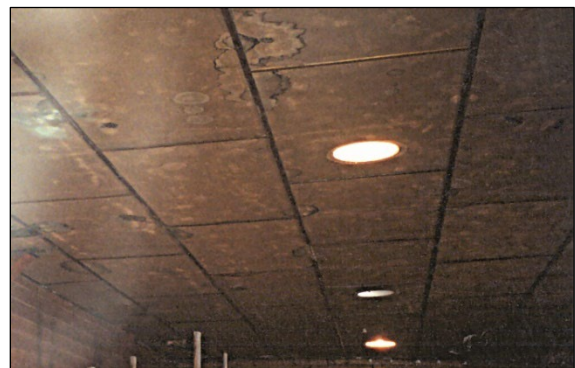
Figure 1.6—The ceiling panels were stained and discolored.

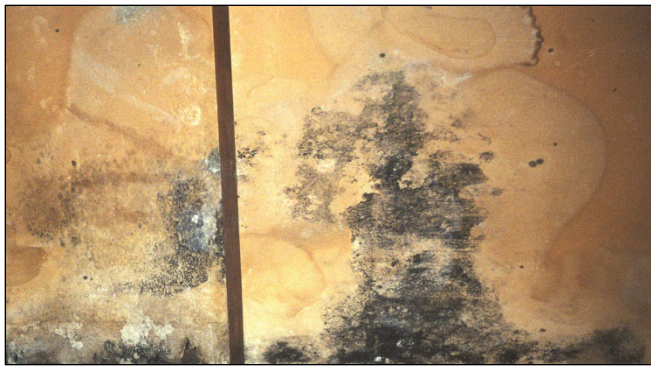
**Figure 1.7—Close-up of the severely stained and discolored ceiling panels.**

Inspection of the Red Cliff Recreation Hall near Bayfield, Wisconsin, revealed severe staining and discoloration of the fiberboard product used in the ceiling (Figs. 1.6 and 1.7). Discoloration and mold indicated that the structure had been exposed to moisture and the wood could possibly be deteriorated. Removal of several ceiling panels revealed that the fiberglass insulation above them was saturated with water (Fig. 1.8). This moisture provided an ideal environment for the growth of mold and decay fungi. As a consequence of this moisture exposure, wood members in the roof and walls also contained areas of deterioration (Fig. 1.9).

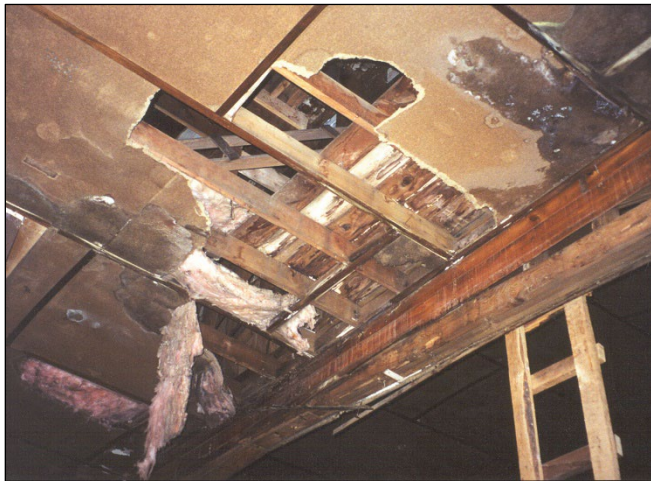
**Figure 1.8—Removing the ceiling panels revealed that the fiberglass insulation was saturated with water.**

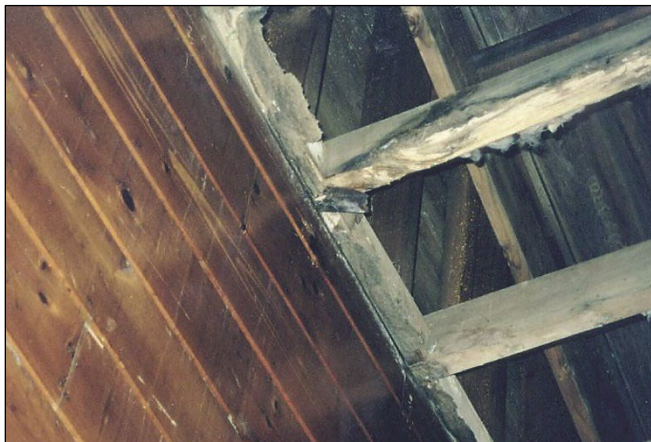
**Figure 1.9—As a consequence of the moisture exposure, wood members in the roof and walls also contained areas of deterioration.**

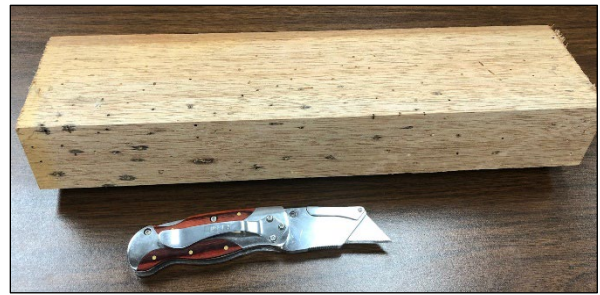
**Figure 1.10—Beetle damaged section of a board. Note many of the holes show fungal staining about their perimeter. Also note, many of the holes / tunnels are not perpendicular to the surface of the board which indicates the holes were present in the log at the time the board was milled therefrom.**

Figure 1.10 shows a piece of lumber with numerous remnant beetle galleries and holes. Many of the holes show fungal staining. Holes that are generally all round and perpendicular to the face or edge of a board indicate that the board was infected, the beetles matured therein, and exited through the surface. Holes that are not perpendicular to the face of a board often indicate that the board was sawn from an infected log and that the galleries were present at the time the board was sawn from the log, as appears to be the case in Figure 1.10.

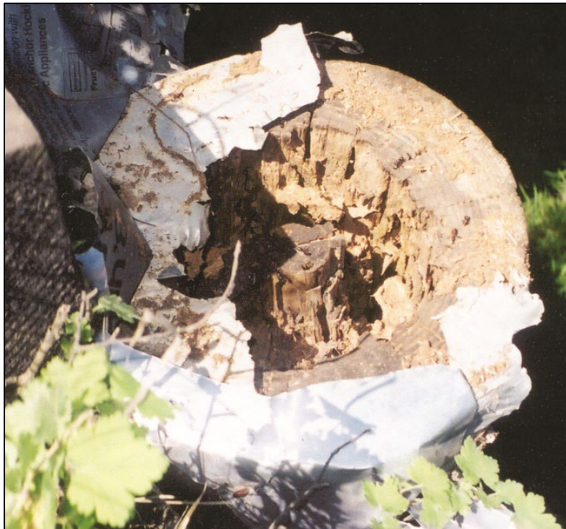
Figure 1.11—Damage to a bridge piling.

Figure 1.11 is a piling from a bridge. Initially deteriorated by decay, carpenter ants were attracted to the softened wood and continued to destroy the piling. Once the flashing was removed, the severe deterioration could be readily observed.

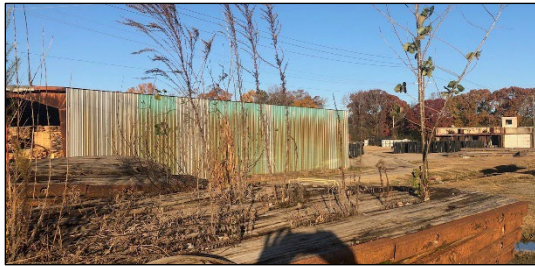
Figure 1.12—Flora, including a hardwood sapling, growing from the surface of a stack of wet timber mats. These mats are evidently decayed and ready to be stripped of their metal hardware, chipped, and used for mulch or boiler fuel.

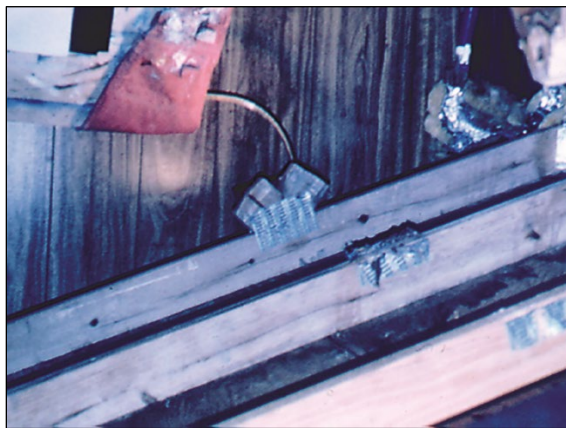
Figure 1.13—Metal plate connectors were cut and bent so that the webs could be removed. This should *never* be done.

Frequently, it is observed that entire structural members have been removed. Figures 1.13 and 1.14 show an in-service wood truss that had its webs removed by the homeowner with the intent of creating living space in the attic. This should *never* be done and *must* be noted in any inspection report. Any change to web or chord members *must* be reported. In some cases, entire assemblies are missing. For example, instances have occurred where truss spacing was specified on blueprints at 16 in. on center but due to miscommunication were installed at 24 in. on center. In such cases, routine snow loading can cause collapse.

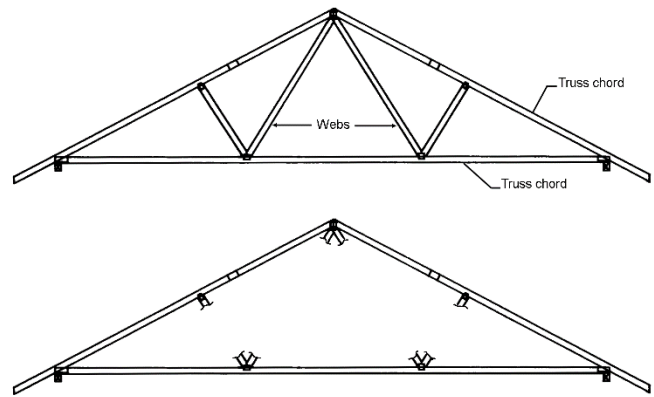
Figure 1.14—The homeowner removed the webs from the truss leaving only the chords to support the roof. This should *never* be done.

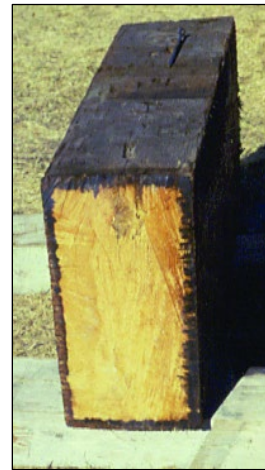
Figure 1.15—Only the outer portion of this timber contains preservatives.

Checks and splits in members can indicate a weakened member. The large timber shown in Figure 1.15 was treated with preservatives. Note that only the outer portion of the timber contains preservatives. (Depth of preservative

treatment depends on species of wood and characteristics of treatment.) If a check or split develops in the timber that is of sufficient depth, the inner untreated wood is susceptible to moisture and decay fungi. Checks are normally superficial and do not affect structural performance. The effects checks and splits have on structural performance are discussed in detail in Chapter 6.

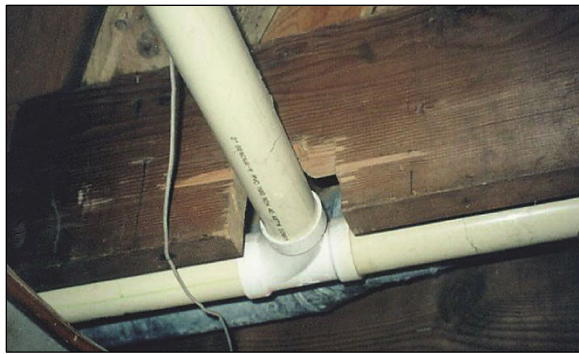
**Figure 1.16—A floor joist was cut to make room for plumbing. This should *never* be done.**

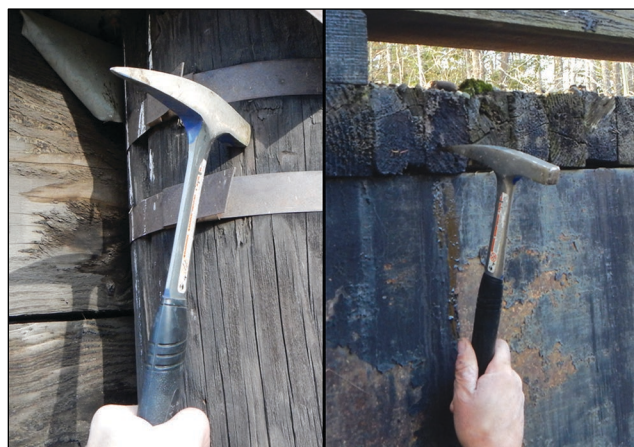
**Figure 2.1—A hammer pick is an effective tool for initial assessments of timber bridge elements.**

One of the most commonly used techniques for detecting deterioration is to hit the surface of a member with a hammer or other object. Based on the sound quality or surface condition, an inspector can identify areas of concern for further investigation using advanced tools like a stress wave timer or resistance microdrill. Deteriorated areas typically have a hollow or dull sound that may indicate internal decay. A pick hammer commonly used by geologists is recommended for use in timber structures because it allows inspectors to combine the use of sound and the pick end to probe the element (Fig. 2.1).

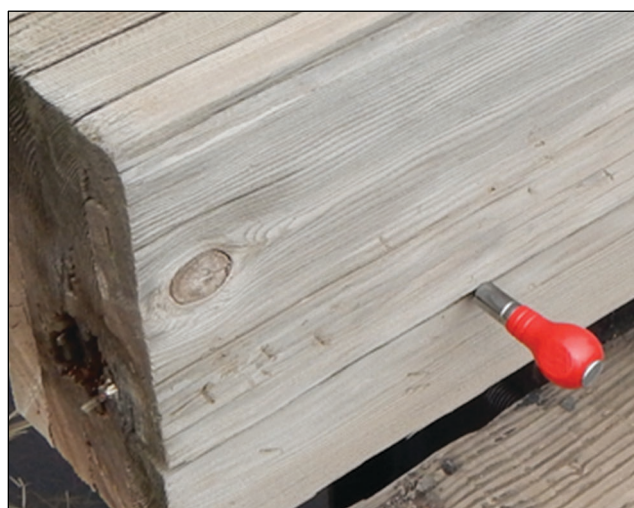
**Figure 2.2—An awl is used to assess depth and presence of decay in a horizontal split.**

Probing with a moderately pointed tool, such as an awl or knife, locates decay near the wood surface as indicated by excessive softness or a lack of resistance to probe penetration and the breakage pattern of the splinters. A brash break indicates decayed wood, whereas a splintered break indicates sound wood. Although probing is a simple inspection method, experience is required to interpret results. Care must be taken to differentiate between decay and water-softened wood, which may be sound but somewhat softer than dry wood. Assessing damage in soft-textured woods, such as western redcedar, is sometimes difficult. Figure 2.2 shows an awl probe inserted into a split to assess depth and presence of decay.

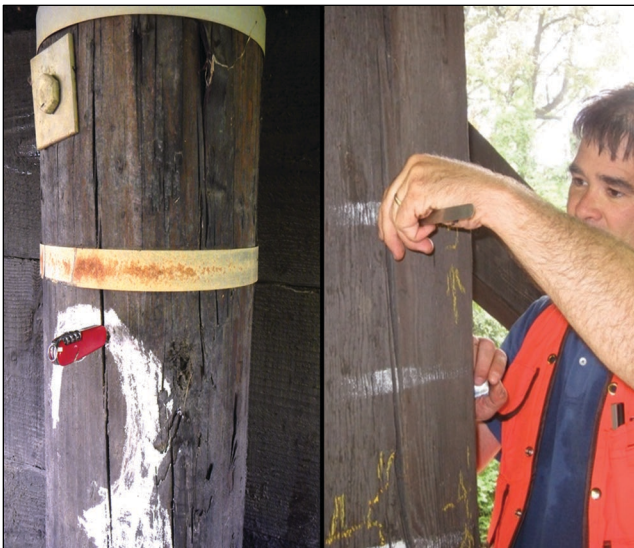
**Figure 2.3—Probes are used to assess depth of cracks, checks, and through splits in timber bridge elements.**

such as stress wave inspection. Figure 2.3 shows the use of probes to assess the depth of checks and cracks in timber bridge elements.

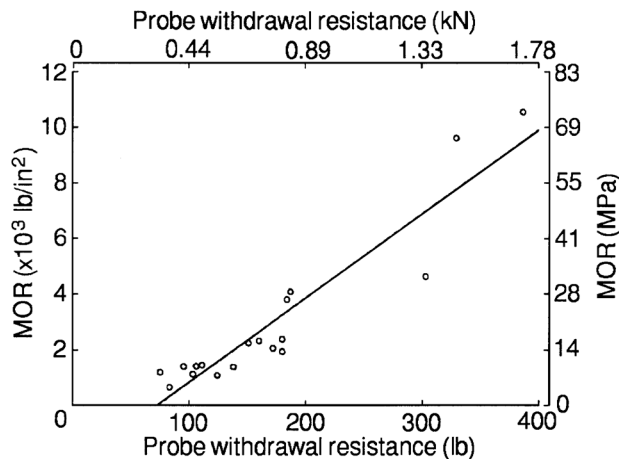
**Figure 2.4—Relationship between withdrawal resistance and residual strength. MOR, modulus of rupture.**

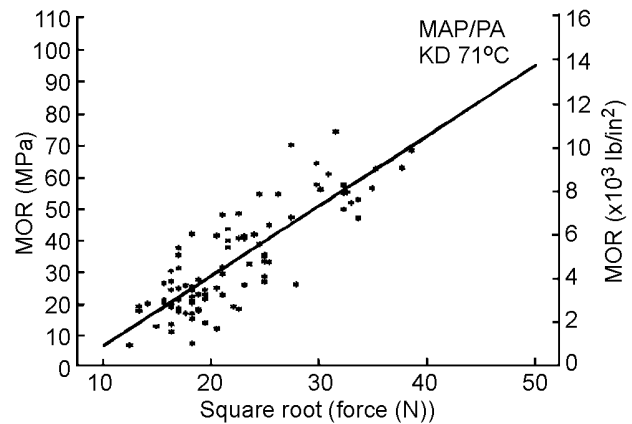
**Figure 2.5—Relationship of screw-withdrawal force to bending strength for 12-mm- (1/2-in.-) thick plywood. MAP, mono-ammonium phosphate; PA, phosphoric acid; KD, dry-kiln drying temperature; and MOR, modulus of rupture.**

A modification to Talbot's technique was developed for use in evaluating in-service strength of fire-retardant-treated (FRT) plywood in the early 1990s. A portable screw withdrawal system was utilized to inspect FRT plywood and identify substantial degrade. An extensive research effort was devoted to the use of Talbot's test for assessing residual strength of in-service panel products treated with fire retardant. Winandy et al. (1998) designed and conducted tests on a large sample of plywood specimens that were treated with fire-retardant chemicals and subsequently exposed to elevated temperatures. Screw withdrawal loads were determined for each specimen prior to static bending tests. Correlative relationships were then established between screw withdrawal strength and static bending properties (Fig. 2.5). More recent evaluations were

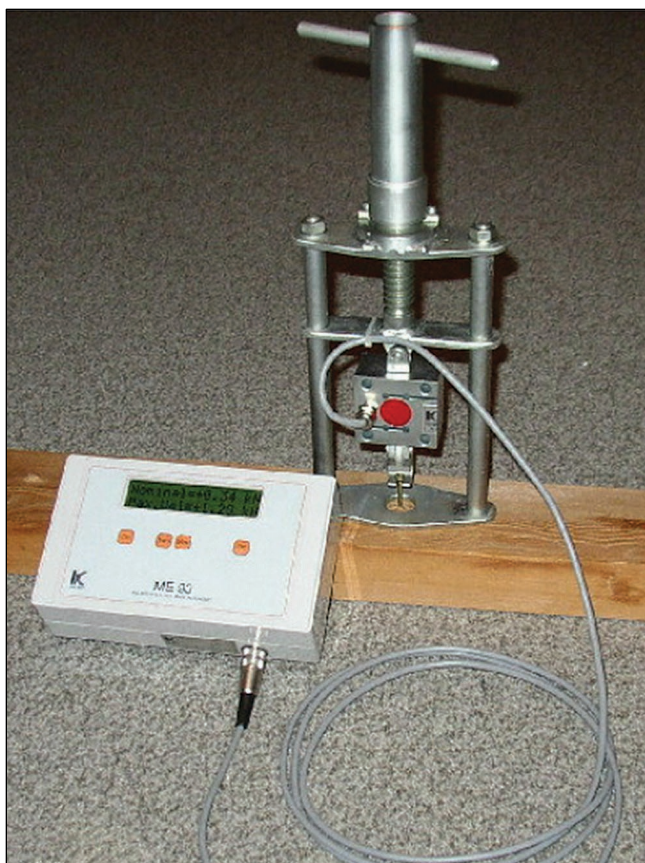
**Figure 2.6—Screw withdrawal resistance meter that can be used to assess local wood quality.**

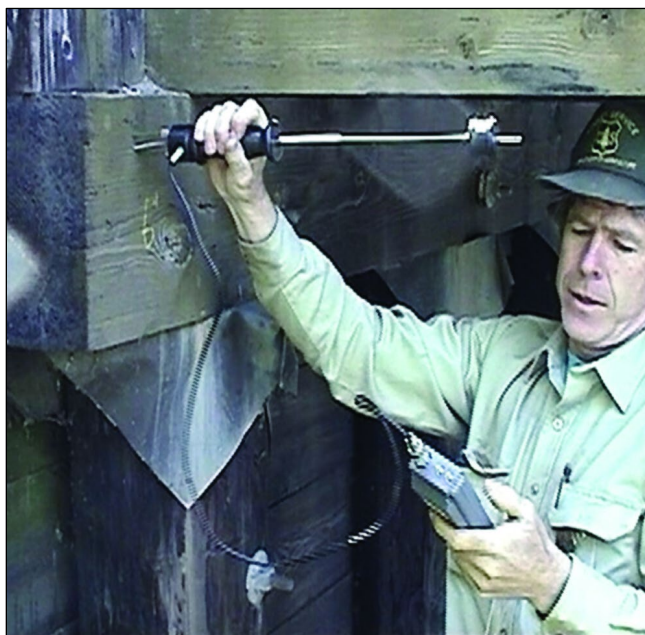
**Figure 2.7—A pin-style moisture meter is used to determine moisture content of timber elements.**

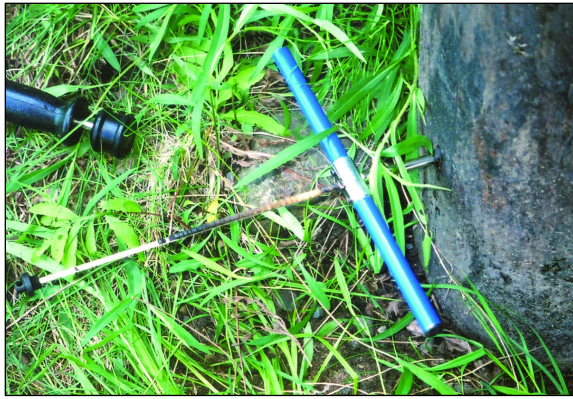
**Figure 2.8—An increment core can be used to conduct inspections of timber bridge elements. This image shows an extracted core from an in-service timber pile ready for examination.**

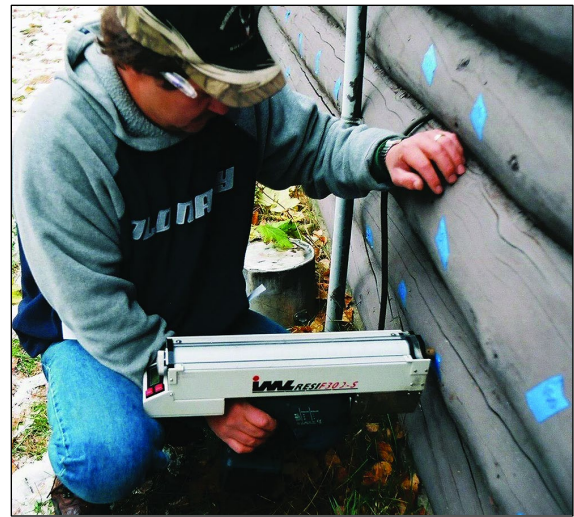
**Figure 2.9—A resistance microdrill used for inspection of a historic Civilian Conservation Corps log cabin.**

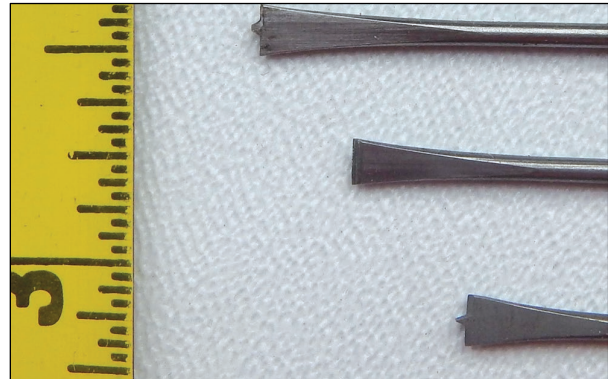
**Figure 2.10—Flat-tipped resistance drill bits used to inspect timber materials.**

Resistance drill equipment measures the resistance of wood members to a 0.6-in.- (1.5-mm-) diameter drill bit with a 0.18-in. (3.0-mm) head. This flat tipped drill bit travels through the member at a defined movement rate and generates information that allows an inspector to determine the exact location and extent of any damaged area. Figure 2.10 shows several drill bit ends that are used in resistance drills. Although the unit is usually drilled into a member in a direction perpendicular to the surface, it is also possible to drill into members at an angle (Fig. 2.11).

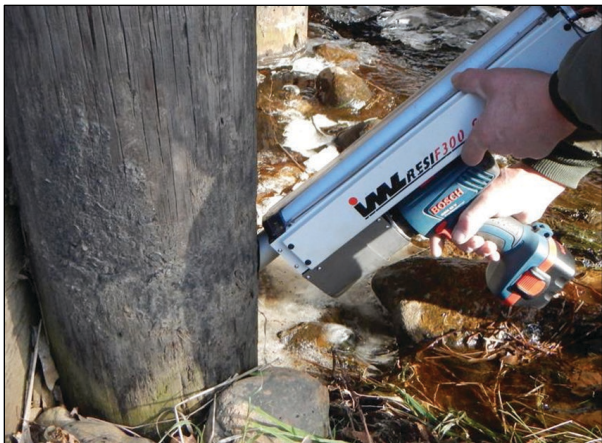
Figure 2.11—Drilling can take place at an angle to assess the area below ground line.

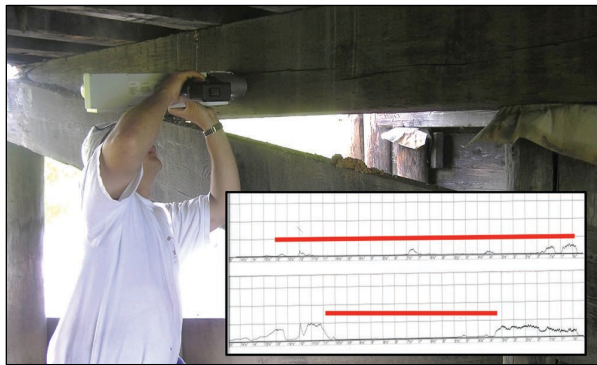
Figure 2.12—Resistance microdrilling showing significant decay in the bridge pile cap. The inset shows the paper chart readout from a commercial drilling unit.

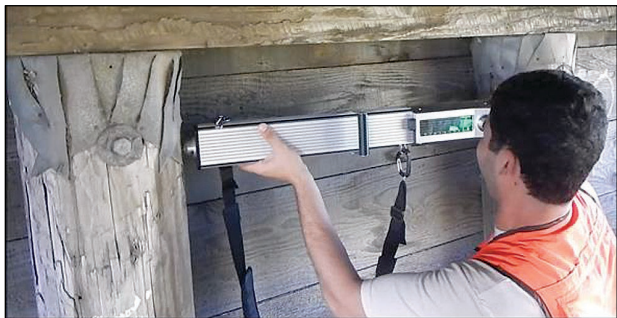
Figure 2.13—Electronic display on a resistance drill.

Resistance drills collect data electronically and can produce a chart showing relative resistance over the drilling path. Modern tools have the ability to view the data on a tablet computer or mobile phone. Areas of sound wood have various levels of resistance, depending on the density of the species; voids show no resistance. The inspector can determine areas of low, mild, and high levels of decay with this tool and quantify the level of decay in the cross section. Figure 2.12 shows a timber abutment cap being assessed with a resistance microdrill and the resulting chart image, which shows minimal drilling resistance and indicates that the majority of the cap is decayed. Figure 2.13 shows a commercial model with an electronic display that allows data to be reviewed in the field and then further processed using a computer in the office. All holes should be filled after drilling, especially if no decay is present. For the microdrill, this can be accomplished by injecting a small amount of silicone sealant or marine adhesive into the small opening (Fig. 2.14).

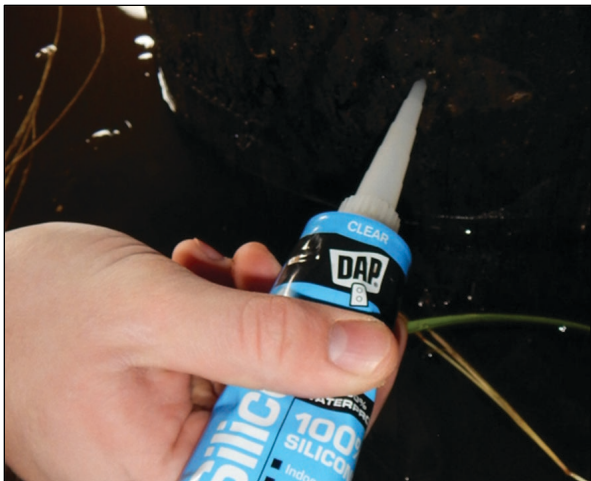
Figure 2.14—Silicone is used to fill the small drilling hole.

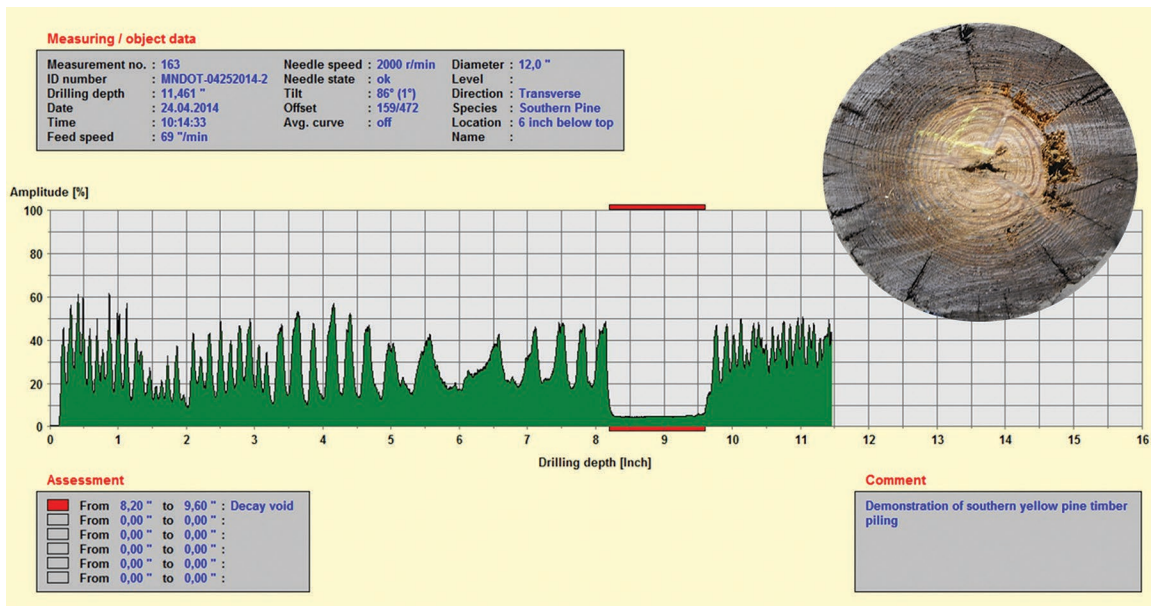
Figure 2.15—Electronic view of a southern yellow pine timber piling showing a decay pocket between 8 and 10 in. of the drilling profile.

(such as conifers) not be misinterpreted as decay. The very center of softwood species near the pith will have low resistance and lack the defined growth rings visible in the outer sections. It is important to understand the type of wood that is being drilled. Sound wood from many hardwood species may have high levels of resistance (over 50%), whereas sound wood from softwood conifers may have low levels of resistance (in the range of 15% to 50+%, depending on its inherent density). It is important to evaluate the levels of decay across the full dimension because some species have low resistance values but are not decayed. Further, each piece of commercial equipment provides different scales and may indicate different resistance levels. Table 2.1 shows a general assessment rating index that can provide support for the bridge inspector in evaluating resistance data collected during testing. Example electronic drilling charts for a southern yellow pine pile and a Douglas-fir pile cap are shown in Figures 2.15 and 2.16, respectively.

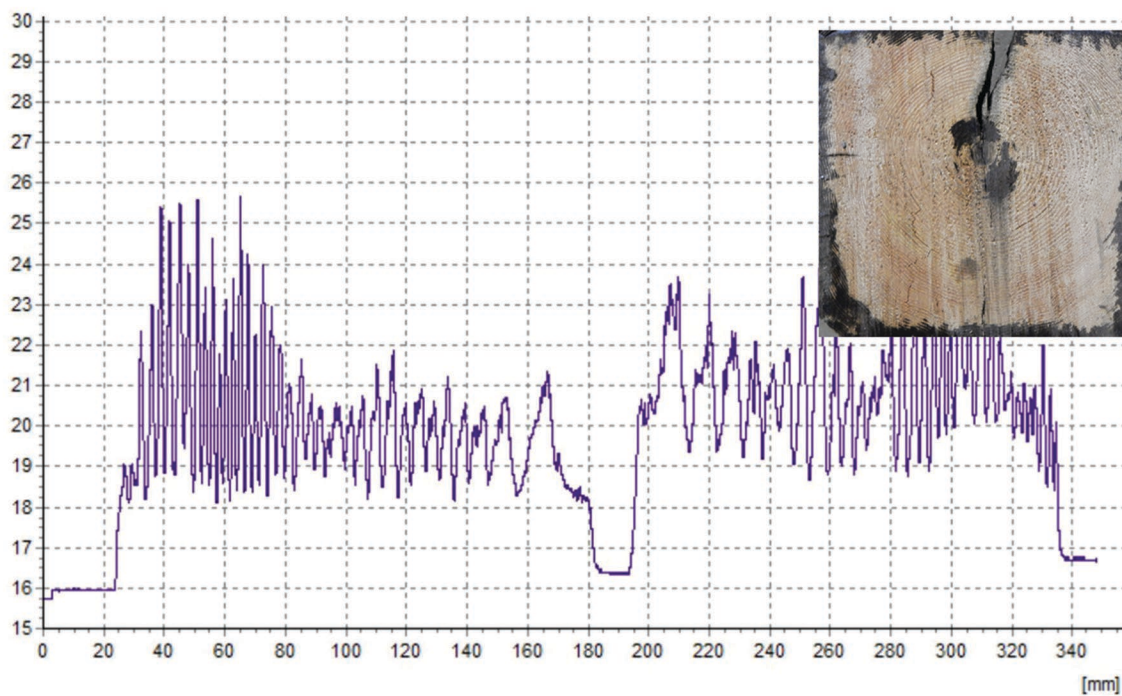
Figure 2.16—Electronic resistance chart of a Douglas-fir pile cap showing a large crack between 180 and 200 mm along the drilling path.

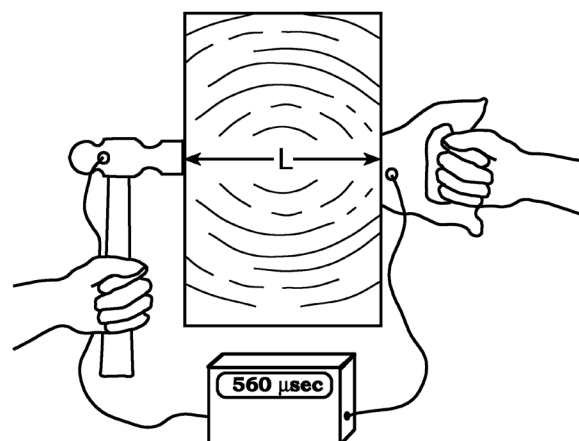
Figure 3.1—Stress wave timer.

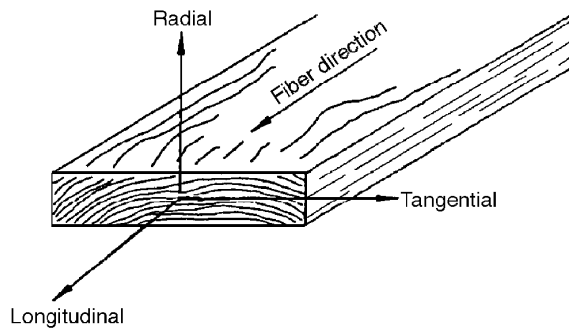
**Figure 3.2—Three principal axes of wood with respect to grain direction and growth rings.**

The velocity at which a stress wave propagates in wood is a function of the angle at which the fibers of wood are aligned (which is also a determinant of other physical and mechanical properties). For most structural members, fibers of the wood align more or less with the longitudinal axis of the member (Fig. 3.2).

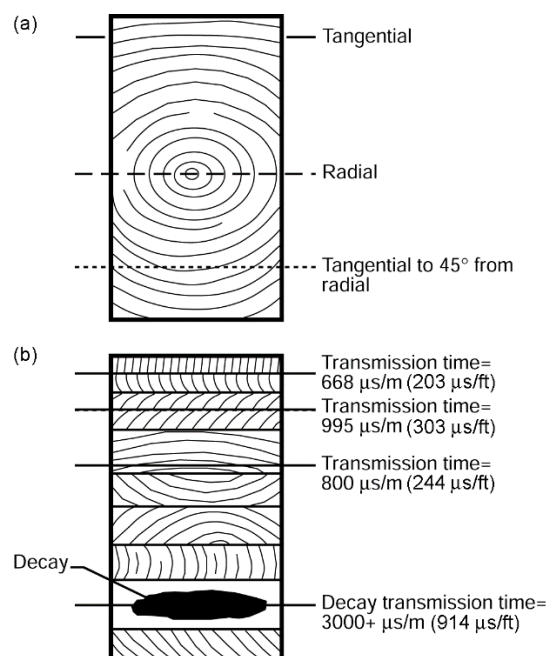
**Figure 3.3—Transverse stress wave paths and transmission times: (a) timber, (b) glulam beam.**

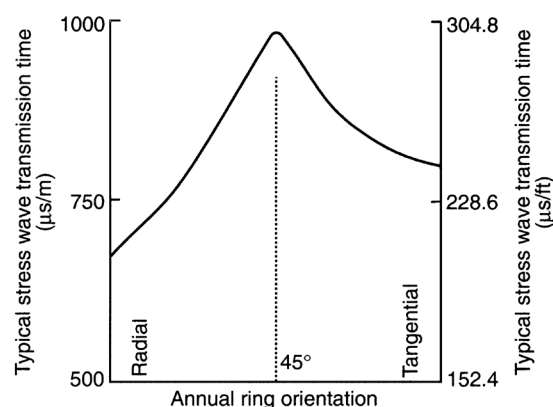
**Figure 3.4—Transverse stress wave transmission time compared with annual ring orientation.**

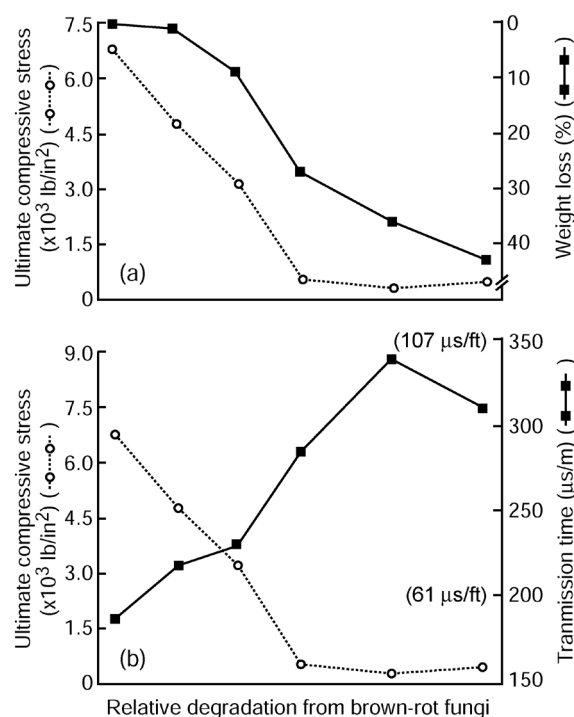
**Figure 3.5—Relationship between stress wave transmission time and fungal degradation (Pellerin et al. 1985) (1 lb/in<sup>2</sup> = 6.9 kPa).**

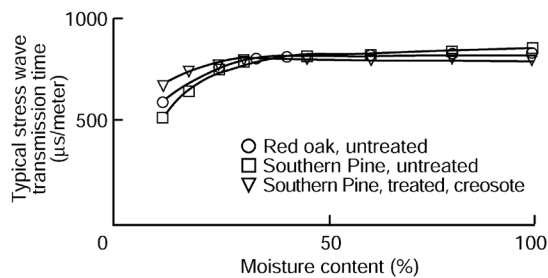
**Figure 3.6—Transverse stress wave transmission times in Southern Pine and red oak piling.****Table 3.4—Stress wave transmission time adjustment factors for temperature at various moisture contents for Douglas-fir**

Considerable research has shown the effect of moisture in wood on stress wave transmission time. Several studies have revealed that stress wave transmission times perpendicular to the grain of wood follow a relationship (Fig. 3.6). At moisture contents less than approximately 30%, transmission time decreases with decreasing moisture content. Corrections for various moisture content values are summarized in Table 3.4.

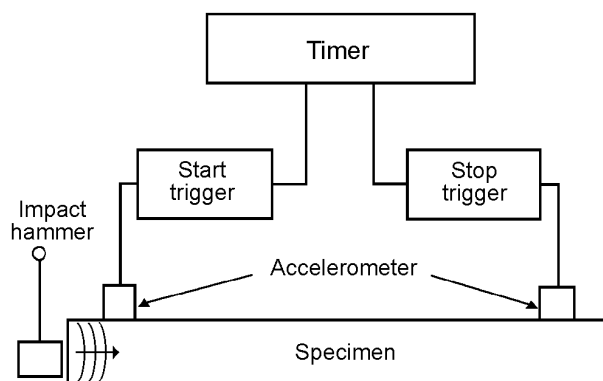
**Figure 3.7—Technique used to measure impact-induced stress wave transmission times in various wood products.**

Several techniques can be used to measure stress wave transmission time in wood. The most common technique uses simple time-of-flight-type measurement systems. Two commercially available systems that use this technique are illustrated in Figures 3.7 and 3.8.

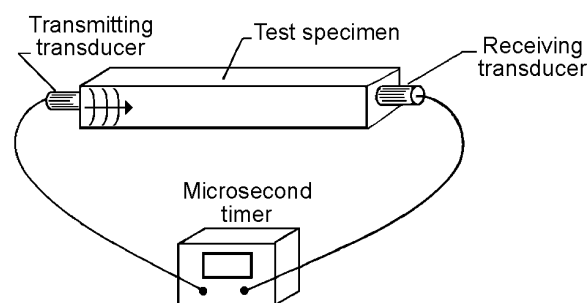
**Figure 3.8—Ultrasonic measurement system used to measure stress wave transmission times in various wood products.**

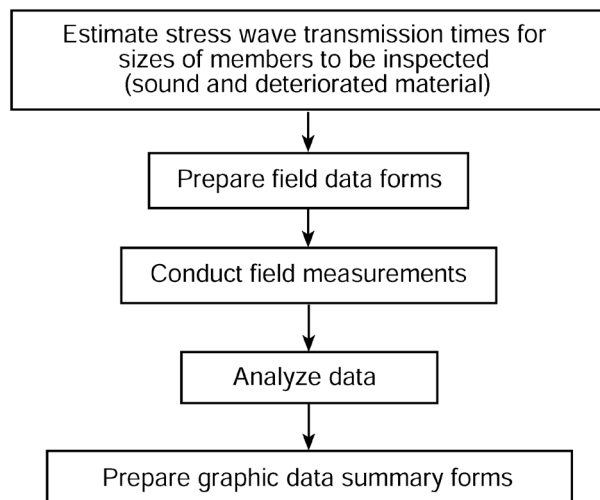
**Figure 3.9—General procedures used to prepare and use stress wave timing methods for field work.**

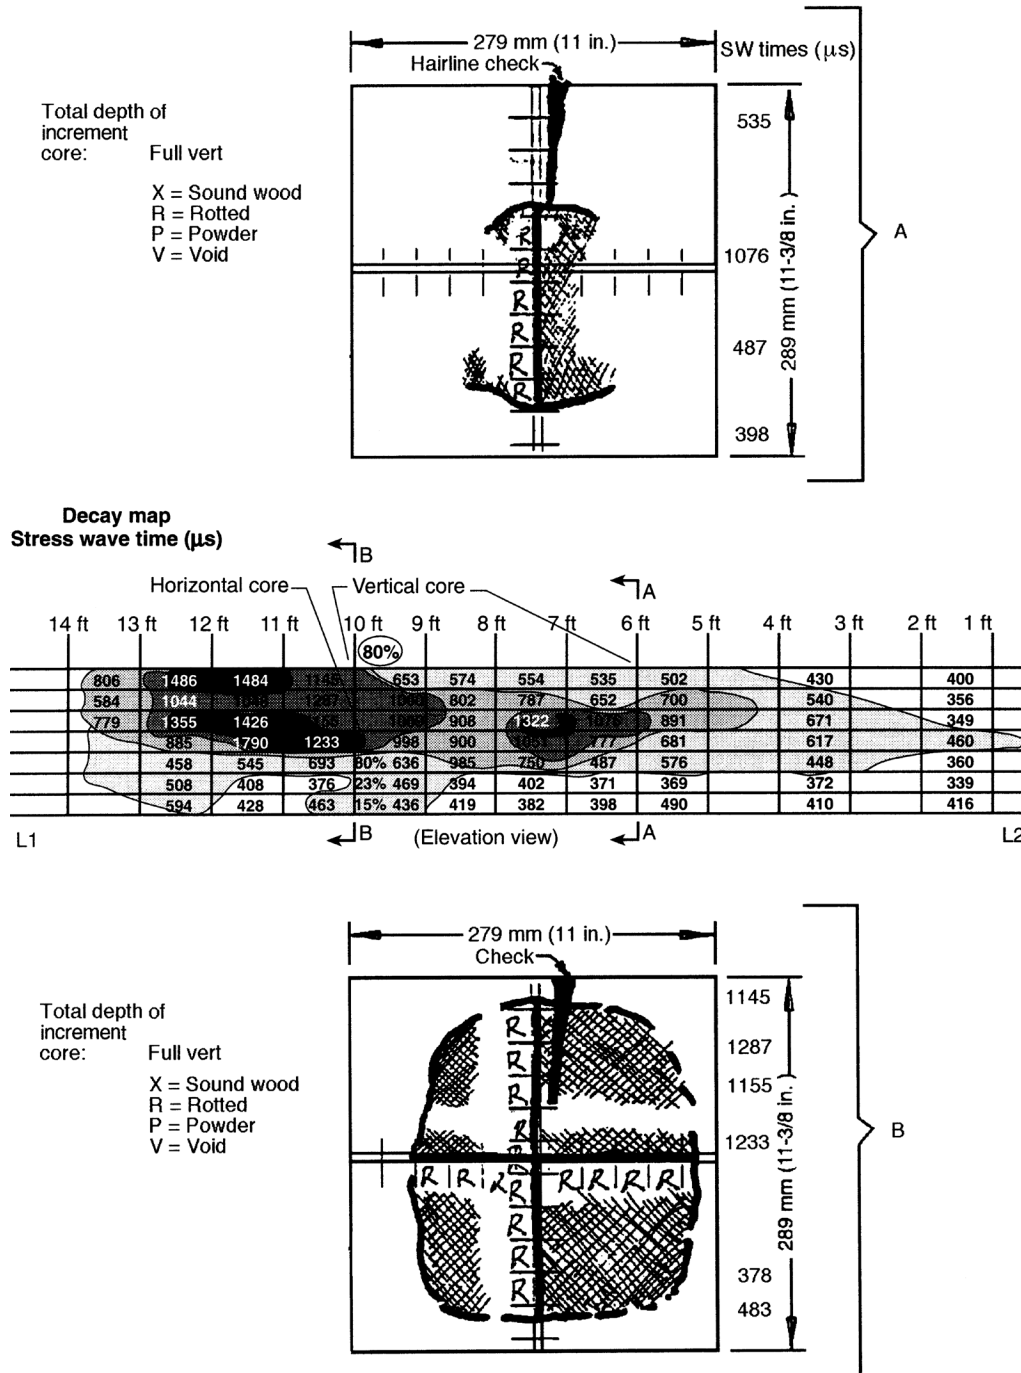
Figure 3.11—Examples of summary form (top) and data summary form.

When data have been gathered, it is useful to present them in an easy-to-read manner. Figure 3.11 illustrates various data summary forms. From these, the presence and extent of degradation can readily be seen.

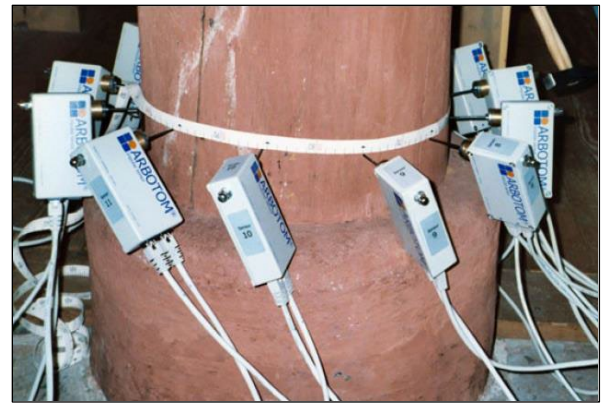
Figure 4.1—Acoustic tomography test on a timber post.

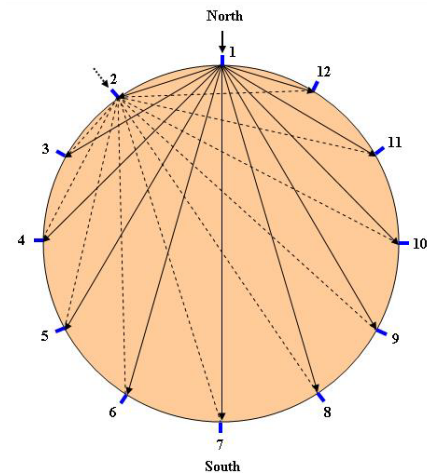
Figure 4.2—Sensor arrangement and paths of acoustic measurement on a round timber.

Figure 4.2 illustrates the sensor arrangement and paths of acoustic waves for a tomography test on a round timber. Acoustic TOF data are obtained by sequentially tapping each pin using a steel hammer. A complete TOF data matrix can be obtained through this measurement process at each test location.

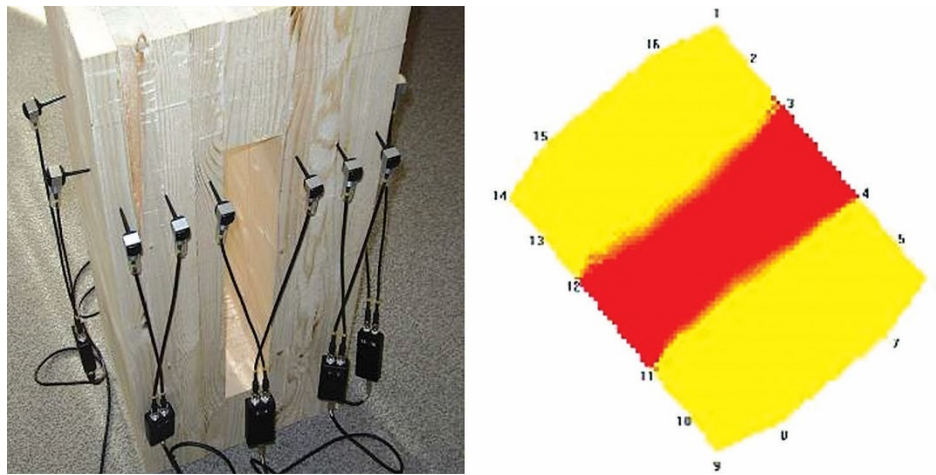
**Figure 4.3—Acoustic tomography test on a glued-laminated specimen with a simulated void (Divos 2006).**

*Glued-laminated timber specimen:* Divos (2006) demonstrated the use of acoustic tomography on a section of glued-laminated timber with a simulated void (Fig. 4.3). Sixteen sensors were strategically placed on four faces of the specimen (Fig. 4.3a). The center void can be visualized as a red color zone in the tomogram (Fig. 4.3b).

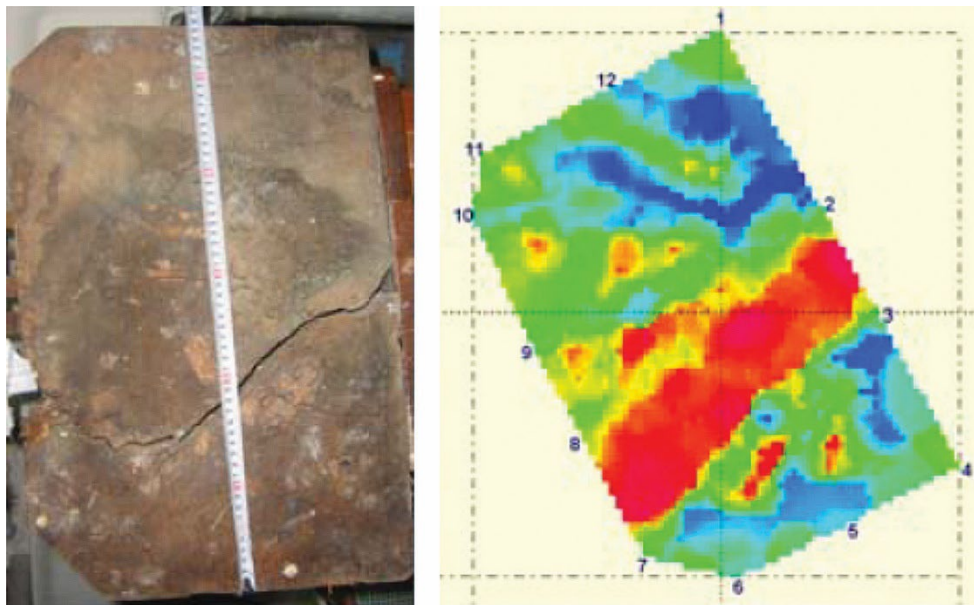
**Figure 4.4—Acoustic tomogram revealed internal crack of an old timber at the Imperial Palace in Beijing (Yu et al. 2009).**

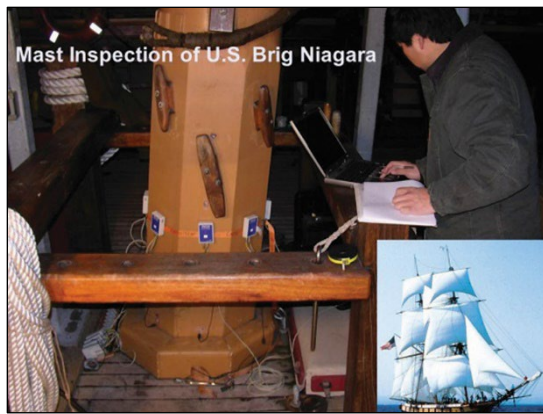
**Figure 4.5—Inspection of the masts of the U.S. Brig Niagara using acoustic tomography.**

*In-service masts of historic wooden ship:* Wang and Wacker (2006) inspected the masts of the U.S. Brig Niagara, a reconstruction of an early 19th century wooden warship of the U.S. Navy, using acoustic tomography technique (Fig. 4.5). The fore mast and main mast are both fabricated from southern yellow pine glulam. Primary concerns were locations at the main deck level where water often comes in and creates moist conditions. Tomography testing on both masts indicated sound cross sections at the deck level, which were further confirmed by resistance drilling tests.

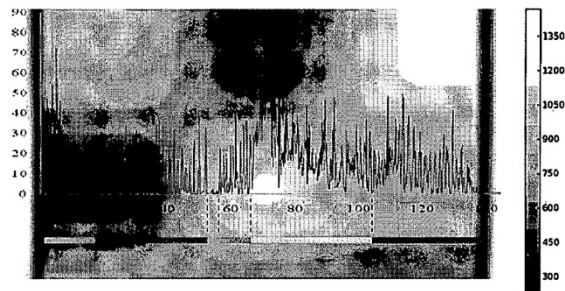
**Figure 4.6—Tomogram of a timber section superimposed with the relative resistance profile (Riggio and Pizza 2011).**

*Tomography complemented with micro resistance drilling:* Riggio and Piazza (2011) used a multi-channel device (TDAS 16–Boviar SRL) with an ultrasonic probe of 55 kHz to map decayed areas in timbers. Acoustic velocity maps were represented in a diagram by 256 levels of grey, with the white level corresponding to maximum velocity and the black level corresponding to minimum velocity. Complementary to TOF tomography, micro resistance drilling tests were carried out in portions of the sections to provide data for confirmation of the tomograms. Figure 4.6 shows the tomogram acquired from a decayed cross section superimposed with a relative resistance profile. The  $x$  axis of the plot is positioned along the corresponding drilling path. The presence of void and poor quality of the timber can be identified by low values of both acoustic velocity and relative drilling resistance. The void area in the left portion of the timber is confirmed by the almost flat resistance profile, and the sound wood in the central part is confirmed by the high resistance profiles. Results indicated that integral of relative resistance profile divided by penetration depth and average acoustic velocity values in tomograms can be used to give general interpretation of the tests.

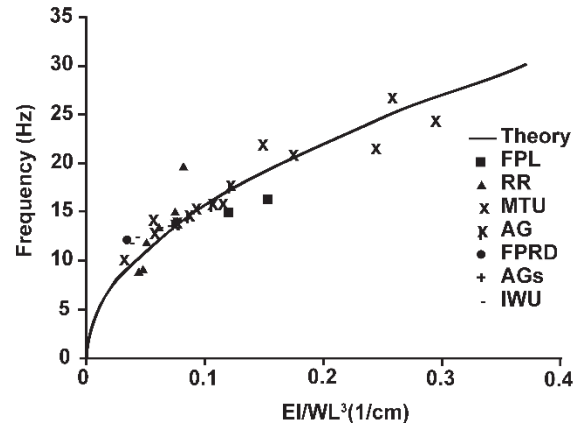
Figure 4.7—Scatter plot of in-place floor test data and previously tested lab-built floor sections.

A total of 30 in-place floors and four configurations of two salvaged floor sections were tested both dynamically and statically (Forsman and Erickson 2001, Soltis et al. 2002, Wang et al. 2005, Hunt et al. 2007). The forced natural frequencies and configuration were measured. According to Equation (4), the square of forced damped natural frequency for each floor is correlated to the factor  $EI/WL^3$ , where  $EI$  was determined by the static load test,  $W$  is estimated weight of the floor/section, and  $L$  is measured floor span. The solid curve in Figure 4.7 is the hypothesized response of the natural frequencies with different  $EI/WL^3$  configurations. Data points in Figure 4.7 are measured natural frequencies of the prior tested laboratory-built floor sections. A least squares analysis yields a coefficient of determination  $r^2 = 0.85$  for comparing empirical data versus theory. Based on these favorable results, the hypothesis that in-place wood floors, such as those tested in this project, can be modeled as a simply supported, one-way beam system under transverse vibration with viscous damping was not rejected.

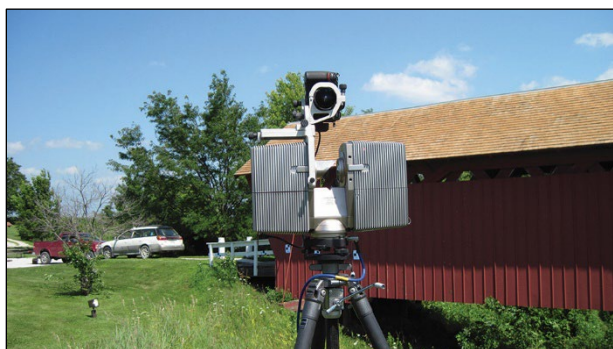
**Figure 4.8—A FARO laser scanner used to scan a historic covered bridge.**

2. A FARO LS 880 3D laser scanner was used to conduct the scan. The scanner was placed at several vantage points inside and outside the bridge, so that all visible surfaces of the bridge could be documented. Individual scans were completed in approximately 15 to 20 min. Each completed scan was saved to a computer as an .ls file. (A computer with substantial computing power and RAM is highly recommended to process the millions of data points created during the scanning process.) Time duration: 10 person-hours.

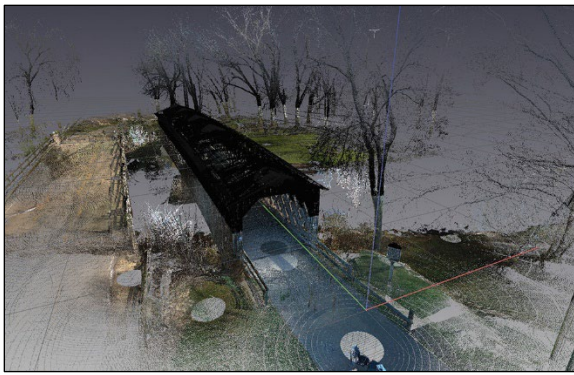
**Figure 4.9—Point cloud image of the Cedarburg Bridge (SightLine, LLC).**

Figures 4.9 to 4.11 show various images created from 3D laser scanning conducted during the project for the Cedarburg Bridge. This includes point cloud images and AutoCAD drawings created from the point cloud images.

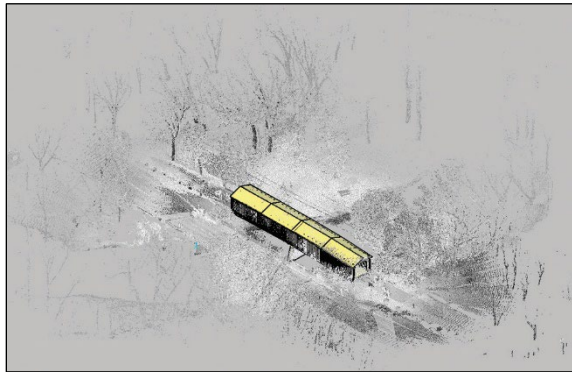
**Figure 4.10—3D AutoCAD image of the Cedarburg Bridge embedded in point cloud data (SightLine, LLC).**

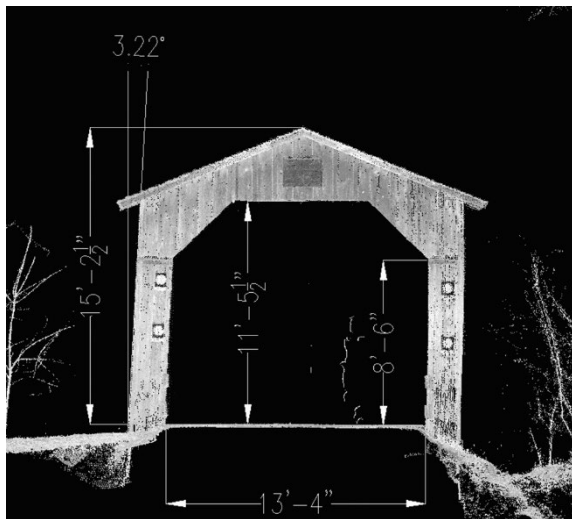
**Figure 4.11—Dimensioned point cloud image of bridge entry on Cedarburg Bridge (SightLine, LLC).**

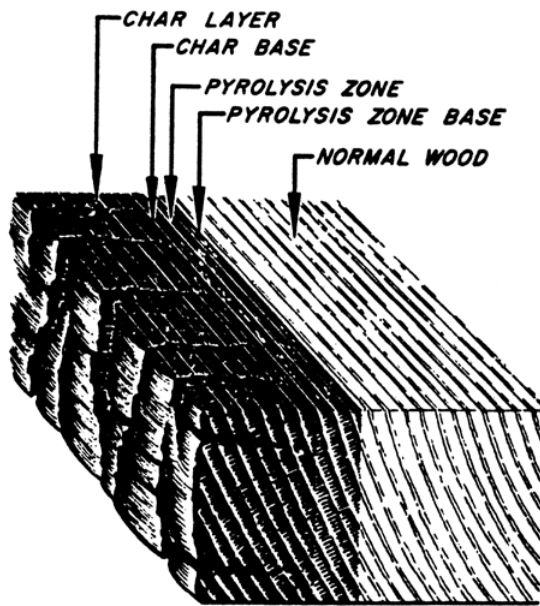
Figure 5.1—Degradation zones in a charred piece of wood.

For wood members that have charred, the char layer can be easily scrapped off. The char itself has no residual load capacity. The wood beneath the char layer has residual load capacity, but this residual capacity will be less than the load capacity prior to the fire. Members that have only visual smoke damage or slight browning of the surface will maintain a significant percentage of the original residual load capacity.
