Forest Products Laboratory | General Technical Report FPL–GTR–299 | March 2025

# Wood and Timber Condition Assessment Manual

Third Edition

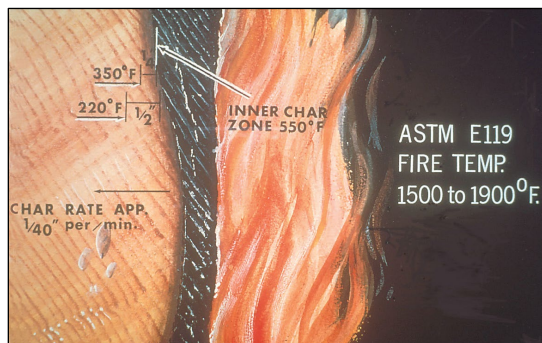
Figure 5.2—Charring wood member exposed to the standard fire exposure of 815 to 1,038 °C.

ASTM E119 (ASTM 2022b) standard test method is the test for determining the fire-resistance rating of a structural member or assemblies for building code purposes. The standard fire exposure is a specified time–temperature curve of 538 °C (1,000 °F) at 5 min, 843 °C (1,550 °F) at 30 min, 927 °C (1,700 °F) at 1 h, and 1,010 °C (1,850 °F) at 2 h. This severe and direct fire exposure results in rapid surface charring, the development of a char layer with a base temperature of approximately 300 °C (550 °F), and a steep temperature gradient of 177 °C (350 °F) at 6 mm (0.2 in.) and 104 °C (220 °F) at 13 mm (0.5 in.) beneath the char layer (Fig. 5.2). For a large wood member directly exposed to the standard fire exposure, the char rate is approximately 0.6 mm/min (38 mm/h, 1.5 in/h, 1/40 in/min). Char rate in the standard test depends on species, density, moisture content, and duration of exposure (White and Nordheim 1992). Most research on fire endurance of wood members has been directed toward predicting or understanding their

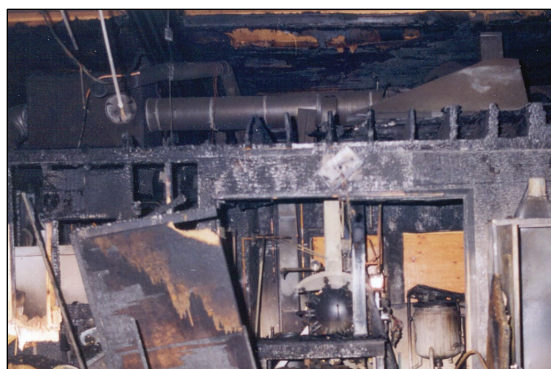
**Figure 5.3—Area of fire origin in Building 2 fire at the Forest Products Laboratory.**

As noted by Buchanan (2001), it is valuable to visit the fire scene immediately after the fire to make notes of all of the damage that occurred. The post-fire situation after the mid-1990s fire in a building at the USDA Forest Products Laboratory, is illustrated in Figure 5.3. For most fire investigations conducted by fire departments and other investigators, the intent is to establish the cause for initial ignition and fire growth. The standard guide for such investigations is NFPA 921. This guide advocates a

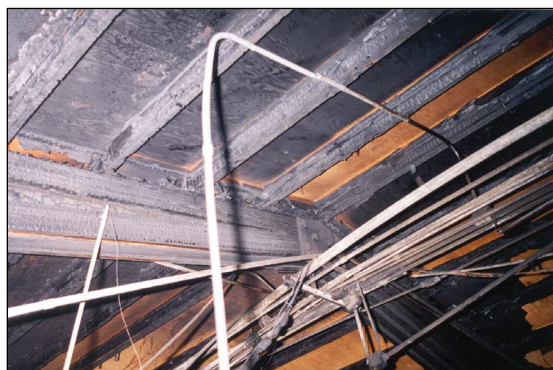
**Figure 5.4—Charred and uncharred wood members in the Building 2 fire at the Forest Products Laboratory.**

Wood exposed to temperatures in excess of approximately 300 °C (550 °F) will form a residual char layer on the surface (Fig. 5.4). With prolonged exposure, charring of wood can occur at lower temperatures. Although it retains the anatomical structure of uncharred wood, the char layer can be easily scraped or sand-blasted off.

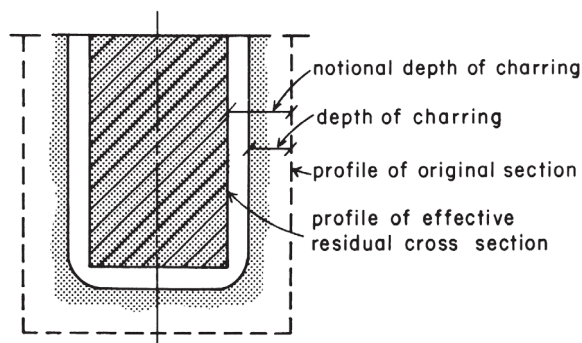
**Figure 5.5—Residual cross section of a charred wood member.**

In an inspection of charred members, it is important to understand that the char layer exhibits significant shrinkage, resulting in fissures in the char layer. Glowing combustion of char can also occur. As a result, the thickness of the residual char layer is less than depth of charring (Fig. 5.5). The profile of the original section will need to be determined from construction records or similar uncharred members.

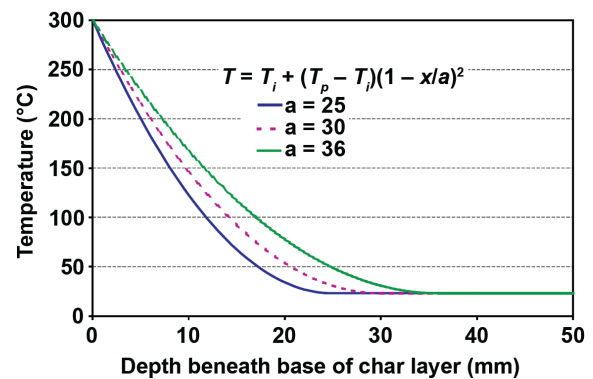
Figure 5.6—Temperature profile beneath the base of the char layer of a semi-infinite wood slab directly exposed to the ASTM E119 standard fire exposure.

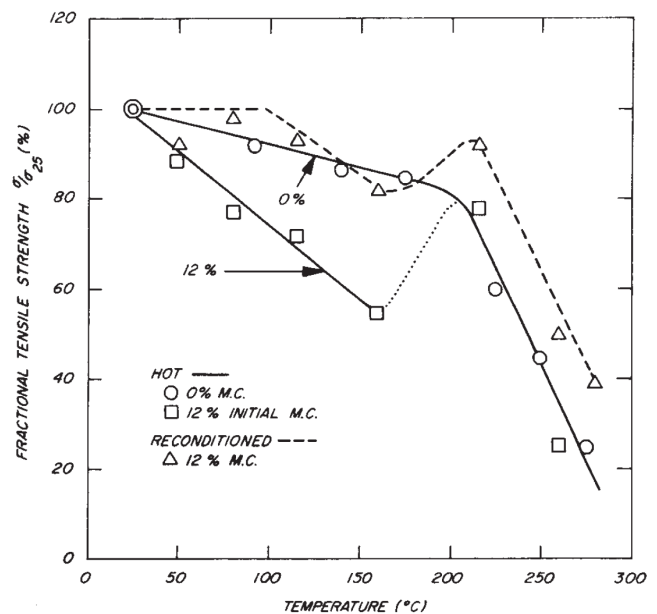
Figure 5.7—Fractional tensile strength as function of temperature (Schaffer 1977, 1982b, 1984).

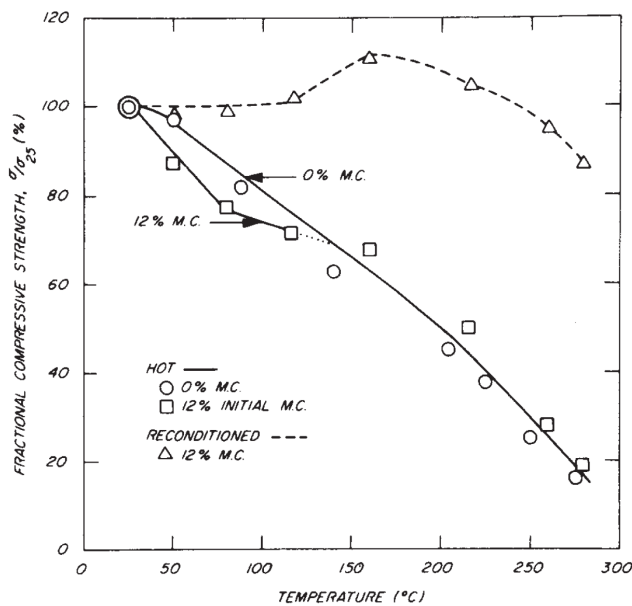
**Figure 5.8—Fractional compressive strength as function of temperature (Schaffer 1982a,b).**

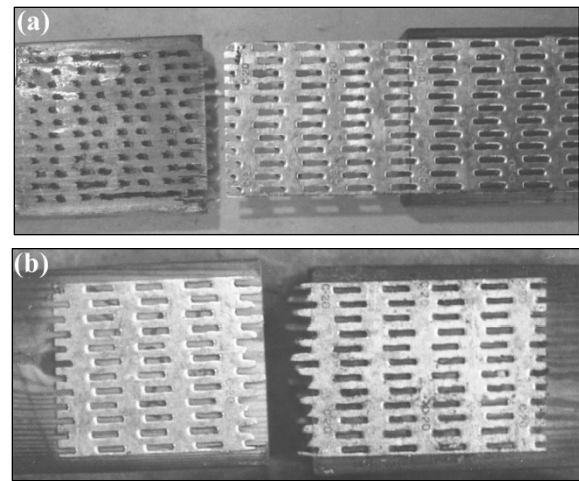
**Figures 5.9—(a) Test specimens of metal plate connections illustrating charred wood failure beneath the plate, and (b) metal plate failure of plate with uncharred wood beneath the plate.**

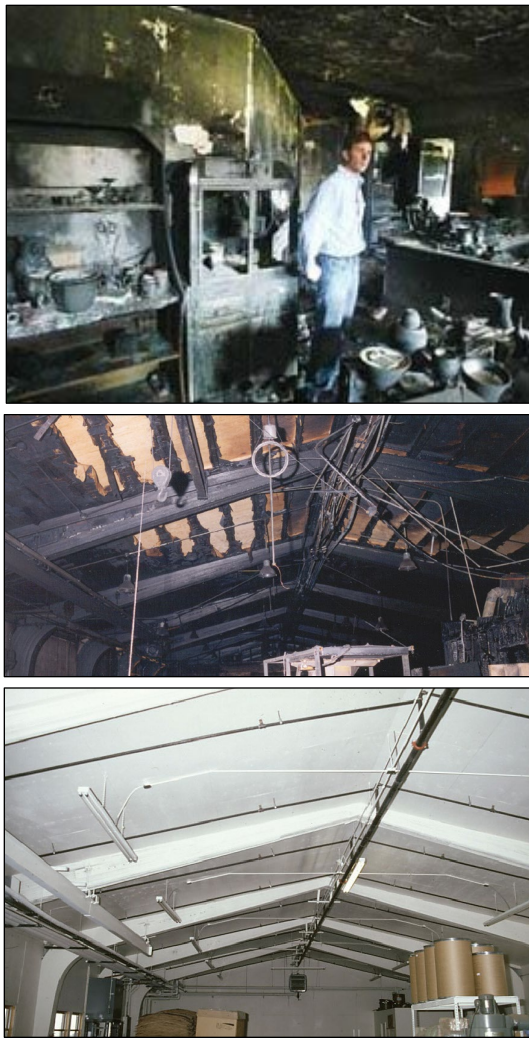
**Figure 5.10—Post-fire inspection (top) of residence; post-fire (middle) and post-repair (bottom) of Building 2 at the Forest Products Laboratory.**

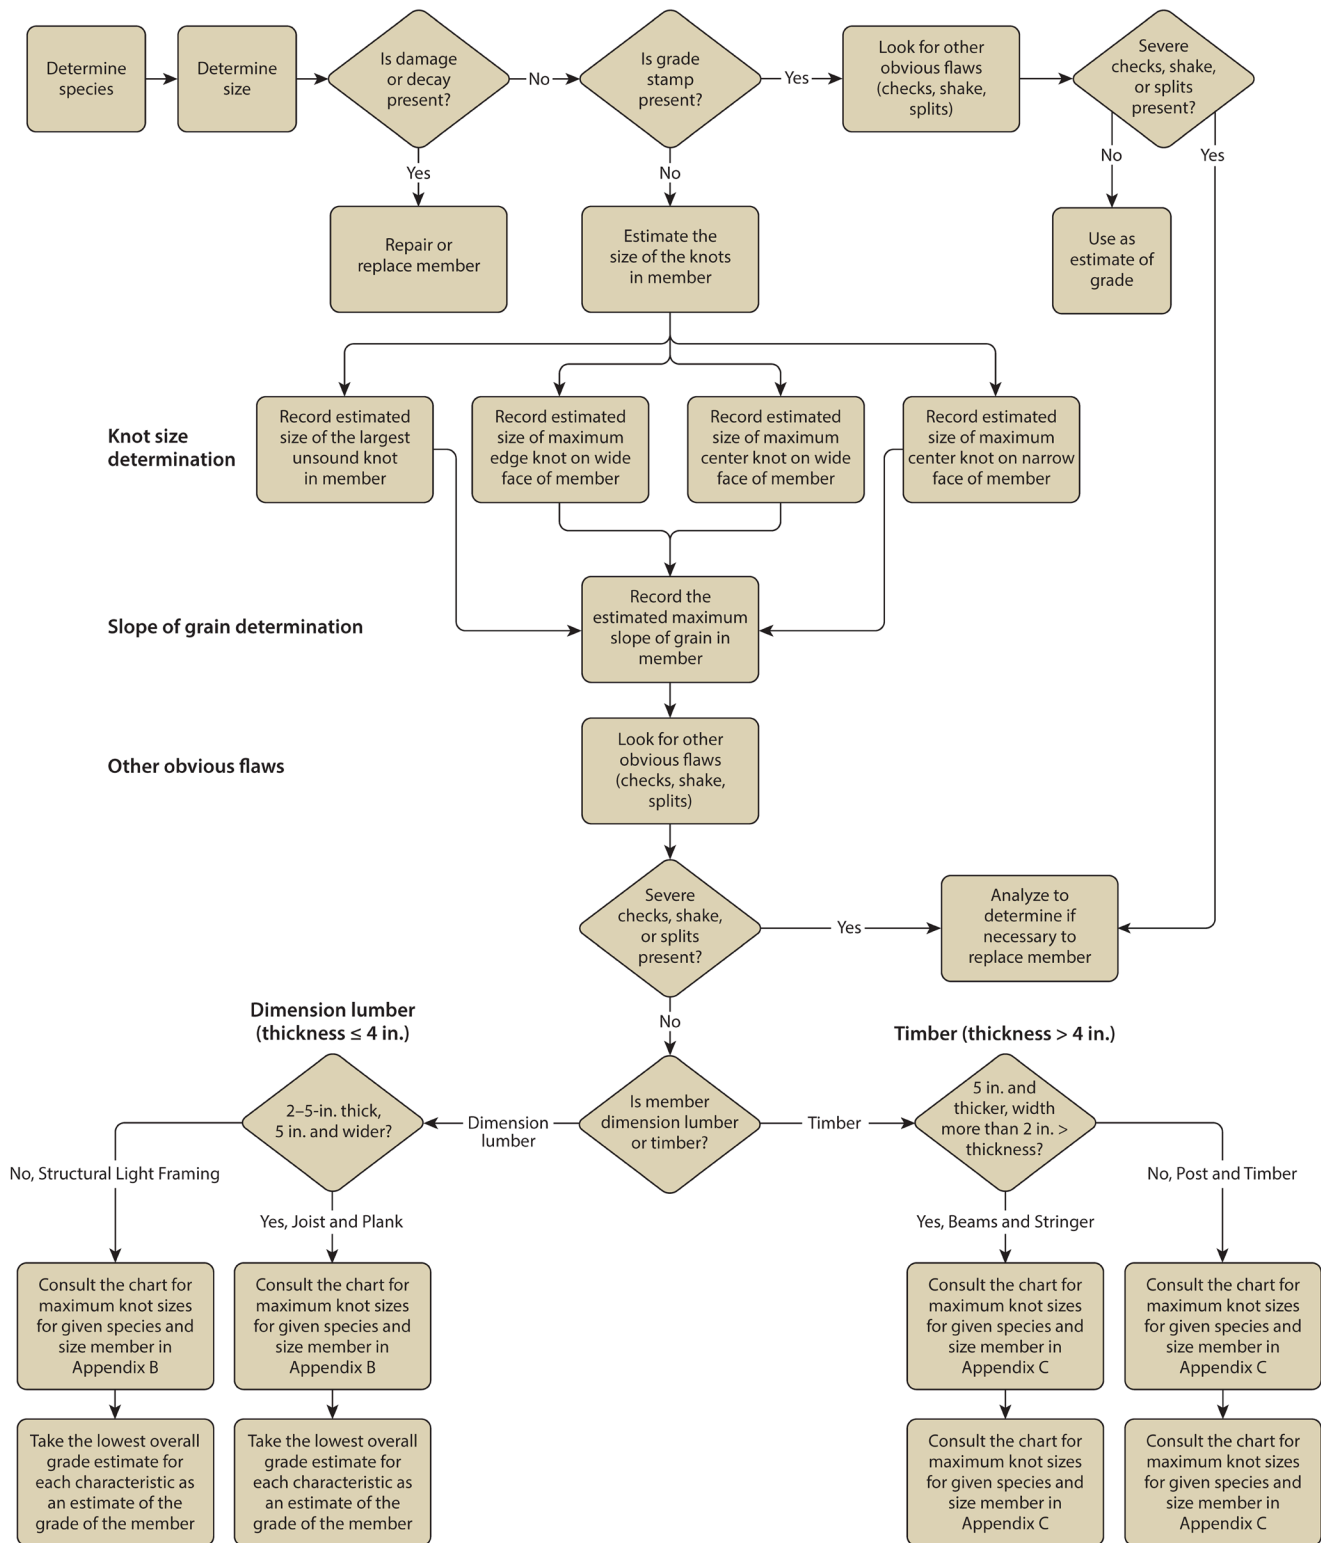
Figure 6.1—Steps for member grading.

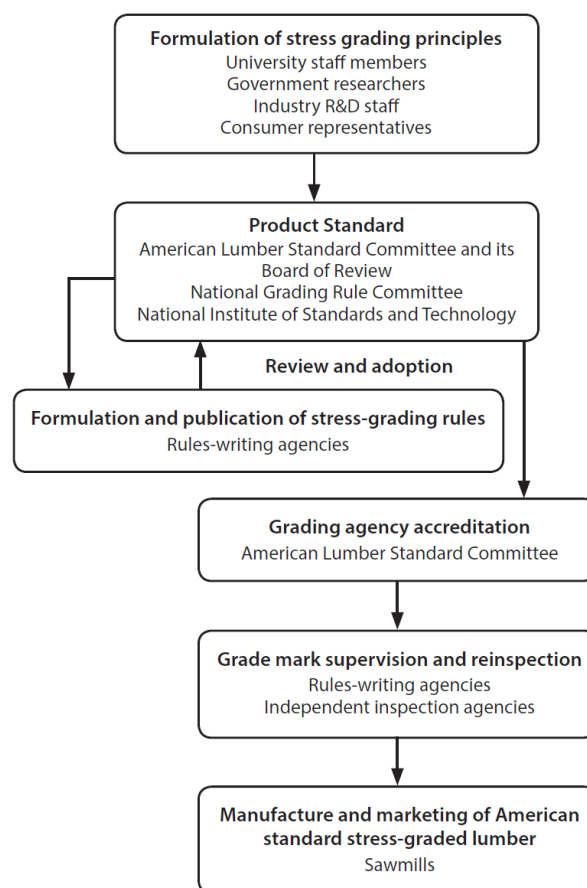
**Figure 6.4—Voluntary system of responsibilities for stress grading under the American Softwood Lumber Standard.**

stress-graded lumber (Fig. 6.4). Stress-grading principles are developed from research findings and engineering concepts, often within committees and subcommittees of ASTM International (formerly the American Society for Testing and Materials), and then applied to product classes. Lumber cannot be graded as American Standard lumber unless the grade rules have been approved by the American Lumber Standard Committee (ALSC), Inc., Board of Review. Virtually all commercial softwood and hardwood lumber used for structural purposes that is manufactured in the United States is stress graded under American Lumber Standard practice and is called American Lumber Standard program lumber. The American Lumber Standard has been modified several times, including the addition of hardwood species to the standard beginning in 1970. The current edition is the American Softwood Lumber Standard PS 20–20 (DOC [current edition]). Distinctive grade marks for each species or species grouping are provided by accredited agencies. The principles of stress grading are also applied to several hardwood species under provisions of the American Softwood Lumber Standard, ASTM International, and then applied to product classes. The allowable design properties are tabulated in the Supplement to the National Design Specification (AWC 2024).

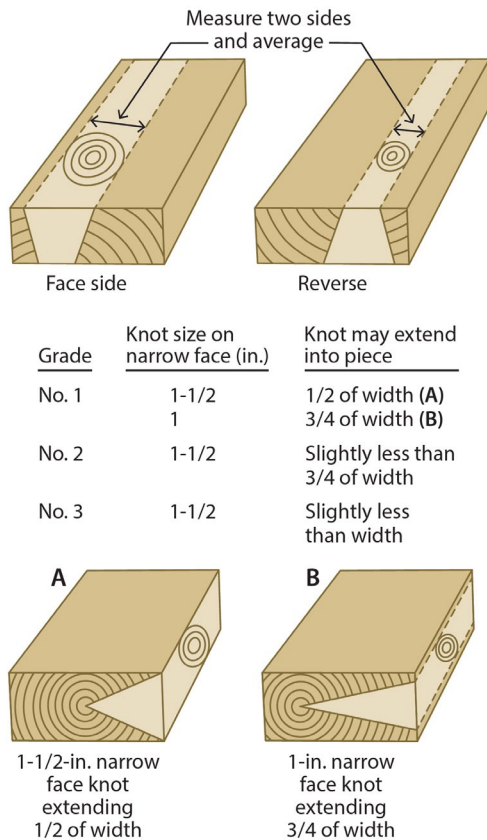
**Figure 6.5—Diagram from a pocket guide showing measurement of knots on 2- to 4-in. lumber that included structural joists and planks (SPIB 2021a). Used by permission of Southern Pine Inspection Bureau.**

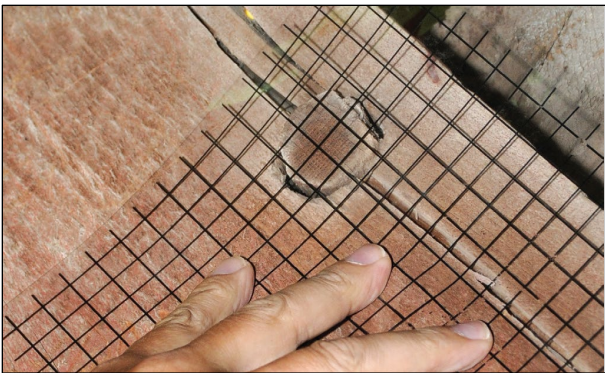
**Figure 6.6—Example of using grid to establish the size of knot in bridge member. The measured knot in the example is 1-1/2 in.**

Knot sizes are likely to be difficult to assess on many members in structures. A scale is often used for quick estimates of knot size. Anthony et al. (2009) discuss another useful technique (a grid on a clear film) for estimating knots in dimension lumber. When properly aligned, the grid allows you to make a good estimate of knot size to the closest 1/4 in. (Fig. 6.6). Accurately capturing maximum knot size for the centerline and edge of the member is highly important; these are usually the controlling features for establishing grade.

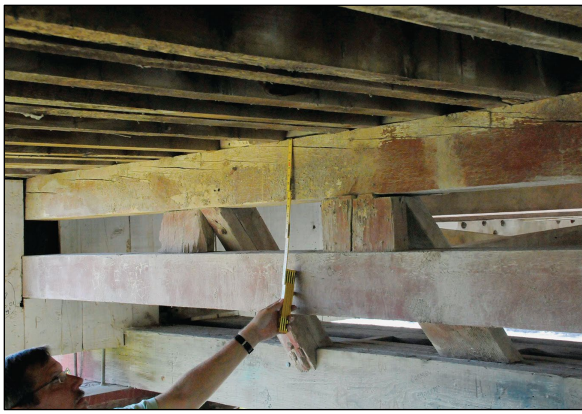
**Figure 6.8—Example of using checking in a member to measuring the slope of grain in bridge. The end of the scale points to the start of one check.**

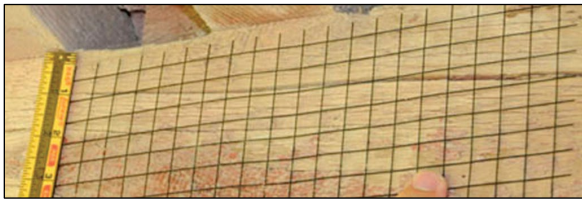
**Figure 6.9—Use of grid to easily estimate the slope of grain. The 2:18 grids above implies 1 in 9 slope of grain. The black line shows the direction of slope of grain.**

To measure slope of grain, the clear sheet with a printed 1/2-in. grid can once again be put to use (Fig. 6.9). In this example, the area that appears to have significant slope of grain should be measured from an axis parallel to the long axis of the member. The grid can be used to establish the rise-over-run ratio. To do so, the total number of inches for the rise can be determined along the vertical axis by counting from the lowest point of the rise to the highest point of the rise (or wherever the grain crosses the edge of the acetate sheet). The total number of inches in the run can be determined along the horizontal axis by counting across from the lowest point of the rise to the highest point of the rise (or wherever the grain crosses the edge of the acetate sheet). These measurements can then be used to represent the actual slope of grain over a given length to determine the appropriate grade. As with knots, the most severe slope of

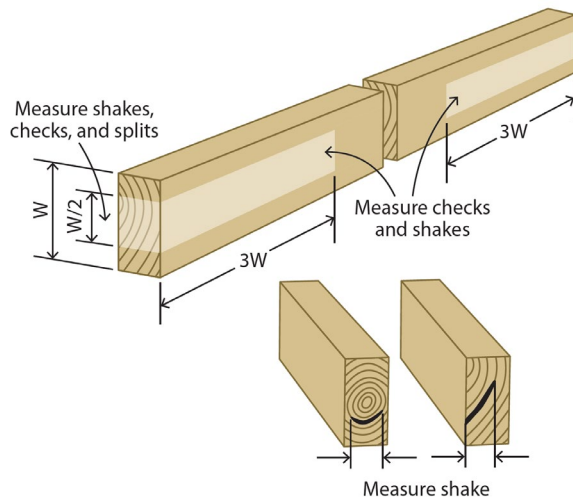
**Figure 6.10—Beams and stringer checks, shake, and split measurement.**

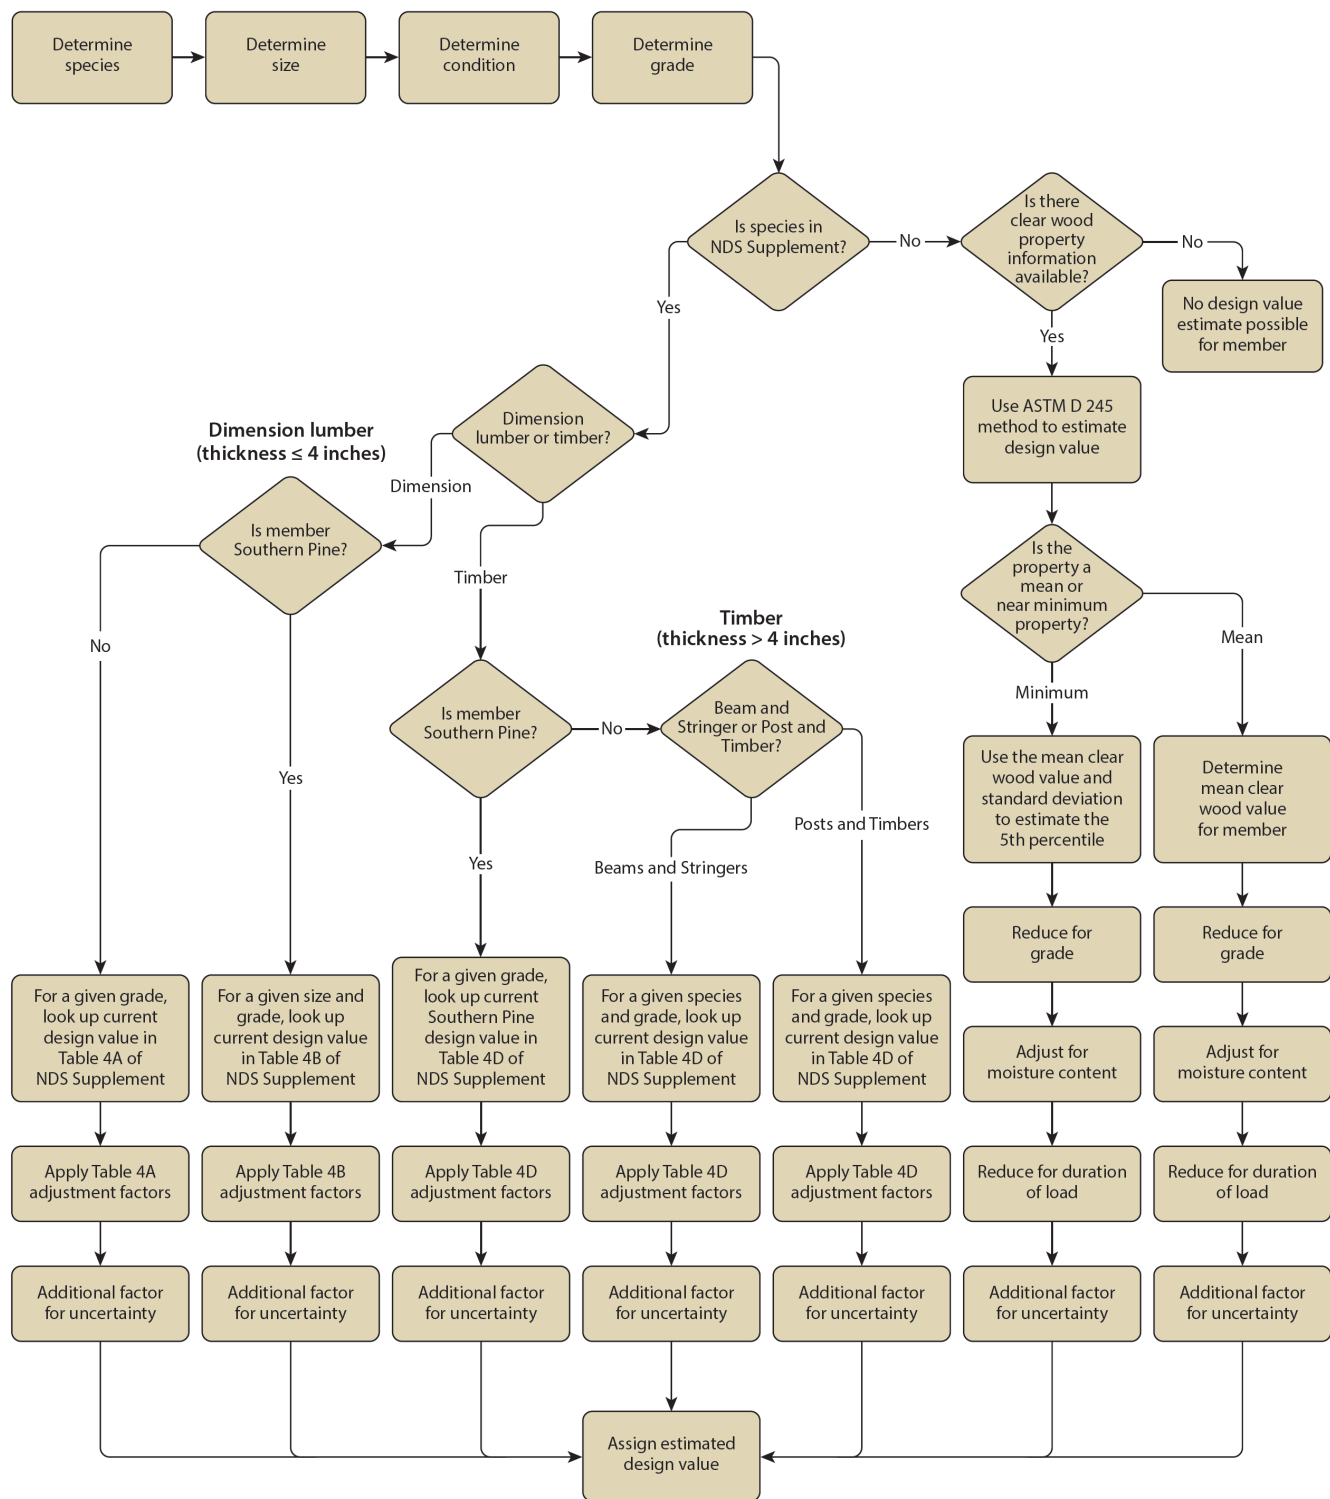
Figure 6.14—Flow chart for design value assignment.

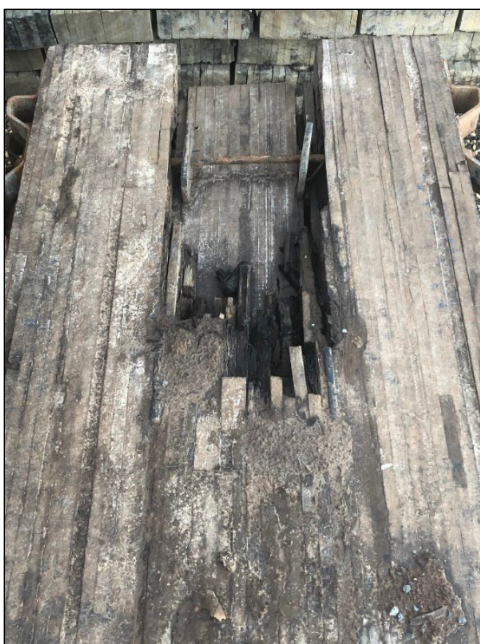
**Figure 7.1—Wood mat composed of three pressure-treated glued-laminated timbers with a broken middle member. This mat can be disassembled, repaired, and returned to service.**

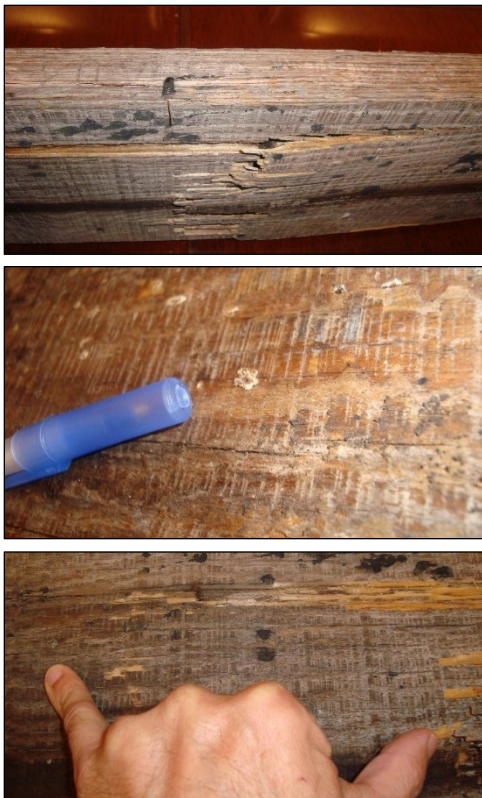
**Figure 7.2—Fractured piece of laminated veneer lumber scaffold planking. Before use, cursory observation suggested that the specimen was sound. However, examination after fracture noted multiple fungal fruiting bodies, indicating advanced decay, in relatively close proximity to the fracture. Ballpoint pen cap and hand indicate the size of fungal fruiting body and its proximity to the fracture, respectively.**

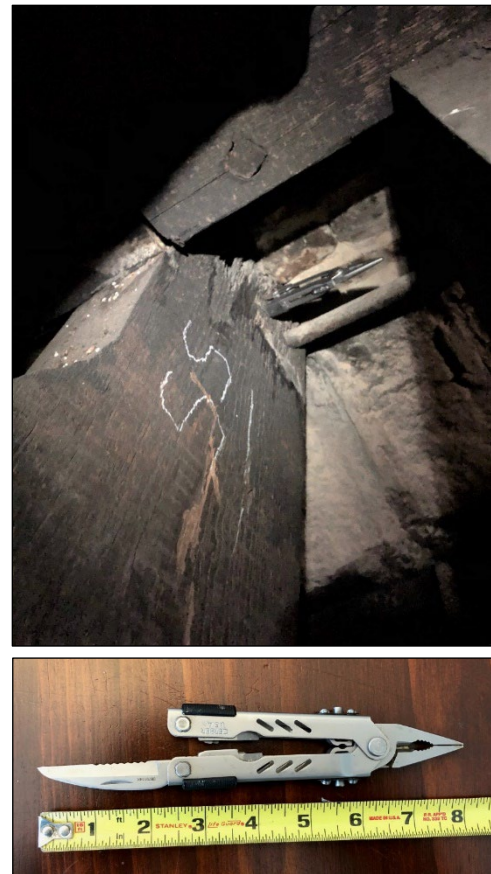
**Figure 7.3—Upper frame is a knife blade inserted fully into the decayed end of the 4-by 14-in. tension chord of a heavy timber truss. Such decay necessarily negates the contribution of the member. Lower image shows the 2.5-in.-long blade.**

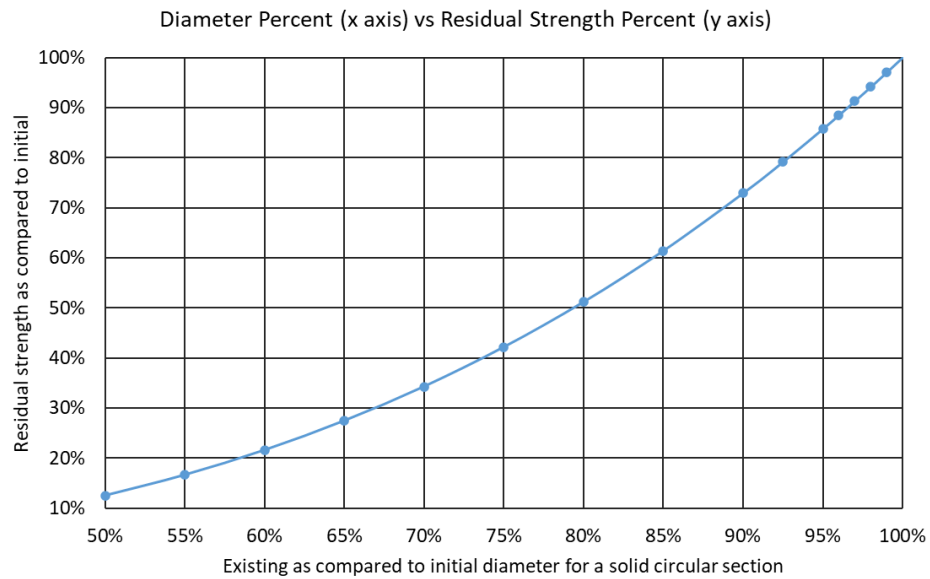
**Figure 7.4—Reduction in strength of a round solid section due to reduction in overall outside circumference/diameter, using formula section modulus  $Z = \pi d^3/32$ .**

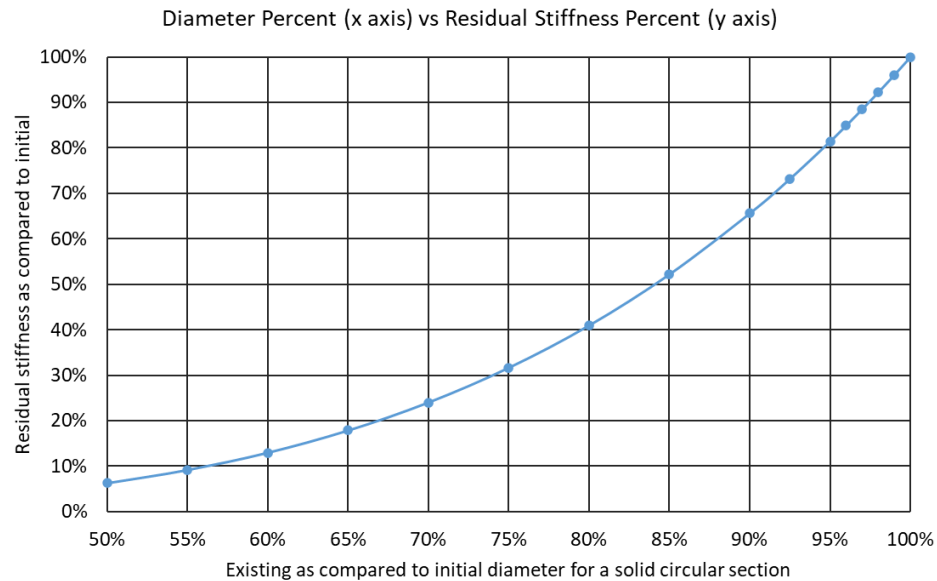
**Figure 7.5—Reduction in stiffness of a round solid section due to reduction in overall outside circumference/diameter, using formula moment of inertia  $I = 0.25\pi r^4$ .**

Figures 7.4 and 7.5 show strength and stiffness loss resulting from reduction in cross section for round poles. Over long periods of time, often on the order of decades, poles or pilings may lose their section properties, particularly at groundline or the intertidal line, due to deterioration, weathering, or abrasion from the outside, thereby leaving a solid round core of smaller diameter than initially. Similarly poles (and in many cases trees) may develop heart rot, in which case the core of the pole becomes deteriorated while the outer shell remains sound. In that case, the section becomes ring (or doughnut) shaped. Mats often become abraded at their leading edges through use and handling. They may also become thinner over time, particularly due to abrasion by steel grousers on crawler tractors, pipelayers, and other heavy equipment. When mats become thinner, their strength decreases as a square function of thickness and their ability to resist deflection decreases as a cubic function of thickness. Figures 7.4 to 7.9 illustrate the strength and stiffness loss of these scenarios: solid round section decreasing in diameter (as a pole or piling may after decades in service), solid round section becoming hollow in the middle (as some poles or live trees may develop heart rot in their core), and flat rectangular section becoming thinner (as can happen to timber mats over time in service). As an example, Figure 7.10 shows a knife blade driven into the shell of a wood utility pole at the groundline after removal from service. The diameter of the pole at the groundline is 12.4 in. The knife penetrated to an approximate maximum depth of 3/8 in. So the effective diameter at the groundline was 11.7 in. ( $12.4 \text{ in.} - (2 \times 3/8 \text{ in.})$ ), thus at the time of measurement, the diameter was 94% ( $(11.7 \text{ in.} / 12.4 \text{ in.}) \times 100$ ). Thus, per Figures 7.4 and 7.5, as compared to initial, its residual strength and stiffness appear to be 83% to 85% and 78% to 80%, respectively.

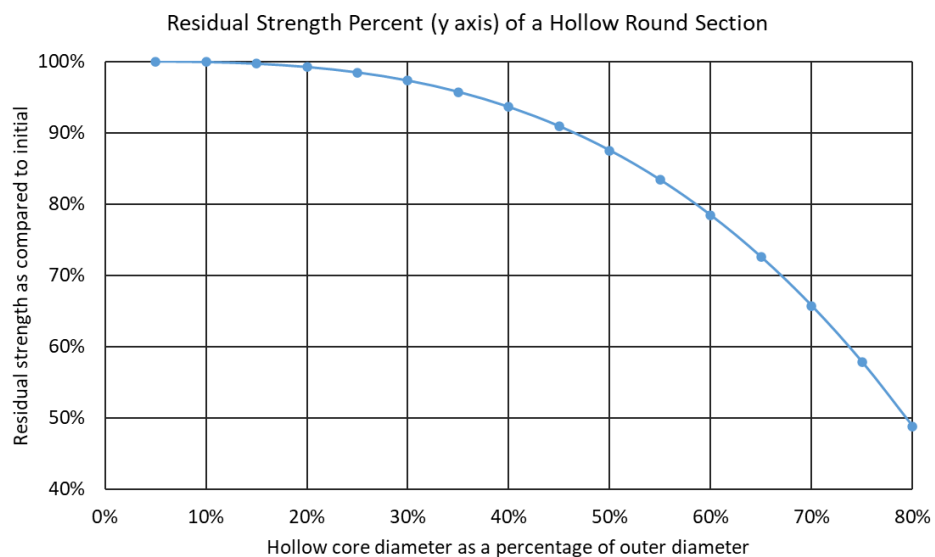
**Figure 7.6—Reduction in strength of a round section due to hollowing out of the core, such as due to heart rot. This section can be considered a ring. Strength is proportional to the section modulus of the outer diameter minus the section modulus of the inner diameter.**

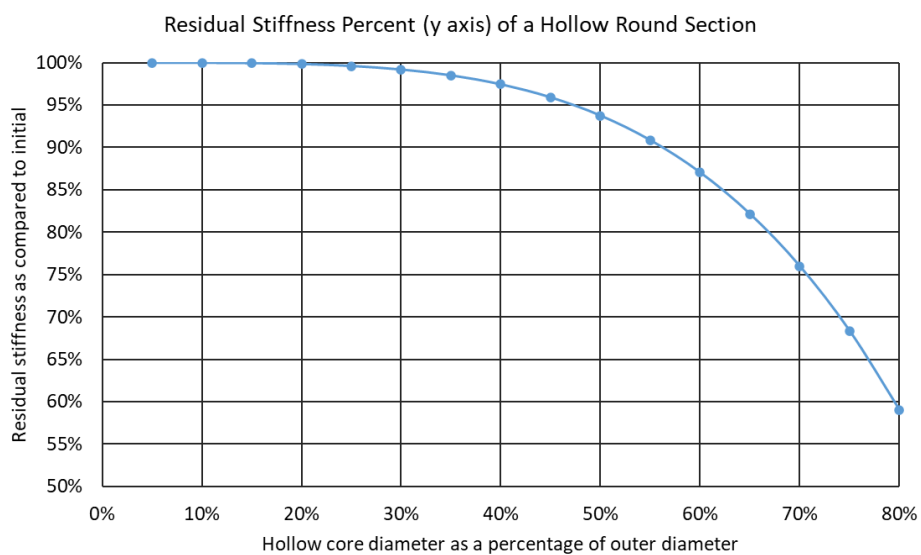
**Figure 7.7—Reduction in stiffness of a round section due to hollowing out of the core, such as due to heart rot. This section can be considered a ring. Stiffness is proportional to the moment of inertia of the the outer diameter minus the moment of inertia of the inner diameter.**

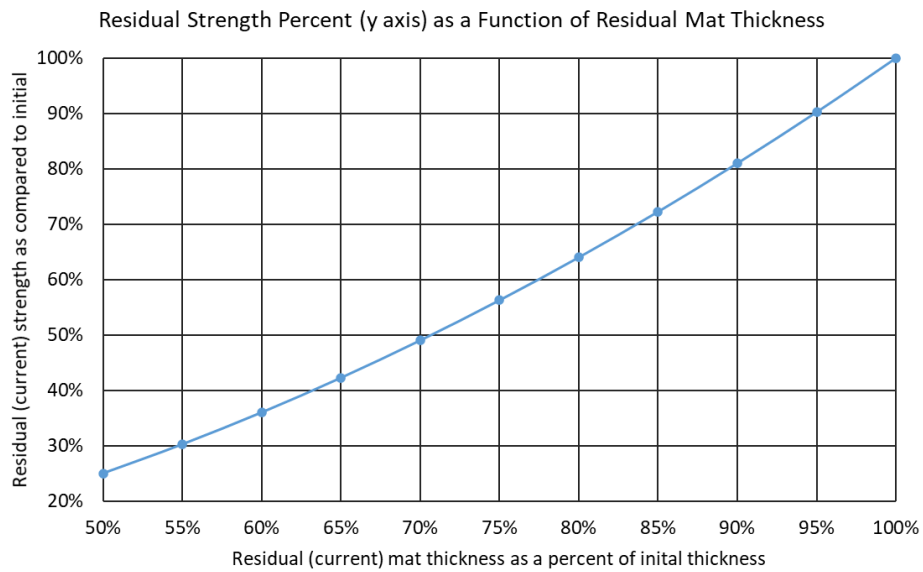
**Figure 7.8—Reduction in strength of a flat section, such as a timber mat, due to decrease in overall thickness. This thickness reduction often occurs through routine use and handling. Strength is proportional to section modulus and section modulus is proportional to thickness squared:  $Z = bh^2/6$ .**

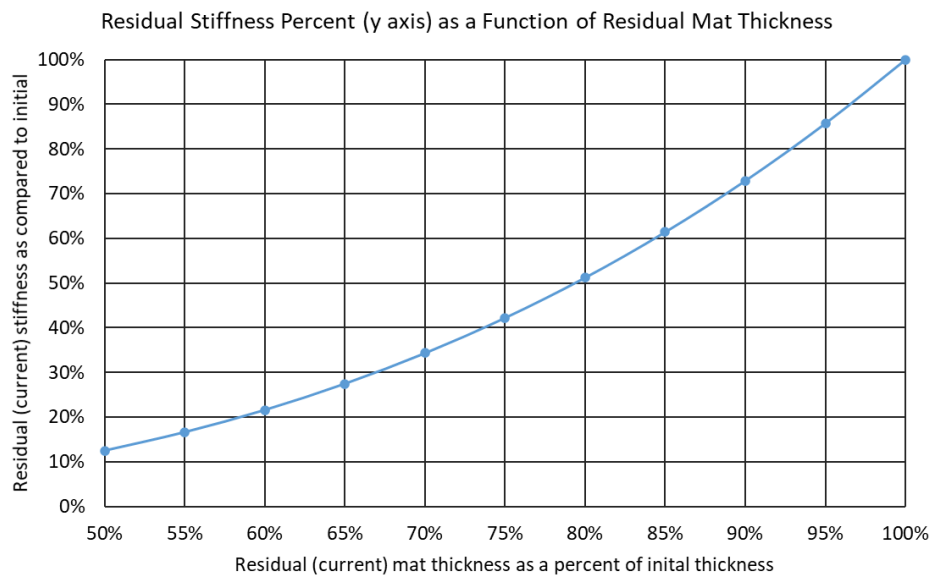
**Figure 7.9—Reduction in stiffness, ability to resist deflection and deformation, of a flat section, such as a timber mat, due to decreases in overall thickness over time. This thickness reduction often occurs through routine use and handling. Stiffness is proportional to moment of inertia and moment of inertia is proportional to thickness cubed:  $I = bh^3/12$ .**

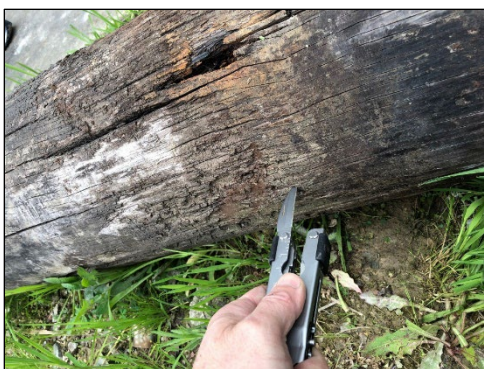
**Figure 7.10**—The knife blade is driven approximately 3/8 in. into the shell of a utility pole.

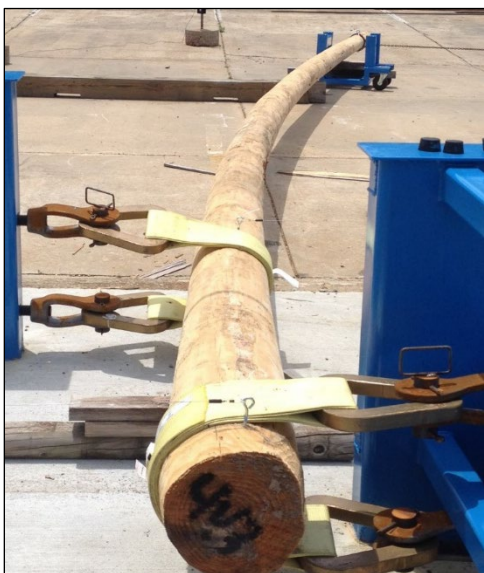
**Figure 7.11**—A class 4, 40-ft Southern Pine utility pole during ASTM D1036-12 (ASTM 2018) flexural test. Per ANSI O5.1, Annex B (AWPA 2017), the minimum required tip load is 2,400 pounds, applied 2-ft from the end.

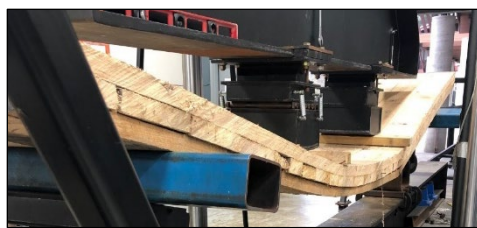
**Figure 7.12**—Freshly manufactured green oak three-ply bolt-laminated mat during flexural testing. The span to depth ratio of the composite section is approximately 28:1.

Figure 7.12 shows a new, freshly manufactured oak three-ply bolt-laminated timber mat during flexural testing. This type of bolt-laminated construction develops low stiffness and high deflection compared with adhesive-bonded cross-laminated timber. This figure illustrates that in order to use deflection as a qualitative measure of condition, one must have an appreciation of how baseline deflection of new, freshly manufactured material appears under load. The ability of mechanically fastened (bolted, nailed, or some combination of these) three-ply mats to deflect often

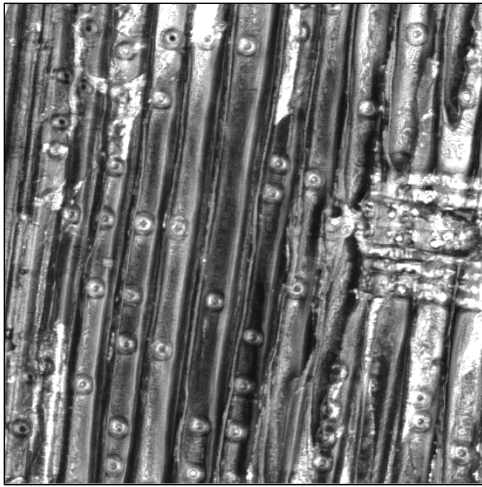
**Figure 7.13—Sound, nondecayed wood cells from a plug taken as part of an in-service assessment of a foundation beam. Magnification is 200x.**

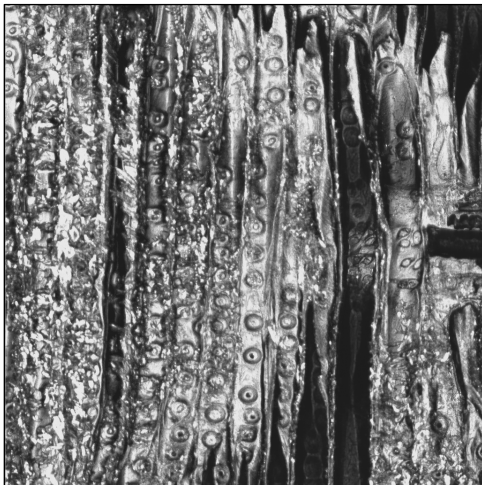
**Figure 7.14—Decayed and damaged wood cells in wood plug taken as part of an in-service assessment of a foundation beam. Magnification is 200x.**

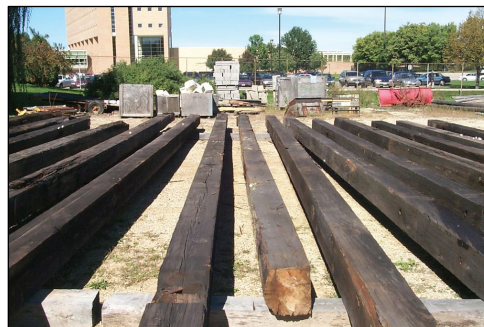
Figure 8.1—Fifteen 12- by 12-in. white pine timbers removed from the Quincy Mine Blacksmith Shop.

Fifteen 12- by 12-in. white pine timbers removed from the Quincy Mine Blacksmith Shop were transported to the USDA Forest Products Laboratory (FPL) in Madison, Wisconsin, on August 2, 2001 (Fig. 8.1). The timber specimens ranged from 25.5 to 50 ft in length; 13 of the specimens were about 50 ft long (originally used as tension members in the roof trusses) and 3 of the specimens were from 26 to 34 ft long (probably used as pitched chord or web materials). These timbers were part of the original roof structures and had been exposed to weather for several

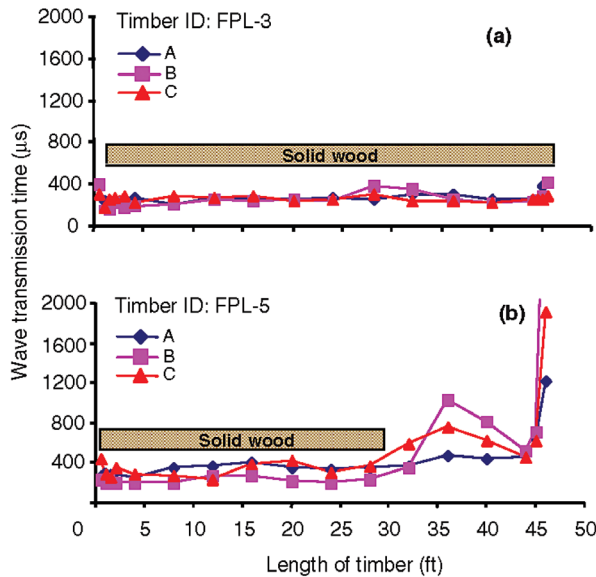
Figure 8.3.—Typical scan results from 12- by 12-in. white pine timbers.

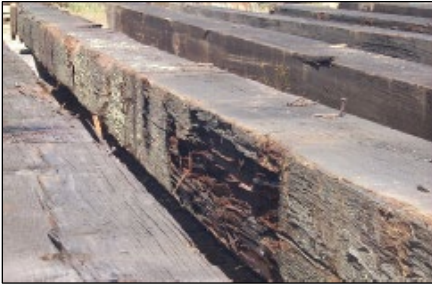
Surface decay

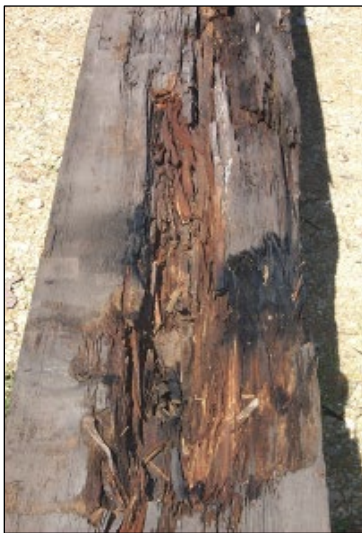
Severe decay damage

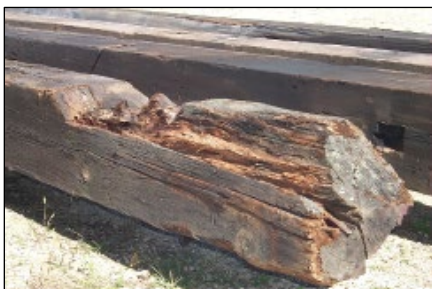
End decay

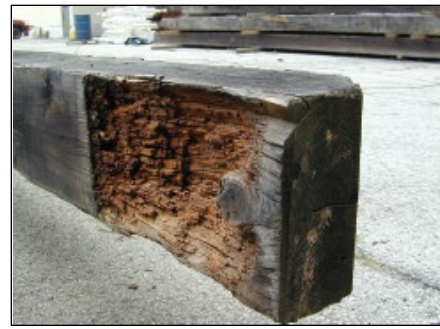
End decay

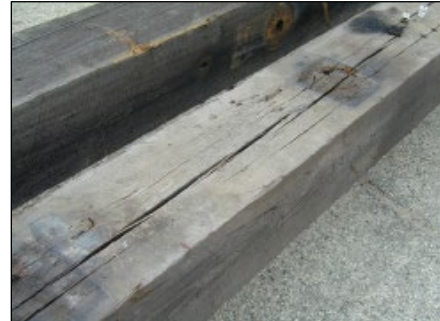
Large, deep check

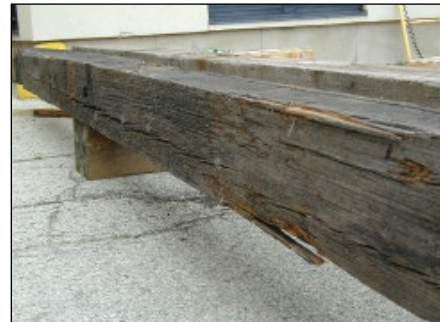
Surface decay and multiple cracks

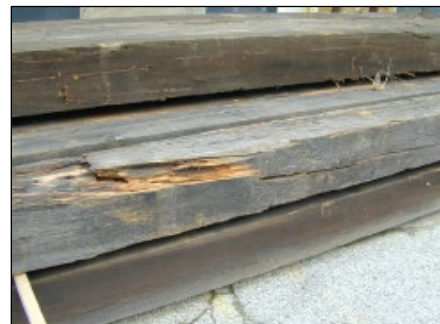
Mechanical damage

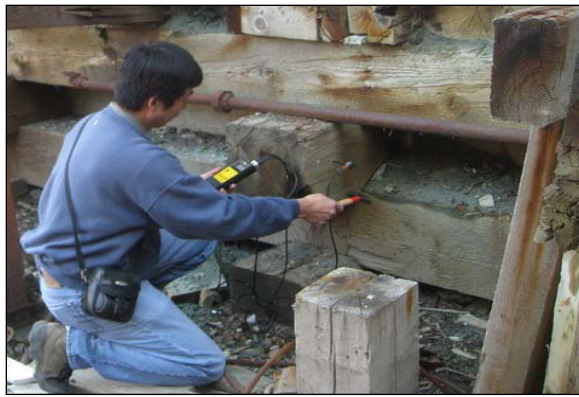
Stress wave measurements being conducted using a microsecond timer device.

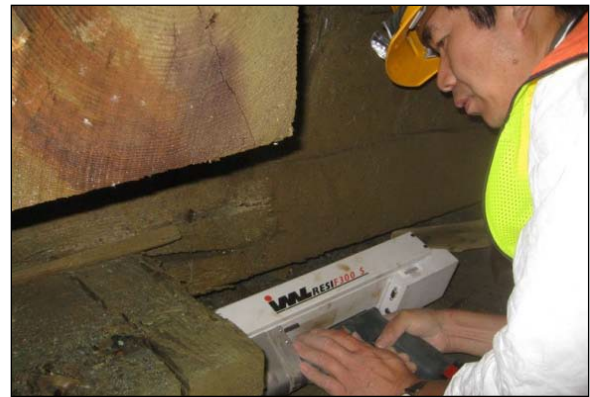
Resistance micro-drilling being performed at a foundation member.

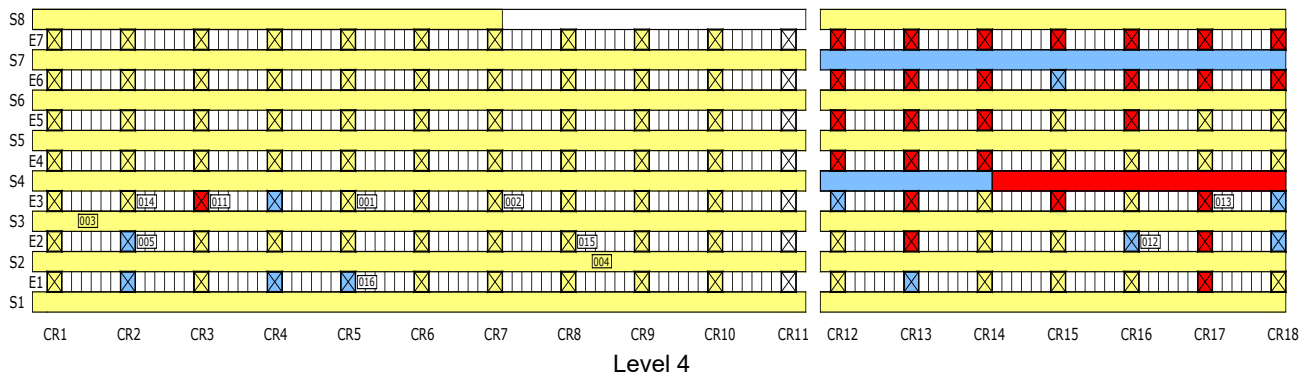
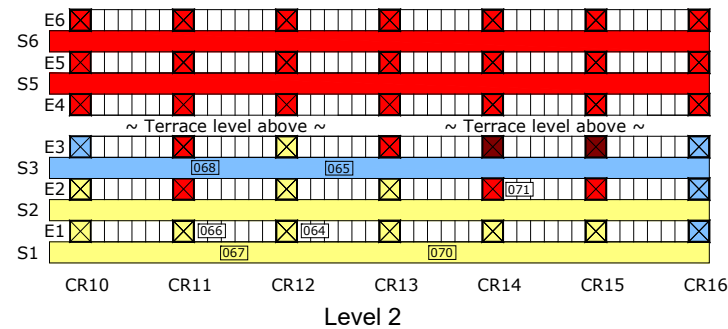
A graphical summary of stress wave scanning and resistance micro-drilling results for levels 2 and 4 of the foundation.

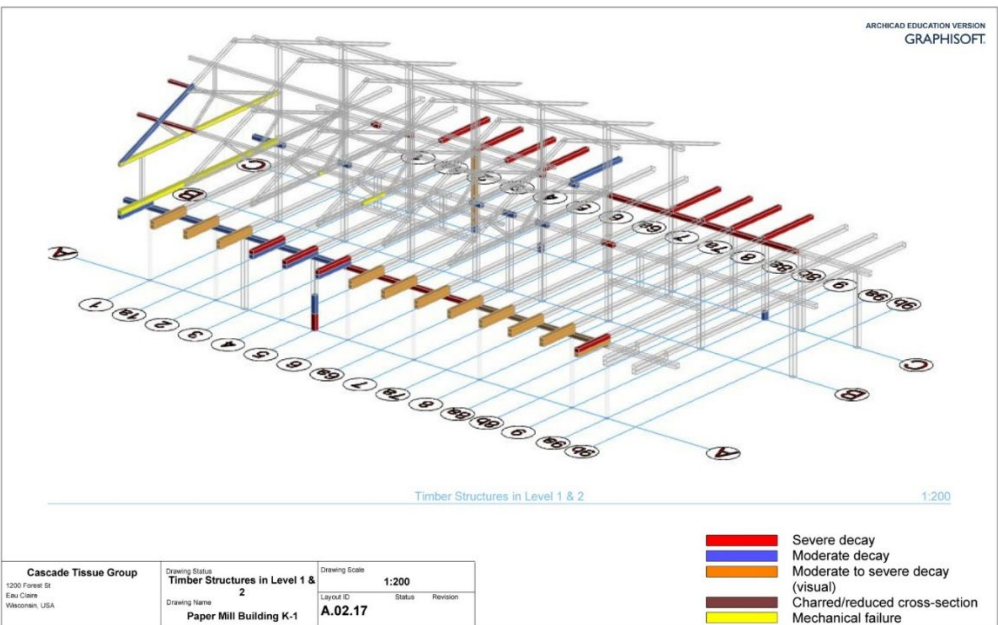
Condition map of the timber structures in levels 1 and 2 of the paper mill building.

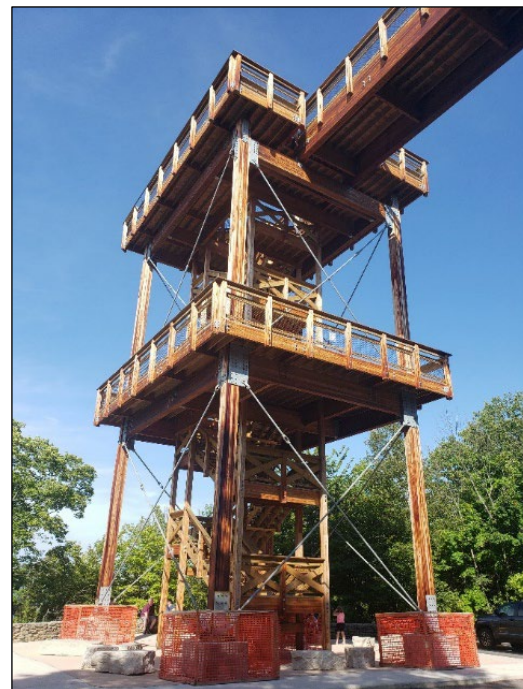
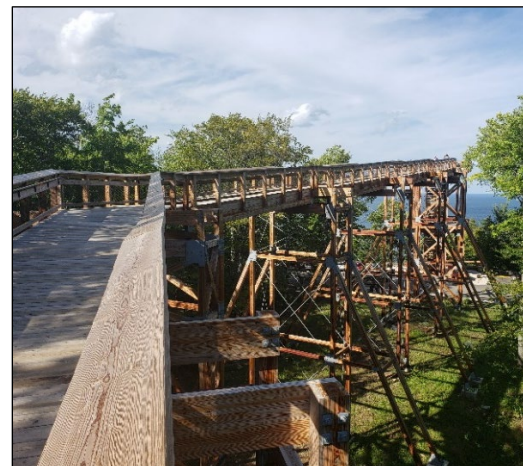
The replacement of Eagle Tower, built with glued-laminated timber, was opened in 2021.

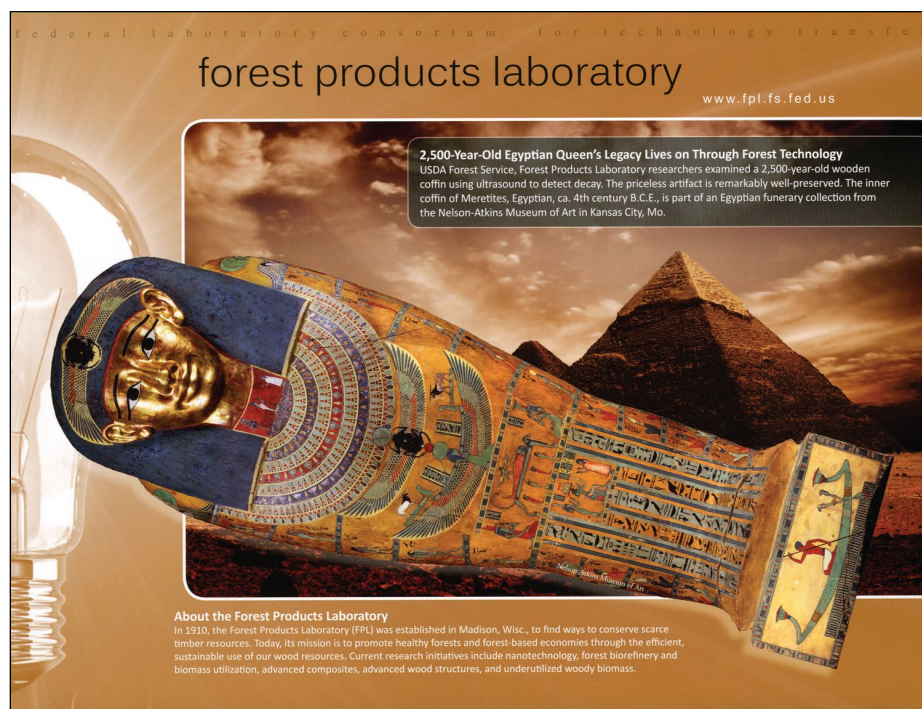
The coffin was constructed from sycamore fig trees, *Ficus sycomorosa*. This tree species was known as the “tree of life” in ancient Egypt and was cultivated commonly. Visual inspection and stress wave techniques were used to assess the condition of the upper and lower portions of the coffin. Much of the wood was solid, with no deterioration present. Estimates of several important mechanical properties were made.
