Northern Research Station | General Technical Report NRS-231 | June 2025

# Designing Flood Resilient Road-Stream Crossings: a Case Study from the July 2016 Northwest Wisconsin Flood

Dale Higgins and Deahn M. Donner

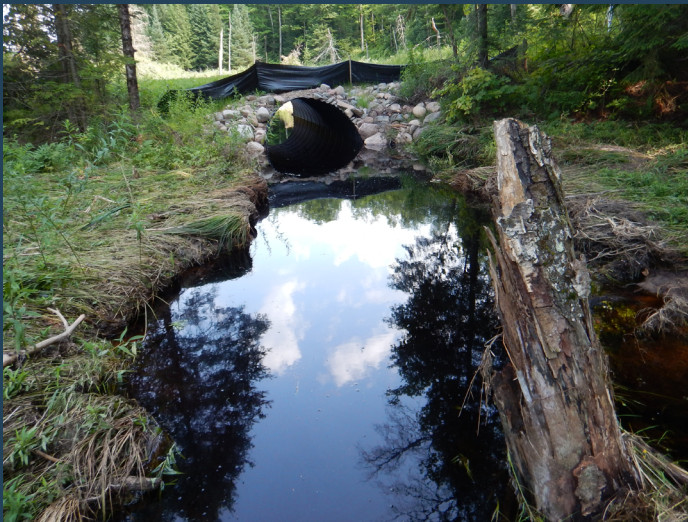
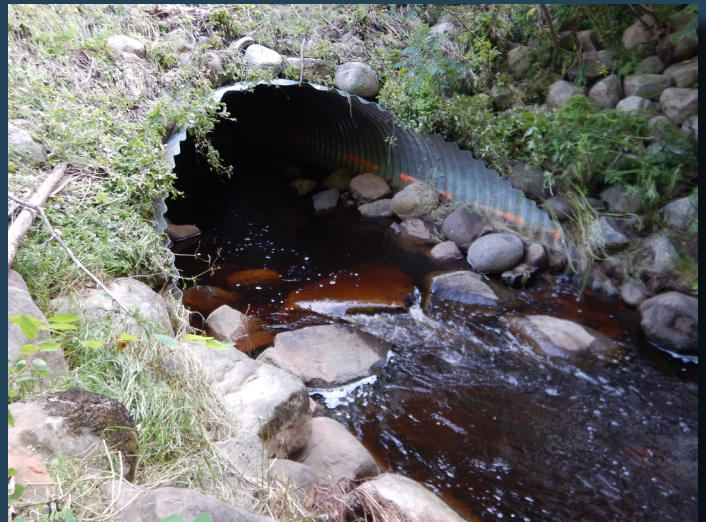
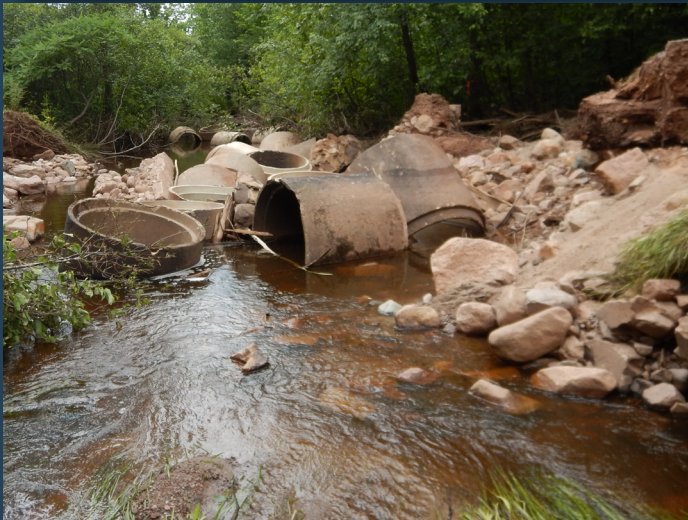
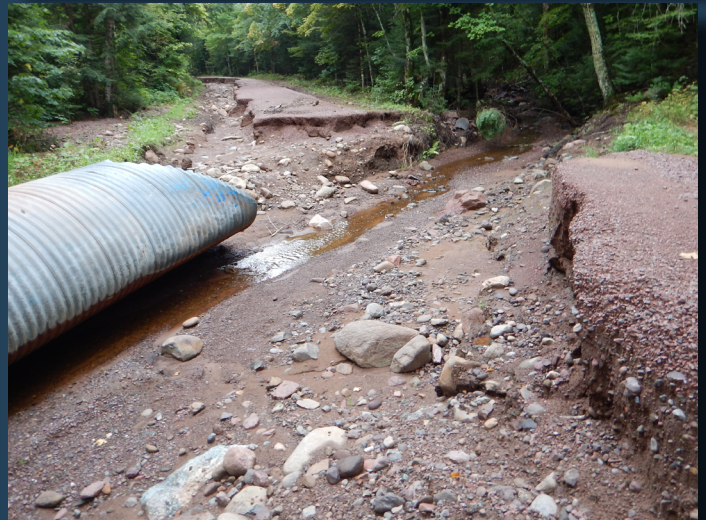
Upper left: Unnamed tributary to Morgan Falls Creek at Forest Trail 209 on July 20, 2016. The maximum water depth over trail was 0.6 feet on July 12, 2016. Upper right: Preemption Creek at Forest Road 377 on July 16, 2016. The maximum water depth over the road was 0.5 feet on July 12, 2016. Lower left: Mineral Lake Inlet at Forest Road 187 on July 17, 2016. Site failed on July 12, 2016. Lower right: Unnamed tributary to Hawkins Creek at Forest Road 383 on September 7, 2016. Site failed on July 12, 2016. USDA Forest Service photos by Dale Higgins.
