United States  
Department of  
Agriculture

Forest Service

General Technical  
Report  
PNW-101

# Evolution of Large, Organic Debris After Timber Harvest: Maybeso Creek, 1949 to 1978

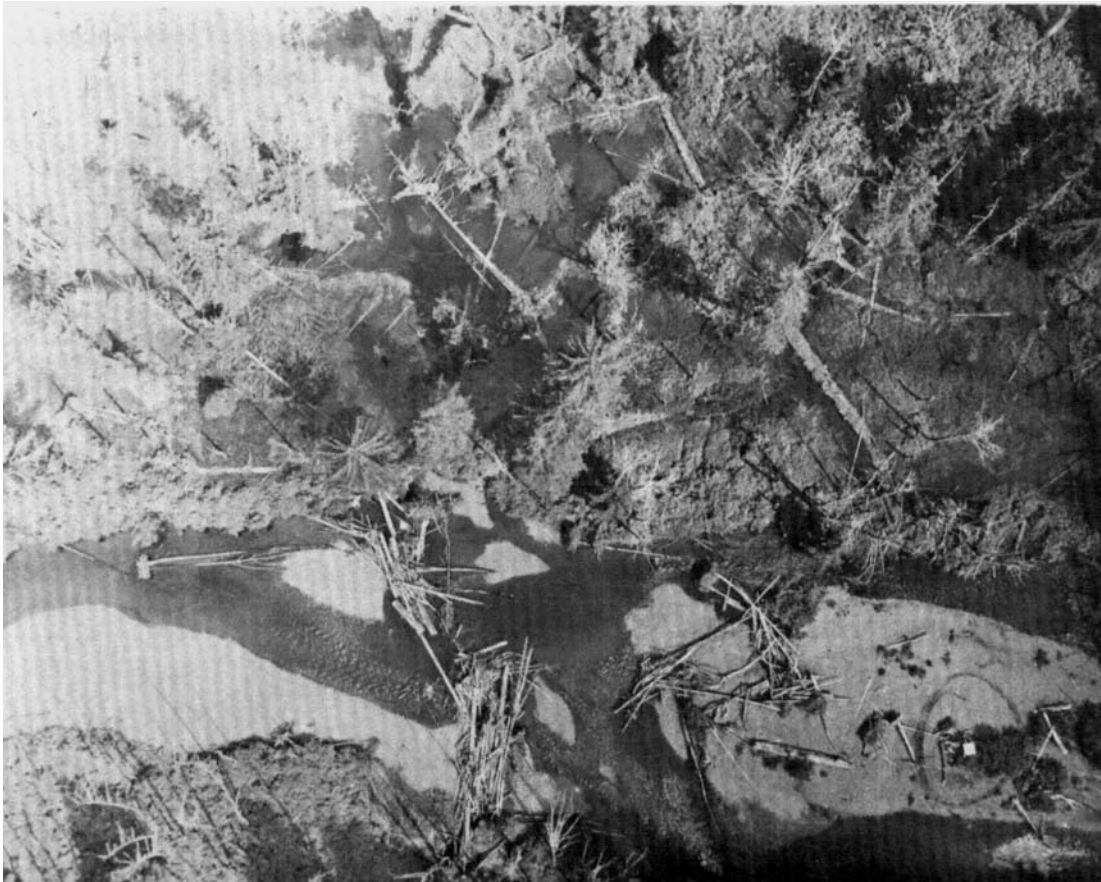
Figure 11.--Aerial photograph of map section 34, Maybeso Creek, 1961.

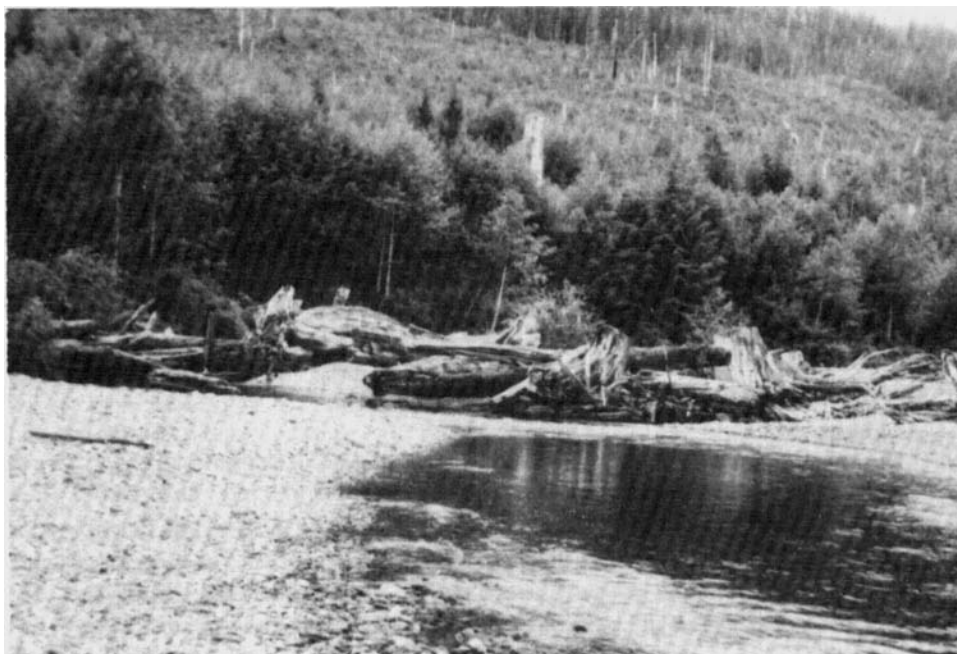
Figure 12.--Remnant accumulation of debris on a gravel bar in 1974.

Above the first 1 000 m (3,281 ft) of stream, sparse (with respect to 1960) tree-size debris accumulations occurred on gravel bars (fig. 12). These were generally above water during low or moderate flows. They appeared to be stable and, in some cases, were partially buried. It is possible that similar pieces may be embedded beneath the gravel bars (fig. 13).

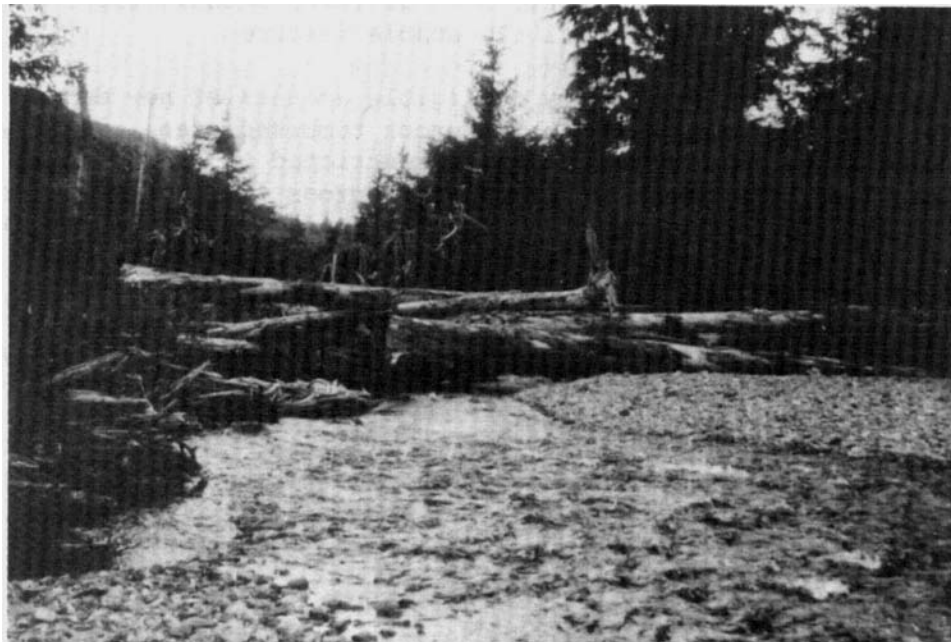
Figure 14.--Residual accumulation in 1978. Area corresponds to jam shown in the lower section in figure 6.

Accumulations remaining in 1978 in Maybeso Creek appeared relatively stable. The jam shown in the 1960 map section in figure 6 appeared little changed in 1978 (fig. 14). These areas were typically characterized by deep pools with large gravel deposits above and below the accumulations. In some cases side channels were formed, but this did not appear to be as common as indicated in the 1949 map section (fig. 6). Although local movement of gravel is likely, the major pieces of debris appeared to be well embedded, and waterflow was not severely constricted.

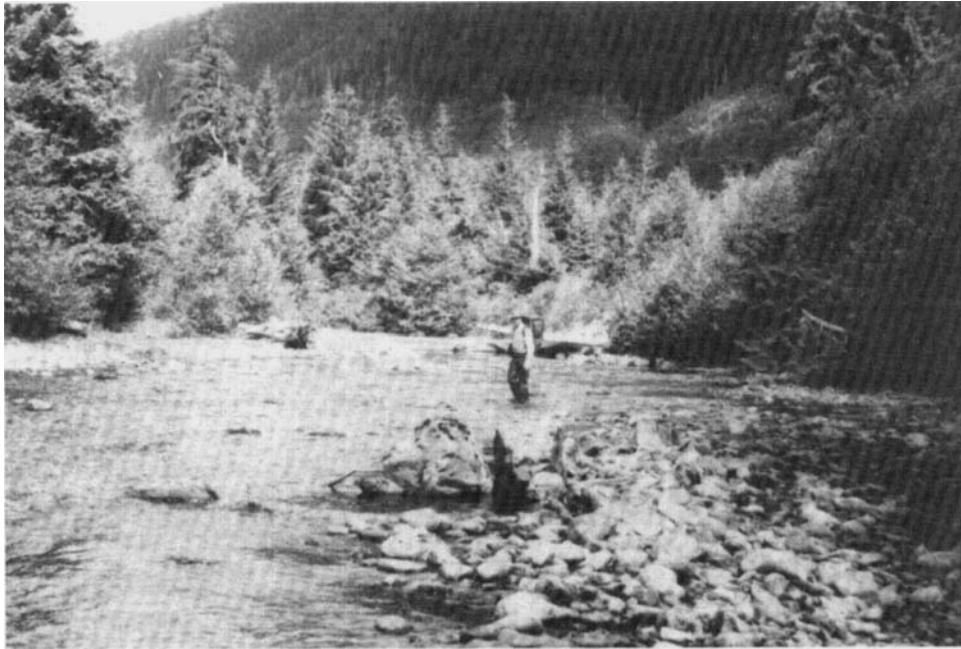
Figure 16.--View from downstream into the area shown on the map sections in figure 15.

Logging debris commonly destabilized existing natural accumulations of debris. As a result, many natural accumulations were either washed out or became so clogged that a new channel was formed. An example of this process is shown in figures 15 and 16. The 1949 map section shows a relatively sparse, extensive accumulation with a series of side channels and islands. In 1960 this section was completely choked with debris. By 1978 this area was rechanneled into a relatively straight riffle section shown by the dashed line in figure 15. Figure 16 shows a view of the area in 1978.

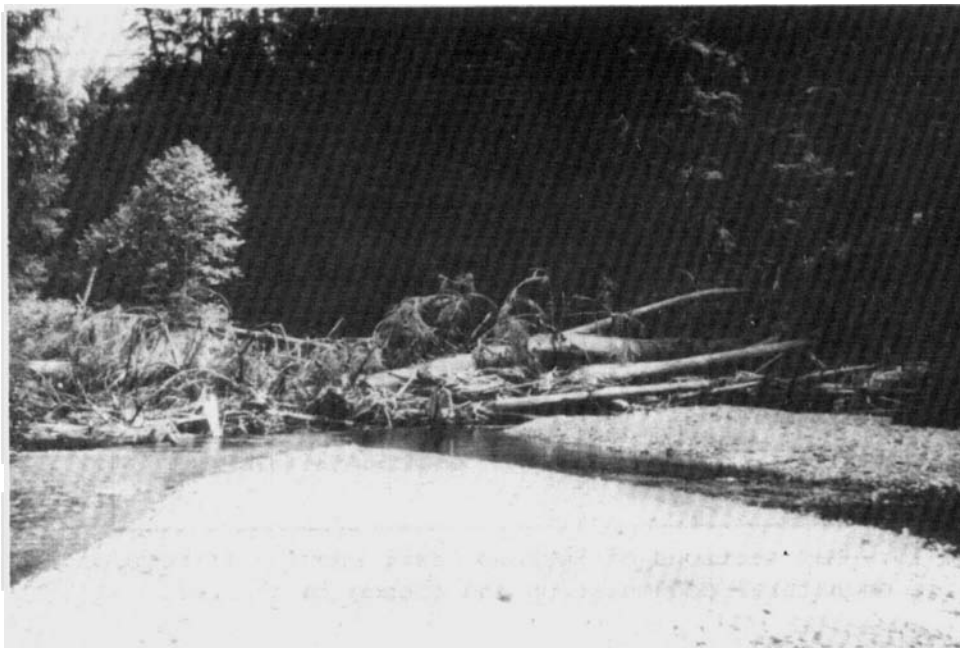
Figure 17.--Input of large debris to Maybeso Creek observed in 1978.

Throughout the cut areas, only negligible amounts of new debris after logging were observed. In the uncut timbered area, new blowdown was evident (fig. 17). New debris was restricted to less than 20 m of the stream length but extended completely across the channel. The effect on the stream is partly illustrated in figure 17 by the buildup of gravel in the foreground. In addition, logging debris was collecting in the jam. Individual logs from the 150 road bridge, which was located approximately 2 000 m (6,562 ft) upstream, were observed in the jam. The area around the jam appeared to be active, with bank cutting along the north side and scour under the jam. No evidence of braiding was observed.

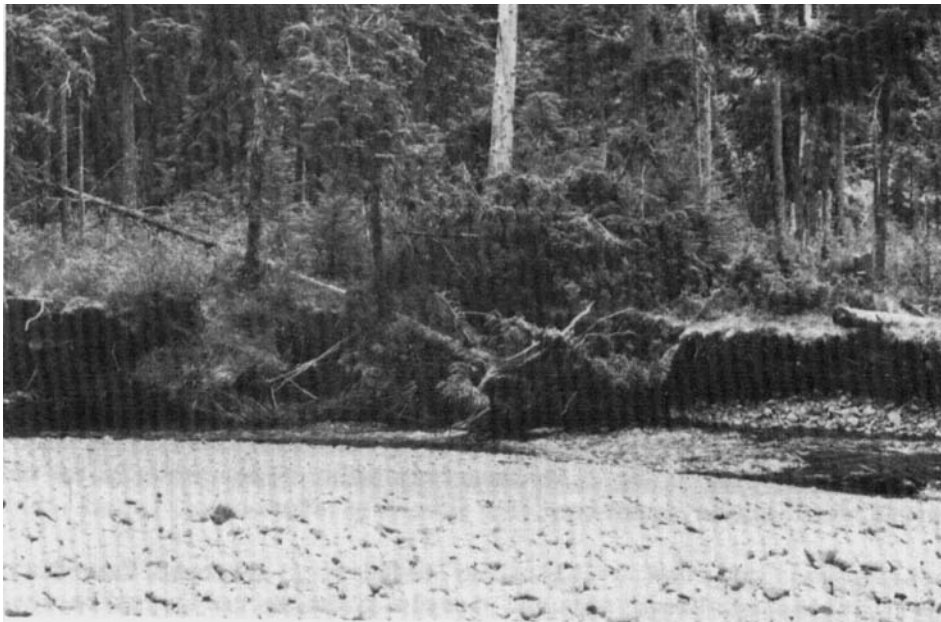
Figure 18.--Illustration of streambank undercutting along Maybeso Creek in 1978.

Figure 18 shows the primary large debris input to Maybeso Creek following logging. Bank cutting has tipped small hemlock into the stream. This material is easily floated and will not appear as a stable feature as did the large spruce and hemlock blowdown shown throughout the 1960 map sections. It is apparent that small, young hemlock and alder do not replace old-growth Sitka spruce and hemlock as a source of large debris.
