Forest Products Laboratory | Research Note FPL-RN-433 | July 2026

# Condition Assessment of a 55-year-old Glued-laminated Timber Arch: Nondestructive Evaluation and Toughness Test Results

The subject of this report is a timber footbridge constructed during the 1960s to connect two buildings on the FPL campus. The main supporting members were glulam arches manufactured by Sentinel Structures (Peshtigo, WI, USA) from southern pine dimension lumber (Fig. 1). A structural condition assessment of the arches was performed in 1997. After deconstruction of the bridge in 2024, the ends of

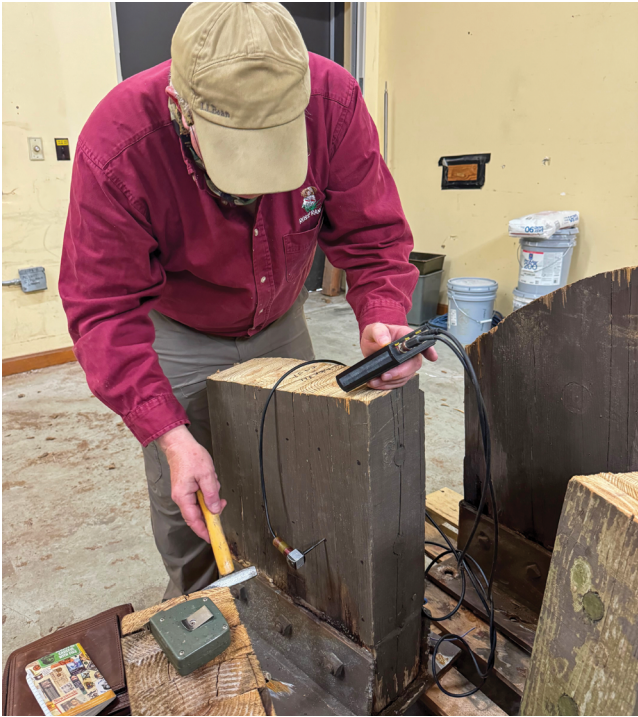
**Figure 3.**—Nondestructive testing of arch end sections (stubs). Courtesy photo by Laurice M. Spinelli Correa.

**2024 Inspection**—The footbridge was deconstructed in 2024. During deconstruction, the ends of each arch were cut and placed in a conditioned space at FPL. In June of that year, specimens were transported from FPL to Mississippi State University for testing on the same arch ends that were tested in 1997 (Fig. 3). Each end was nondestructively tested using the 1997 inspection method. The 1997 and 2024 inspections yielded comparable results.

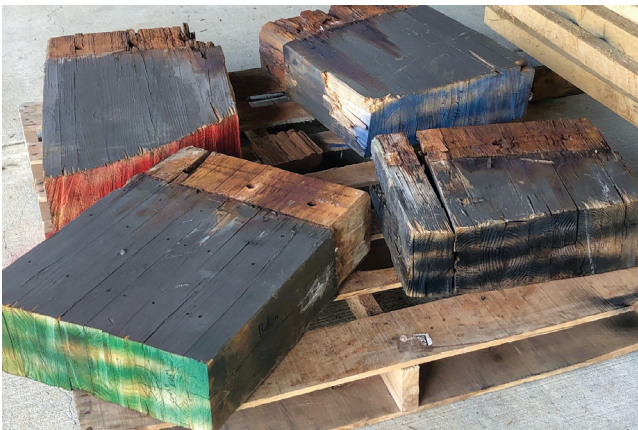
**Figure 4.**—Glulam stubs after steel anchorage shoe removal and color coding. Courtesy photo by Laurice M. Spinelli Correa.

black to correspond to the original location of arch ends and preserve identification throughout processing (Table 2). Figure 4 shows the stubs after steel anchorage shoe removal and color coding. Stubs were stored in an outdoor protected shed, where the approximate equilibrium moisture content was 12 to 16 percent.

A visual inspection showed that the southwest stub had heavy deterioration and delamination; however, the constituent pieces were maintained in order throughout, so the original shape of the stub was preserved. The northeast stub had significant deterioration in two laminae that were otherwise covered by the steel anchorage shoe. The stubs had dot markings that indicated the locations of the time of flight measurements. In each stub, five laminae had time of flight measurements. The time of flight measurement scheme is shown in Figure 5. Note that due to the length of the specimen stub, no evaluation was conducted at 12 in. for the southwest stub.

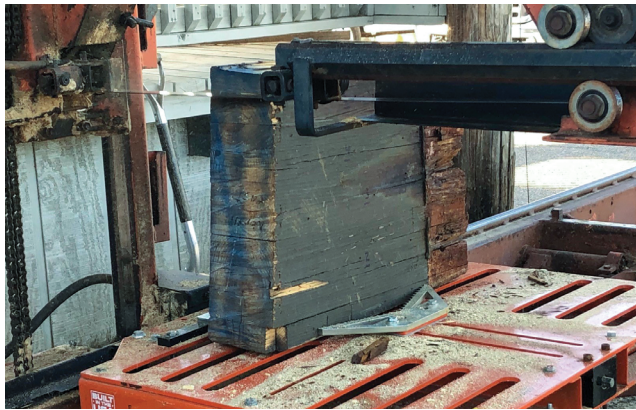
**Figure 6.**—Glulam stub on the bandsaw mill during lamina-of-interest recovery. Courtesy photo by Laurice M. Spinelli Correa.

Sawmilling was required to reduce the stubs to their five constituent laminae of interest. The goal of the sawmilling process was to remove these five laminae from each of the stubs in order to produce toughness specimens from the same five laminae on which time of flight measurements had been made. Stubs were band sawn on July 2, 2024. For specimen preparation, stubs were placed on a portable bandsaw mill. Layer by layer, the time of flight laminae were removed and reserved. Figure 6 illustrates one stub on the bandsaw mill. Figure 7 illustrates the laminae of interest recovered after bandsaw milling.

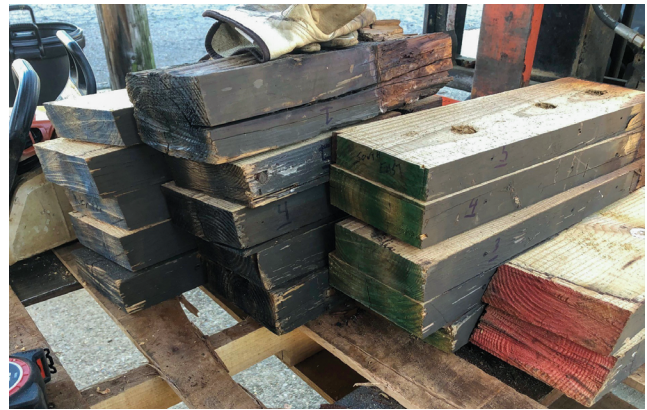
**Figure 7.**—Laminae of interest during recovery and sorting while bandsaw milling. Courtesy photo by Laurice M. Spinelli Correa.

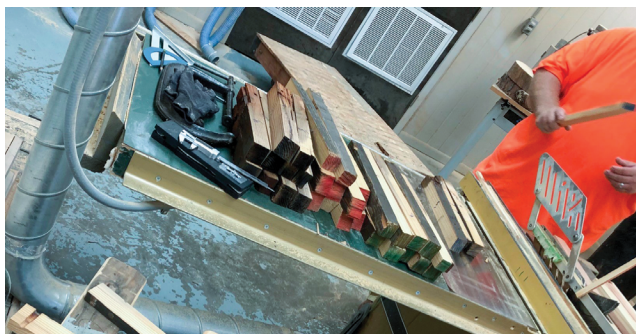
**Figure 8.**—Ripping operation by which 0.79 by 0.79 in. cross sectional toughness specimen blanks were recovered from each lamina of interest. Courtesy photo by Laurice M. Spinelli Correa.

Next, toughness specimens were machined from the laminae of interest. Figure 8 illustrates the ripping process by which cross section toughness specimens measuring approximately 0.79 by 0.79 in. were recovered from the laminae. Many of the laminae were split at mid width, and many had previous inspection or fumigation holes at mid width. Effort was made to recover one specimen from each edge of each lamina, which yielded two toughness specimens per lamina (most laminae yielded two clear specimens). A total of 40 toughness specimens were produced (four stubs, each with five laminae of interest and two toughness specimen laminae). While the arches were subjected to compression forces in-service, toughness was chosen to evaluate degree of deterioration because it has been shown to be the most sensitive to deterioration from decay (Table 1).

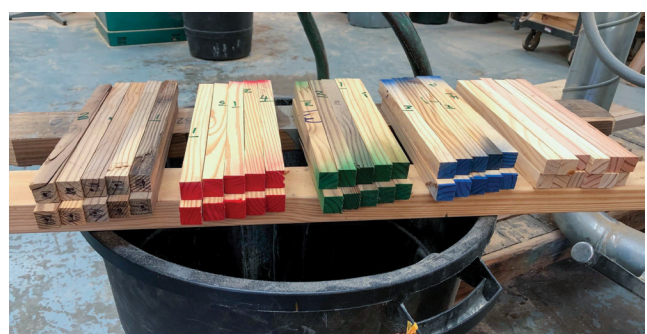
**Figure 9.**—Toughness specimens after processing, prior to moisture conditioning at 12 percent equilibrium moisture content. Courtesy photo by Laurice M. Spinelli Correa.

In some cases, additional processing was required to remove warp, cross grain, or other potentially strength-reducing characteristics. Once the specimen blanks were ripped, each specimen was crosscut to the requisite 11-in. length and the ends repainted. Figure 9 shows the specimens after machining and repainting. Specimens were then placed in an environmental chamber for moisture conditioning at approximately 70 °F (21.11 °C) and 12 percent equilibrium moisture content for approximately 30 days.
