# CALIFORNIA FORESTRY NOTE

No. 120

## STATE FOREST ROAD 600: A RIPARIAN ROAD DECOMMISSIONING CASE STUDY IN JACKSON DEMONSTRATION STATE FOREST

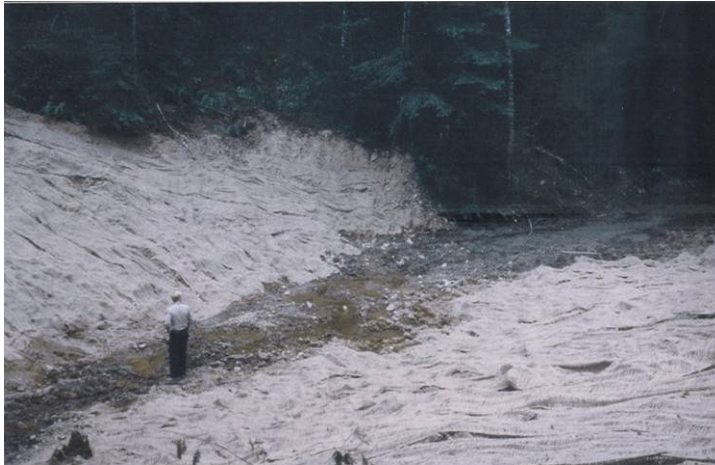
**Figure 2. Excavated crossing CX-21 with jute netting on side slopes, November 1998.**

Jackson Demonstration State Forest contracted for the decommissioning of 4.6 km (2.8 mi) of South Fork Caspar road segments in 1998 with an addendum to a timber sale agreement. Contract specifications required that stream crossings be excavated to the depth of the original channel, with side bank slopes not to exceed 50%. Jute netting was required to be installed for erosion control within 30 m (100 ft) of the well-defined channel area. Additionally, the contract specified that conifers were to be planted at a 3 m by 3 m (10 ft) spacing within the area covered by jute netting (figure 2).

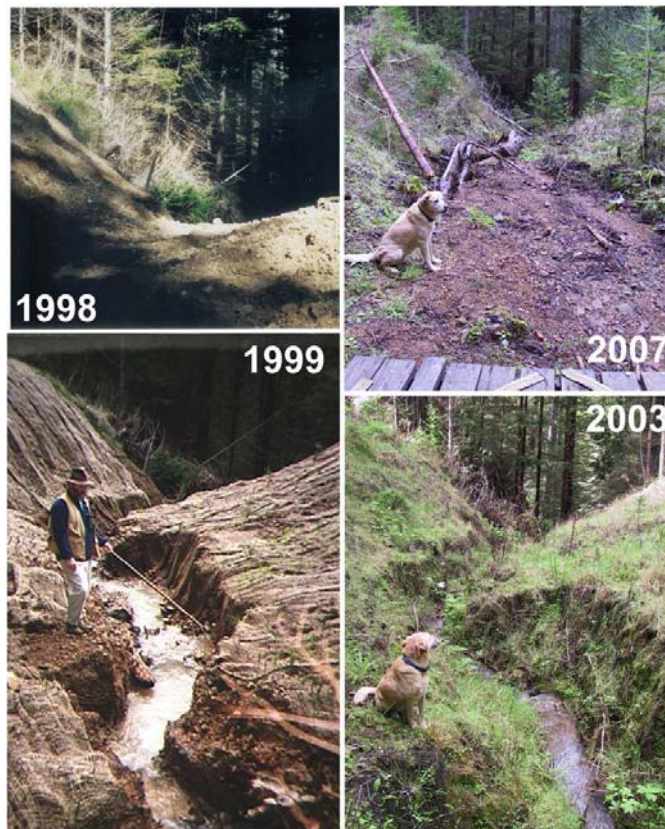
**Figure 3. Treated crossing CX-7 eroded severely and has yet to stabilize. In 2006, a debris flow deposit filled much of the void.**

After one winter, evidence of channel downcutting, gully erosion, and mass wasting was apparent (figure 3). Gully erosion measured at 32 sites totaled 651 m<sup>3</sup> (851 yd<sup>3</sup>), with approximately half of this erosion occurring at just four sites--an eroded volume approximating four percent of the total fill removed (651 m<sup>3</sup>/17,900 m<sup>3</sup>). Erosion was negligible along the outsloped road surface and at most cross-drain locations.
